Expansion of Research and Residential Facilities for The Swire Institute of Marine Science, Faculty of Science, The University of Hong Kong at Cape d' Aguilar, Shek O, Hong Kong Submission of Monthly Environmental Monitoring and Audit Report No.29

MONTHLY ENVIRONMENTAL MONITORING AND AUDIT

(EM&A) REPORT (NO. 29)

Expansion of Research and Residential Facilities for the Swire Institute of Marine Science, The University of Hong Kong at Cape D'Aguilar, Shek O

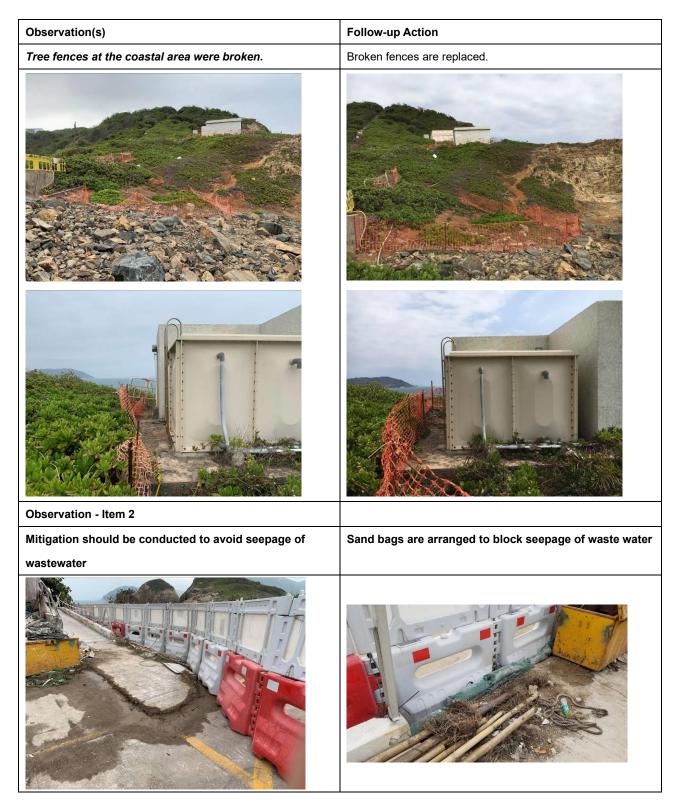
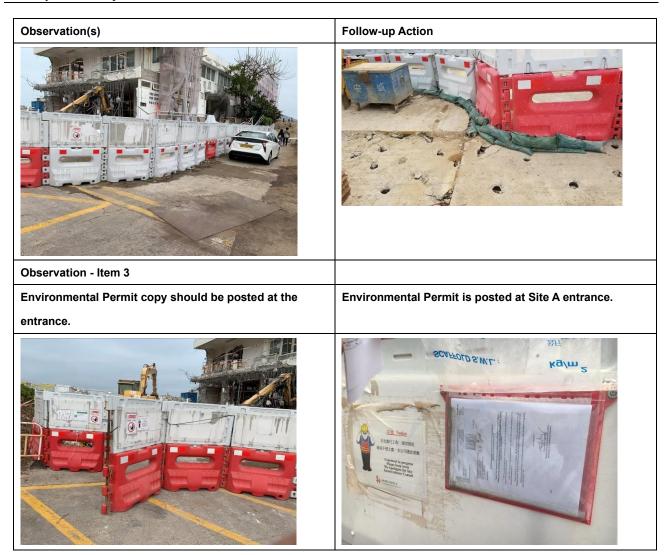
Table 2-3: Site Observations

- 2.4.1. Site inspection was carried out on a monthly basis to monitor the implementation of mitigation measures under the Contract. In the reporting period, site inspection was carried out on 24 February 2020.
- 2.4.2. Minor deficiencies were observed during site inspection. Key observations during the site inspections are summarized in Table 2-3.

- 2.4.3. TYSAN has rectified all observations identified during environmental site inspection in the reporting period.
- 2.4.4. Ecology and landscape and visual monitoring had been conducted on 29 February 2020. As reported by Qualified Ecologist, observations and recommendation are summarised as below
- 2.4.5. There is no change in form, health & structural condition and amenity value for all six recorded species of plant species of conservation importance.
- 2.4.6. Severe damage caused by Typhoon Mangkhut in September 2018 to the coastal vegetation remained. No *Lysimachia mauritiana* (濱海珍珠菜) could be observed in one of the protection zone near Academic Block (Site A) over 18 months. The original plants in this zone have certified as dead. The two rediscovered individuals kept growing in other protection zones, with some seedlings observed in vicinity (Plate 1).

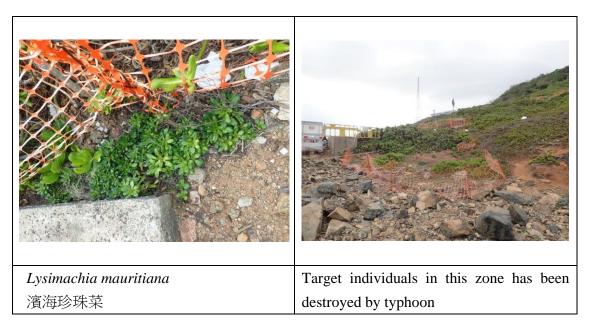
Plate 1. Photographic records of the six recorded plants species of conservation importance with protection zone.

- 2.4.7. *Pittosporum tobira* (海桐) has shown slight dieback of twigs, with regeneration of young leaves; while surrounding invasive species (*Leucaena leucocephala* and *Lantana camara*) still existed. Clearance within the protection zone has been conducted.

- 2.4.8. Another invasive species *Bidens alba* has also rapidly grown and covering the growing area of *Vitis bryoniifolia* (蘡薁). Clearance within the protection zone has been conducted. No leaves could be observed for this deciduous climber during this monitoring.
