Expansion of Research and Residential Facilities for The Swire Institute of Marine Science, Faculty of Science, The University of Hong Kong at Cape d' Aguilar, Shek O, Hong Kong Submission of Monthly Environmental Monitoring and Audit Report No.30

MONTHLY ENVIRONMENTAL MONITORING AND AUDIT

(EM&A) REPORT (NO. 30)

Expansion of Research and Residential Facilities for the Swire Institute of Marine Science, The University of Hong Kong at Cape D'Aguilar, Shek O

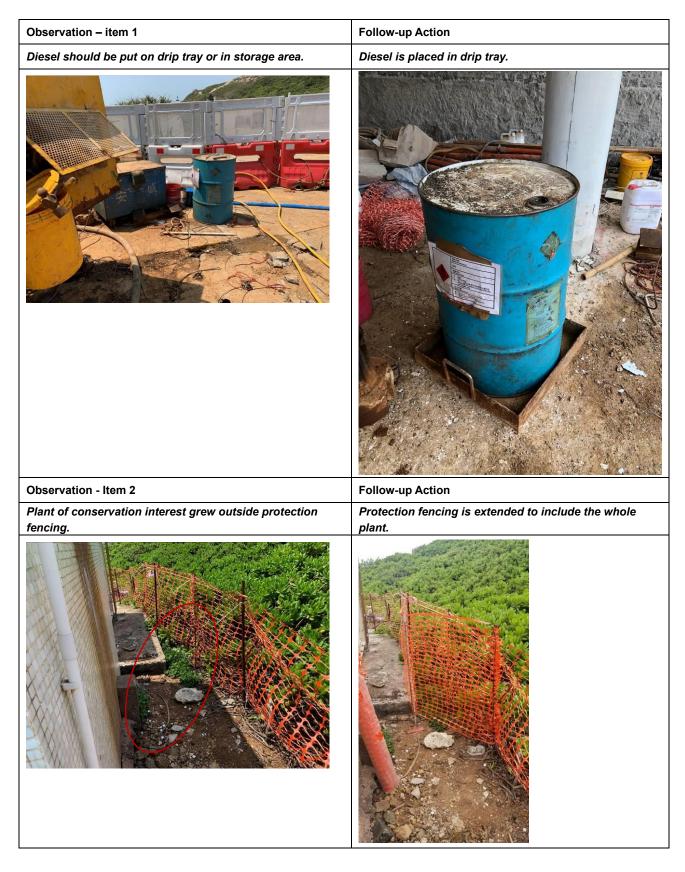
Table 2-3: Site Observations

- 2.4.3. TYSAN has rectified all observations identified during environmental site inspection in the reporting period.
- 2.4.4. Ecology and landscape and visual monitoring had been conducted on 3 April 2020. As reported by Qualified Ecologist, observations and recommendation are summarised as below

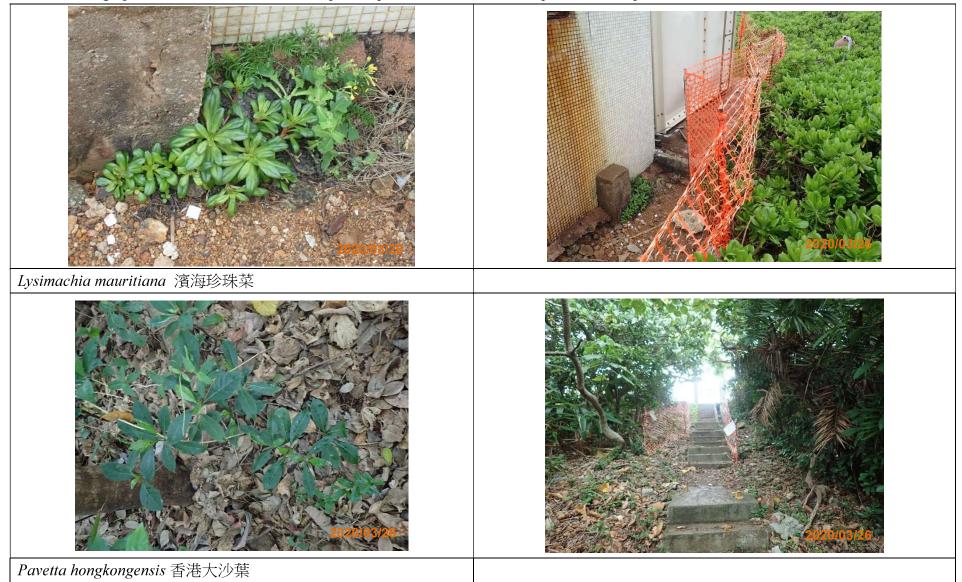
PLATE 1: Photographic Records of the Six Recorded Plants Species of Conservation Importance with Protection Zone. Plate 1. Photographic records of the six recorded plants species of conservation importance with protection zone.

- 2.4.5. There is no change in form, health & structural condition and amenity value for all six recorded species of plant species of conservation importance.

- 2.4.6. Severe damage caused by Typhoon Mangkhut in September 2018 to the coastal vegetation remained. No *Lysimachia mauritiana* (濱海珍珠菜) could be observed in one of the protection zone near Academic Block(Site A) over 18 months. The original plants in this zone have certified as dead. The two rediscovered individuals kept growing in other protection zones, with some seedlings observed in vicinity (**Plate 1**).

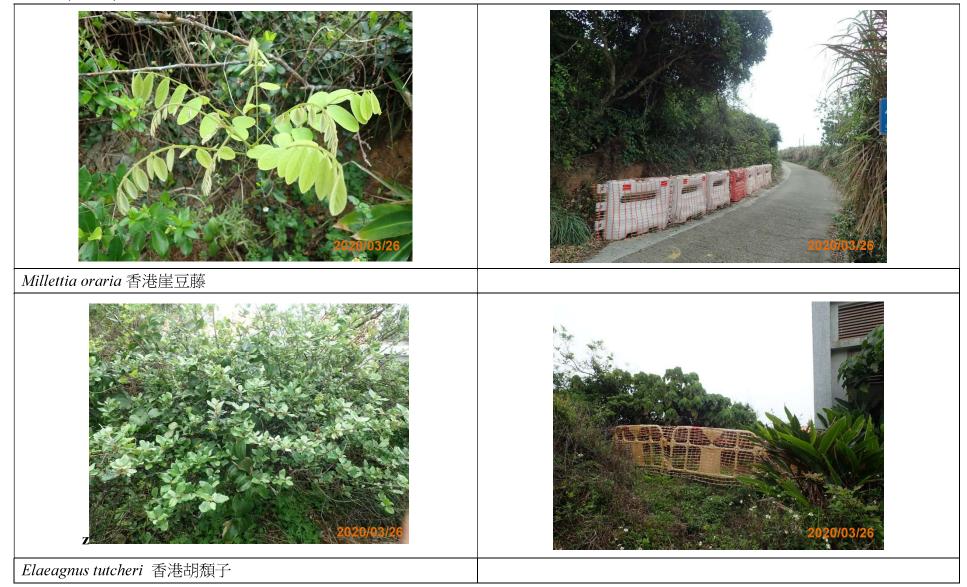
Plate 1 (cont'd).

- 2.4.7. Pittosporum tobira (海桐) has shown slight die back of twigs, with regeneration of young leaves; while surrounding invasive species (Leucaena leucocephala and Lantana camara) still existed (Plate 1). Clearance within the protection zone has been conducted.

- 2.4.8. Another invasive species *Bidens alba* has also rapidly grown and covering the growing area of *Vitis bryoniifolia* (蘡薁). Clearance within the protection zone has been conducted. New young leaves could be observed for this deciduous climber during this monitoring.

<i>Pittosporum tobira</i> 海桐	Collapsed fencing to be rectified
Vitis bryoniifolia 蘡薁

- 4.1.6. Protection zone has been provided in accordance with Condition 2.6 of the Environmental Permit. Any damage of the protection zone (e.g. due to coastal weather condition or disturbance of hikers and visitors) should be repaired promptly. Warning sign should be maintained at prominent positions within the works area to encourage hikers and visitors keeping away from any no-entry area or protection zone.
