**Expansion of Research and Residential Facilities for
The Swire Institute of Marine Science, Faculty of Science,
The University of Hong Kong at Cape d' Aguilar, Shek O, Hong Kong
Submission of Monthly Environmental Monitoring and Audit Report No.31**

**MONTHLY ENVIRONMENTAL MONITORING AND AUDIT
(EM&A) REPORT (NO. 31)**

**Expansion of Research and Residential Facilities for the Swire Institute of
Marine Science, The University of Hong Kong at Cape D'Aguiar, Shek O**

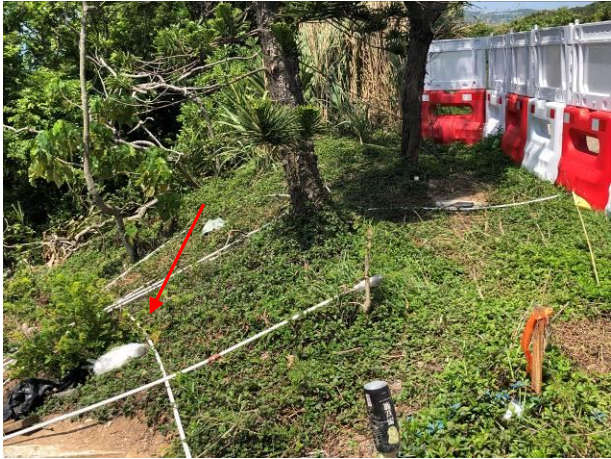
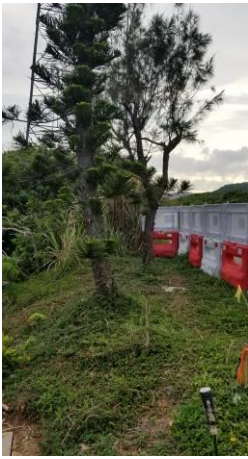
Observation(s) on 28 April 2020	Follow-up Action
<p>Observation – Item 1</p> <p><i>General refuse was disposed inside the tree protection zone near the dormitory.</i></p>	<p>Rectified by HKU site contractor on 2 May 2020</p> <p><i>Refuse is cleared away from tree protection zone at Site F.</i></p>

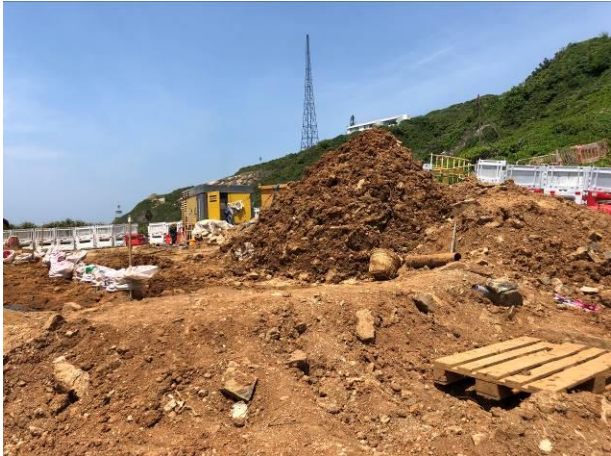
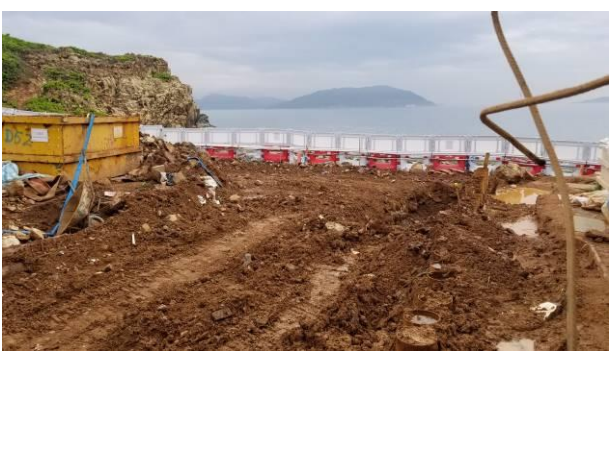
<p>Observation - Item 2</p> <p><i>Stockpile should be covered by tarpaulin</i></p>	<p>Rectified by HKU site contractor on 6 May 2020</p> <p><i>Stockpile has been removed.</i></p>

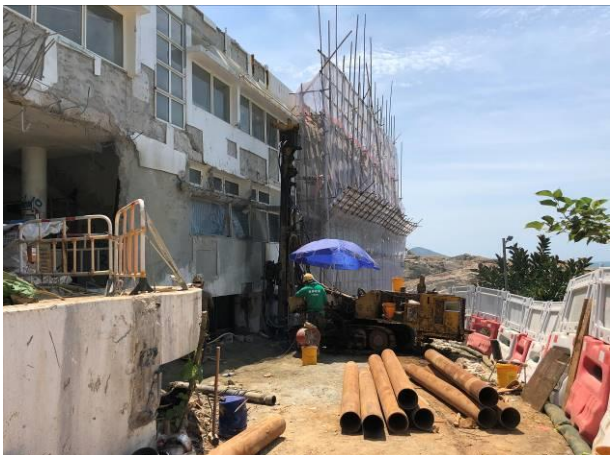
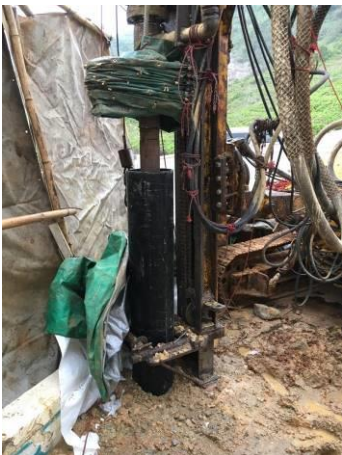
<p>Observation - Item 3</p> <p><i>Acoustic barrier should be provided for piling work.</i></p>	<p>Rectified by HKU site contractor on 2 May 2020</p> <p><i>Acoustic barrier is provided.</i></p>

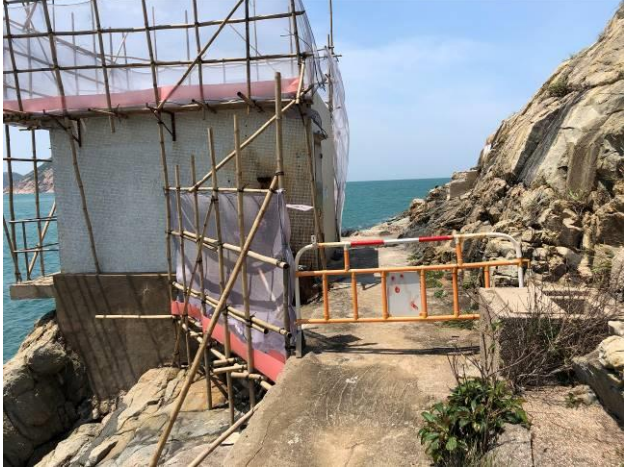
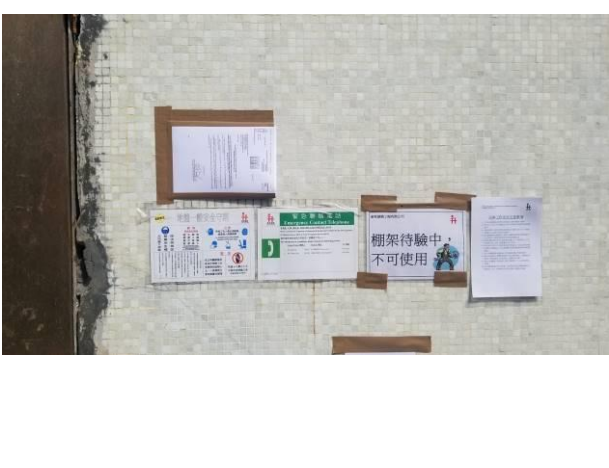
Observation(s) on 28 April 2020	Follow-up Action
Observation - Item 4	Rectified by HKU site contractor on
EP copy should be displayed at the entrance of site area of the pump house.	EP copy is displayed at Site D entrance.

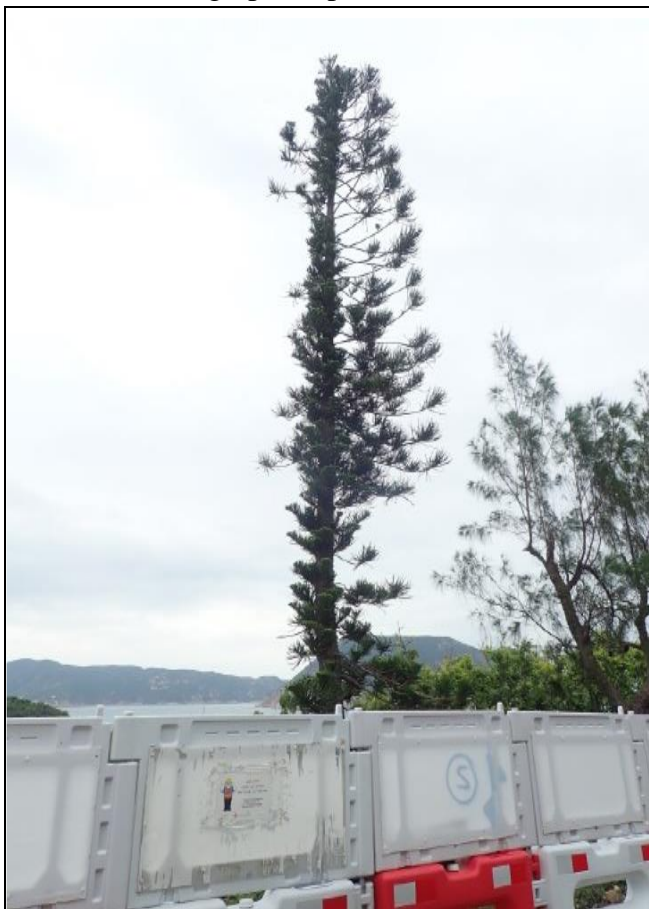
No change in condition of T5 from previous monitoring.

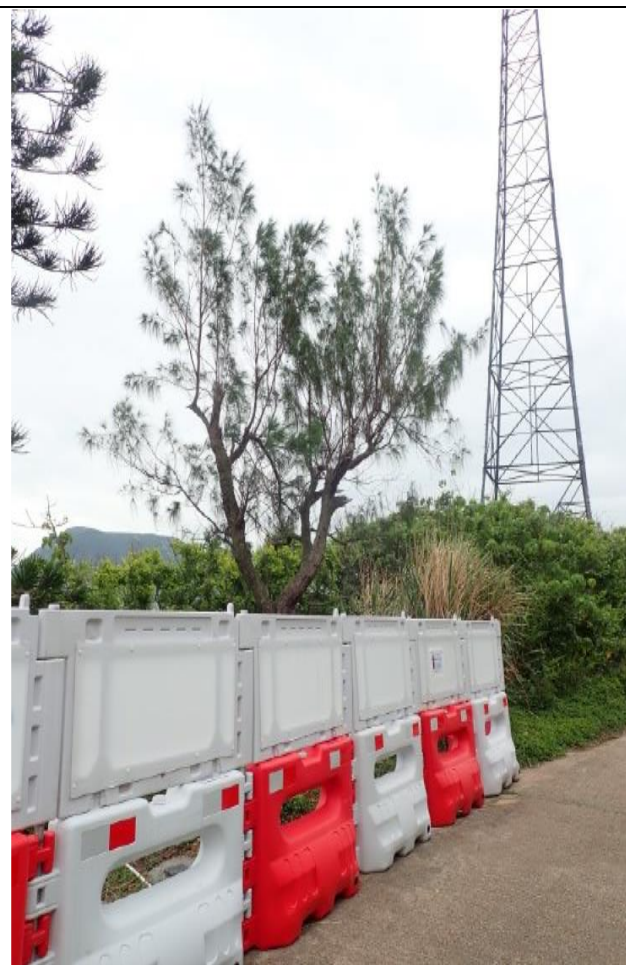
No change in condition of T6 from previous monitoring.

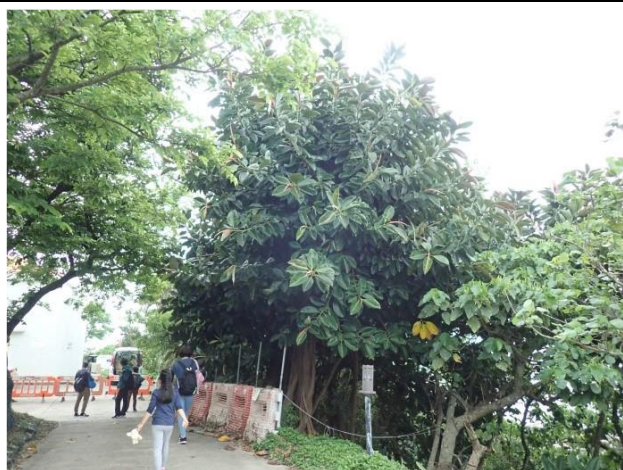
- 2.4.9. For the three retained trees, there is no change in overall condition of T5, T6 and TA; while broken branches in TA due to the typhoon damage should receive appropriate assessment and treatment. There is no update on compensatory planting after felling of the 15 approved trees. Corresponding photographic records of T5, T6 and TA are illustrated in **Plate 2**.

No change in condition of TA from previous monitoring.

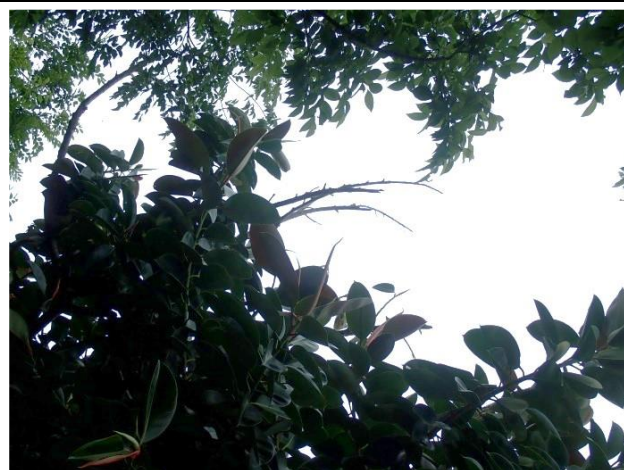
Damages by the Typhoon Mangkhut remained on TA.

- 4.1.8. Broken branches in the retained tree TA due to the typhoon damage remained. Relevant authority shall be contacted for appointing a Certified Arborist or equivalent to conduct a Tree Risk Assessment (TRA) on this tree, in order to get Lands Department's approval on taking corresponding actions (e.g. pruning). Once the TRA appointment is confirmed, good written and photographic records (e.g. personal, date and time, actions, etc.) should be made before, during and after any actions of treatment for the assessed tree (i.e. TA)
