Environmental Permit (No. EP-537/2017)

**Expansion of Research and Residential Facilities for  
The Swire Institute of Marine Science, Faculty of Science,  
The University of Hong Kong at Cape d' Aguilar, Shek O, Hong Kong  
Submission of Monthly Environmental Monitoring and Audit Report No.32**

**MONTHLY ENVIRONMENTAL MONITORING AND AUDIT  
(EM&A) REPORT (NO. 32)**

**Expansion of Research and Residential Facilities for the Swire Institute of  
Marine Science, The University of Hong Kong at Cape D'Aguilar, Shek O**

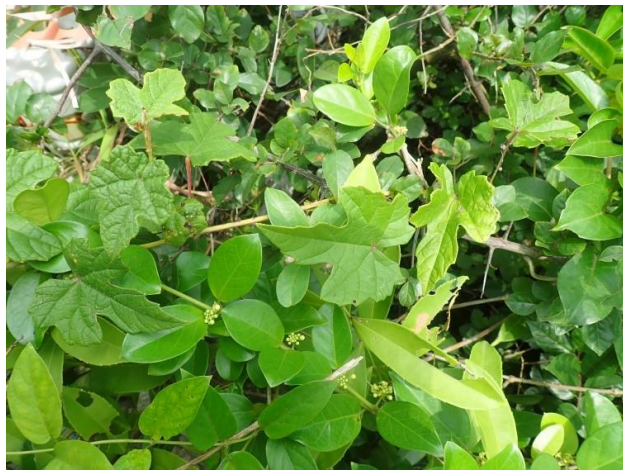
- 2.4.4. There is no change in form, health & structural condition and amenity value for all six recorded plant species of conservation importance.
- 2.4.5. Severe damage caused by Typhoon Mangkhut in September 2018 to the coastal vegetation remained. No *Lysimachia mauritiana* (濱海珍珠菜) could be observed in one of the protection zone near Academic Block (Site A) over 20 months. The original plants in this zone have certified as dead. The two rediscovered individuals kept growing in other protection zones, with some seedlings observed in vicinity (Plate 1).

- 2.4.6. *Pittosporum tobira* (海桐) has shown slight dieback of twigs, with regeneration of young leaves; while surrounding invasive species (*Leucaena leucocephala* and *Lantana camara*) still existed. Clearance within the protection zone has been conducted.

- 2.4.7. Another invasive species *Bidens alba* has also rapidly grown and covering the growing area of *Vitis bryoniifolia* (蓼藎). Clearance within the protection zone has been conducted. Leaves could be observed for this deciduous climber during this monitoring.

*Vitis bryoniifolia* 蓊藎

- 4.1.5. However re-establishment of *Lysimachia mauritiana* (濱海珍珠菜) is ongoing. The two rediscovered individuals kept growing in other protection zones, with some seedlings observed in vicinity. Building up additional assurance colonies by collecting seeds may still be feasible.

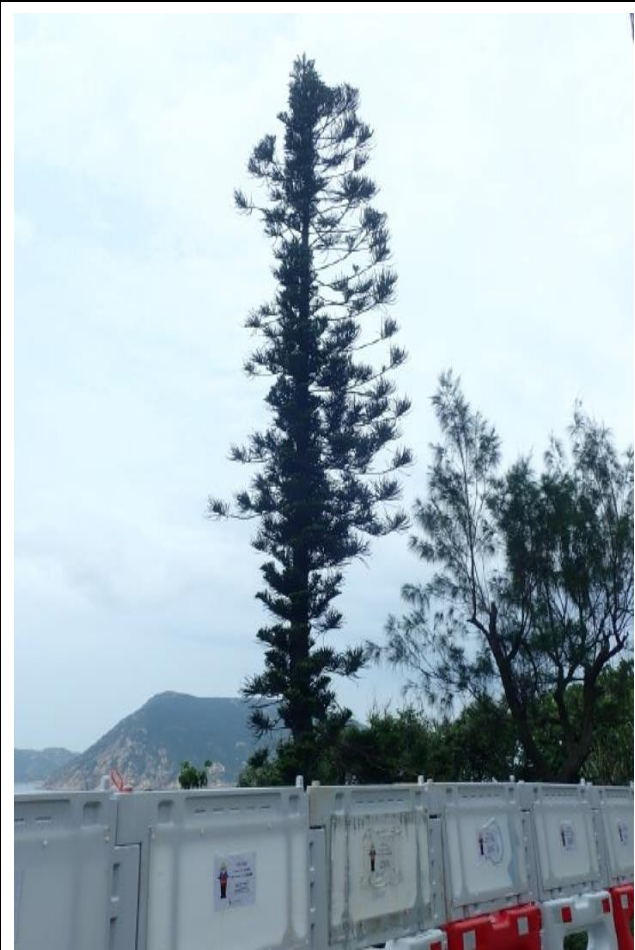
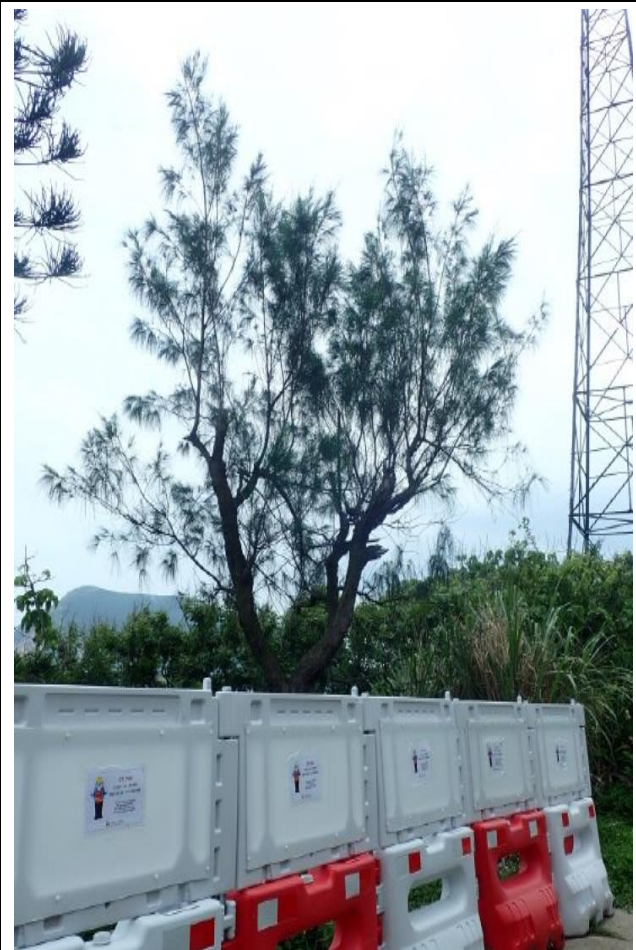
- 2.4.8. For the three retained trees, there is no change in overall condition of T5; while regeneration of new foliage made tree health of T6, as well as tree form of TA to be assessed from poor to fair. Broken branches in TA due to the typhoon damage should receive appropriate assessment and treatment. Corresponding photographic records of T5, T6 and TA are illustrated in **Plate 2**.

<p>No change in condition of T5 from previous monitoring.</p>	<p>No change in condition of T6 from previous monitoring.</p>

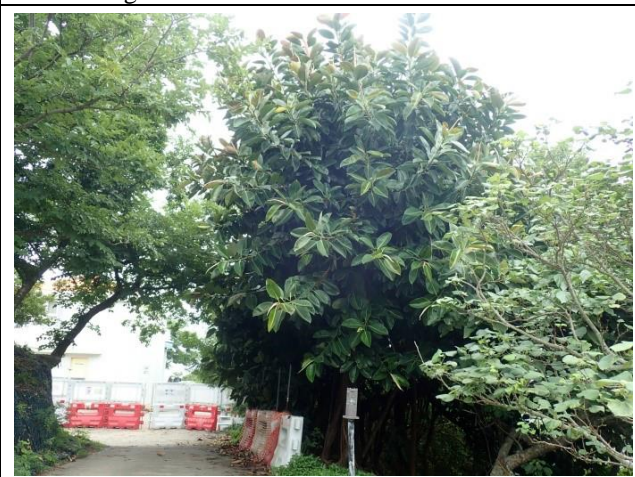
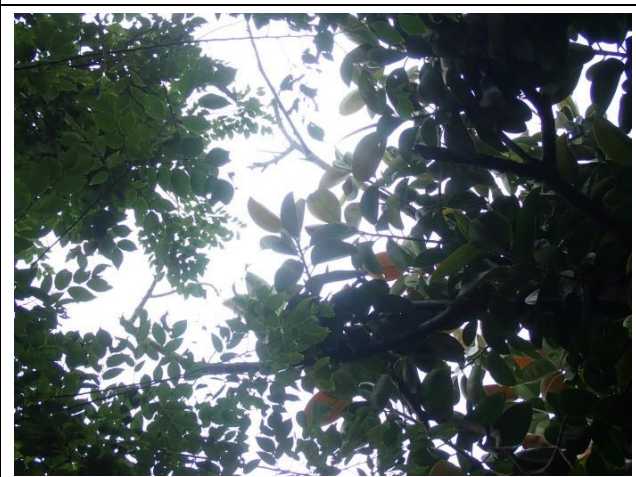
<p>No change in condition of TA from previous monitoring.</p>	<p>Damages by the Typhoon Mangkhut remained on TA.</p>

- 4.1.8. Broken branches in the retained tree TA due to the typhoon damage remained. Relevant authority shall be contacted for appointing a Certified Arborist or equivalent to conduct a Tree Risk Assessment (TRA) on this tree, in order to get Lands Department's approval on taking corresponding actions (e.g. pruning). Once the TRA appointment is confirmed, good written and photographic records (e.g. personal, date and time, actions, etc.) should be made before, during and after any actions of treatment for the assessed tree (i.e. TA)
