**Expansion of Research and Residential Facilities for
The Swire Institute of Marine Science, Faculty of Science,
The University of Hong Kong at Cape d' Aguilar, Shek O, Hong Kong
Submission of Monthly Environmental Monitoring and Audit Report No.33**

**MONTHLY ENVIRONMENTAL MONITORING AND AUDIT
(EM&A) REPORT (NO. 33)**

**Expansion of Research and Residential Facilities for the Swire Institute of
Marine Science, The University of Hong Kong at Cape D'Aguiar, Shek O**

**MONTHLY ENVIRONMENTAL
MONITORING AND AUDIT
(EM&A) REPORT (NO.33) -**

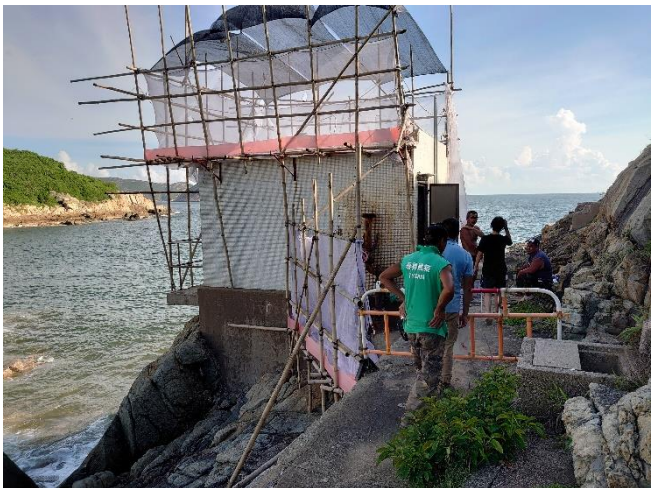
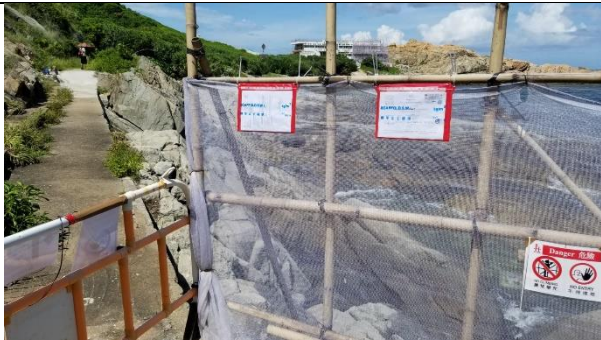
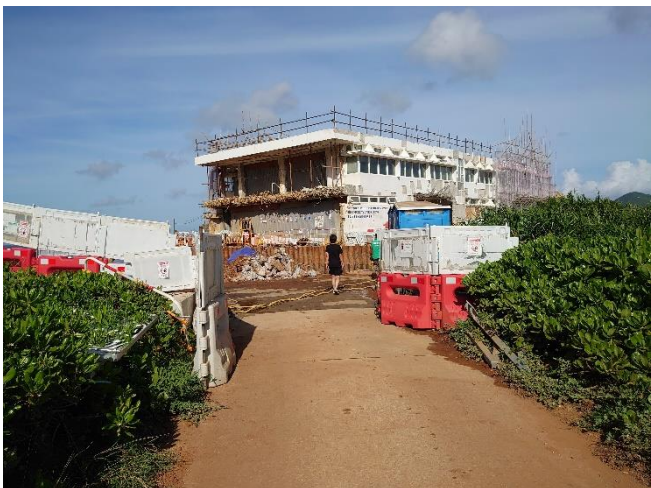
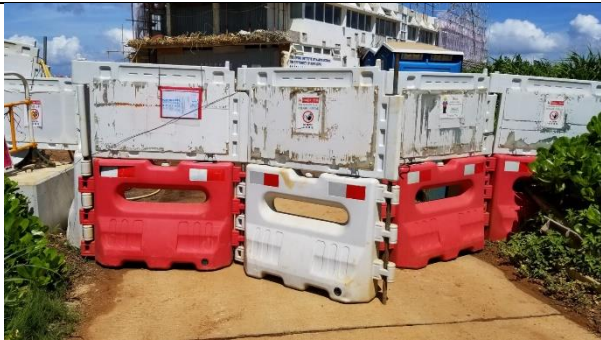
Observation - Item 1	
Observed on 23 June 2020	Rectified by the Contractor on 26 June 2020
<i>Permits shall be placed at entrances conspicuously.</i>	<i>Permit copies were post at the entrance of the site area.</i>

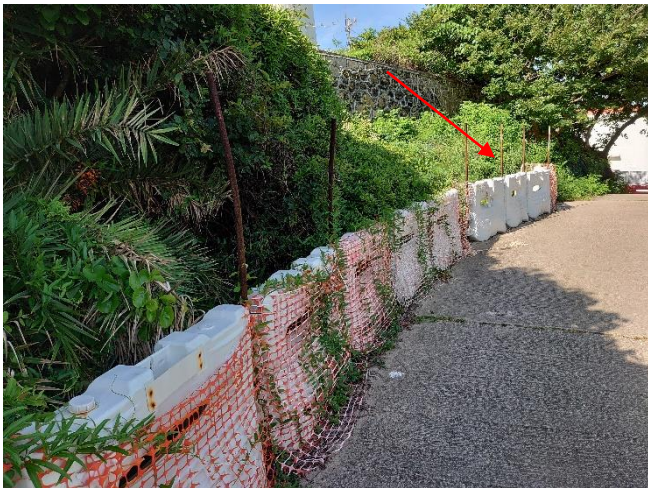
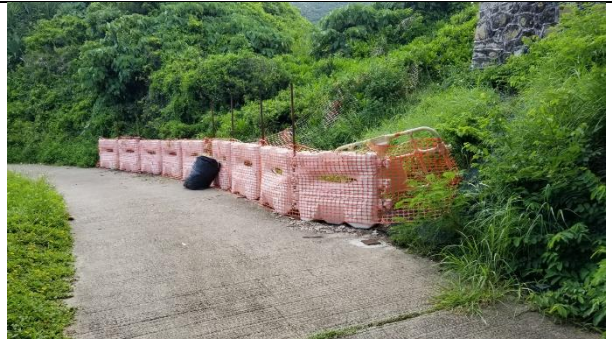
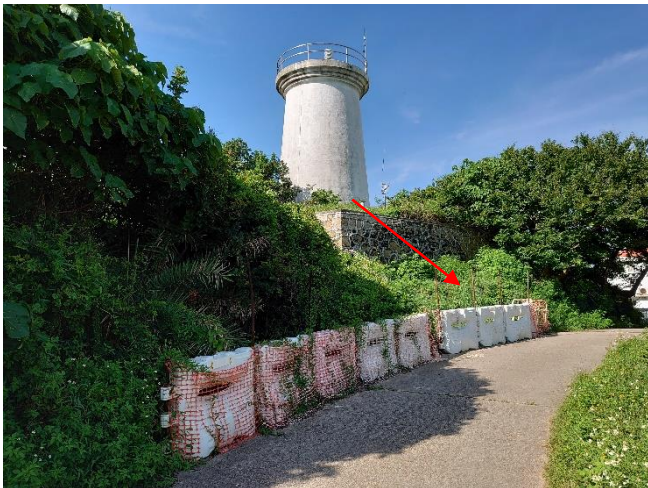
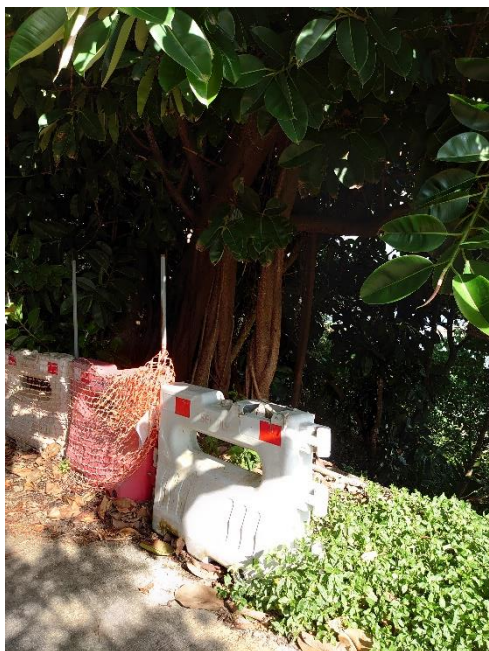
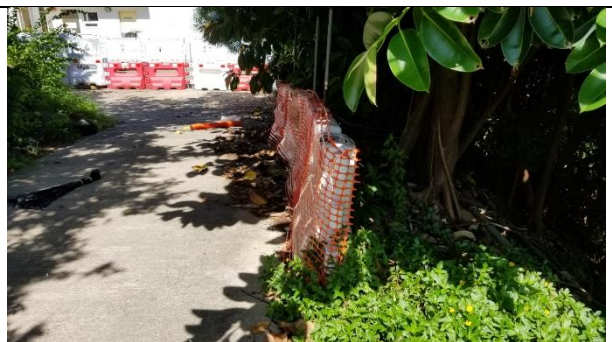
Observation - Item 2	
Observed on 23 June 2020	Rectified by the Contractor on 28 June 2020
<i>Orange nets for tree fences shall be maintained.</i>	<i>Orange nets were repaired.</i>

Observation - Item 3	
Observed on 23 June 2020	Rectified by the Contractor on 28 June 2020
Some garbage was observed in some tree protection areas	Garbage was removed.

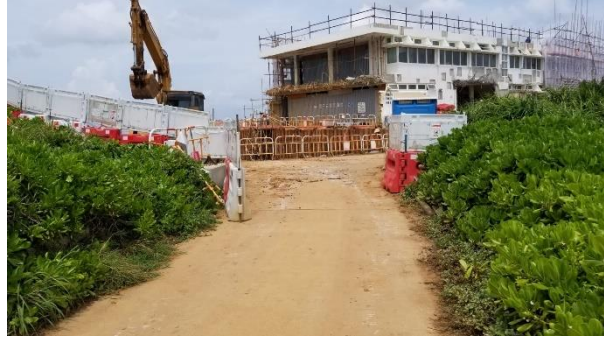
<p>Observation - Item 4</p>	
<p>Observed on 23 June 2020</p>	<p>Rectified by the Contractor on 06 July 2020</p>
<p><i>Some construction materials were observed to be put on vegetation.</i></p>	<p><i>Construction materials were removed.</i></p>
