**Expansion of Research and Residential Facilities for  
The Swire Institute of Marine Science, Faculty of Science,  
The University of Hong Kong at Cape d' Aguilar, Shek O, Hong Kong  
Submission of Monthly Environmental Monitoring and Audit Report No.34**

**MONTHLY ENVIRONMENTAL MONITORING AND AUDIT  
(EM&A) REPORT (NO. 34)**

**Expansion of Research and Residential Facilities for the Swire Institute of  
Marine Science, The University of Hong Kong at Cape D’Aguiar, Shek O**

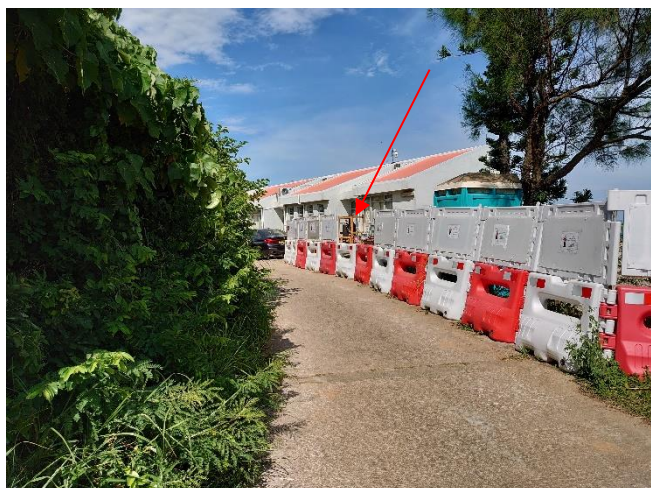
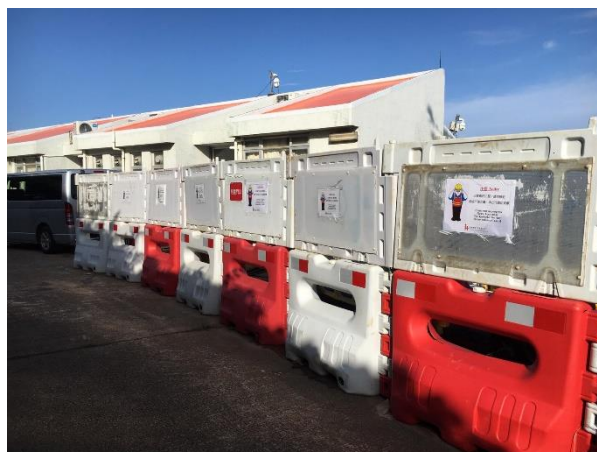
<b>Observation - Item 2</b>	
<b>Observed on 29 July 2020</b>	<b>Rectified by the Contractor on 1 Aug 2020</b>
<b><i>The hoarding was partly broken at Location F.</i></b>	<b><i>Hoarding is repaired.</i></b>
<b>Observation - Item 2</b>	
<b>Observed on 29 July 2020</b>	<b>Rectified by the Contractor on 1 Aug 2020</b>
<b><i>The hoarding was partly broken at Location F.</i></b>	<b><i>Hoarding is repaired.</i></b>

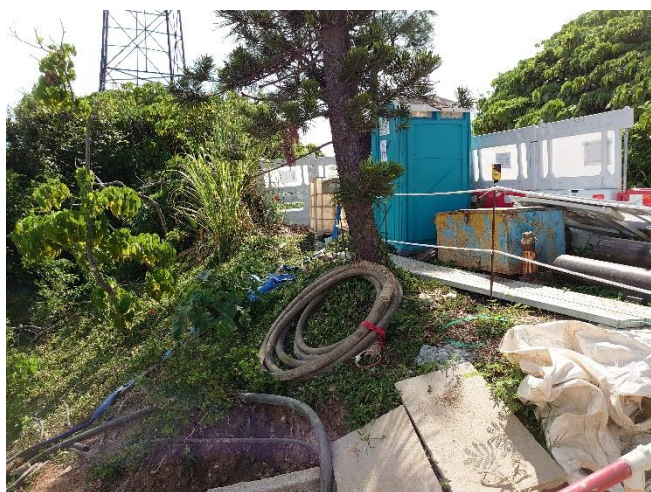
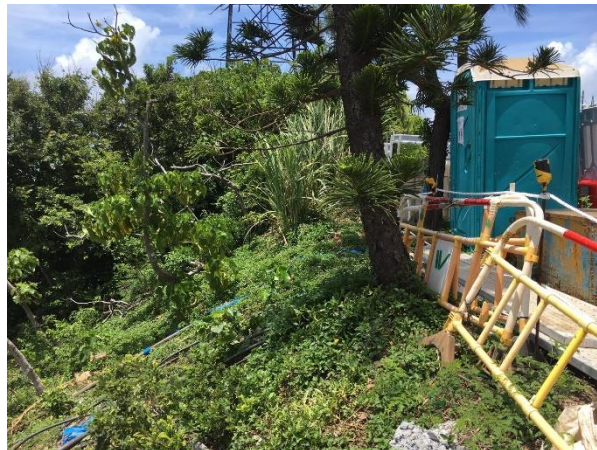
**Observation - Item 3**

***Construction materials should not be put on root position of retained tree.***

***Construction materials is removed from root position of retained tree.***

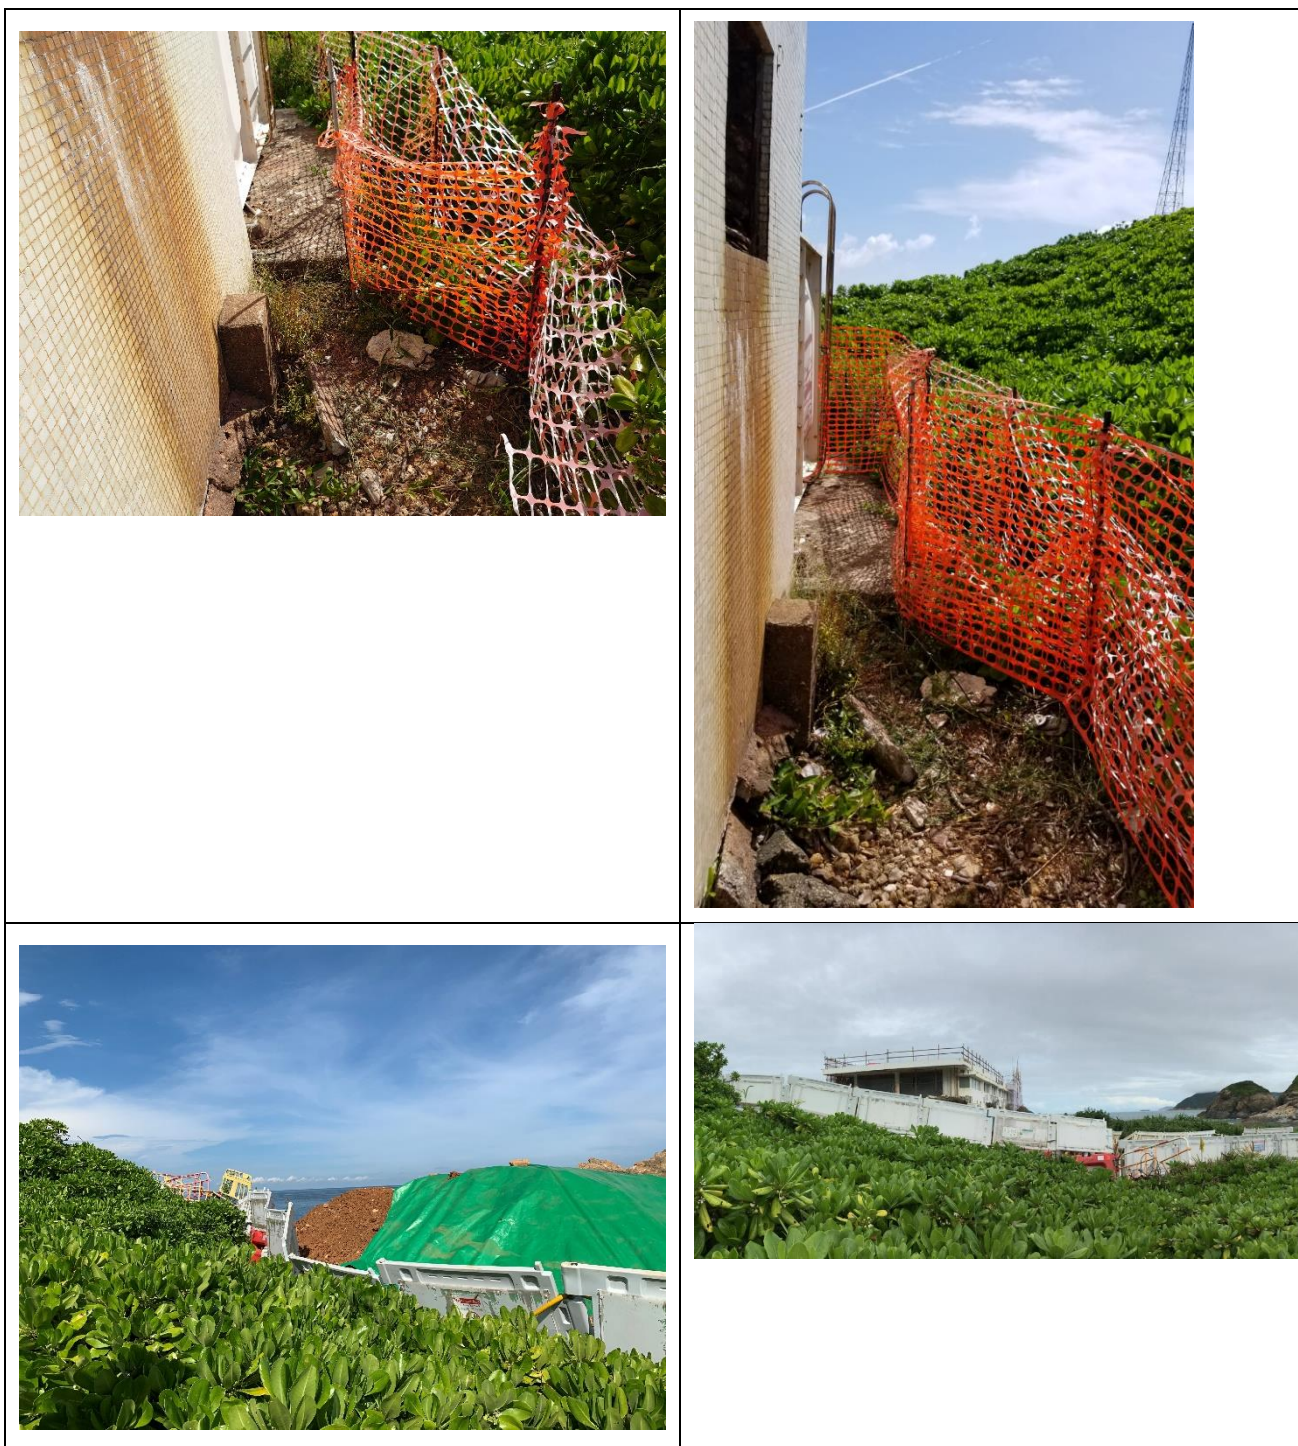
<b>Observation - Item 4</b>	
<b>Observed on 29 July 2020</b>	<b>Rectified by the Contractor on 4 Aug 2020</b>
<i>Small area of oil spillage was observed at Location A. The spillage should be treated as chemical waste.</i>	<i>Spillage was treated and removed.</i>

<b>Observation - Item 5</b>	
<b>Observed on 29 July 2020</b>	<b>Rectified by the Contractor on 1 August 2020</b>
<i>Pump House at Location A, the orange nets should be repaired. Hoarding should be reinforced to avoid overflow of mud.</i>	<i>Orange net is repaired. Hoarding is reinforced.</i>

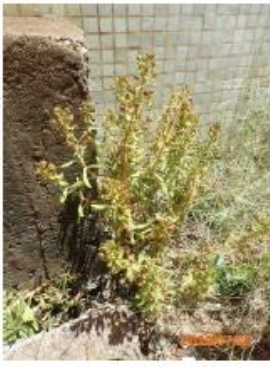
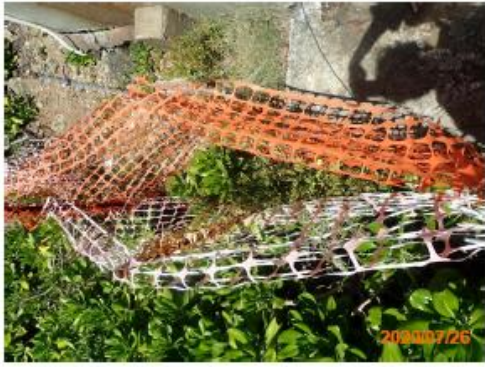
<p><i>Lysimachia mauritiana</i> 濱海珍珠菜</p>

- 2.4.5. Severe damage caused by Typhoon Mangkhut in September 2018 to the coastal vegetation remained. No *Lysimachia mauritiana* (濱海珍珠菜) could be observed in one of the protection zone near Academic Block (Site A) over 22 months. The original plants in this zone have certified as dead. The two rediscovered individuals kept growing in other protection zones, with some seedlings observed in vicinity (Plate 1).

- 4.1.5. However re-establishment of *Lysimachia mauritiana* (濱海珍珠菜) is ongoing. The two rediscovered individuals kept growing in other protection zones, with some seedlings observed in vicinity. Building up additional assurance colonies by collecting seeds may still be feasible.

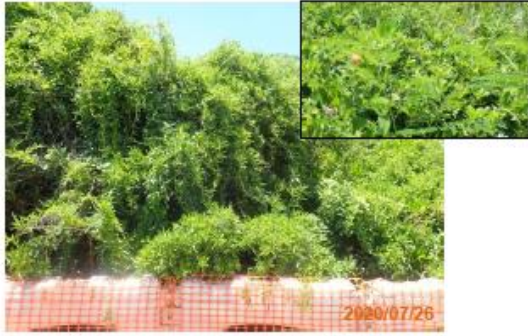
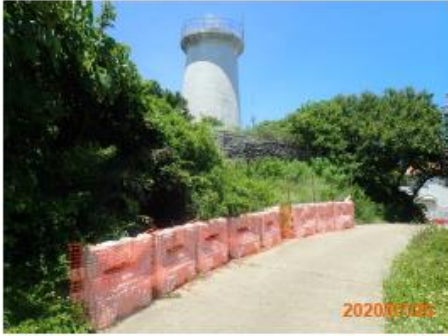
<p><i>Pittosporum tobira</i> 海桐; with the invasive <i>Leucaena leucocephala</i> nearby (inset)</p>

- 2.4.6. *Pittosporum tobira* (海桐) has shown slight dieback of twigs, with regeneration of young leaves; while surrounding invasive species (*Leucaena leucocephala* and *Lantana camara*) still existed. Clearance within the protection zone has been conducted.

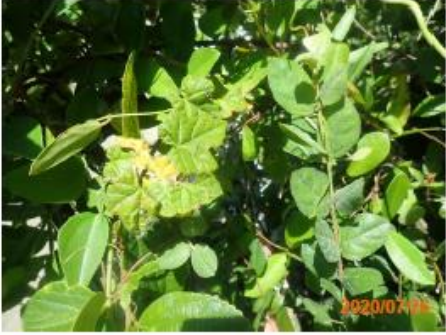
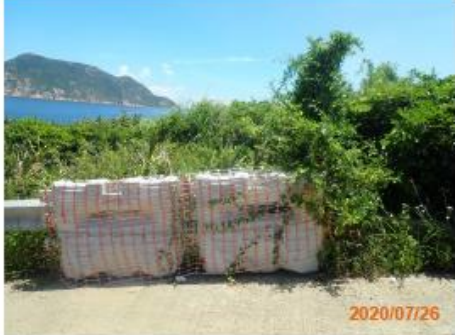
<p><i>Vitis bryoniifolia</i> 雙葉</p>

- 2.4.7. Another invasive species *Bidens alba* has also rapidly grown and covering the growing area of *Vitis bryoniifolia* (蔓莢). Clearance within the protection zone has been conducted. Leaves could be observed for this deciduous climber during this monitoring.

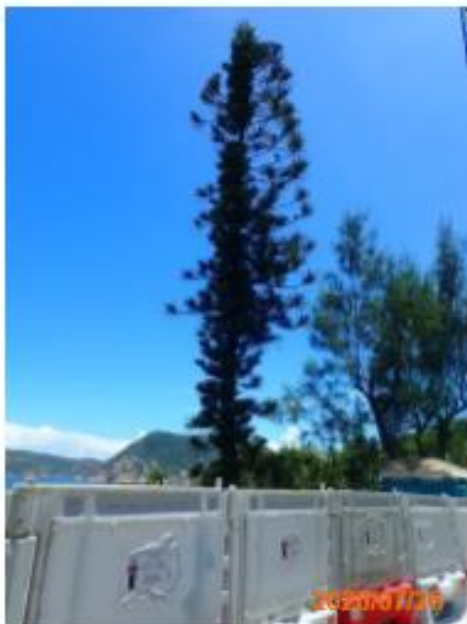
No change in condition of T5 from previous monitoring.

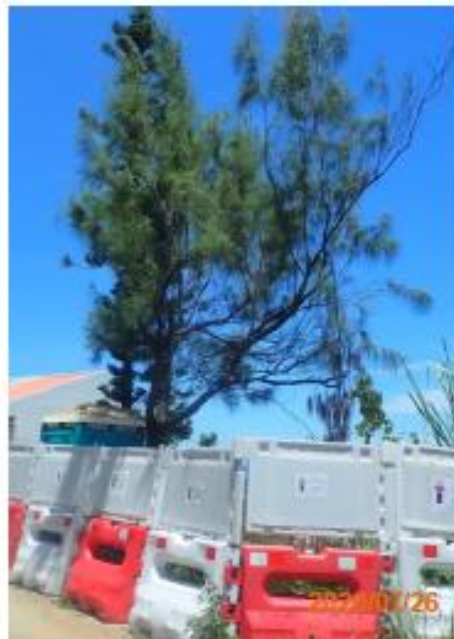
No change in condition of T6 from previous monitoring.

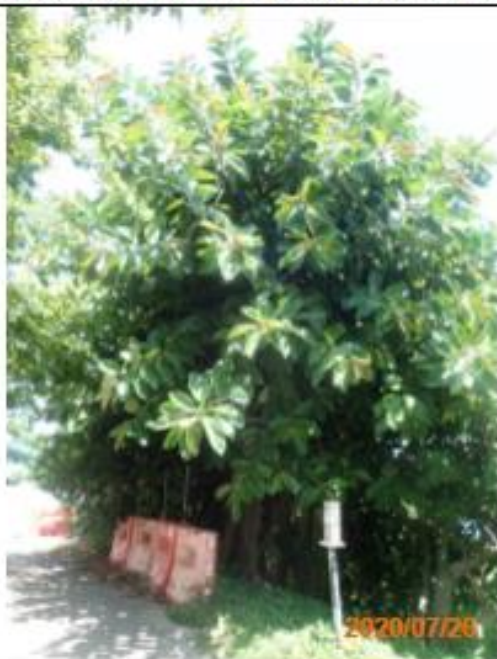
No change in condition of TA from previous monitoring.

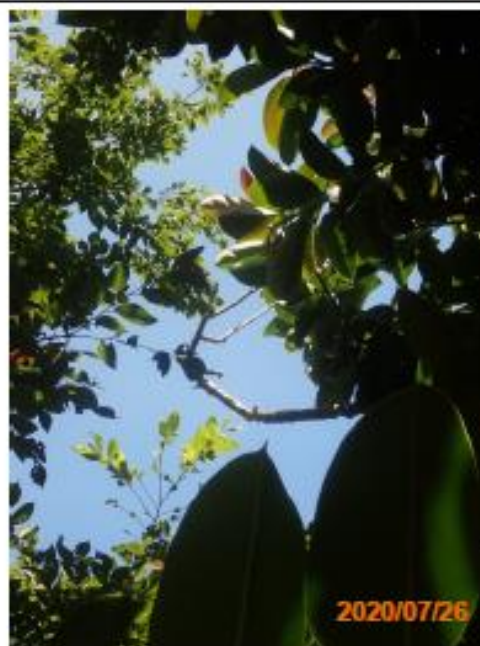
- 2.4.8. For the three retained trees, there is no change in overall condition of T5; while regeneration of new foliage made tree health of T6, as well as tree form of TA to be assessed from poor to fair. Broken branches in TA due to the typhoon damage should receive appropriate assessment and treatment. Corresponding photographic records of T5, T6 and TA are illustrated in **Plate 2**.

Damages by the Typhoon Mangkhut remained on TA.

- 4.1.8. Broken branches in the retained tree TA due to the typhoon damage remained. Relevant authority shall be contacted for appointing a Certified Arborist or equivalent to conduct a Tree Risk Assessment (TRA) on this tree in order to get Lands Department's approval on taking corresponding actions (e.g. pruning). Once the TRA appointment is confirmed, good written and photographic records (e.g. personal, date and time, actions, etc.) should be made before, during and after any actions of treatment for the assessed tree (i.e. TA)
