**Expansion of Research and Residential Facilities for
The Swire Institute of Marine Science, Faculty of Science,
The University of Hong Kong at Cape d' Aguilar, Shek O, Hong Kong
Submission of Monthly Environmental Monitoring and Audit Report No.35**

**MONTHLY ENVIRONMENTAL MONITORING AND AUDIT
(EM&A) REPORT (NO. 35)**

**Expansion of Research and Residential Facilities for the Swire Institute of
Marine Science, The University of Hong Kong at Cape D'Aguiar, Shek O**

**MONTHLY ENVIRONMENTAL
MONITORING AND AUDIT
(EM&A) REPORT (NO.35) -**

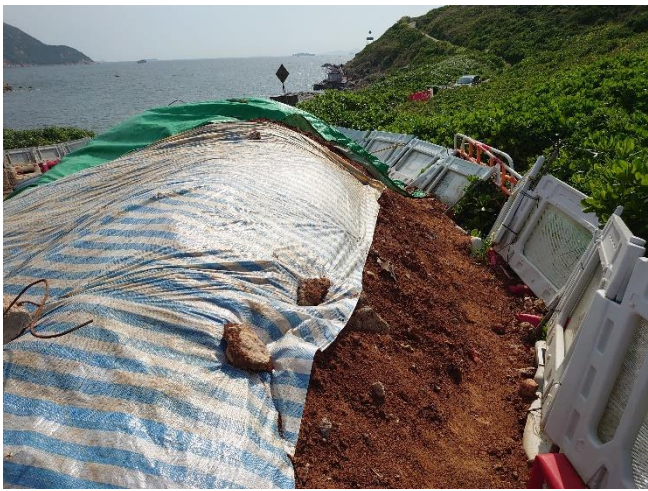
Observation - Item 1	
Observed on 24 August 2020	Rectified by the Contractor on 27 Aug 2020
<i>At Location A, orange nets need to be repaired,</i>	<i>Orange net is repaired.</i>

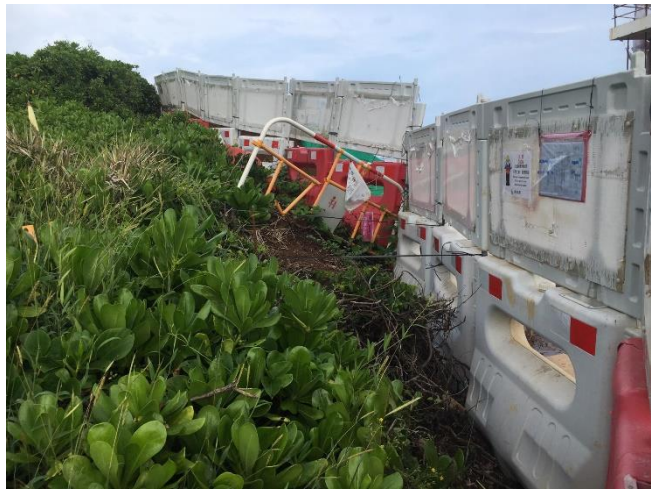
Observation - Item 2	
Observed on 24 August 2020	Rectified by the Contractor on 3 Sep 2020
<i>At Location A, stockpile is almost overflowing out of the hoarding.</i>	<i>Hoarding is reinforced.</i>

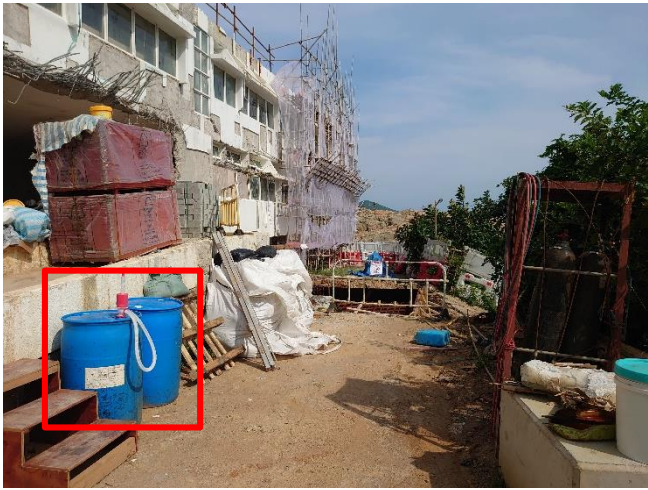
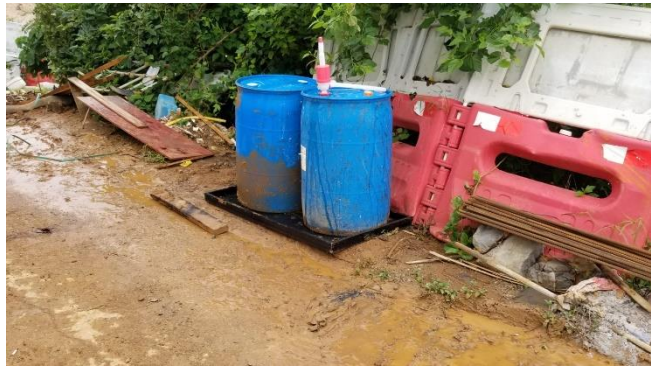
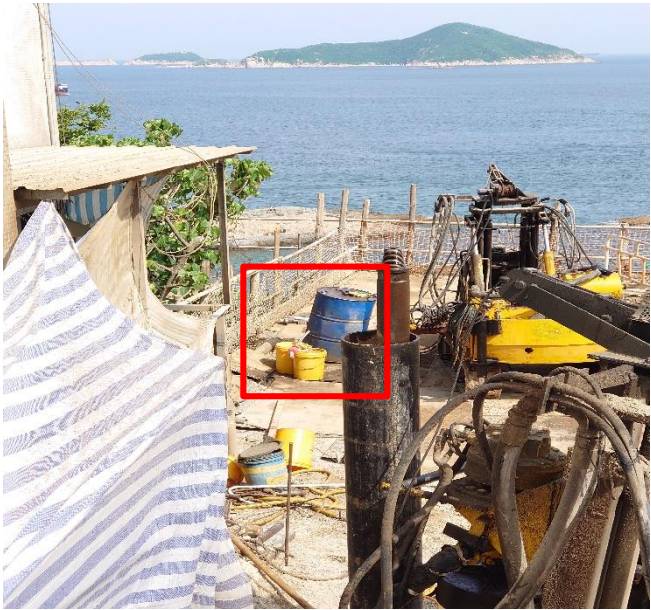
Observation - Item 3	
Observed on 24 August 2020	Rectified by the Contractor on
<i>At the platform of Location F and near the building at Location A, chemicals shall be put on drip trays.</i>	<i>Chemical is placed in drip tray or removed from site.</i>

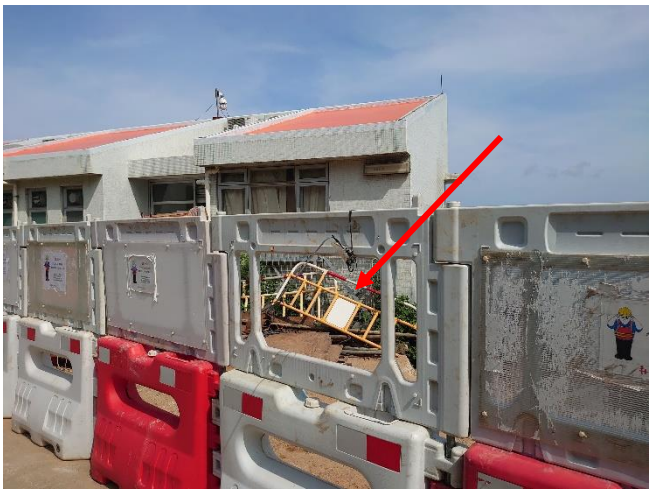
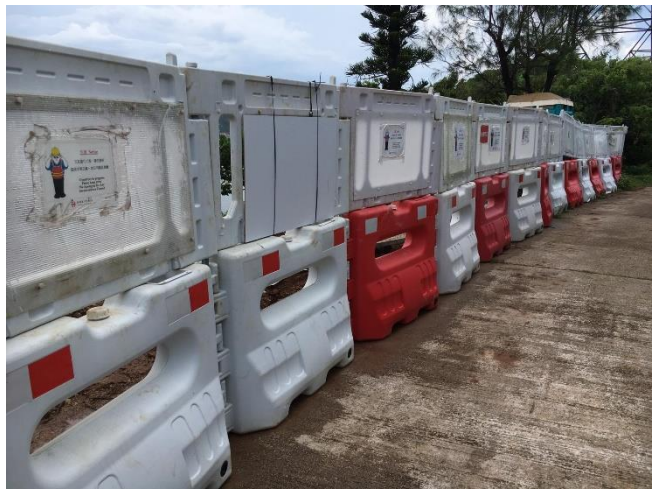
<p>Chemical has been removed from site F.</p>
<p>Observation - Item 4</p>	
<p>Observed on 24 August 2020</p>	<p>Rectified by the Contractor on</p>
<p><i>At Location F, some of the hoarding components need to be repaired.</i></p>	<p><i>Hoarding is repaired to cover the opening.</i></p>

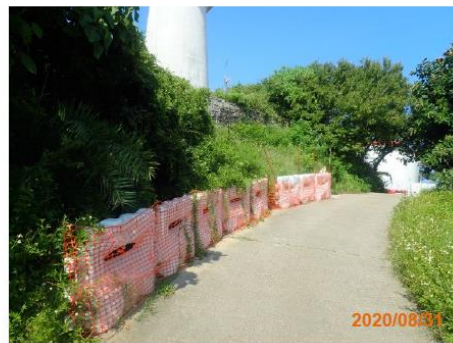
- 2.4.6. *Pittosporum tobira* (海桐) has shown slight dieback of twigs, with regeneration of young leaves; while surrounding invasive species (*Leucaena leucocephala* and *Lantana camara*) still existed. Invasive species shall be cleared together with other overgrown climbers within in close vicinity of the protection zone

Pittosporum tobira 海桐: with the invasive *Leucaena leucocephala* nearby (inset)

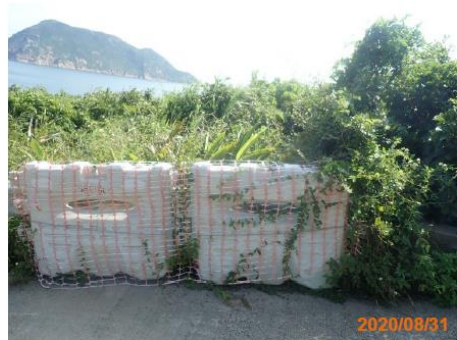
- 2.4.7. Another invasive species *Bidens alba* has also rapidly grown and covering the growing area of *Vitis bryoniifolia* (蔓萸). Invasive species shall be cleared together with other overgrown climbers within in close vicinity of the protection zone. Leaves were not observed for this deciduous climber during this monitoring.

Vitis bryoniifolia 雙葉

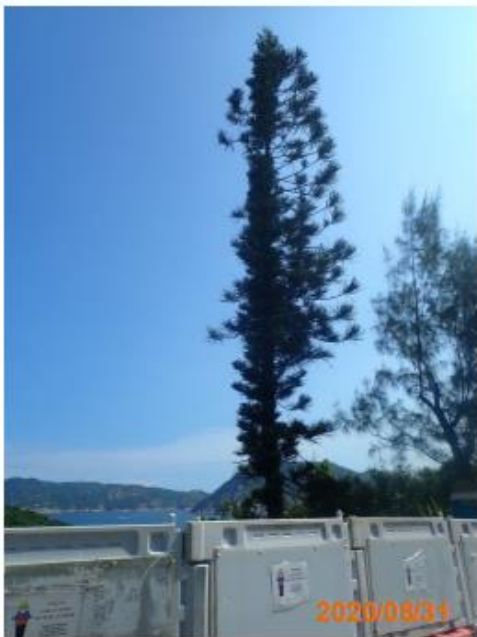
No change in condition of T5 from previous monitoring.

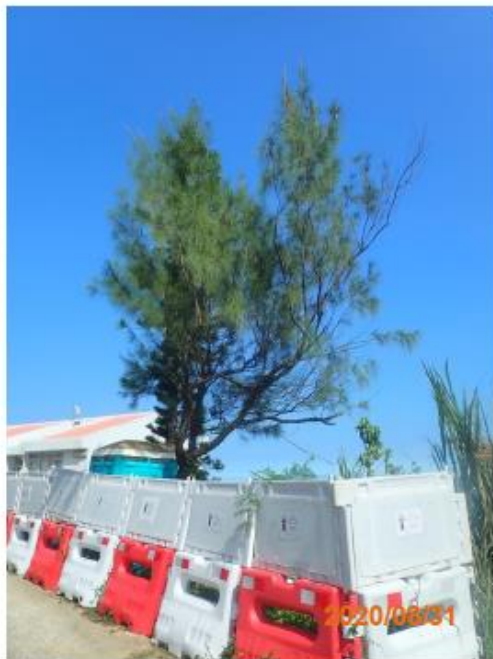
No change in condition of T6 from previous monitoring.

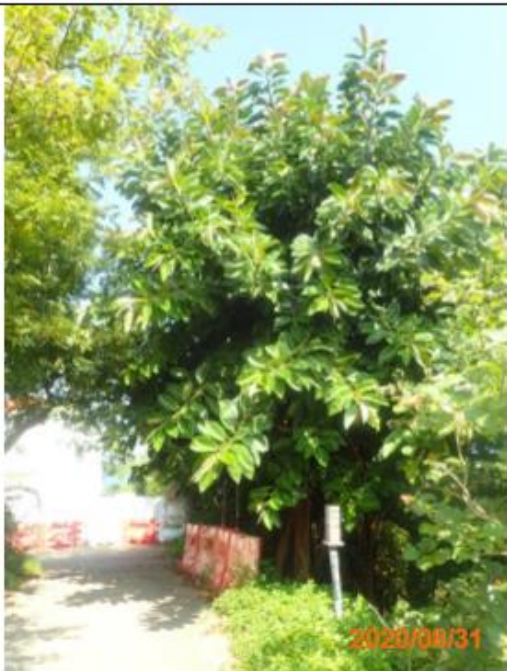
No change in condition of TA from previous monitoring.

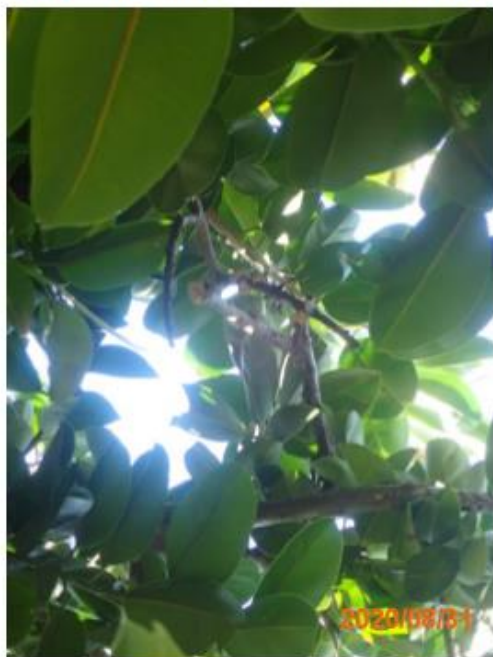
- 2.4.8. For the three retained trees, there is no change in overall condition of T5; while regeneration of new foliage made tree health of T6, as well as tree form of TA to be assessed from poor to fair. Broken branches in TA due to the typhoon damage should receive appropriate assessment and treatment. Corresponding photographic records of T5, T6 and TA are illustrated in **Plate 2**.

Decaying branch hanger on TA.

- 4.1.8. Broken branches in the retained tree TA due to the typhoon damage remained. Relevant authority shall be contacted for appointing a Certified Arborist or equivalent to conduct a Tree Risk Assessment (TRA) on this tree in order to get Lands Department's approval on taking corresponding actions (e.g. pruning). Once the TRA appointment is confirmed, good written and photographic records (e.g. personal, date and time, actions, etc.) should be made before, during and after any actions of treatment for the assessed tree (i.e. TA)
