Environmental Permit (No. EP-537/2017)

**Expansion of Research and Residential Facilities for
The Swire Institute of Marine Science, Faculty of Science,
The University of Hong Kong at Cape d' Aguilar, Shek O, Hong Kong
Submission of Monthly Environmental Monitoring and Audit Report No.37**

**MONTHLY ENVIRONMENTAL MONITORING AND AUDIT
(EM&A) REPORT (NO. 37)**

**Expansion of Research and Residential Facilities for the Swire Institute of
Marine Science, The University of Hong Kong at Cape D'Aguilar, Shek O**

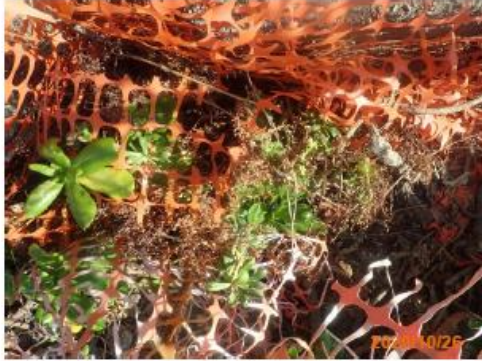
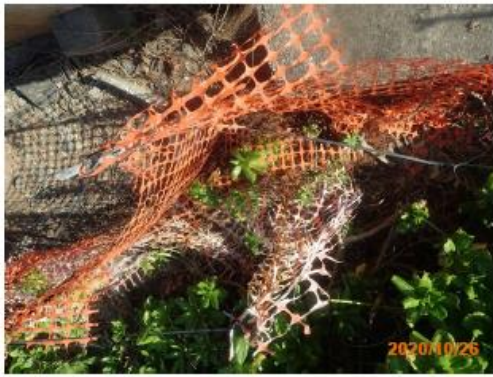
2.4.5. Severe damage caused by Typhoon Mangkhut in September 2018 to the coastal vegetation remained. No *Lysimachia mauritiana* (濱海珍珠菜) could be observed in one of the protection zone near Academic Block (Site A) over 25 months. The original plants in this zone have certified as dead. The two rediscovered individuals kept growing in other protection zones, with some seedlings observed in vicinity (Plate 1).

<p><i>Lysimachia mauritiana</i> 濱海珍珠菜</p>	<p>Collapsed fencing to be rectified</p>

- 4.1.7. Protection zone has been provided in accordance with Condition 2.6 of the Environmental Permit. Any damage of the protection zone (e.g. due to coastal weather condition or disturbance of hikers and visitors) should be repaired promptly. Warning sign should be maintained at prominent positions within the works area to encourage hikers and visitors keeping away from any no-entry area or protection zone.

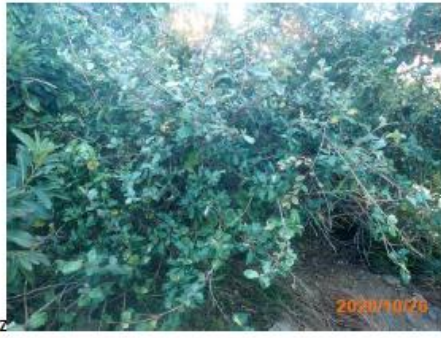
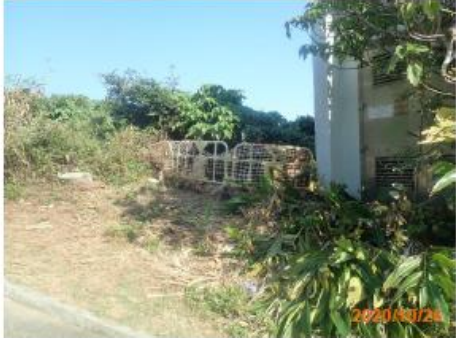
- 2.4.7. Invasive species *Bidens alba* within protection zone of *Elaeagnus tutcheri* (香港胡頹子) has been cleared together with other overgrown climbers.

<p><i>Elaeagnus tutcheri</i> 香港胡頹子</p>	<p>Overgrown weeds have been cleared</p>

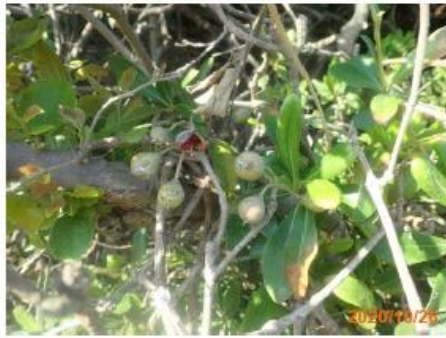
Pittosporum tobira 海桐; fruiting

- 2.4.6. *Pittosporum tobira* (海桐) has shown slight dieback of twigs, with regeneration of young leaves. Invasive *Leucaena leucocephala* and *Lantana camara* within protection zone have been cleared together with other overgrown climbers.

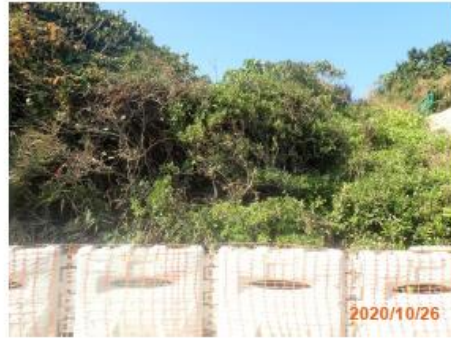
Overgrown climbers has been cleared

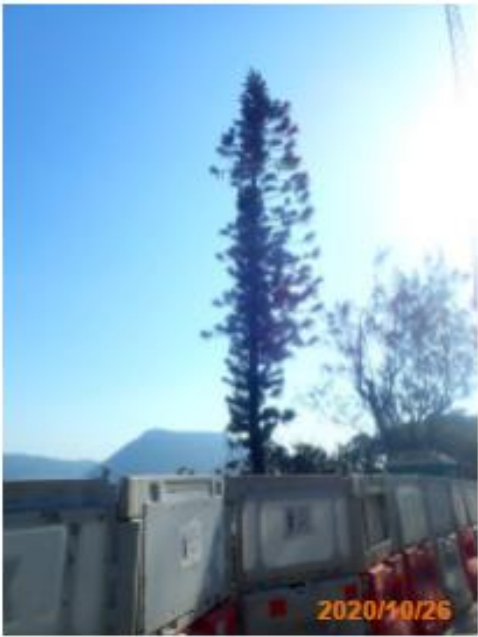
- 2.4.8. For the three retained trees, there is no change in overall condition of T5; while regeneration of new foliage made tree health of T6, as well as tree form of TA to be assessed from poor to fair. Broken branches in TA due to the typhoon damage should receive appropriate assessment and treatment. Corresponding photographic records of T5, T6 and TA are illustrated in **Plate 2**.

<p>No change in condition of T5 from previous monitoring.</p>	<p>No change in condition of T6 from previous monitoring.</p>

<p>No change in condition of TA from previous monitoring.</p>	<p>Decaying branch hanger on TA.</p>

- 4.1.8. Broken branches in the retained tree TA due to the typhoon damage remained. Relevant authority shall be contacted for appointing a Certified Arborist or equivalent to conduct a Tree Risk Assessment (TRA) on this tree in order to get Lands Department's approval on taking corresponding actions (e.g. pruning). Once the TRA appointment is confirmed, good written

and photographic records (e.g. personal, date and time, actions, etc.) should be made before, during and after any actions of treatment for the assessed tree (i.e. TA)
