**Expansion of Research and Residential Facilities for
The Swire Institute of Marine Science, Faculty of Science,
The University of Hong Kong at Cape d' Aguilar, Shek O, Hong Kong
Submission of Monthly Environmental Monitoring and Audit Report No.38**

**MONTHLY ENVIRONMENTAL MONITORING AND AUDIT
(EM&A) REPORT (NO. 38)**

**Expansion of Research and Residential Facilities for the Swire Institute of
Marine Science, The University of Hong Kong at Cape D'Aguilar, Shek O**

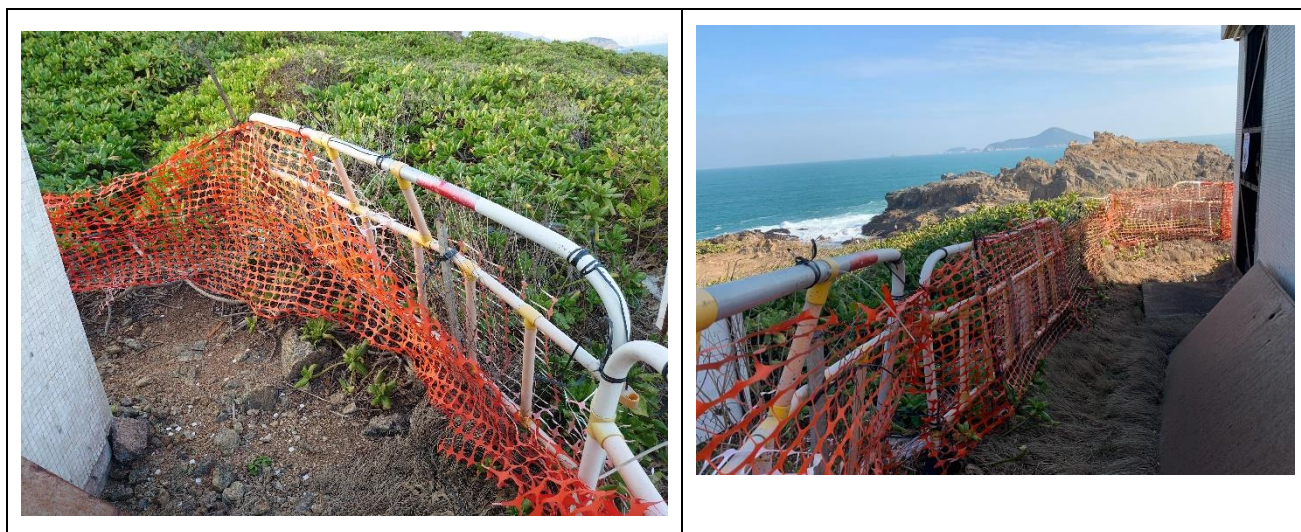
Observation - Item 1	
Observed on 30 November 2020	Rectified by the Contractor on 2 December 2020
<p><i>At site B and site G, orange nets should be reinforced to protect the protective species and for clear site boundary.</i></p>

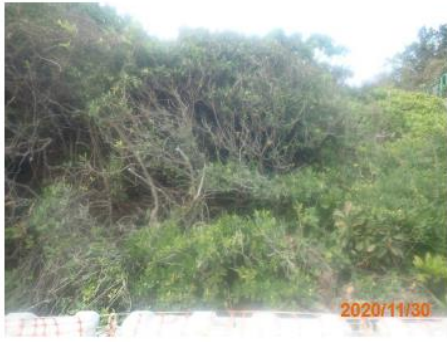
<p><i>Elaeagnus tutcheri</i> 香港胡頹子</p>

- 2.4.7. Invasive species *Bidens alba* within protection zone of *Elaeagnus tutcheri* (香港胡頹子) has been cleared together with other overgrown climbers.

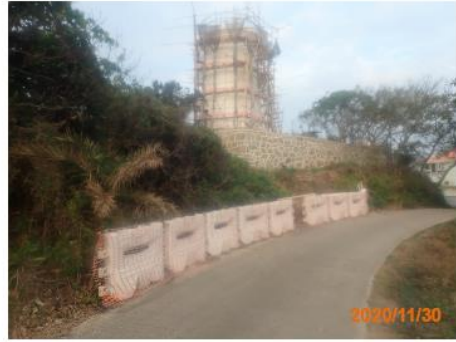
Pittosporum tobira 海桐

- 2.4.6. *Pittosporum tobira* (海桐) has shown slight dieback of twigs, with regeneration of young leaves. Invasive *Leucaena leucocephala* and *Lantana camara* within protection zone have been cleared together with other overgrown climbers.

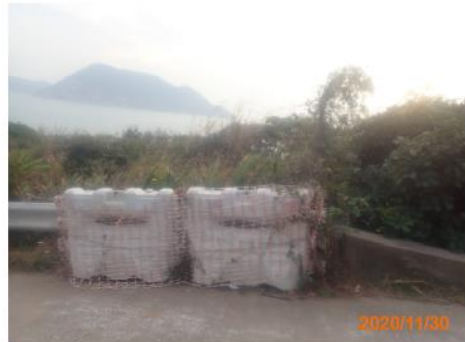
Vitis bryoniifolia 蘼藨 (deciduous)

- 2.4.8. Most leaves of the deciduous *Vitis bryoniifolia* (蘼薺) has dropped.
- 2.4.9. For the three retained trees, there is no change in overall condition of T5; while regeneration of new foliage made tree health of T6, as well as tree form of TA to be assessed from poor to fair. Broken branches in TA due to the typhoon damage should receive appropriate assessment and treatment. Corresponding photographic records of T5, T6 and TA are illustrated in **Plate 2**.
