**Expansion of Research and Residential Facilities for
The Swire Institute of Marine Science, Faculty of Science,
The University of Hong Kong at Cape d' Aguilar, Shek O, Hong Kong
Submission of Monthly Environmental Monitoring and Audit Report No.40**

**MONTHLY ENVIRONMENTAL MONITORING AND AUDIT
(EM&A) REPORT (NO. 40)**

**Expansion of Research and Residential Facilities for the Swire Institute of
Marine Science, The University of Hong Kong at Cape D'Aguiar, Shek O**

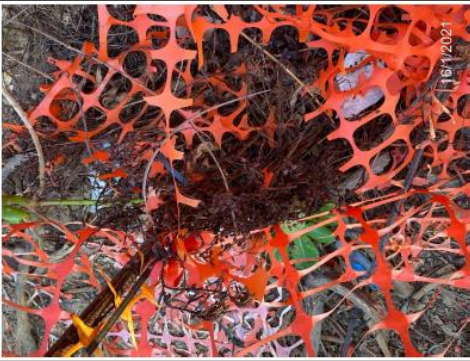
2.4.5. Severe damage caused by Typhoon Mangkhut in September 2018 to the coastal vegetation remained. No *Lysimachia mauritiana* (濱海珍珠菜) could be observed in one of the protection zone near Academic Block (Site A) over 28 months. The original plants in this zone have certified as dead. The two rediscovered individuals and seedlings observed in vicinity have fruited during their end of biennial life cycle (Plate 1).

<p><i>Lysimachia mauritiana</i> 濱海珍珠菜 (biennial)</p>

- 4.1.5. However re-establishment of *Lysimachia mauritiana* (濱海珍珠菜) is ongoing. The two rediscovered individuals and seedlings observed in vicinity have fruited during their end of biennial life cycle. Building up additional assurance colonies by collecting seeds may still be feasible.

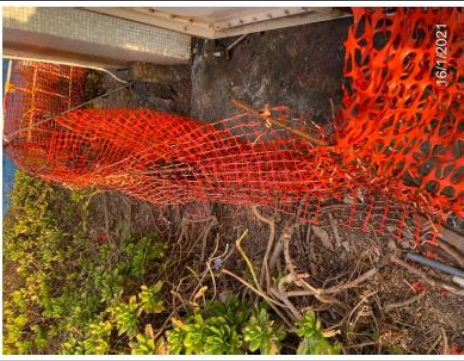
<p><i>Pavetta hongkongensis</i> 香港大沙葉</p>

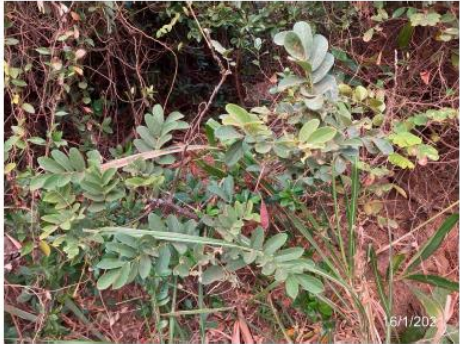
<p><i>Millettia oraria</i> 香港崖豆藤</p>	<p>Collapsed fencing to be rectified</p>

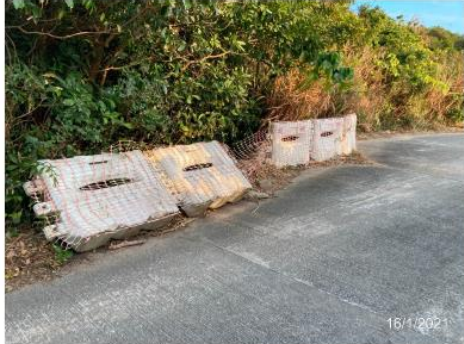
- 2.4.7. Invasive species *Bidens alba* within protection zone of *Elaeagnus tutcheri* (香港胡頹子) has been cleared together with other overgrown climbers.

<p><i>Elaeagnus tutcheri</i> 香港胡頹子</p>	<p>Worn fencing to be rectified</p>

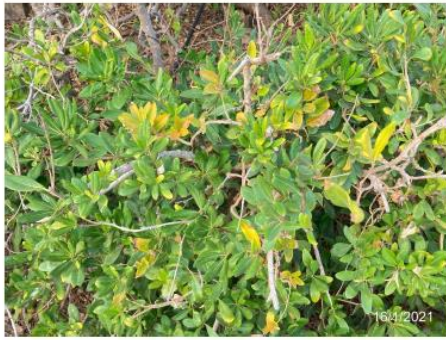
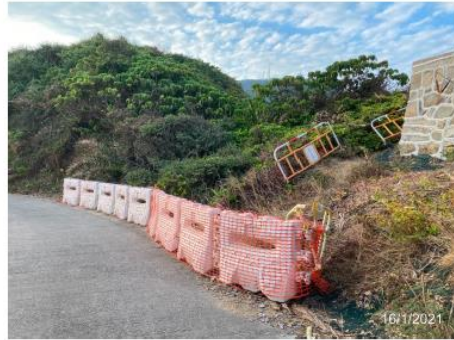
Pittosporum tobira 海桐

- 2.4.6. *Pittosporum tobira* (海桐) has shown slight dieback of twigs, with regeneration of young leaves. Invasive *Leucaena leucocephala* and *Lantana camara* within protection zone have been cleared together with other overgrown climbers.

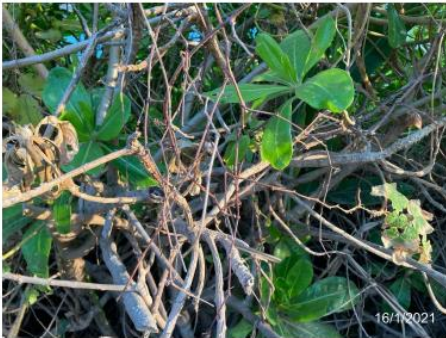
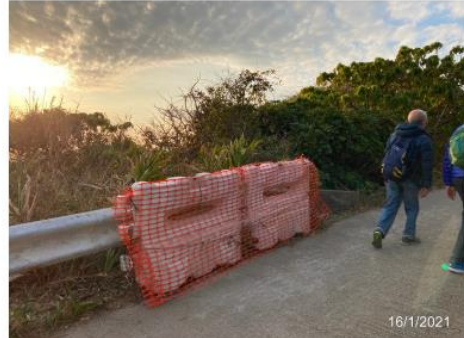
Vitis bryoniifolia 蘼蕪 (deciduous)

- 2.4.8. Most leaves of the deciduous *Vitis bryoniifolia* (蔓莢) has dropped.
- 2.4.9. For the three retained trees, there is no change in overall condition of T5; while regeneration of new foliage made tree health of T6, as well as tree form of TA to be assessed from poor to fair. Broken branches in TA due to the typhoon damage should receive appropriate assessment and treatment. Corresponding photographic records of T5, T6 and TA are illustrated in Plate 2.

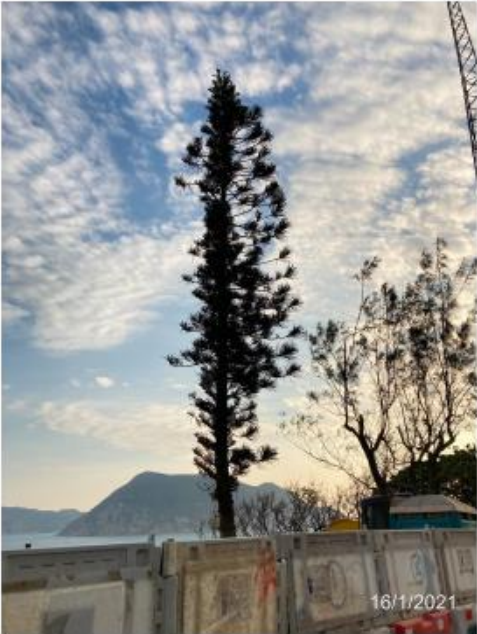
<p>No change in condition of T5 from previous monitoring.</p>	<p>No change in condition of T6 from previous monitoring.</p>

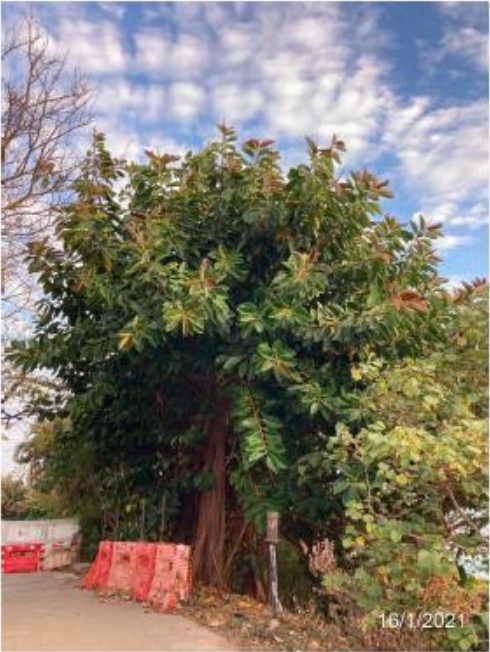
<p>No change in condition of TA from previous monitoring.</p>	<p>Decaying branch hanger on TA.</p>

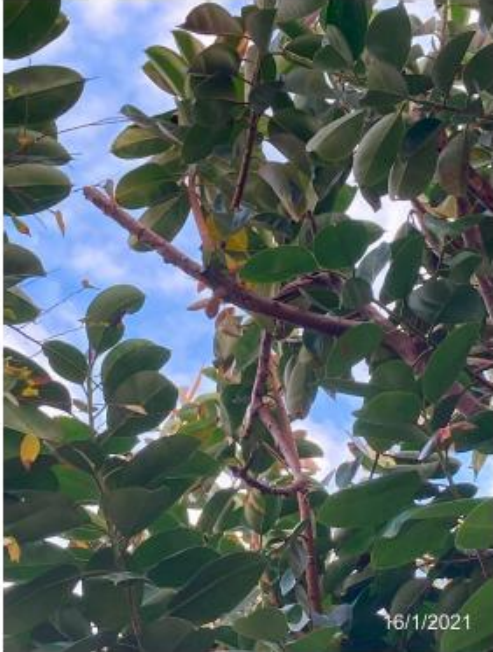
- 4.1.8. Broken branches in the retained tree TA due to the typhoon damage remained. Relevant authority shall be contacted for appointing a Certified Arborist or equivalent to conduct a Tree Risk Assessment (TRA) on this tree in order to get Lands Department's approval on taking corresponding actions (e.g. pruning). Once the TRA appointment is confirmed, good written

and photographic records (e.g. personal, date and time, actions, etc.) should be made before, during and after any actions of treatment for the assessed tree (i.e. TA)
