**Expansion of Research and Residential Facilities for  
The Swire Institute of Marine Science, Faculty of Science,  
The University of Hong Kong at Cape d' Aguilar, Shek O, Hong Kong  
Submission of Monthly Environmental Monitoring and Audit Report No.43**

## **MONTHLY ENVIRONMENTAL MONITORING AND AUDIT (EM&A) REPORT (NO. 43)**

**Expansion of Research and Residential Facilities for the Swire Institute of  
Marine Science, The University of Hong Kong at Cape D'Aguilar, Shek O**

**MONTHLY ENVIRONMENTAL  
MONITORING AND AUDIT  
(EM&A) REPORT (NO.43) -**

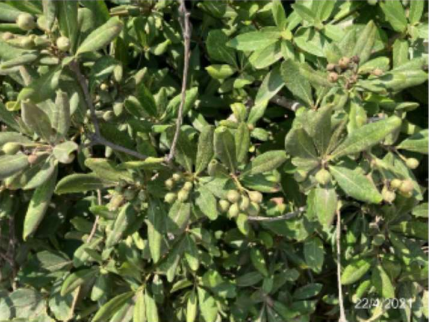
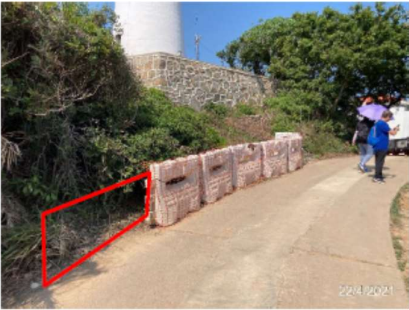
| <p><i>Elaeagnus tutcheri</i> 香港胡頹子</p> | |

- 2.4.7. Invasive species *Bidens alba* within protection zone of *Elaeagnus tutcheri* (香港胡頹子) has been cleared together with other overgrown climbers.

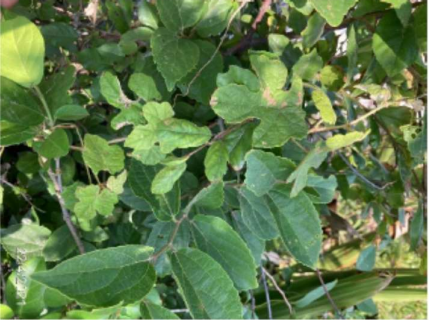
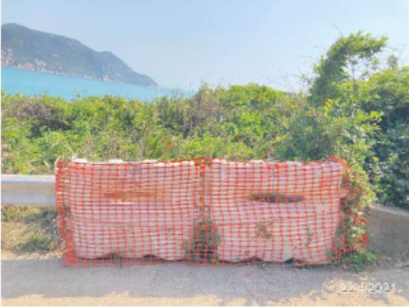
| <p><i>Pittosporum tobira</i> 海桐</p> | <p>Collapsed fencing to be rectified</p> |

- 2.4.6. *Pittosporum tobira* (海桐) has shown slight dieback of twigs, with regeneration of young leaves. Invasive *Leucaena leucocephala* and *Lantana camara* within protection zone have been cleared together with other overgrown climbers.

- 4.1.7. Protection zone has been provided in accordance with Condition 2.6 of the Environmental Permit. Any damage of the protection zone (e.g. due to coastal weather condition or disturbance of hikers and visitors) should be repaired promptly. Warning sign should be maintained at prominent positions within the works area to encourage hikers and visitors keeping away from any no-entry area or protection zone.
