**Expansion of Research and Residential Facilities for
The Swire Institute of Marine Science, Faculty of Science,
The University of Hong Kong at Cape d' Aguilar, Shek O, Hong Kong
Submission of Monthly Environmental Monitoring and Audit Report No.44**

**MONTHLY ENVIRONMENTAL MONITORING AND AUDIT
(EM&A) REPORT (NO. 44)**

**Expansion of Research and Residential Facilities for the Swire Institute of
Marine Science, The University of Hong Kong at Cape D'Aguiar, Shek O**

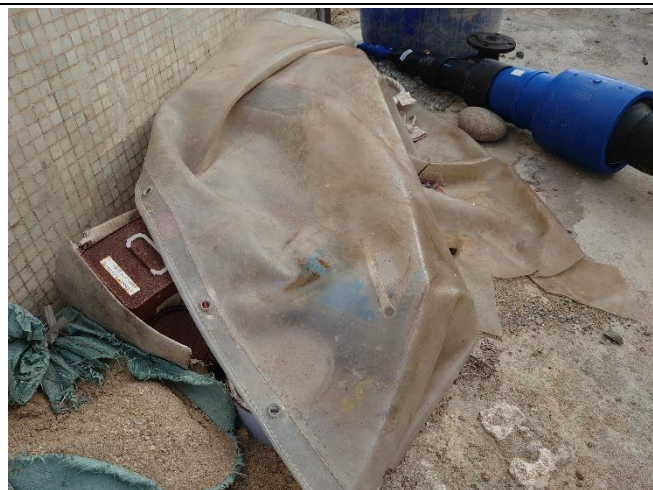
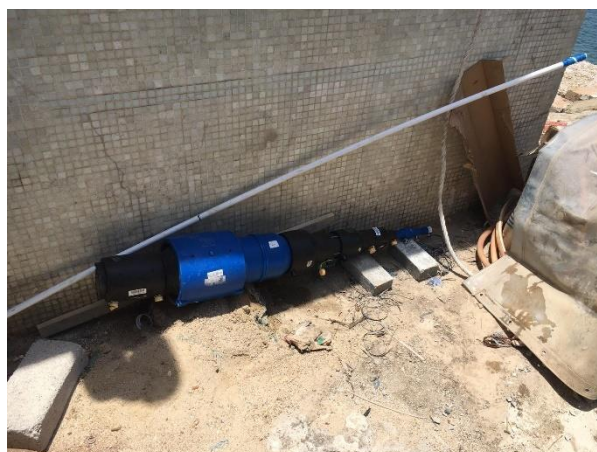
Observation - Item 1	
Observed 20 May 2021	Rectified by the Contractor on 01 Jun 2021
<p><i>Drip trays should be provided for chemical containers at Sites A, F and D.</i></p>  	<p><i>Chemical is removed from site.</i></p>

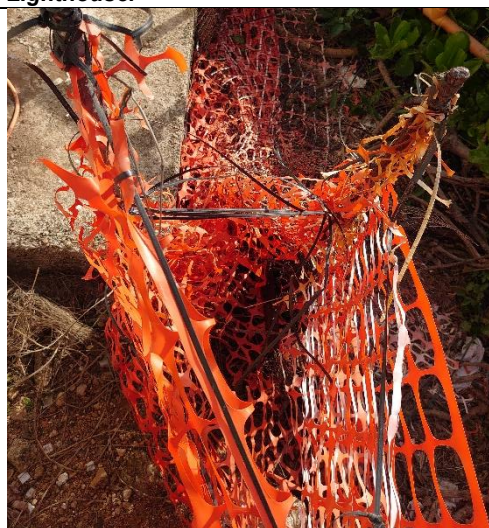
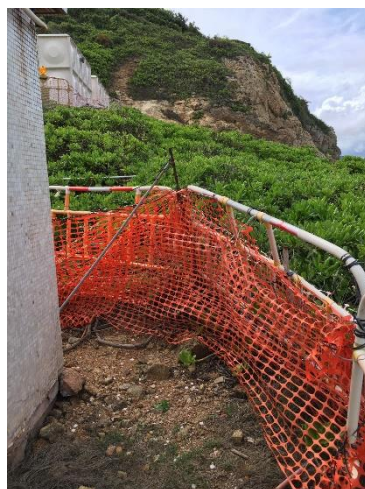
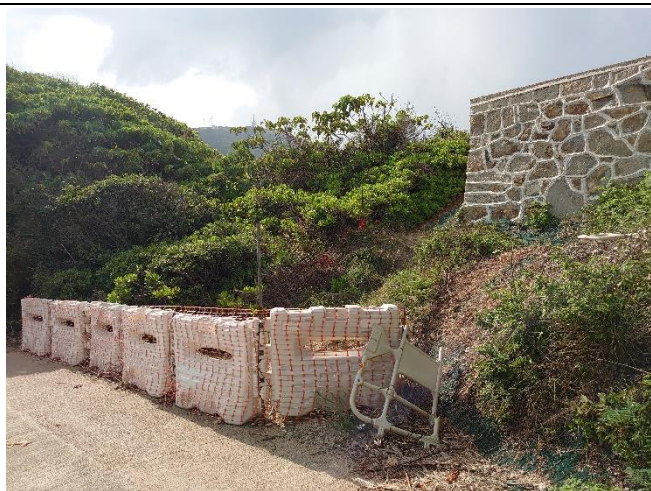
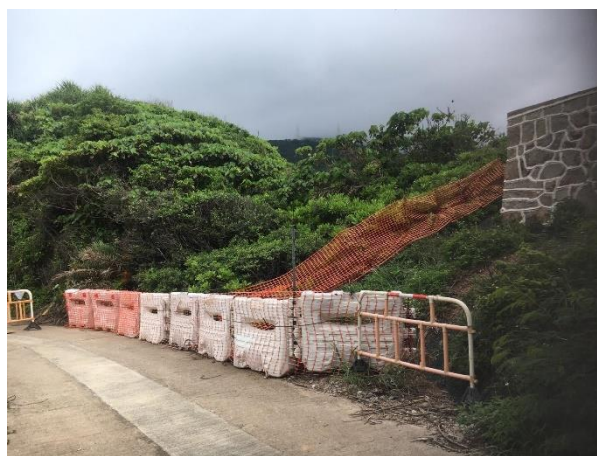
Observation - Item 2

Orange nets should be repaired/added at Sites G and the Lighthouse.

Orange net and fencing barrier is replaced.

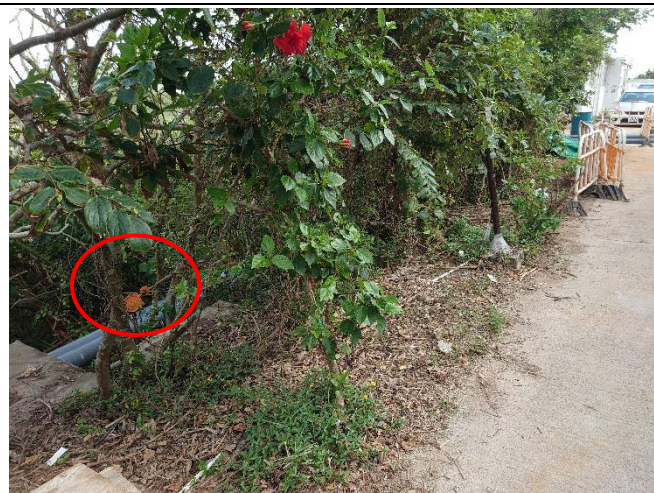
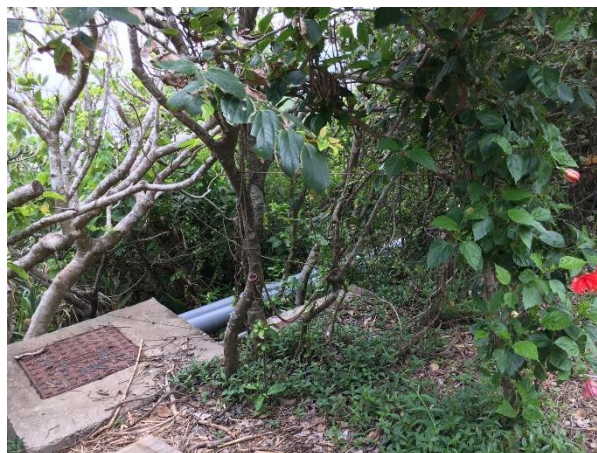
Observation - Item 3

Trees at Site F should not be used as pivot/support point.

Device attached to trees is removed.

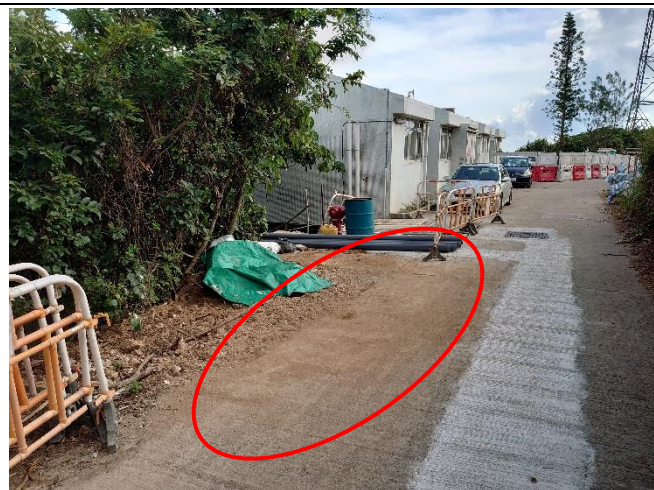
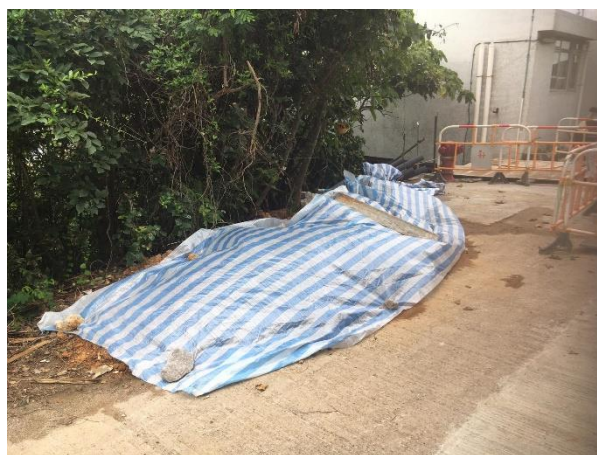
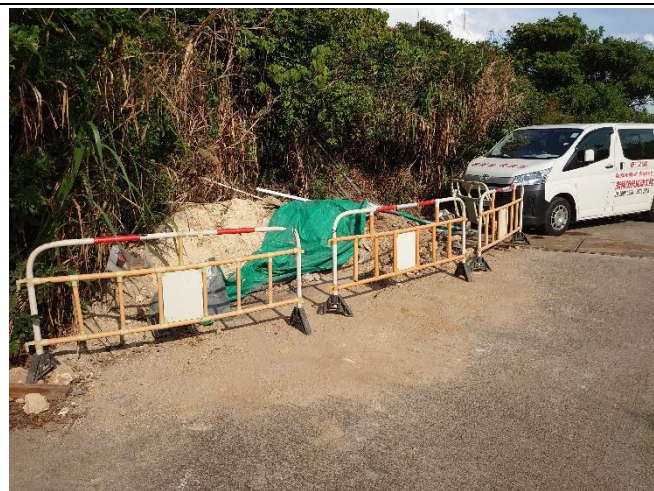
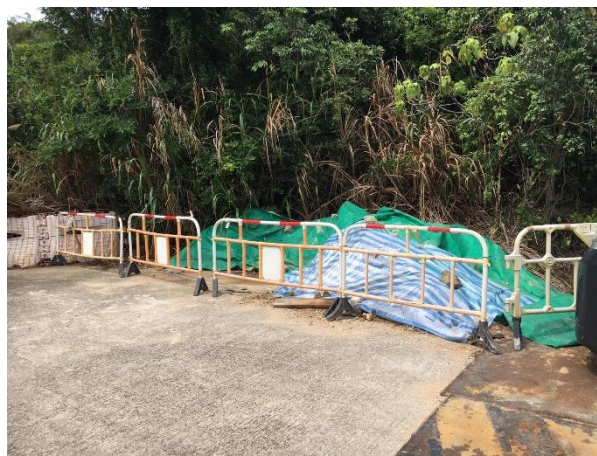
Observation - Item 4

Dusty materials should be contained within the site boundary with proper covering at Sites F and the access road to Site A.

Canvas is used to cover excavated soil.

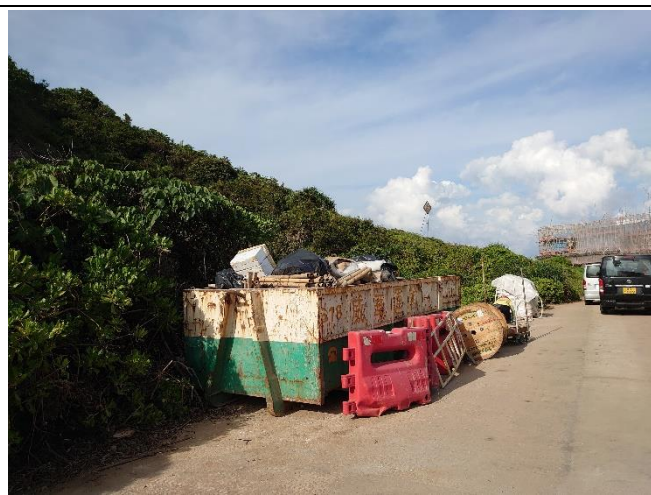
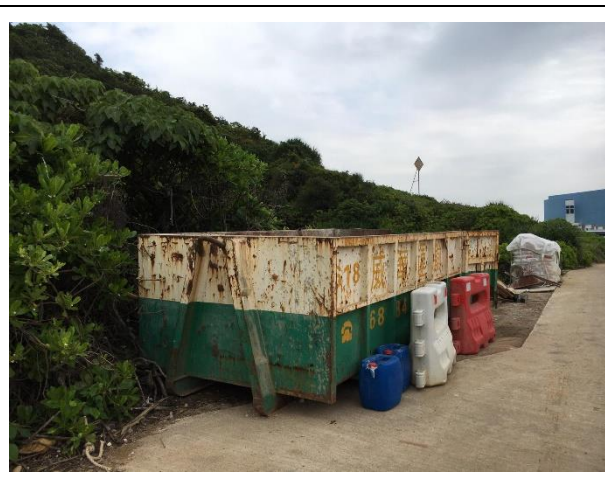
Observation - Item 5

Dumpster at Site A was full and found without cover.

Debris is cleared and cover will be placed when the dumpster is nearly full.

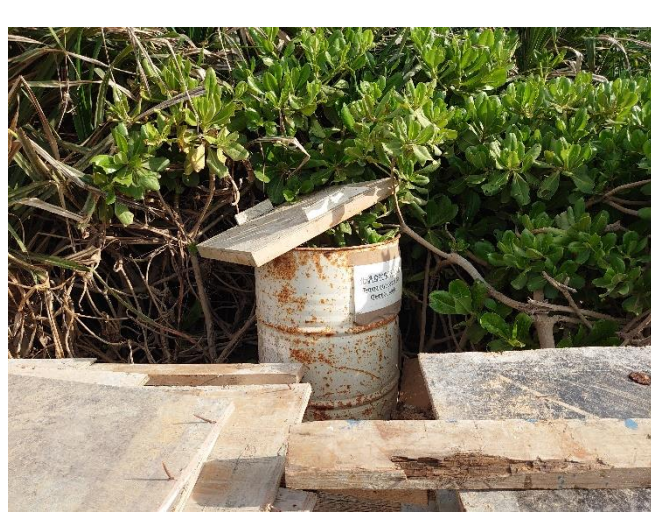
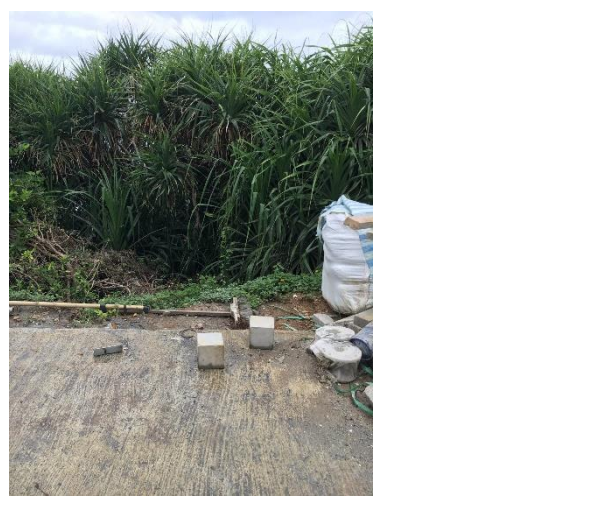
Observation - Item 6

The container labelled “Temporary Storage for chemical waste” was not a proper chem waste storage container. Standard container should be used to store chem waste if any.

The container is removed from site since there is no chemical waste to store at the moment.

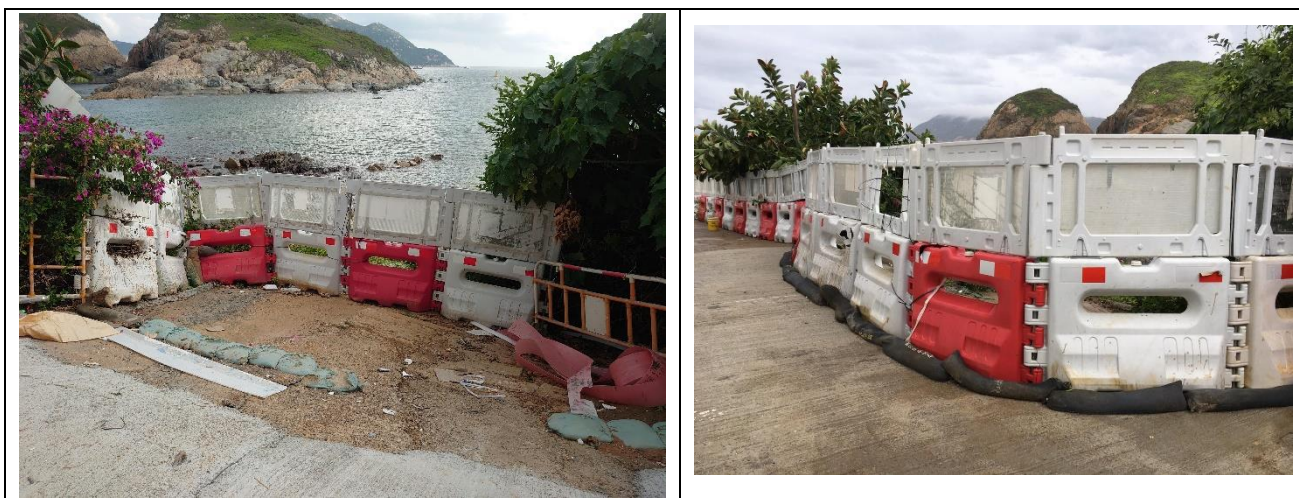
Observation - Item 7

At Site A, proper mitigation measures should be implemented to make sure all runoff/wastewater will not go out of the site boundary.

Barrier is re-arranged and sand bag is placed to prevent runoff from going out of site boundary.

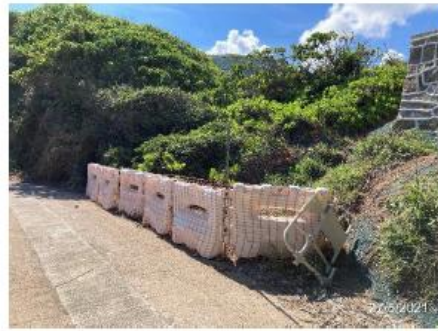
Pittosporum tobira 海桐

- 2.4.6. *Pittosporum tobira* (海桐) has shown slight dieback of twigs, with regeneration of young leaves. Invasive *Leucaena leucocephala* and *Lantana camara* within protection zone have been cleared together with other overgrown climbers.

Collapsed fencing to be rectified

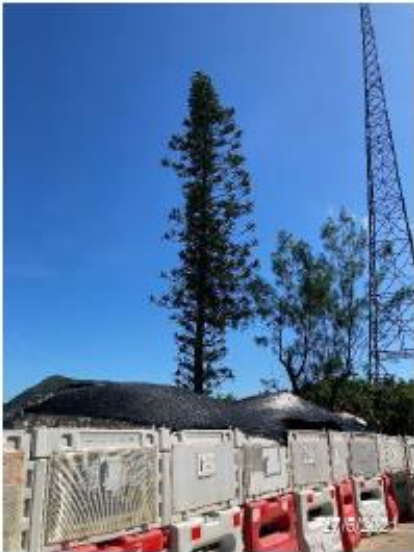
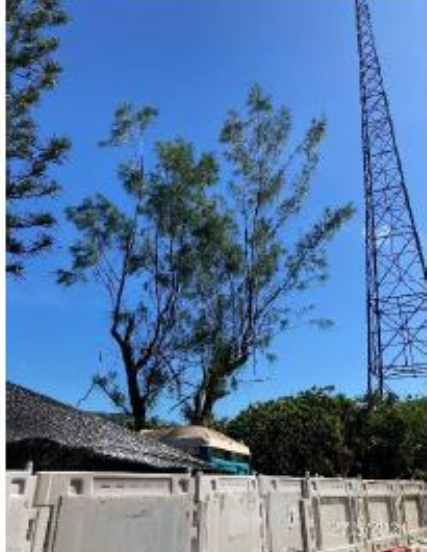
- 2.4.8. Young leaves of the deciduous *Vitis bryoniifolia* (蘗蘊) has emerged.
- 2.4.9. For the three retained trees, there is no change in overall condition of T5; while regeneration of new foliage made tree health of T6, as well as tree form of TA to be assessed from poor to fair. Broken branches in TA due to the typhoon damage should receive appropriate assessment and treatment. Alignment of pipes passing through among aerial roots of TA has been adjusted with minimum pruning of small, non-supportive aerial roots. Soil excavation at the core root zone has been avoided. Since TA (*Ficus elastica*) is a species with extensive aerial root system, such minimum pruning without tearing wounds would be acceptable and unlikely results in

<p>No change in condition of T5 from previous monitoring.</p>	<p>No change in condition of T6 from previous monitoring.</p>

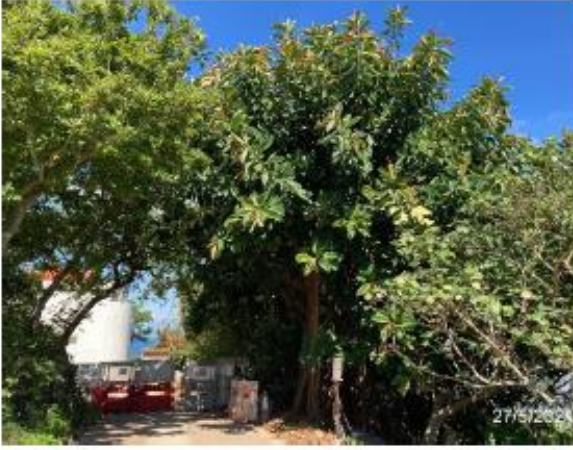
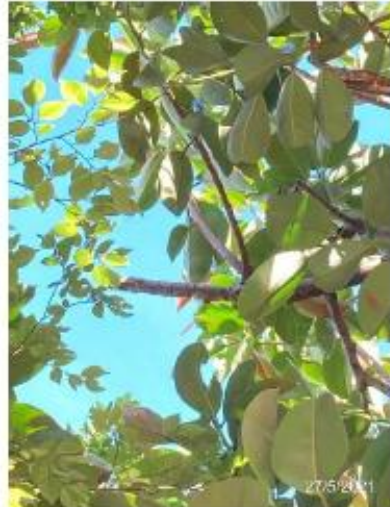
<p>No change in condition of TA from previous monitoring.</p>	<p>Decaying branch hanger on TA.</p>

- 4.1.8. Broken branches in the retained tree TA due to the typhoon damage remained. Relevant authority shall be contacted for appointing a Certified Arborist or equivalent to conduct a Tree Risk Assessment (TRA) on this tree in order to get Lands Department's approval on taking corresponding actions (e.g. pruning). Once the TRA appointment is confirmed, good written

and photographic records (e.g. personal, date and time, actions, etc.) should be made before, during and after any actions of treatment for the assessed tree (i.e. TA)

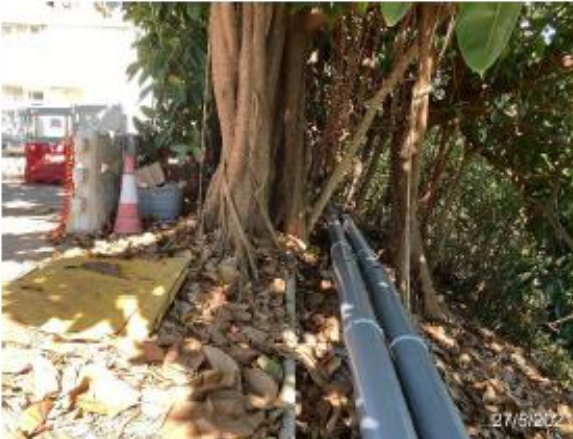
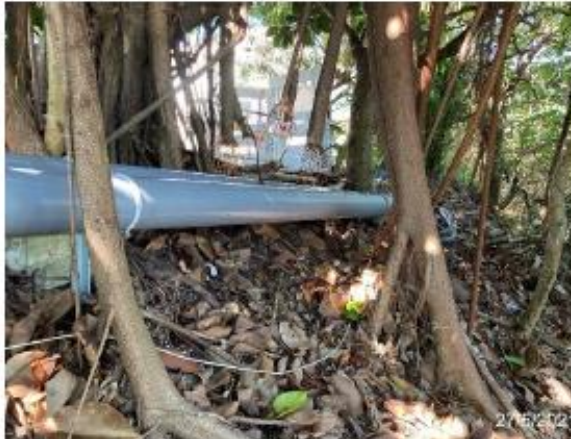
<p>Pipe alignment has been adjusted with minimum pruning of small, non-supportive aerial roots; in order to avoid soil excavation at the core root zone.</p>
