**Expansion of Research and Residential Facilities for
The Swire Institute of Marine Science, Faculty of Science,
The University of Hong Kong at Cape d' Aguilar, Shek O, Hong Kong
Submission of Monthly Environmental Monitoring and Audit Report No.45**

**MONTHLY ENVIRONMENTAL MONITORING AND AUDIT
(EM&A) REPORT (NO. 45)**

**Expansion of Research and Residential Facilities for the Swire Institute of
Marine Science, The University of Hong Kong at Cape D'Aguiar, Shek O**

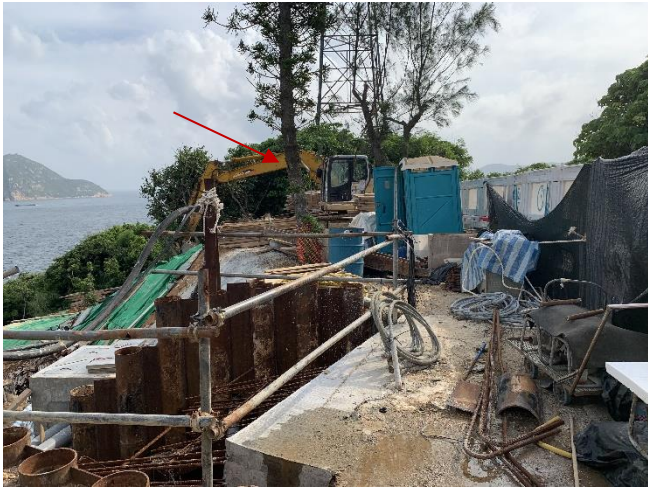
Observation - Item 1	
Observed on 30 June 2021	Rectified by the Contractor on 03 July 2021
<i>At Site F, retained tree should be fenced off.</i>	<i>Retained trees are fenced off.</i>

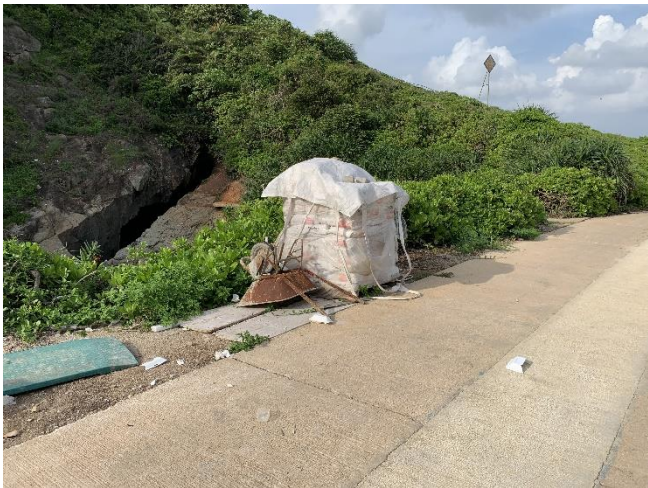
Observation - Item 2	
Observed on 30 June 2021	Rectified by the Contractor on 06 July 2021
<i>Construction material should not be placed on hoard road.</i>	<i>Construction material is removed from roadside.</i>

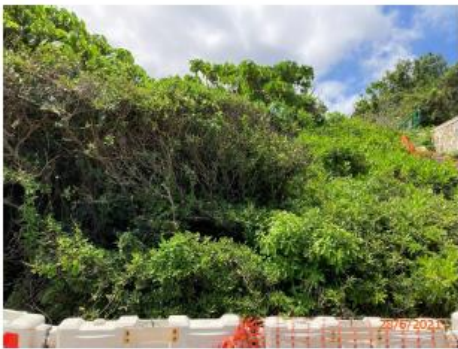
- 2.4.4. There is no change in form, health & structural condition and amenity value for all six recorded plant species of conservation importance.
- 2.4.5. Severe damage caused by Typhoon Mangkhut in September 2018 to the coastal vegetation remained. No *Lysimachia mauritiana* (濱海珍珠菜) could be observed in one of the protection zone near Academic Block (Site A) over 33 months. The original plants in this zone have certified as dead. The two rediscovered individuals and seedlings observed in vicinity have fruited during their end of biennial life cycle (Plate 1).

- 4.1.5. However re-establishment of *Lysimachia mauritiana* (濱海珍珠菜) is ongoing. The two rediscovered individuals and seedlings observed in vicinity have fruited during their end of biennial life cycle. Building up additional assurance colonies by collecting seeds may still be feasible.

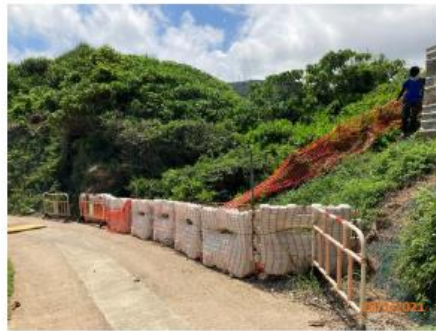
Pittosporum tobira 海桐

- 2.4.6. *Pittosporum tobira* (海桐) has shown slight dieback of twigs, with regeneration of young leaves. Invasive *Leucaena leucocephala* and *Lantana camara* within protection zone have been cleared together with other overgrown climbers.

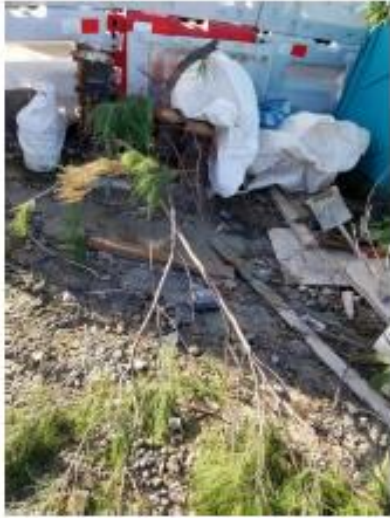
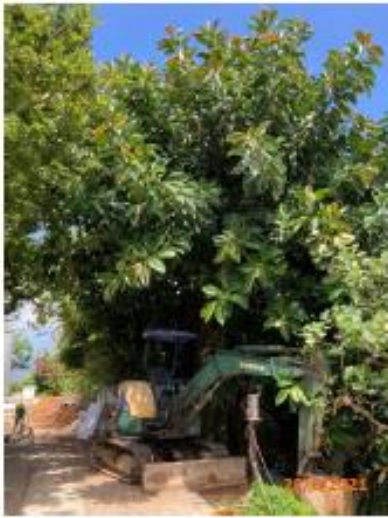
<p>A small branch of T6 was blown down under adverse weather on 7/7 2021, as reported by the Contractor</p>	<p>No change in condition of TA from previous monitoring.</p>

- 4.1.8. A small branch of T6 was blown down under adverse weather on 7th July 2021, as reported by the Contractor, but overall condition of T[^] is not affected. Broken branches in the retained tree TA due to the typhoon damage remained. Relevant authority shall be contacted for appointing a Certified Arborist or equivalent to conduct a Tree Risk Assessment (TRA) on this tree, in order to get Lands Department's approval on taking corresponding actions (e.g., pruning). Once the TRA appointment is confirmed, good written and photographic records (e.g., personal, date and

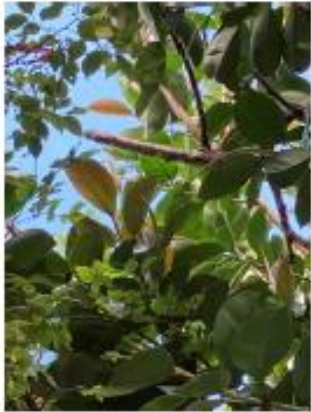
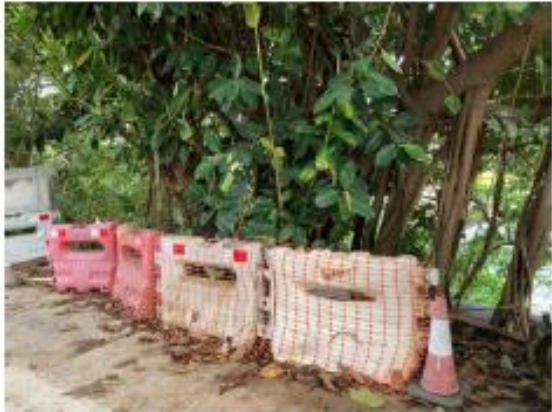
<p>Decaying branch hanger on TA.</p>

time, actions, etc.) should be made before, during and after any actions of treatment for the assessed tree (i.e., TA).
