**Expansion of Research and Residential Facilities for  
The Swire Institute of Marine Science, Faculty of Science,  
The University of Hong Kong at Cape d' Aguilar, Shek O, Hong Kong  
Submission of Monthly Environmental Monitoring and Audit Report No.46**

## **MONTHLY ENVIRONMENTAL MONITORING AND AUDIT (EM&A) REPORT (NO. 46)**

**Expansion of Research and Residential Facilities for the Swire Institute of  
Marine Science, The University of Hong Kong at Cape D'Aguiar, Shek O**

**(Rev. 0)**

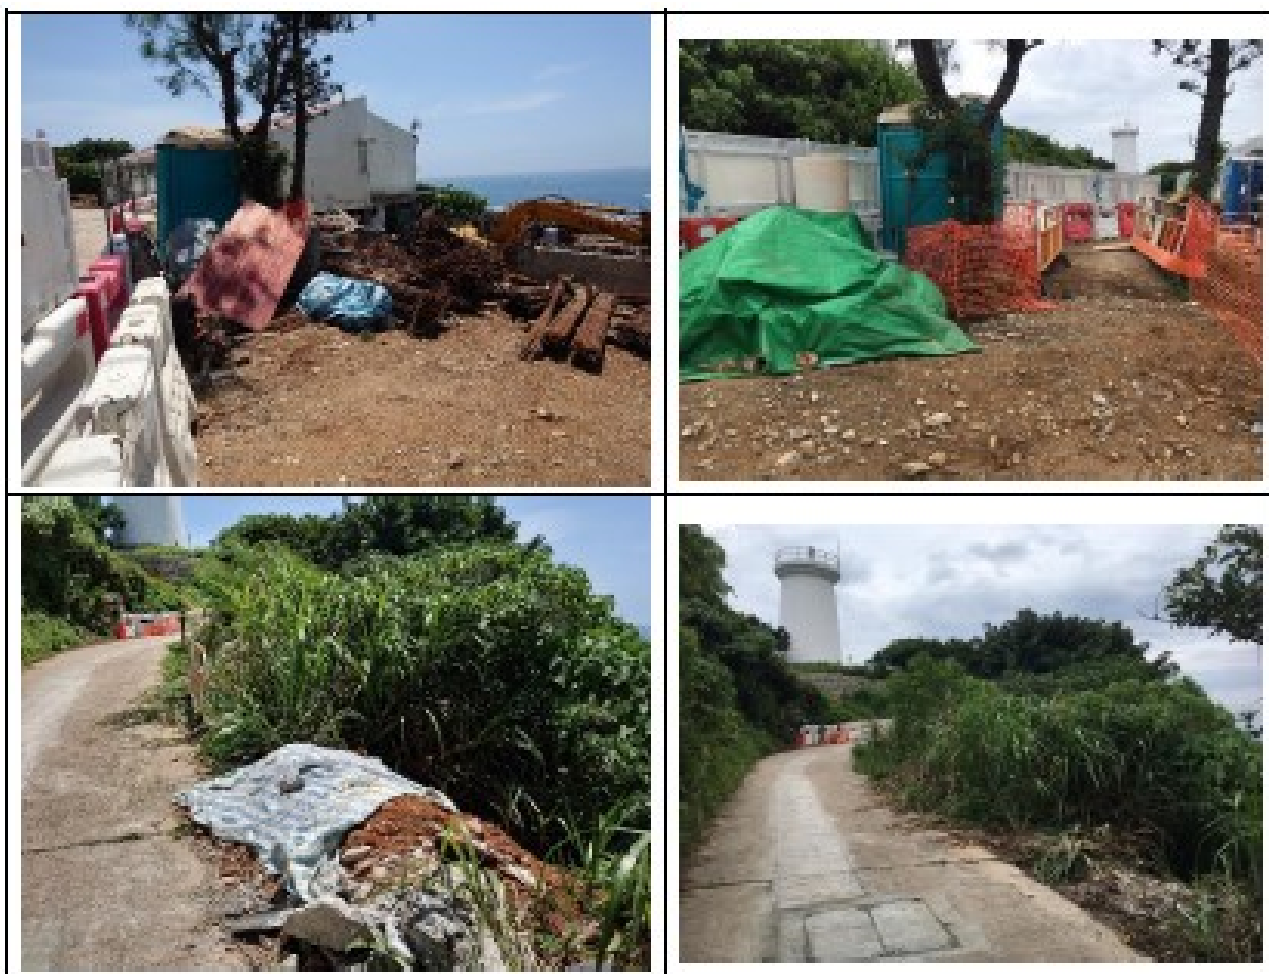
Table 2-3: Site Observations

Observation - Item 1	
Observed 22 July 2021	Rectified by the Contractor on 04 Aug 2021
At site F, construction materials should be contained within site boundary and should not disturb any retaining trees.	Construction materials are moved into site boundary or separated from nearby trees.

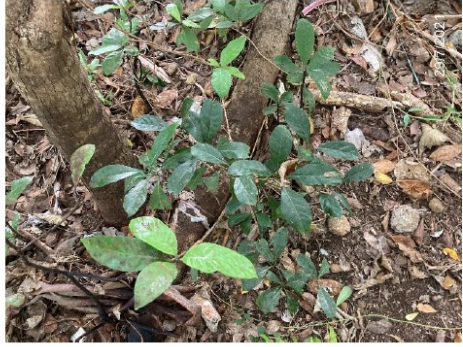
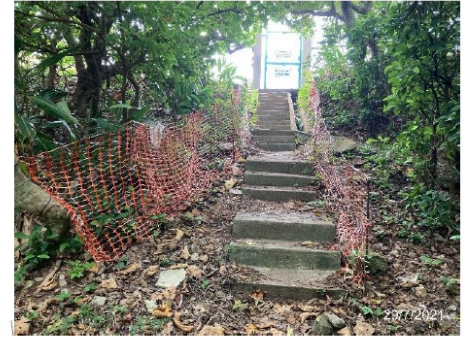
2.4.5. Severe damage caused by Typhoon Mangkhut in September 2018 to the coastal vegetation remained. No *Lysimachia mauritiana* (濱海珍珠菜) could be observed in one of the protection zone near Academic Block (Site A) over 34 months. The original plants in this zone have certified as dead. The two rediscovered individuals and seedlings observed in vicinity have fruited during their end of biennial life cycle (Plate 1).

<p><i>Lysimachia mauritiana</i> 濱海珍珠菜 (biennial)</p>	<p>Collapsed fencing to be rectified</p>

- 4.1.5. However re-establishment of *Lysimachia mauritiana* (濱海珍珠菜) is ongoing. The two rediscovered individuals and seedlings observed in vicinity have fruited during their end of biennial life cycle. Building up additional assurance colonies by collecting seeds may still be feasible.

- 4.1.7. Protection zone has been provided in accordance with Condition 2.6 of the Environmental Permit. Any damage of the protection zone (e.g. due to coastal weather condition or disturbance of hikers and visitors) should be repaired promptly. Warning sign should be maintained at prominent positions within the works area to encourage hikers and visitors keeping away from any no-entry area or protection zone.

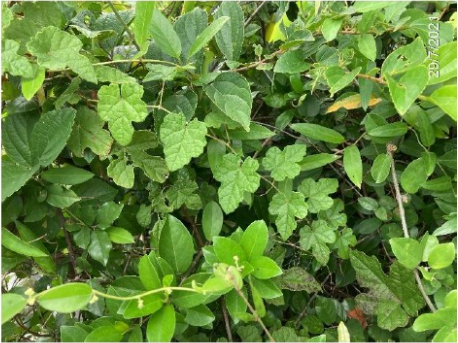
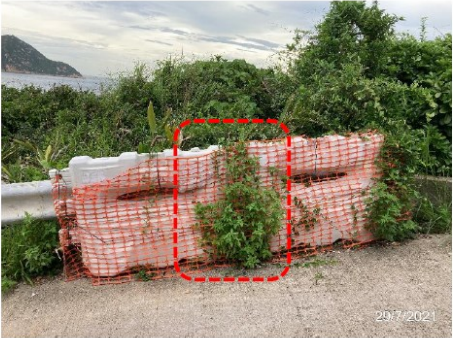
2.4.6. *Pittosporum tobira* (海桐) has shown slight dieback of twigs, with regeneration of young leaves. Invasive *Leucaena leucocephala* and *Lantana camara* within protection zone have been cleared but emerged again with other overgrown climbers..

<p><i>Pittosporum tobira</i> 海桐: sprouts of previously cleared invasive species emerged again (red dottedline)</p>	<p>Collapsed fencing to be rectified</p>

- 4.1.11. To avoid/ reduce potential negative impacts to local native plant community and survival of plant species of conservation important, exotic and highly invasive tree *Leucaena leucocephala* (銀合歡), shrub *Lantana camara* (馬櫻丹), herb *Bidens alba* (白花鬼針草) and climber *Mikania micrantha* (薇甘菊) should be cleared and removed in whole, including the roots, whenever encountered throughout the construction phase, and packed properly before disposed as waste to prevent regrowth and dispersal of pollens and seeds. Invasive species and other overgrown climbers observed within the protection zone of *Pittosporum tobira* (海桐) and *Elaeagnus tutcheri* (香港胡頹子) have been cleared but emerged again as observed in this monitoring..

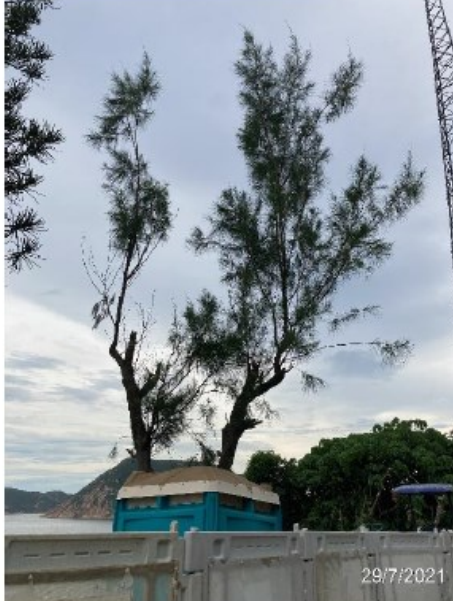
A tree with a more irregular, spreading canopy of dark green needles, situated behind a concrete construction barrier. A crane is visible in the background. The date '29/7/2021' is printed in the bottom right corner of the image.
<p>No change in condition of T5 from previous monitoring.</p>	<p>No change in overall condition of T6 from previous monitoring.</p>

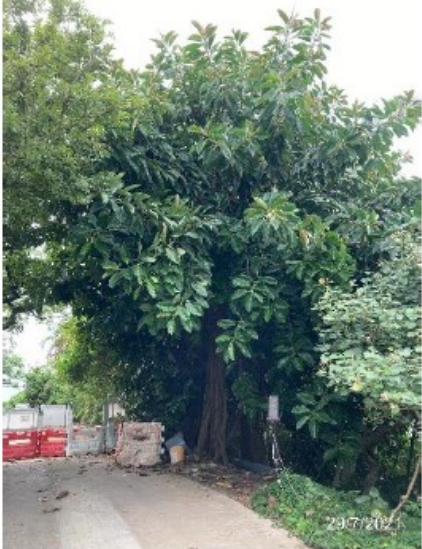
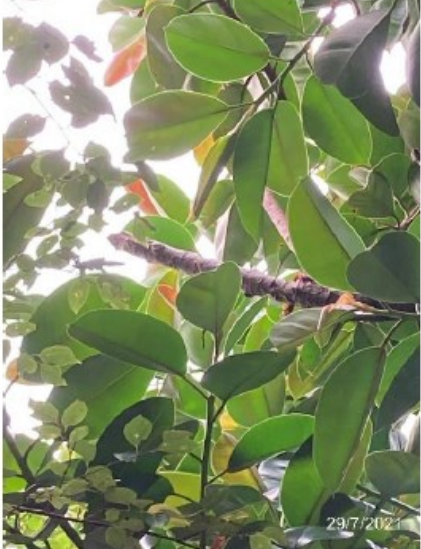
- 4.1.8. A small branch of T6 was blown down under adverse weather on 7th July 2021, as reported by the Contractor, but overall condition of T6 is not affected. Broken branches in the retained tree TA due to the typhoon damage remained. Relevant authority shall be contacted for appointing a Certified Arborist or equivalent to conduct a Tree Risk Assessment (TRA) on this tree, in order

<p>No change in condition of TA from previous monitoring.</p>	<p>Decaying branch hanger on TA.</p>

to get Lands Department's approval on taking corresponding actions (e.g., pruning). Once the TRA appointment is confirmed, good written and photographic records (e.g., personal, date and time, actions, etc.) should be made before, during and after any actions of treatment for the assessed tree (i.e., TA).
