Environmental Permit (No. EP-537/2017)

**Expansion of Research and Residential Facilities for
The Swire Institute of Marine Science, Faculty of Science,
The University of Hong Kong at Cape d' Aguilar, Shek O, Hong Kong
Submission of Monthly Environmental Monitoring and Audit Report No.47**

MONTHLY ENVIRONMENTAL MONITORING AND AUDIT (EM&A) REPORT (NO. 47)

**Expansion of Research and Residential Facilities for the Swire Institute of
Marine Science, The University of Hong Kong at Cape D'Aguiar, Shek O**

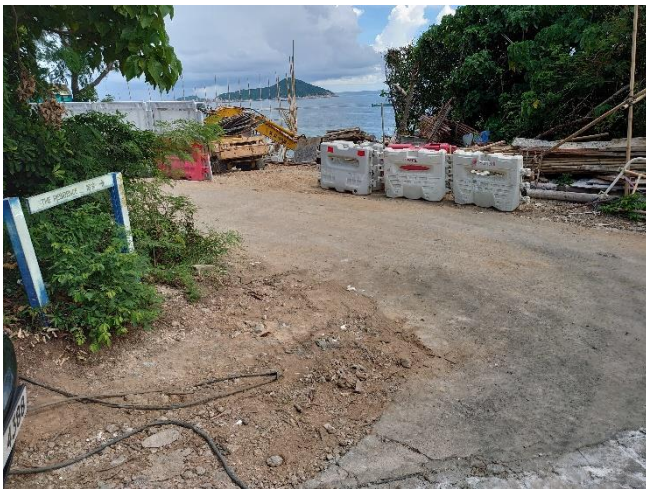
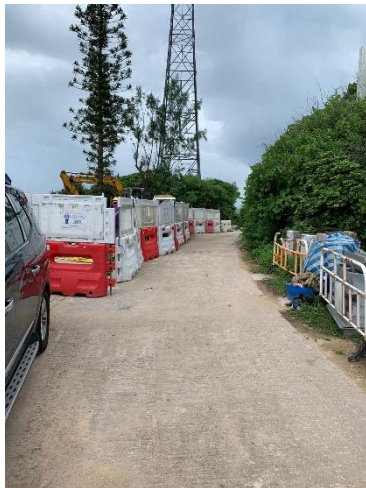
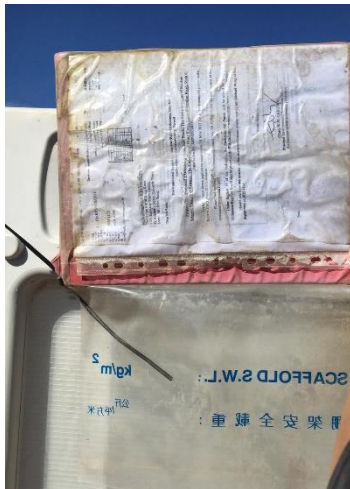
Observation - Item 1	
Observed 25 August 2021	Rectified by the Contractor on 03 Sep 2021
<p>At site F, a vehicle entrance / exit was observed. The area should have a wheel washing bay and wastewater channels leads to a desilting facility. The Environmental Permit should also be displayed at the vehicle entrance.</p>	<p>The opening was temporary for loading and unloading materials. The barrier was reinstated afterwards. Environmental Permit is posted on barrier.</p>

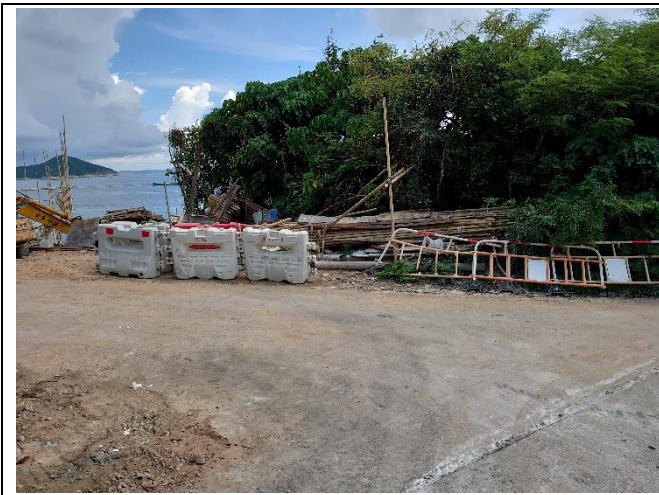
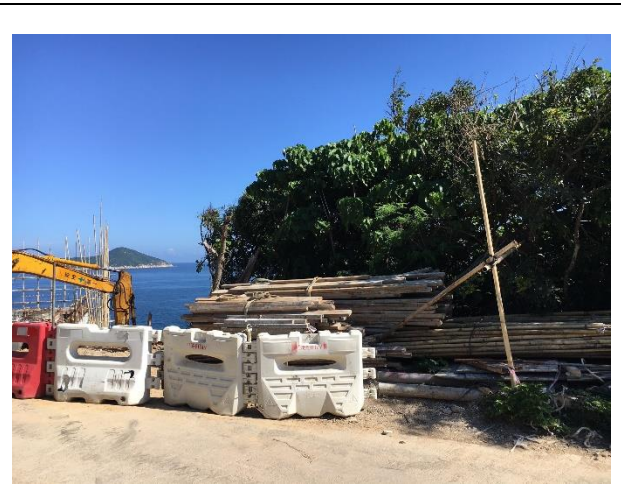
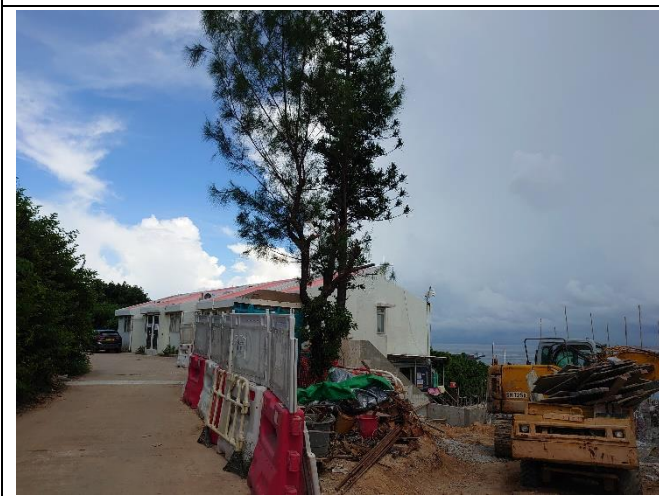
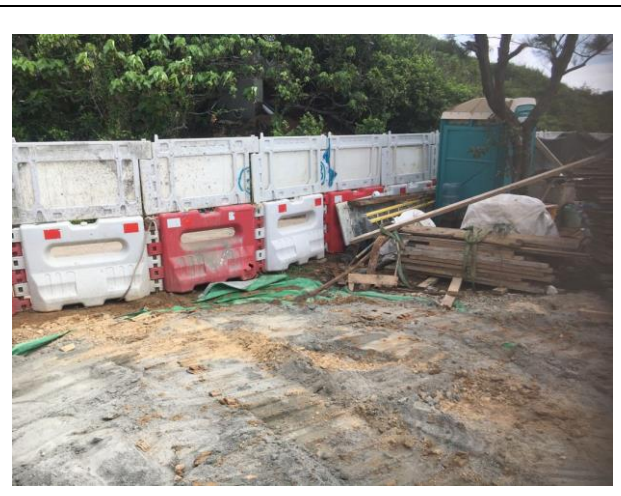
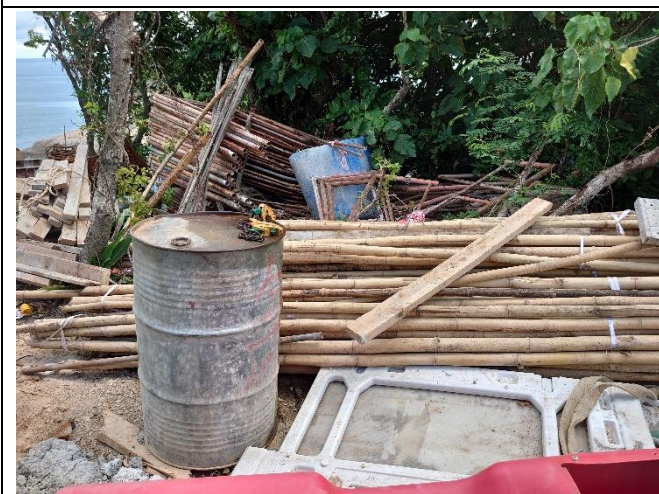
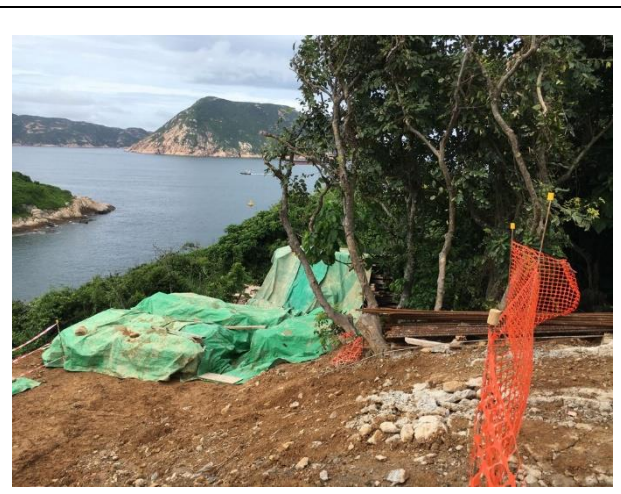
Observation - Item 2	
Observed 25 August 2021	Rectified by the Contractor on 03 Sep 2021
<p>At site F, drip trays should be provided for chemical containers and retaining trees should be free from construction materials.</p>	<p>Chemicals are removed from site. Construction materials are tidied up and moved away from nearby trees.</p>

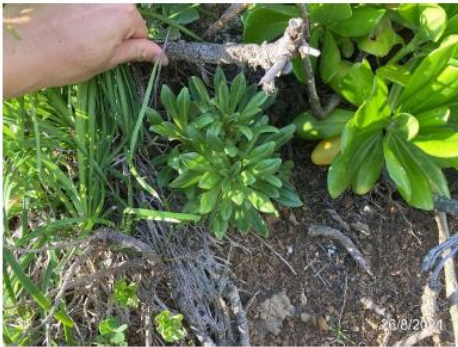
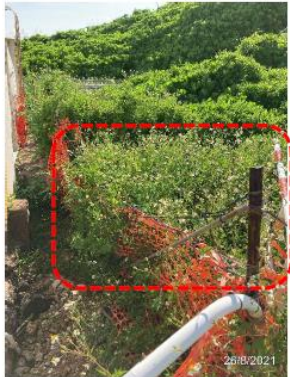
<p><i>Lysimachia mauritiana</i> 濟海珍珠菜 (biennial), a new individual observed outside Academic Block (Site A) in 34 months after the impact of typhoon</p>	<p>Invasive weeds <i>Bidens alba</i> (白花鬼針草) in/around the protection zone shall be cleared, including roots, flowers and seeds (red dotted line)</p>

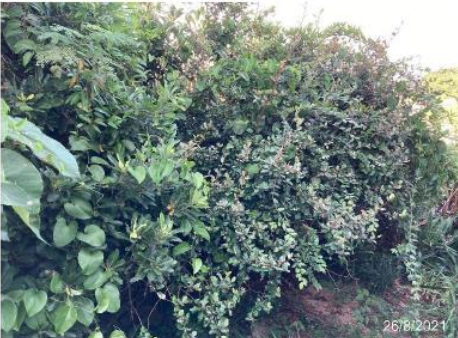
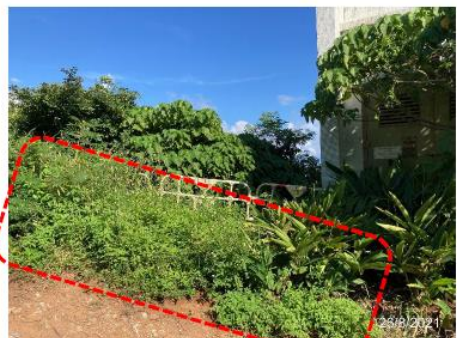
- 2.4.7. Invasive species *Bidens alba* within protection zone of *Elaeagnus tutcheri* (香港胡頹子) has been cleared together with other overgrown climbers.

<p><i>Elaeagnus tutcheri</i> 香港胡頹子</p>	<p>Invasive weeds <i>Bidens alba</i> (白花鬼針草) in/around the protection zone shall be cleared, including roots, flowers and seeds (red dotted line)</p>

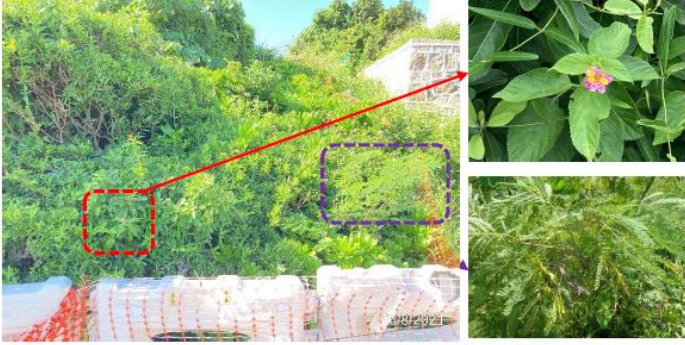
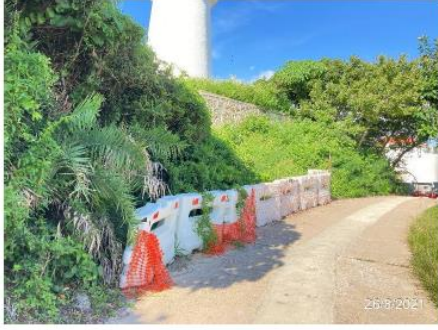
- 2.4.6. *Pittosporum tobira* (海桐) has shown slight dieback of twigs, with regeneration of young leaves. Invasive *Leucaena leucocephala* and *Lantana camara* within protection zone have been cleared together with other overgrown climbers.

<p><i>Pittosporum tobira</i> 海桐; sprouts of previously cleared invasive species emerged again (dotted line)</p>	<p>Collapsed fencing to be rectified</p>

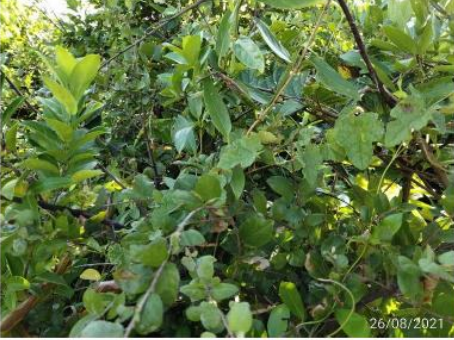
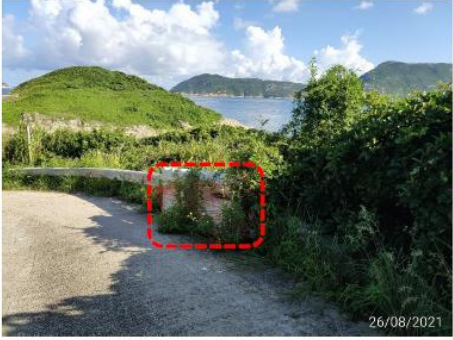
- 2.4.8. Young leaves of the deciduous *Vitis bryoniifolia* (蔓蘗) has emerged.
- 2.4.9. For the three retained trees, there is no change in overall condition of T5, T6 and TA, despite a small branch of T6 was blown down under adverse weather on 7th July 2021, as reported by the Contractor. Broken branches in TA due to the typhoon damage should receive appropriate assessment and treatment. Alignment of pipes passing through among aerial roots of TA has been adjusted with minimum pruning of small, non-supportive aerial roots. Soil excavation at the core root zone has been avoided. Since TA (*Ficus elastica*) is a species with extensive aerial root system, such minimum pruning without tearing wounds would be acceptable and unlikely results in significant impact to the tree.

<p><i>Vitis bryoniifolia</i> 嬰菓 (deciduous)</p>	<p>Previously cleared invasive species emerged again (red dotted line)</p>

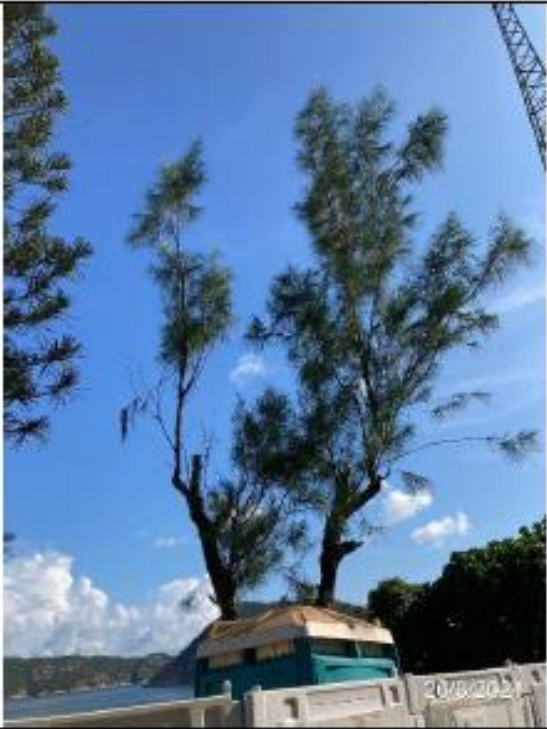
- 4.1.8. A small branch of T6 was blown down under adverse weather on 7th July 2021, as reported by the Contractor, but overall condition of T6 is not affected.

A tree with a more irregular, spreading canopy of green needles. A crane is visible in the upper right corner. A blue and white structure is partially visible at the base of the tree.
<p>No change in condition of T5 from previous monitoring.</p>	<p>No change in overall condition of T6 from previous monitoring.</p>

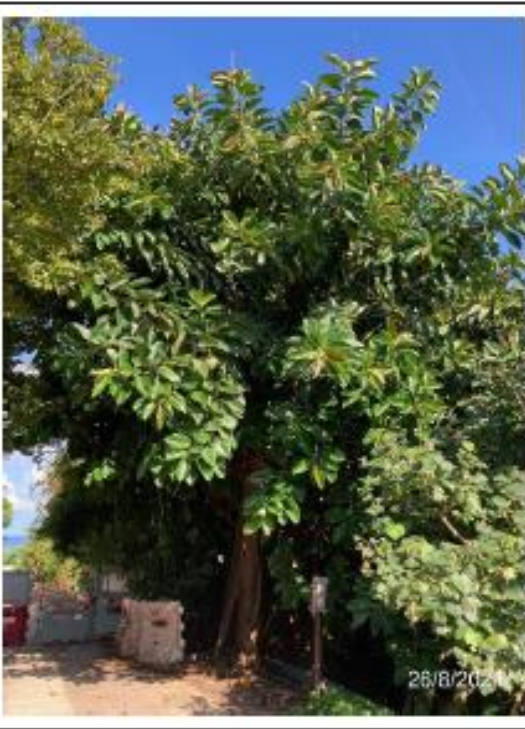
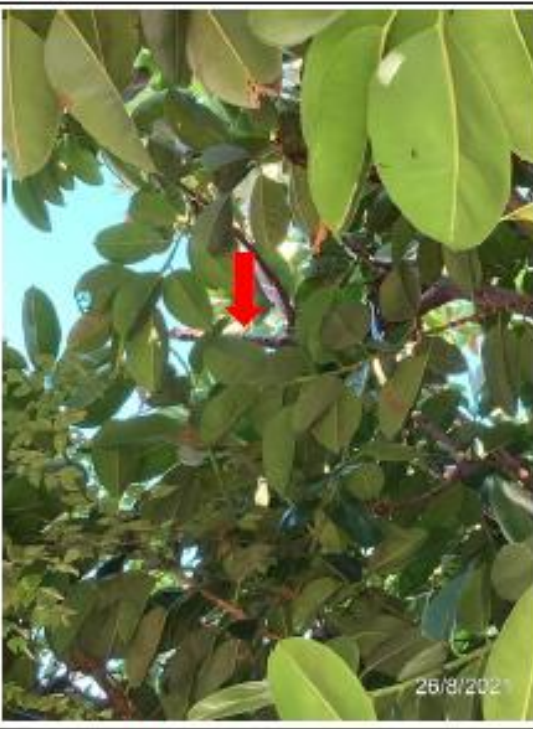
A close-up view of a tree branch with green leaves. A red arrow points to a small, dark, decaying branch hanger. A date stamp '26/8/2021' is visible in the bottom right corner.
<p>No change in condition of TA from previous monitoring.</p>	<p>Decaying branch hanger on TA.</p>

- 4.1.9. Broken branches in the retained tree TA due to the typhoon damage remained. Relevant authority shall be contacted for appointing a Certified Arborist or equivalent to conduct a Tree Risk Assessment (TRA) on this tree in order to get Lands Department's approval on taking corresponding actions (e.g. pruning). Once the TRA appointment is confirmed, good written and photographic records (e.g. personal, date and time, actions, etc.) should be made before, during and after any actions of treatment for the assessed tree (i.e. TA)
