**Expansion of Research and Residential Facilities for
The Swire Institute of Marine Science, Faculty of Science,
The University of Hong Kong at Cape d' Aguilar, Shek O, Hong Kong
Submission of Monthly Environmental Monitoring and Audit Report No.49**

**MONTHLY ENVIRONMENTAL MONITORING AND AUDIT
(EM&A) REPORT (NO. 49)**

**Expansion of Research and Residential Facilities for the Swire Institute of
Marine Science, The University of Hong Kong at Cape D'Aguiar, Shek O**

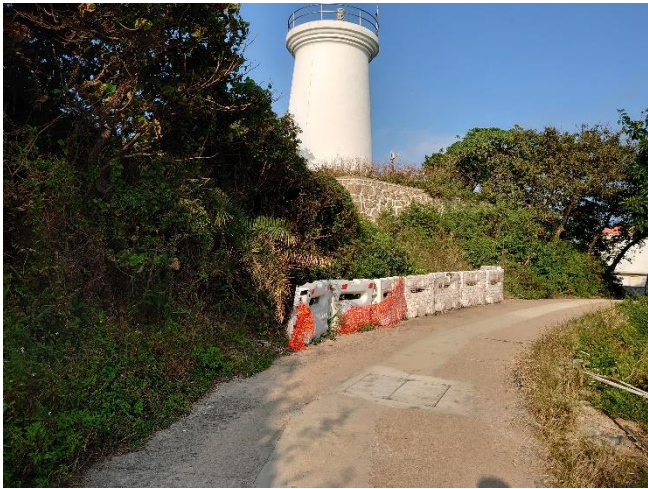
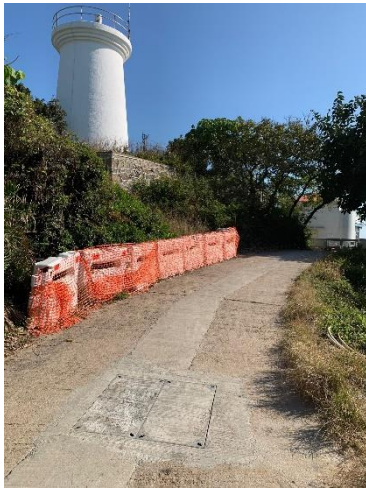
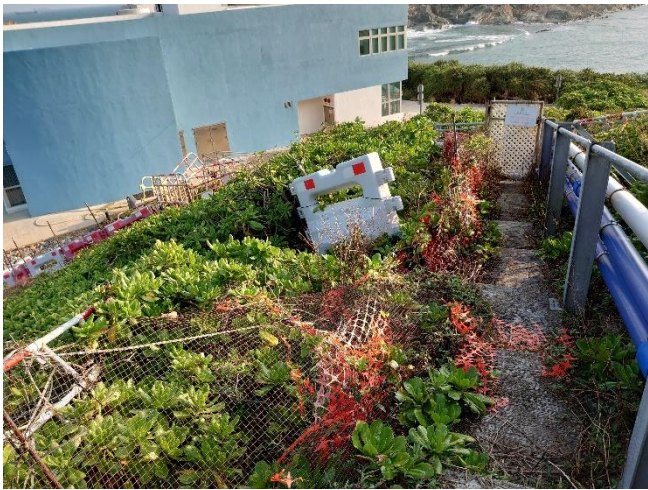
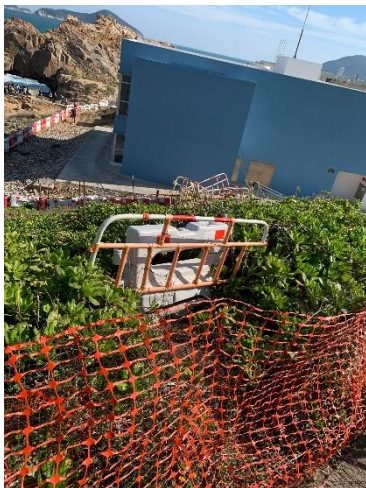
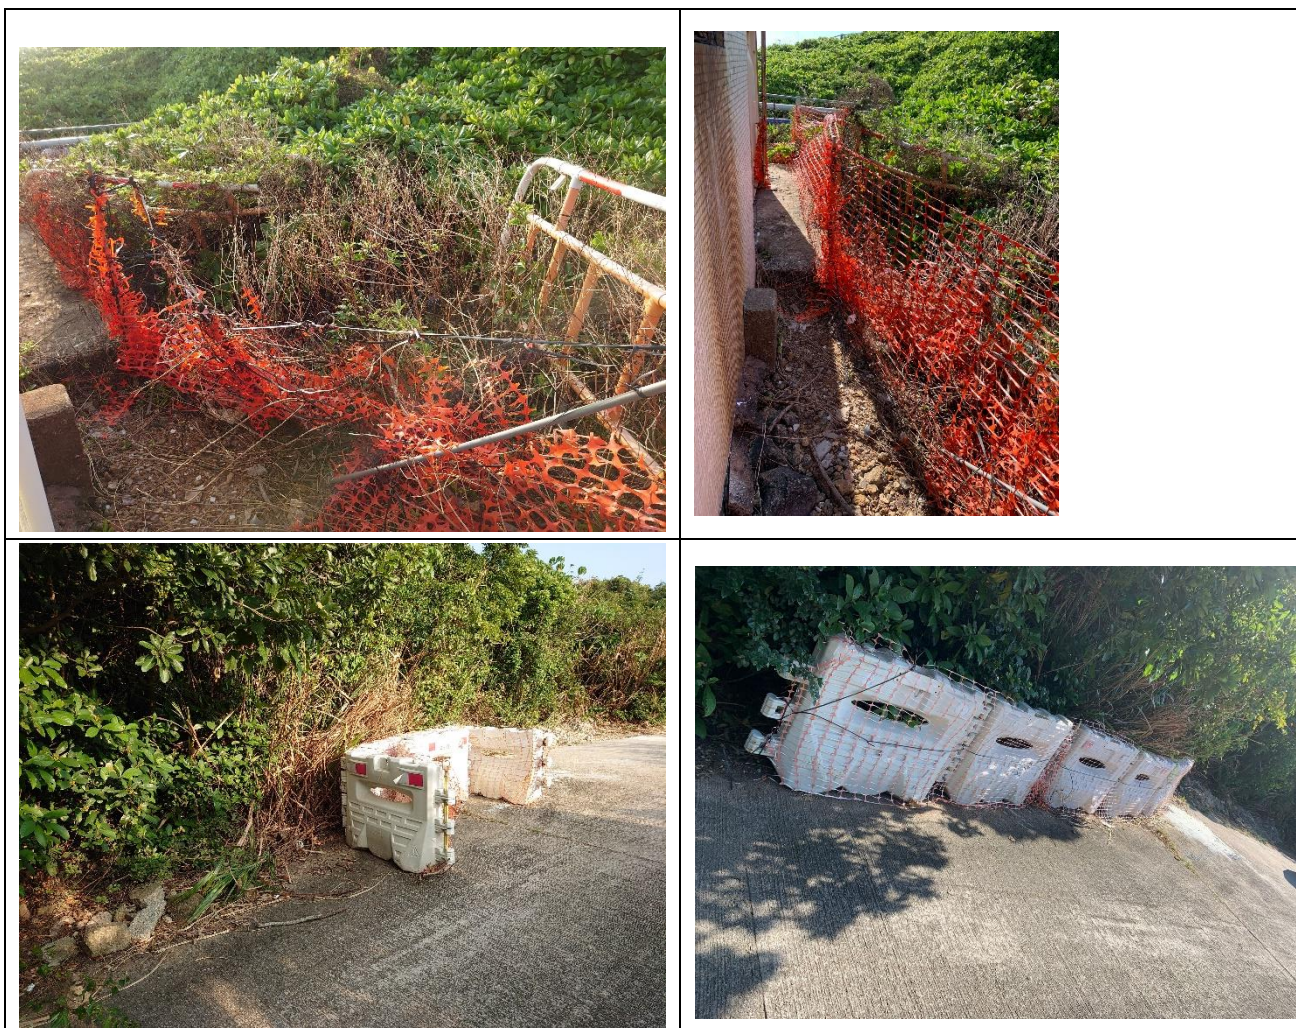
Observation - Item 1	
Observed 29 October 2021	Rectified by the Contractor on 12 Nov 2021
<p><i>Orange nets should be well-maintained. Tree protection measures (fencing) on the access road to Site A should be put back in place.</i></p>	<p><i>Orange net is repaired.</i></p>

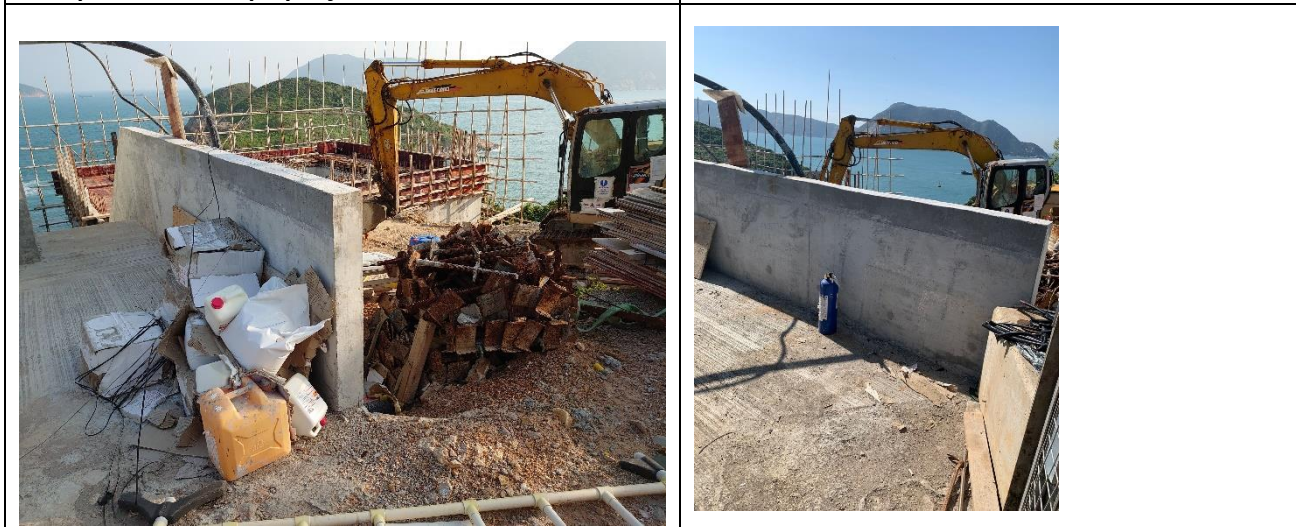
Observation - Item 2

At Site F, drip tray should be provided for chemical containers. Dusty materials should be removed and stockpiles should be properly covered.

Chemical is removed from site. Stockpile is covered with canvas.

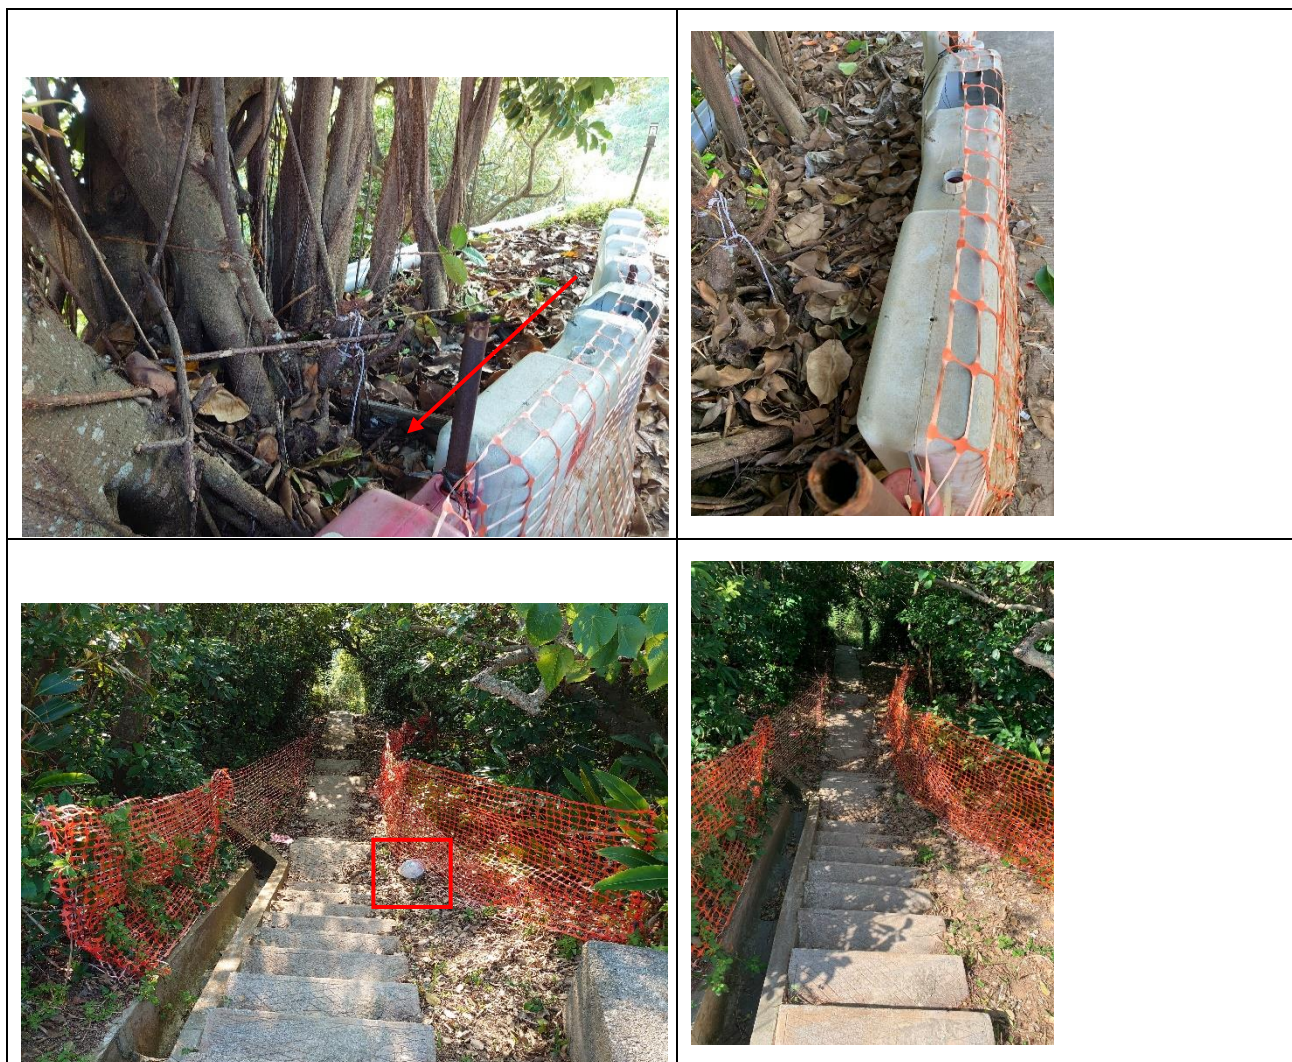
<p>Observation - Item 3</p>	
<p>Observed 29 October 2021</p>	<p>Rectified by the Contractor on 13 Nov 2021</p>
<p><i>At Site A, dusty materials on road should be cleaned to maintain good housekeeping.</i></p>	<p><i>Road is cleaned.</i></p>

<p>Observation - Item 4</p>	
<p>Observed 29 October 2021</p>	<p>Rectified by the Contractor on 13 Nov 2021</p>
<p><i>At Site B and PCCW, construction materials should be properly placed.</i></p>	<p><i>Materials are removed / moved to proper storage.</i></p>

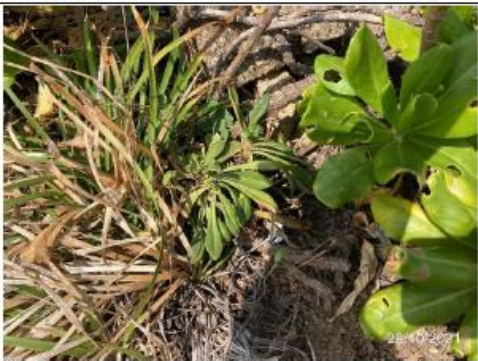
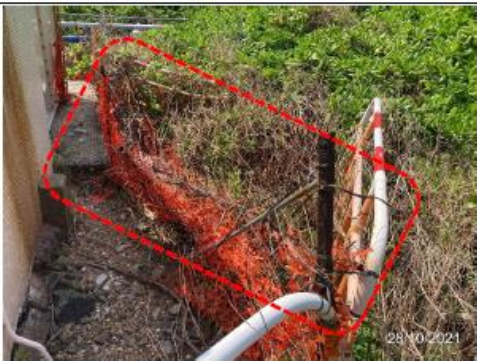
2.4.5. Severe damage caused by Typhoon Mangkhut in September 2018 to the coastal vegetation remained. No *Lysimachia mauritiana* (濱海珍珠菜) could be observed in one of the protection zone near Academic Block (Site A) over 37 months. The original plants in this zone have certified as dead. However, a new healthy individual was observed nearby (Plate 1). In contrast, the individual within current protection zone has ended by its biennial life cycle without new seedlings regenerated from seeds (Plate 1).

<p><i>Lysimachia mauritiana</i> 濱海珍珠菜 (biennial), a new individual observed outside Academic Block (Site A)</p>	<p>Collapsed fencing to be rectified; Invasive weeds <i>Bidens alba</i> (白花鬼針草) in/around the protection zone shall be cleared, including roots, flowers and seeds (red dotted line)</p>

- 4.1.3. There is no change in form, health & structural condition and amenity value for all six recorded plant species of conservation importance.
- 4.1.4. Coastal vegetation had been wholly destroyed and removed by the typhoon, including most *Lysimachia mauritiana* (濱海珍珠菜). No individual was observed in one of the protection zone that near Academic Block (Site A) over 37 months. The original plants in this zone have certified as dead. However re-establishment of *Lysimachia mauritiana* (濱海珍珠菜) is on-going. A new healthy individual was observed nearby. A protection zone shall be added for it.

- 4.1.5. In contrast, the individual within current protection zone has ended by its biennial life cycle without new seedlings regenerated from seeds. Observation will be continued to confirm any emerge of new seedlings. Building up additional assurance colonies by collecting seeds may still be feasible.

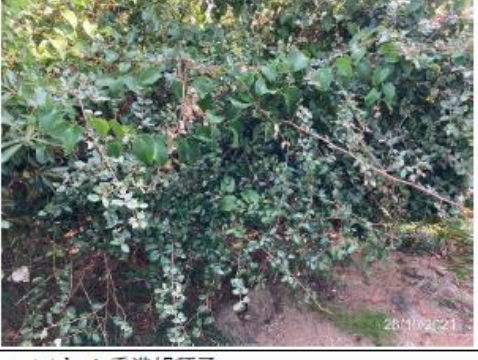
- 2.4.7. Invasive species *Bidens alba* within protection zone of *Elaeagnus tutcheri* (香港胡頹子) has been cleared but emerged again with other overgrown climbers.

<p><i>Elaeagnus titcheri</i> 香港胡頹子</p>	<p>Invasive weeds <i>Bidens alba</i> (白花鬼針草) in/around the protection zone shall be cleared, including roots, flowers and seeds (red dotted line)</p>

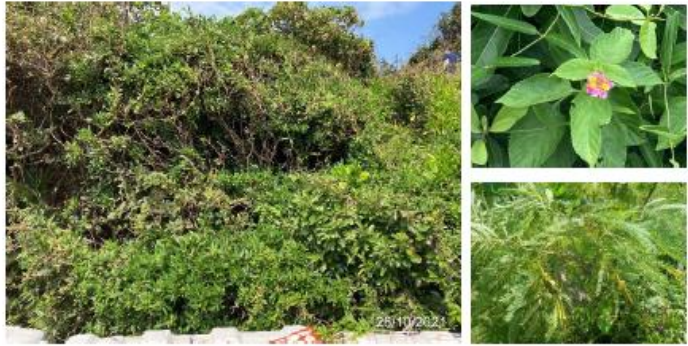
- 2.4.6. *Pittosporum tobira* (海桐) has shown slight dieback of twigs, with regeneration of young leaves. Invasive *Leucaena leucocephala* and *Lantana camara* within protection zone have been cleared but emerged again with other overgrown climbers.

<p><i>Pittosporum tobira</i> 海桐; sprouts of previously cleared invasive species emerged again (inset)</p>	<p>Collapsed fencing to be rectified</p>

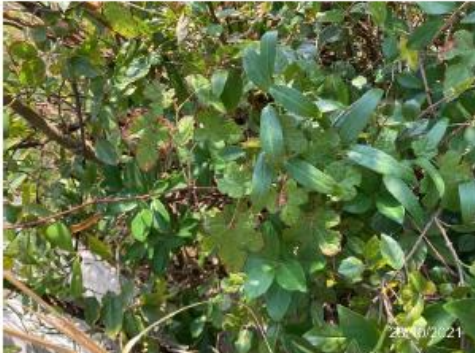
<p><i>Vitis bryoniifolia</i> 雙葉 (deciduous)</p>	<p>Collapsed fencing to be rectified; Previously cleared invasive species emerged again (red dotted line)</p>

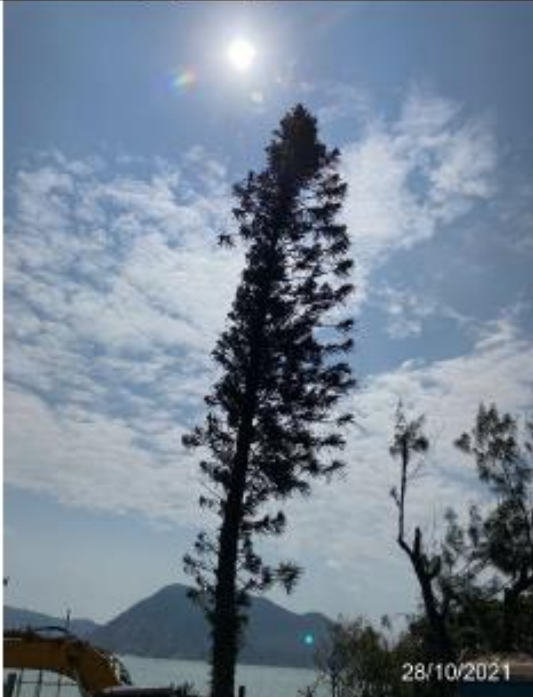
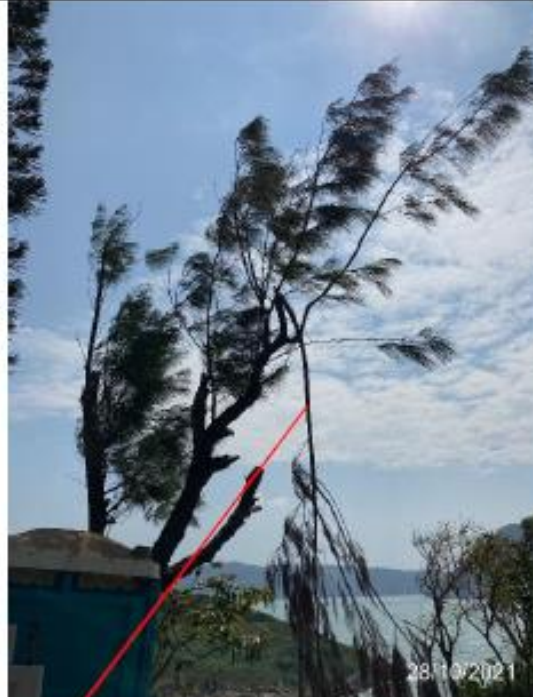
- 4.1.8. A small branch of T6 was blown down under adverse weather on 7th July 2021, as reported by the Contractor. Another branch of T5 was newly broken, probably by the two recent typhoons in October 2021, but overall condition of T6 is not affected.

<p>28/10/2021</p>
<p>No change in condition of T5 from previous monitoring.</p>	<p>Another branch of T6 was broken by the two typhoons in October 2021.</p>

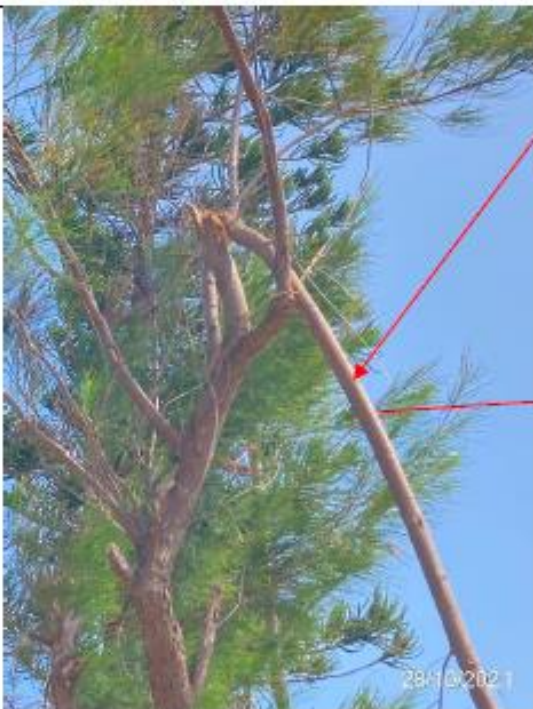
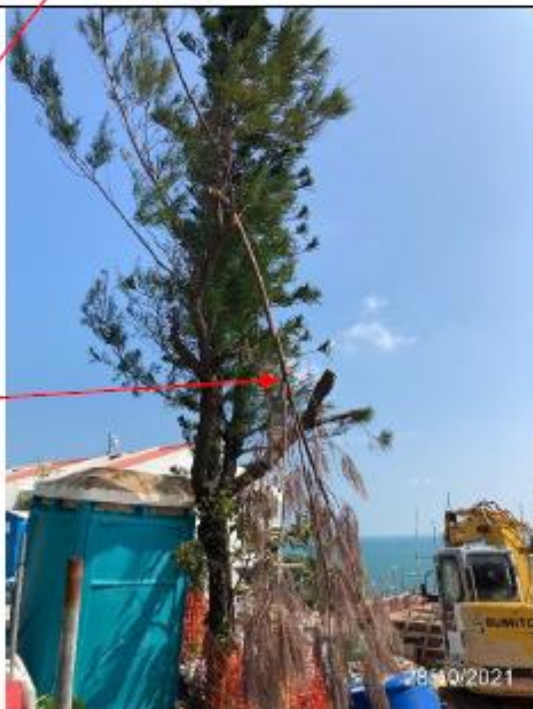
- 2.4.8. Leaves of the deciduous *Vitis bryoniifolia* (蘗蘂) is still observable.
- 2.4.9. For the three retained trees, there is no change in overall condition of T5, T6 and TA, despite a small branch of T6 was blown down under adverse weather on 7th July 2021, as reported by the Contractor. Another branch of T6 was broken, probably due to the 2 Typhoons Kompasu & Lionrock in October 2021. Several broken stubs on TA were also observed. Broken branches due to the typhoon damage should receive appropriate assessment and treatment. Alignment of pipes passing through among aerial roots of TA has been adjusted with minimum pruning of small, non-supportive aerial roots. Soil excavation at the core root zone has been avoided. Since TA (*Ficus elastica*) is a species with extensive aerial root system, such minimum pruning without tearing wounds would be acceptable and unlikely results in significant impact to the tree. Corresponding photographic records T5, T6 and TA are illustrated in Plate 2.

<p>28/10/2021</p>
<p>Broken branch of T6</p>	<p>Broken branch of T6</p>

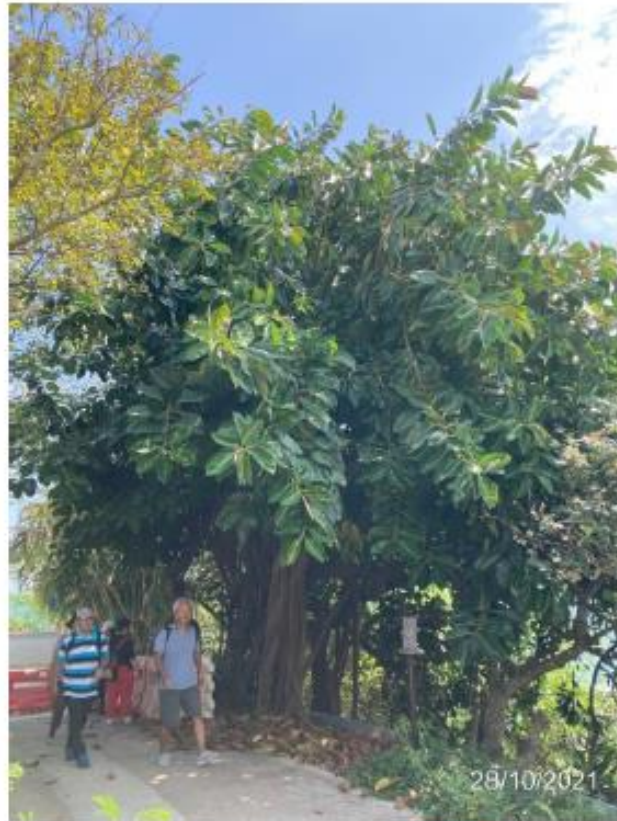
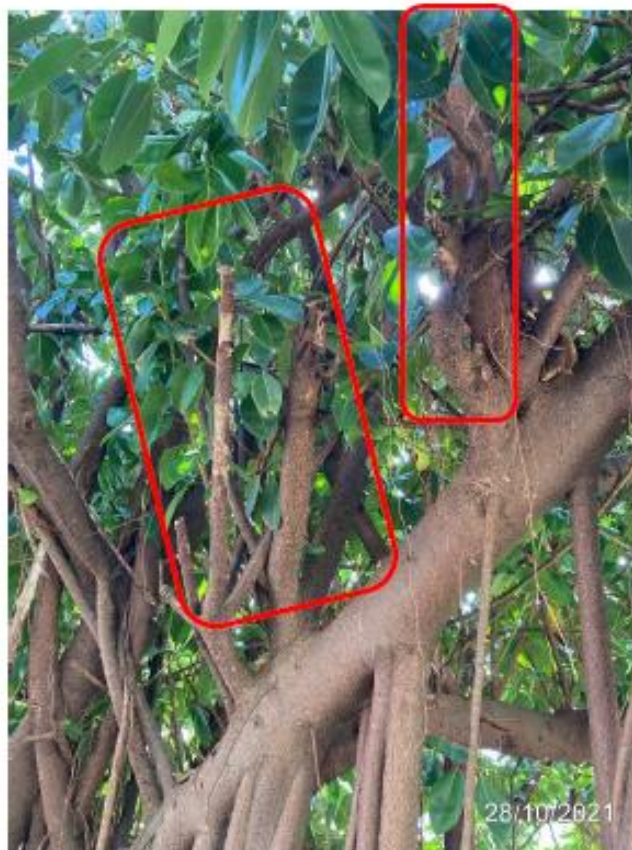
No change in overall condition of TA from previous monitoring. A few broken stubs shall be pruned.

- 4.1.9. Broken branches in the retained tree TA due to the typhoon damage remained. Relevant authority shall be contacted for appointing a Certified Arborist or equivalent to conduct a Tree Risk Assessment (TRA) on this tree in order to get Lands Department's approval on taking corresponding actions (e.g. pruning). Once the TRA appointment is confirmed, good written and photographic records (e.g. personal, date and time, actions, etc.) should be made before, during and after any actions of treatment for the assessed tree (i.e. TA)

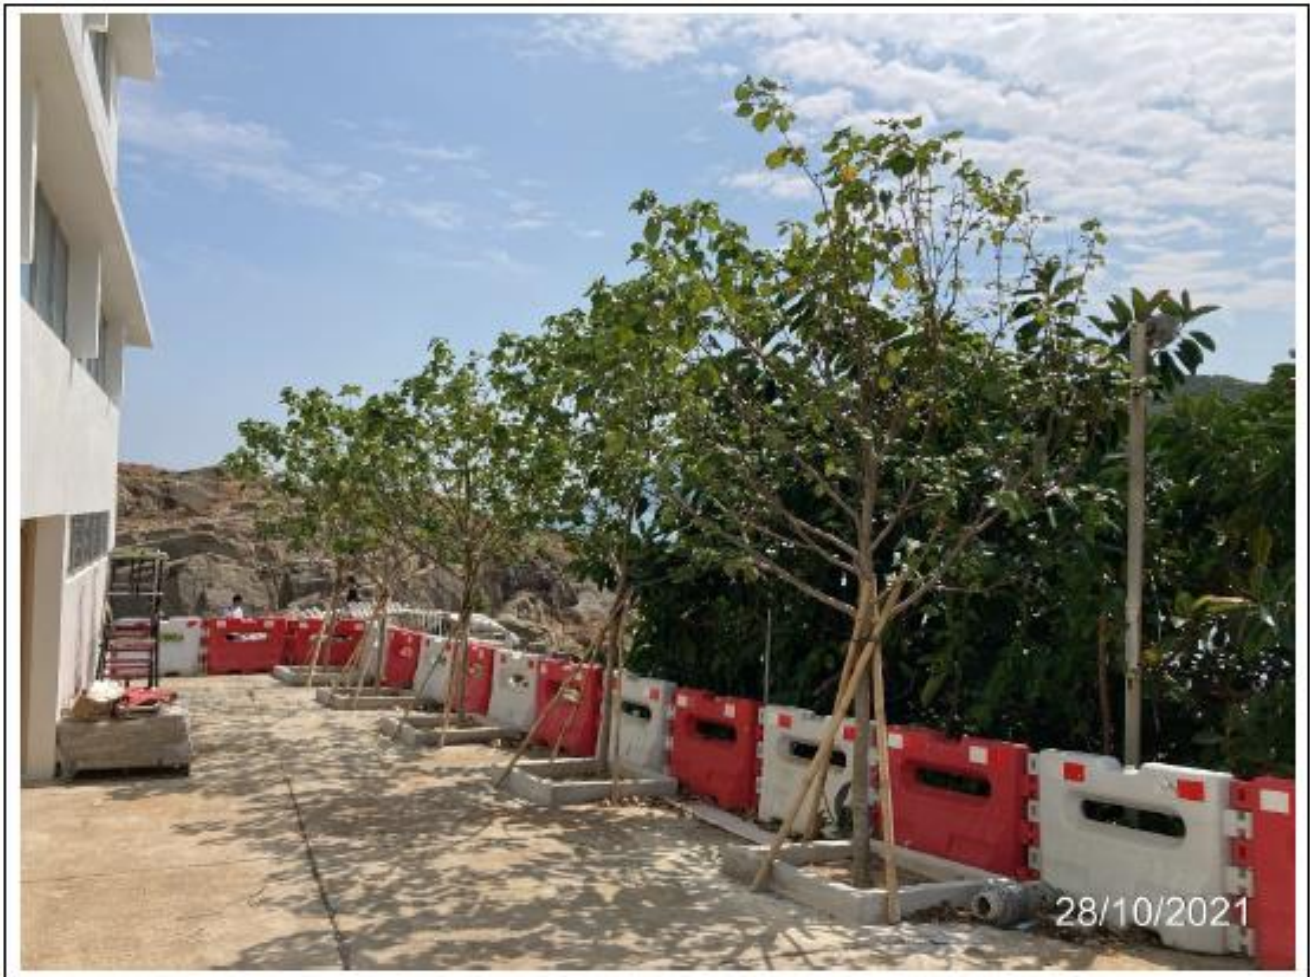
Plate 3: Five compensatory *Hibiscus tiliaceus* trees have been planted outside Academic Block.

- 2.4.10. Compensatory planting is in progress. Five *Hibiscus tiliaceus* (黃槿) trees have been planted at new tree pits outside the Academic Block (Plate 3).
