**MONTHLY ENVIRONMENTAL MONITORING AND AUDIT
(EM&A) REPORT (NO. 50)**

**Expansion of Research and Residential Facilities for the Swire Institute of
Marine Science, The University of Hong Kong at Cape D'Aguiar, Shek O**

(Rev. 1)

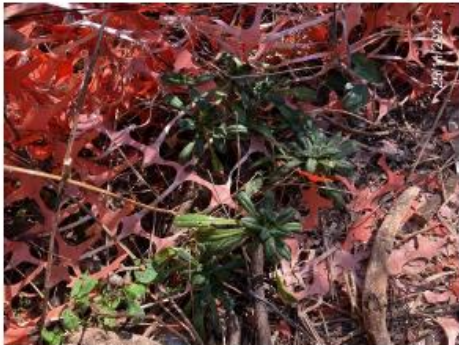
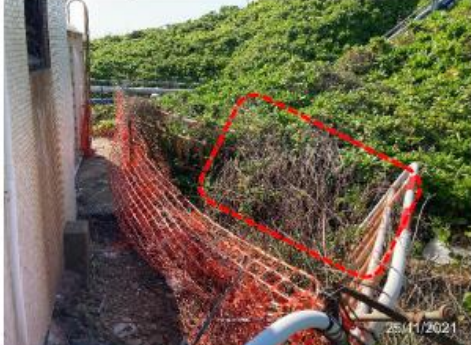
- 2.4.4. There is no change in form, health & structural condition and amenity value for all six recorded plant species of conservation importance.
- 2.4.5. Severe damage caused by Typhoon Mangkhut in September 2018 to the coastal vegetation remained. No *Lysimachia mauritiana* (濱海珍珠菜) could be observed in one of the protection zone near Academic Block (Site A) over 38 months. The original plants in this zone have certified as dead. However, a new healthy individual was observed nearby (Plate 1). In contrast, the individual within current protection zone has ended by its biennial life cycle without new seedlings regenerated from seeds (Plate 1).

<p><i>Lysimachia mauritiana</i> 濱海珍珠菜 (biennial)</p>	<p>Invasive weeds <i>Bidens alba</i> (白花鬼針草) in/around the protection zone shall be cleared, including roots, flowers and seeds (red dotted line). Such removal should be highly cautious without damaging the small <i>Lysimachia mauritiana</i> hidden among the weeds on the ground level.</p>

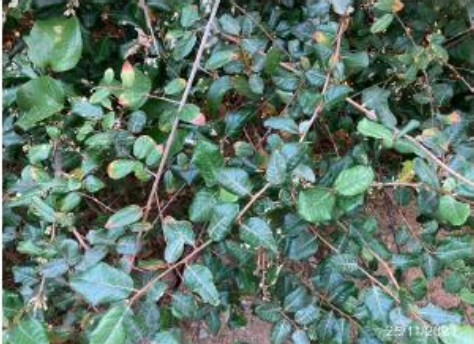
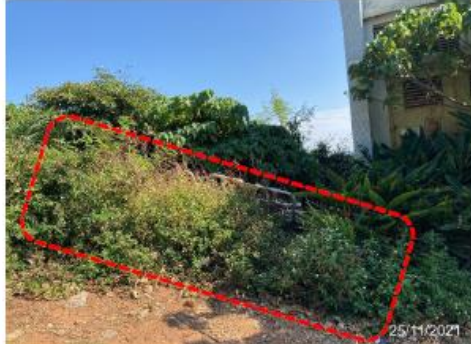
- 2.4.7. Invasive species *Bidens alba* within protection zone of *Elaeagnus tutcheri* (香港胡頹子) has been cleared but emerged again with other overgrown climbers.

<p><i>Elaeagnus titcheri</i> 香港胡頹子</p>	<p>Invasive weeds <i>Bidens alba</i> (白花鬼針草) in/around the protection zone shall be cleared, including roots, flowers and seeds (red dotted line)</p>

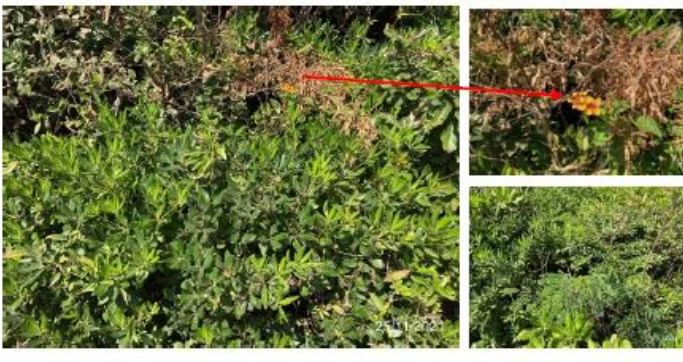
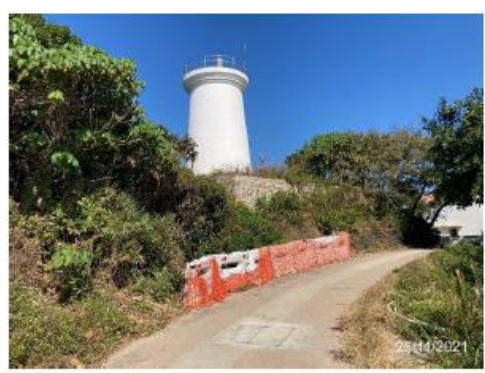
- 2.4.6. *Pittosporum tobira* (海桐) has shown slight dieback of twigs, with regeneration of young leaves. Invasive *Leucaena leucocephala* and *Lantana camara* within protection zone have been cleared but emerged again with other overgrown climbers.

<p><i>Pittosporum tobira</i> 海桐; sprouts of previously cleared invasive species emerged again (inset)</p>	<p>Collapsed fencing to be rectified</p>

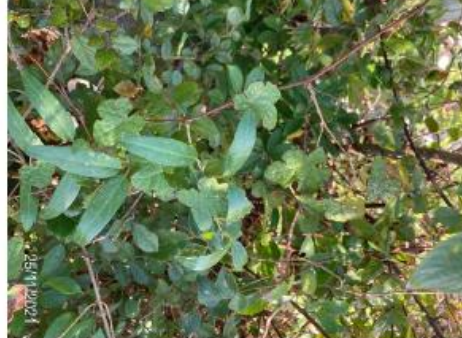
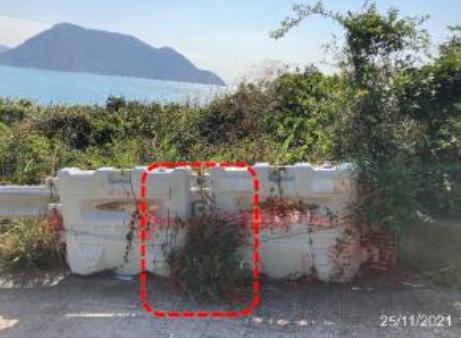
- 2.4.8. Leaves of the deciduous *Vitis bryoniifolia* (襲蔭) is still observable.
- 2.4.9. For the three retained trees, there is no change in overall condition of T5, T6 and TA, despite a small branch of T6 was blown down under adverse weather on 7th July 2021, as reported by the Contractor. Another branch of T6 was broken, probably due to the 2 Typhoons Kompas & Lionrock in October 2021. Several broken stubs on TA were also observed during last monitoring. These stubs due to the typhoon damage have been pruned. Alignment of pipes passing through among aerial roots of TA has been adjusted with minimum pruning of small, non-supportive aerial roots. Soil excavation at the core root zone has been avoided. Since TA (*Ficus elastica*) is a species with extensive aerial root system, such minimum pruning without tearing wounds would be acceptable and unlikely results in significant impact to the tree. Corresponding photographic records T5, T6 and TA are illustrated in Plate 2.

<p><i>Vitis bryoniifolia</i> 雙葉 (deciduous)</p>	<p>Collapsed fencing to be rectified; Previously cleared invasive species emerged again (red dotted line)</p>

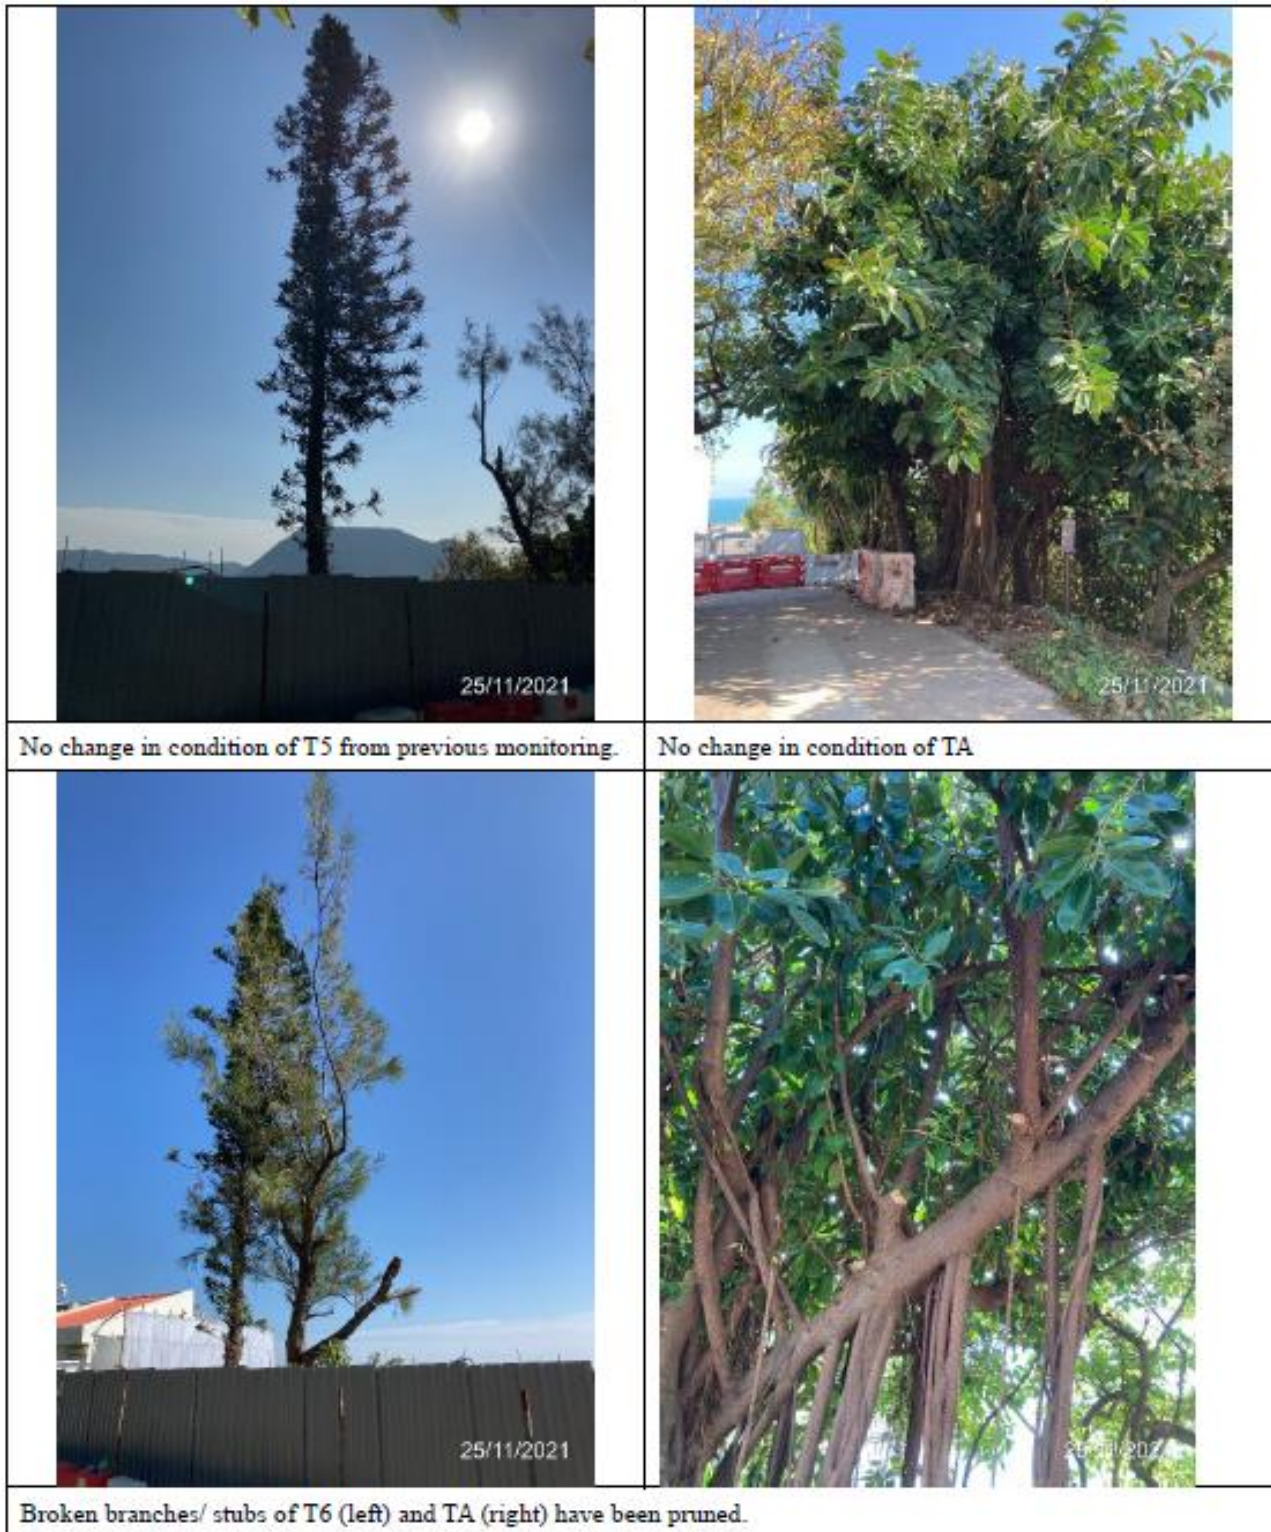
Plate 2: Photographic updates of the three retained trees that close to construction activities.

- 4.1.8. A small branch of T6 was blown down under adverse weather on 7th July 2021, as reported by the Contractor. Another branch of T6 was broken, probably by the two recent typhoons

in October 2021, but overall condition of T6 is not affected. These broken branches, together with those stubs observed in the retained tree TA, have been pruned.

- 4.1.9. Any further appropriate tree treatment on the retained trees is subjected to a Tree Risk Assessment appointment. Good written and photographic records should be made before, during and after any actions of treatment for the assessed tree.

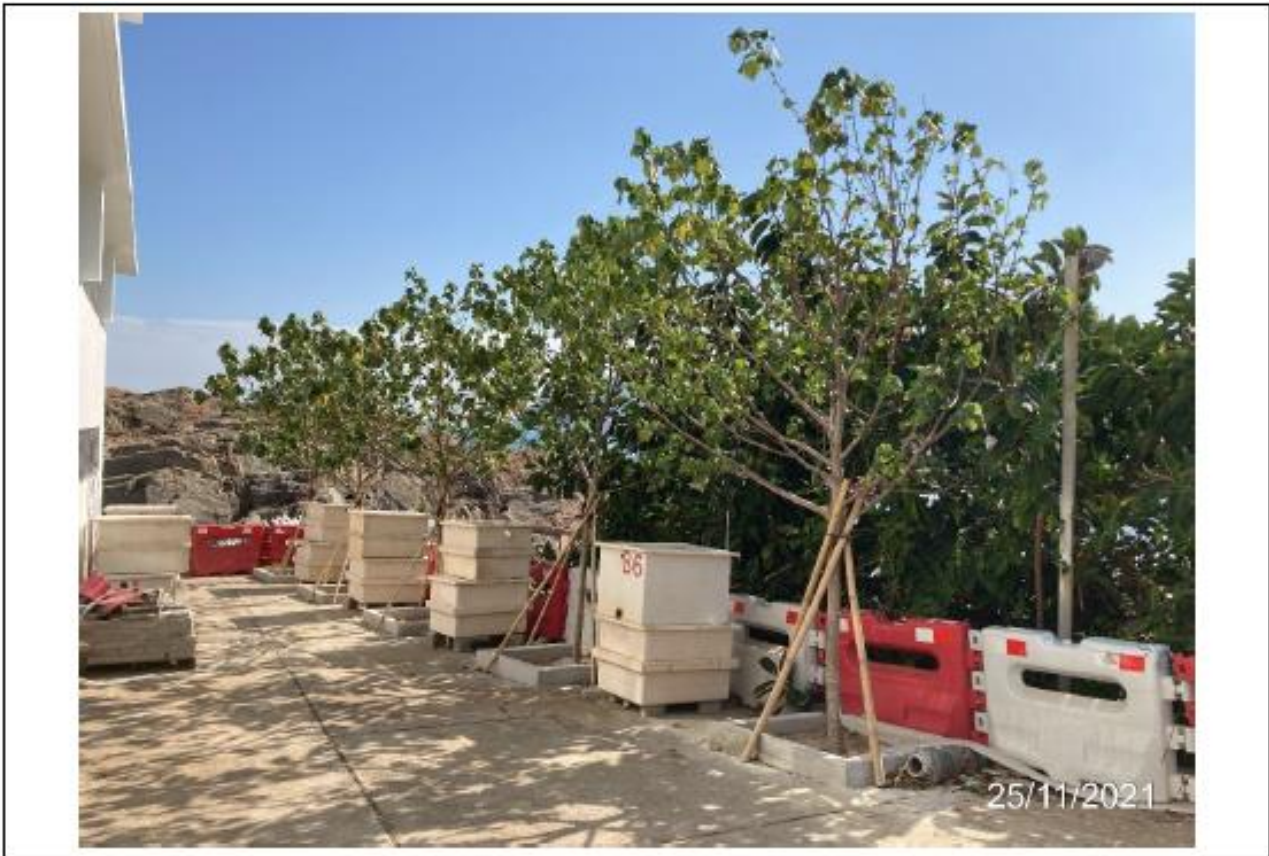
- 2.4.10. Compensatory planting is in progress. Five *Hibiscus tiliaceus* (黃槿) trees have been planted at new tree pits outside the Academic Block (Plate 3).

Plate 3: Five compensatory *Hibiscus tiliaceus* trees have been planted outside Academic Block.
