**Expansion of Research and Residential Facilities for
The Swire Institute of Marine Science, Faculty of Science,
The University of Hong Kong at Cape d' Aguilar, Shek O, Hong Kong
Submission of Monthly Environmental Monitoring and Audit Report No.51**

MONTHLY ENVIRONMENTAL MONITORING AND AUDIT (EM&A) REPORT (NO. 51)

**Expansion of Research and Residential Facilities for the Swire Institute of
Marine Science, The University of Hong Kong at Cape D'Aguiar, Shek O**

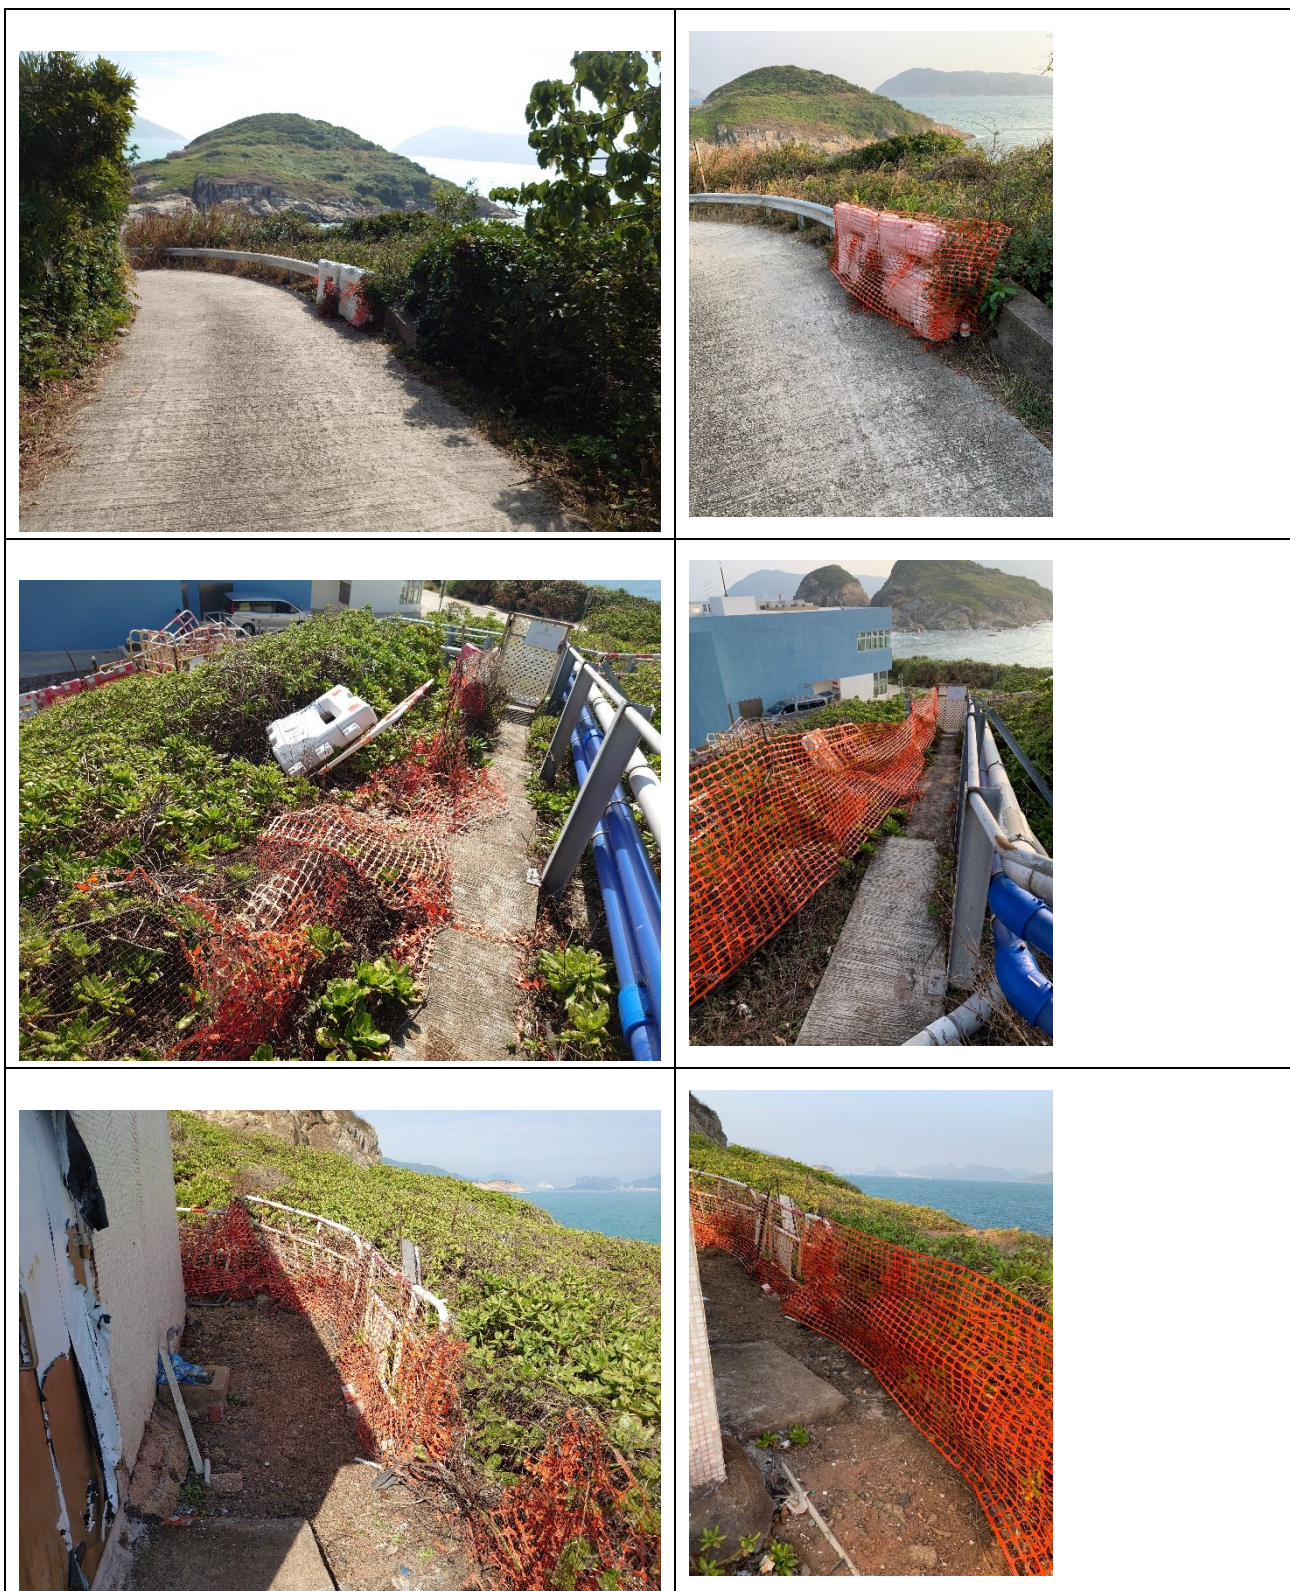
Observation - Item 2	
Observed 29 December 2021	Rectified by the Contractor on
<p><i>Orange nets should be repaired / replaced at Lighthouse, road to Site F, road to Site A, and Site G.</i></p>

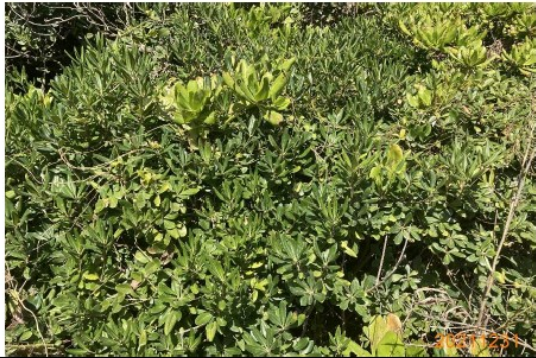
Pittosporum tobira 海桐

- 2.4.6. *Pittosporum tobira* (海桐) has shown slight dieback of twigs, with regeneration of young leaves. Invasive *Leucaena leucocephala* and *Lantana camara* within protection zone have been cleared but emerged again with other overgrown climbers.

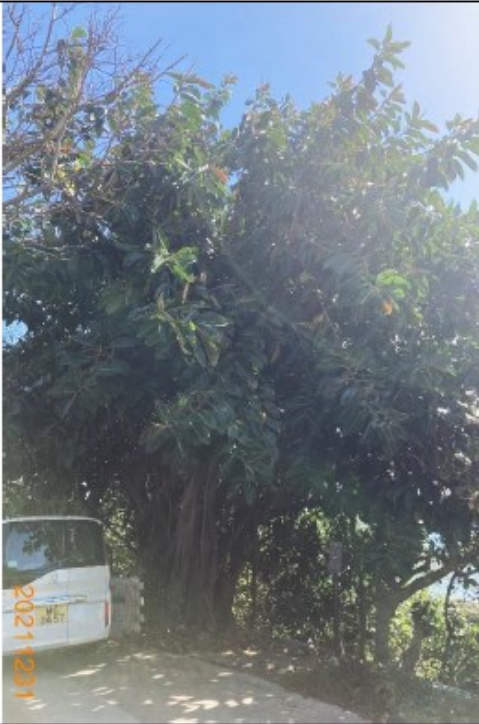
A large, mature tree with a thick trunk and a dense canopy of green leaves. A white van is parked on a paved area in the foreground. A vertical orange timestamp '20211231' is on the left side.
<p>No change in condition of T5 from previous monitoring.</p>	<p>No change in condition of TA</p>

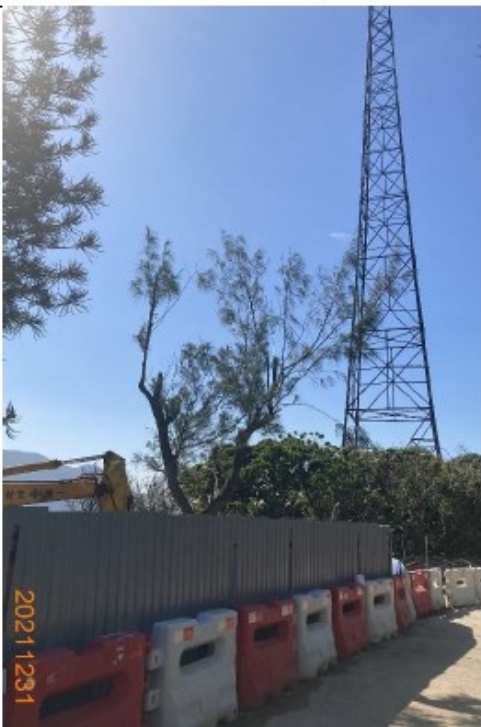
- 4.1.8. A small branch of T6 was blown down under adverse weather on 7th July 2021, as reported by the Contractor. Another branch of T6 was broken, probably by the two recent typhoons in October 2021, but overall condition of T6 is not affected. These broken branches, together

A tree with a thin trunk and sparse green foliage stands in front of a tall, lattice-structured tower. In the foreground, there is a grey metal fence and a row of red and white plastic barriers. A vertical orange timestamp '20211231' is on the left side.	<p>BLANK</p>
<p>No change in condition of T6 from previous monitoring.</p>

with those stubs observed in the retained tree TA, have been pruned. Any further appropriate tree treatment on the retained trees is subjected to a Tree Risk Assessment appointment. Good written and photographic records should be made before, during and after any actions of treatment for the assessed tree.

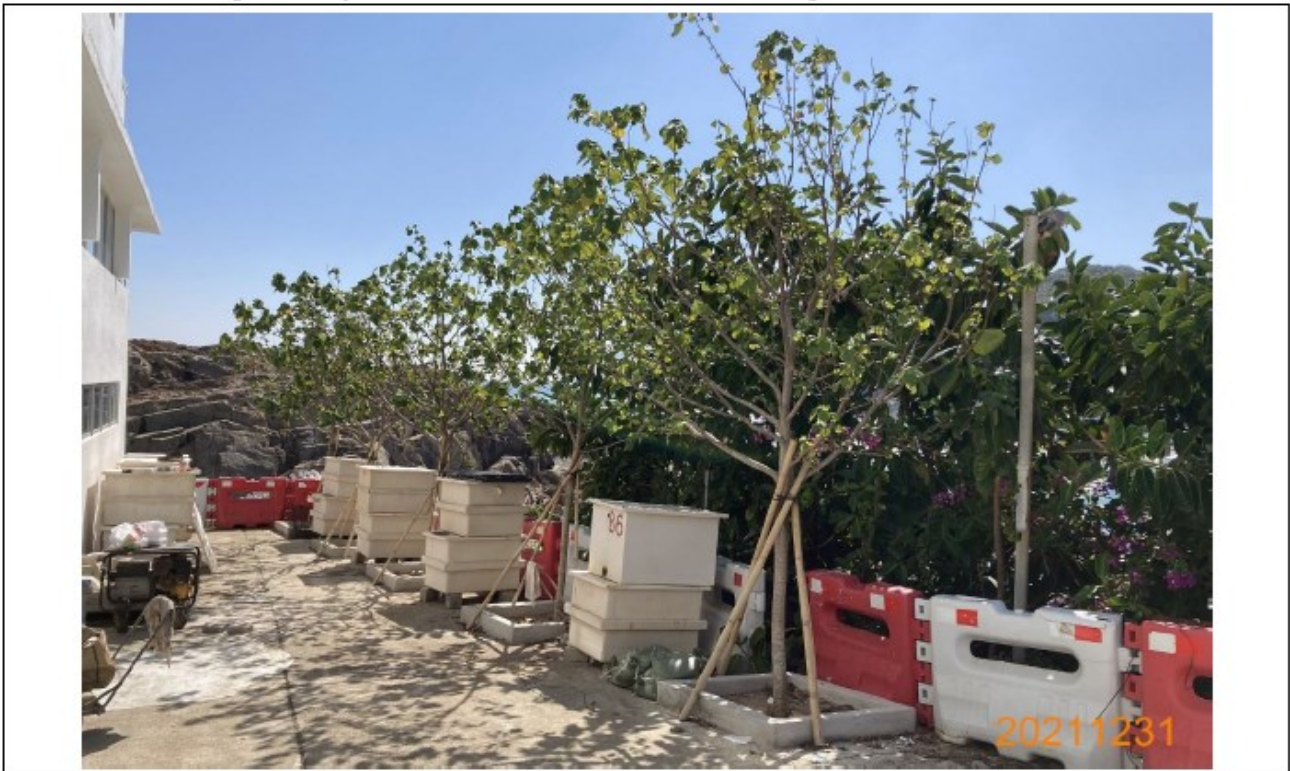
Plate 3: Five compensatory *Hibiscus tiliaceus* trees have been planted outside Academic Block.

- 2.4.10. Compensatory planting is in progress. Five *Hibiscus tiliaceus* (黃槿) trees have been planted at new tree pits outside the Academic Block (Plate 3).
