**Expansion of Research and Residential Facilities for
The Swire Institute of Marine Science, Faculty of Science,
The University of Hong Kong at Cape d' Aguilar, Shek O, Hong Kong
Submission of Monthly Environmental Monitoring and Audit Report No.52**

**MONTHLY ENVIRONMENTAL MONITORING AND AUDIT
(EM&A) REPORT (NO. 52)**

**Expansion of Research and Residential Facilities for the Swire Institute of
Marine Science, The University of Hong Kong at Cape D’Aguiar, Shek O**

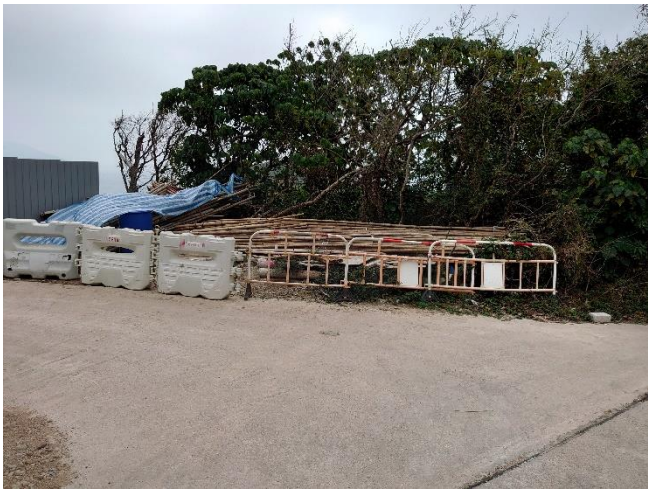
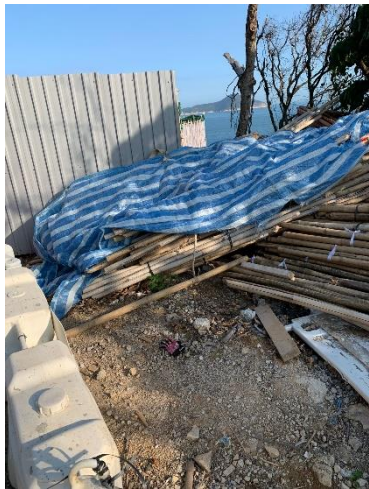
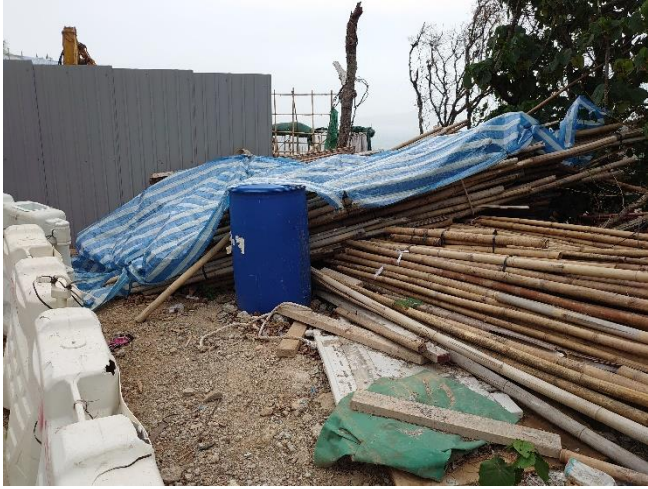
Observation - Item 1	
Observed 27 January 2022	Rectified by the Contractor on 28 Feb 2022
<p><i>At Site B, drip tray should be provided for chemical container, and retaining trees should be free from construction materials.</i></p>	<p><i>Chemical container is removed from site.</i></p>

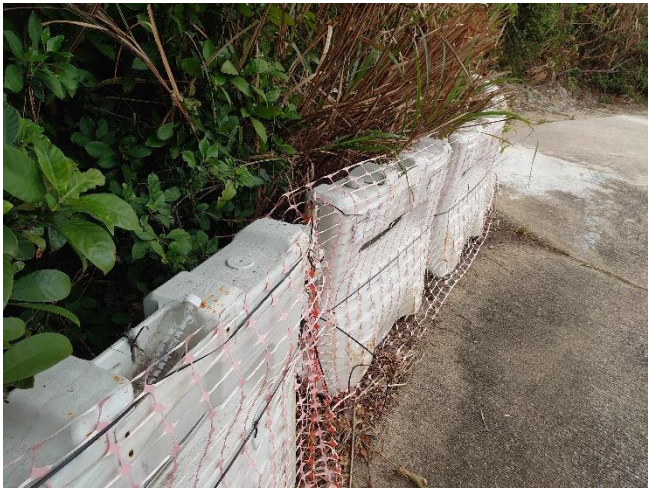
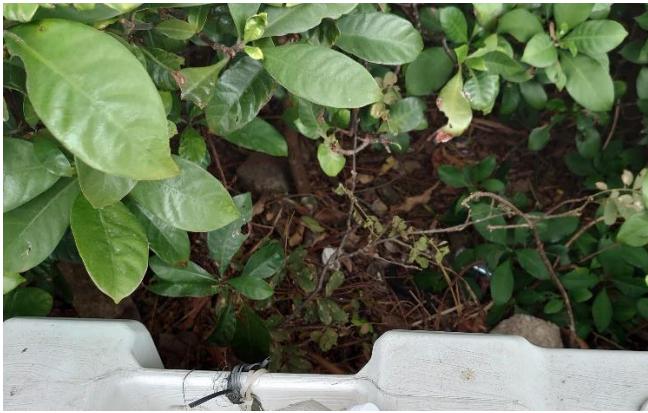
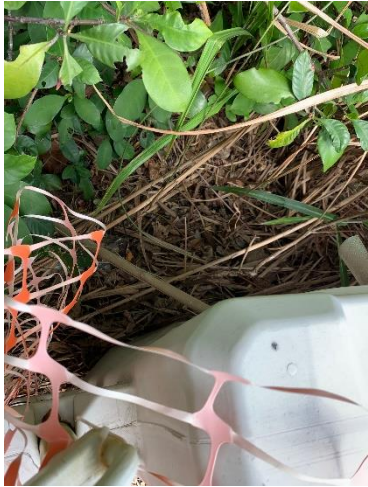
Observation - Item 2	
Observed 27 January 2022	Rectified by the Contractor on 28 Feb 2022
At access road to Site A, rubbish should be removed such that the protective species are not disturbed.	Rubbish is removed from area near the protected species.

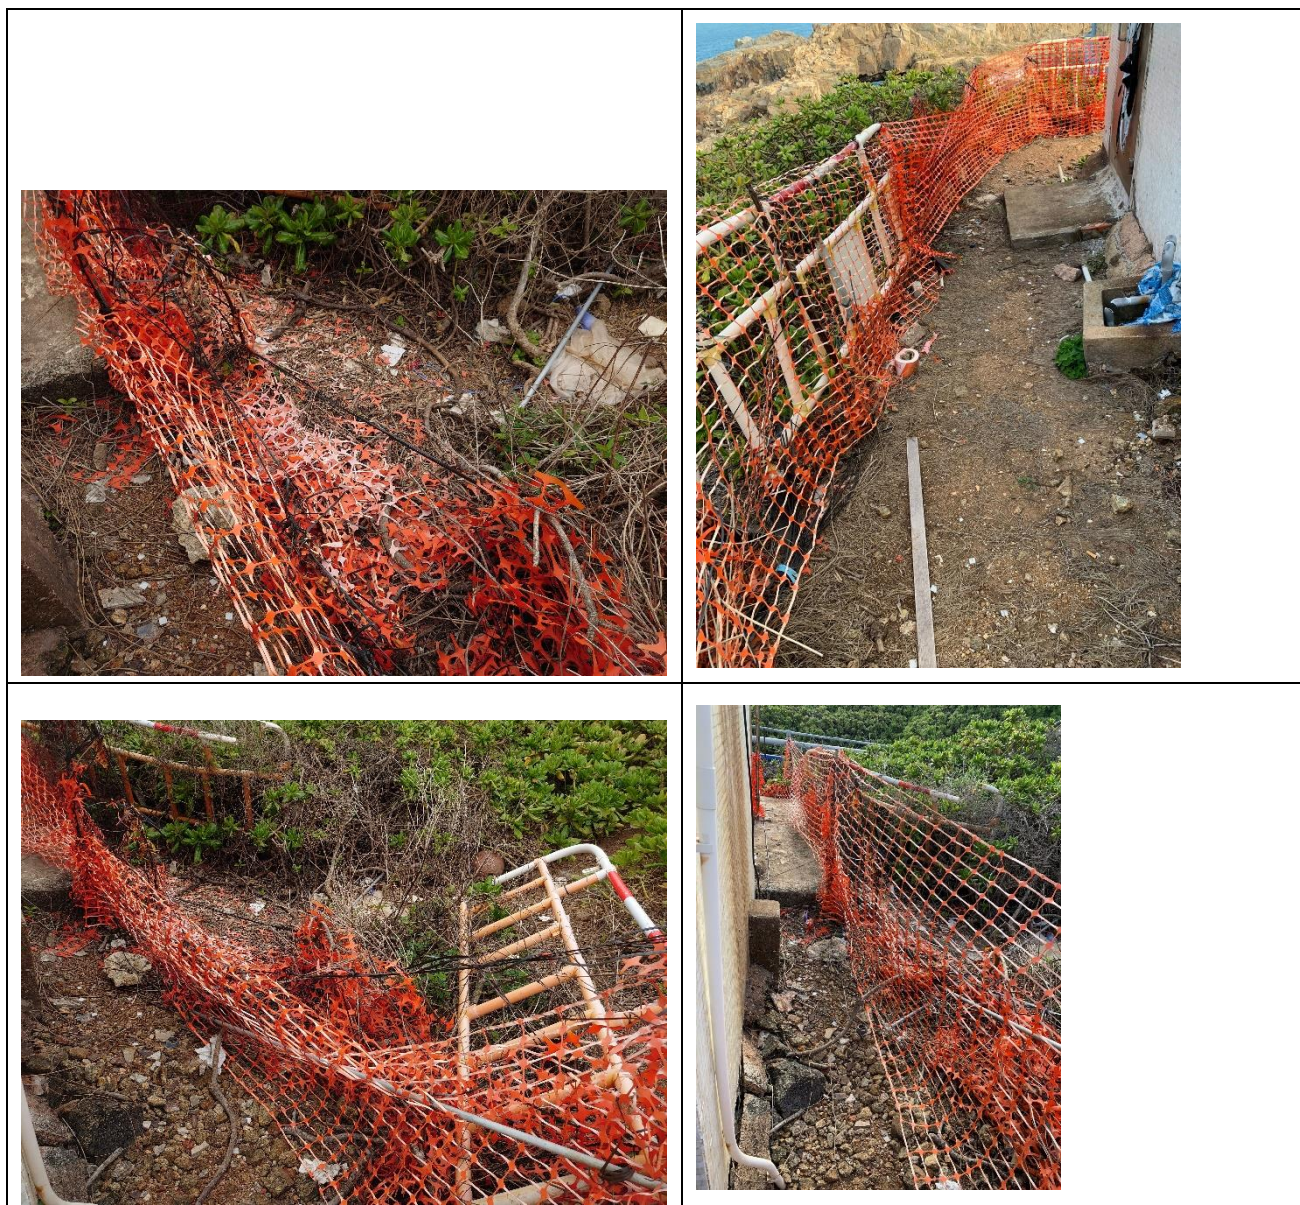
Observation - Item 3	
Observed 27 January 2022	Rectified by the Contractor on 28 Feb 2022
At Site G, the protective species <i>Lysimachia mauritiana</i> should be properly fenced off by orange nets.	Orange net is repaired.

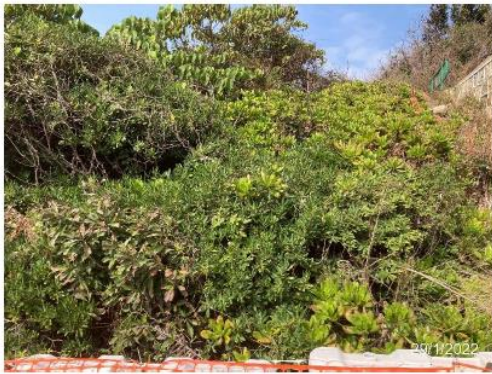
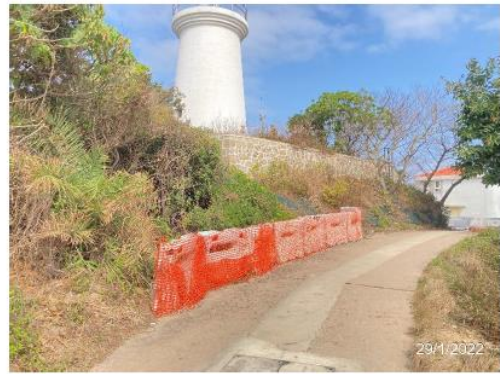
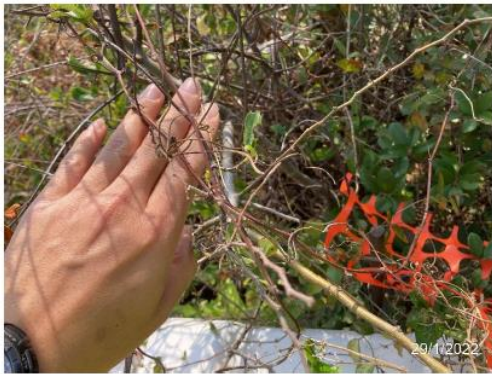
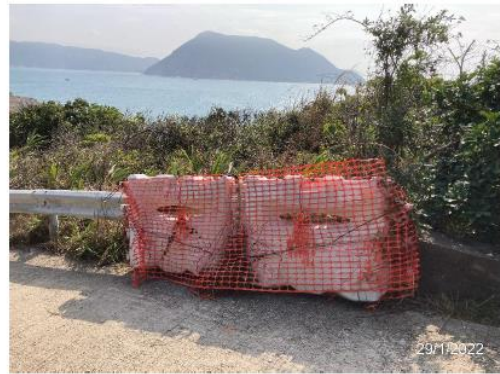
Plate 1. Photographic records of the six recorded plants species of conservation importance with protection zone.

2.4.5. Severe damage caused by Typhoon Mangkhut in September 2018 to the coastal vegetation remained. No *Lysimachia mauritiana* (濱海珍珠菜) could be observed in one of the protection zone near Academic Block (Site A) over 40 months. The original plants in this zone have certified as dead. However, a new healthy individual was observed nearby. In contrast, the individual within current protection zone has ended by its biennial life cycle without new seedlings regenerated from seeds (Plate 1).

- 2.4.6. *Pittosporum tobira* (海桐) has shown slight dieback of twigs, with regeneration of young leaves. Invasive *Leucaena leucocephala* and *Lantana camara* within protection zone have been cleared but emerged again with other overgrown climbers.

- 2.4.7. Invasive species *Bidens alba* within protection zone of *Elaeagnus tutcheri* (香港胡頹子) has been cleared but emerged again with other overgrown climbers.

- 2.4.8. Leaves of the deciduous *Vitis bryoniifolia* (蘼薺) is no more observable.
- 2.4.9. For the three retained trees, there is no change in overall condition of T5, T6 and TA, despite a small branch of T6 was blown down under adverse weather on 7th July 2021, as reported by the Contractor. Another branch of T6 was broken, probably due to the 2 Typhoons Kompas & Lionrock in October 2021. Several broken stubs on TA were also observed during last monitoring. These stubs due to the typhoon damage have been pruned (Plate 2). Alignment of pipes passing through among aerial roots of TA has been adjusted with minimum pruning of small, non supportive aerial roots. Soil excavation at the core root zone has been avoided. Since TA (*Ficus elastica*) is a species with extensive aerial root system, such minimum pruning without tearing wounds would be acceptable and unlikely results in significant impact to the tree. Corresponding photographic records T5, T6 and TA are illustrated in Plate 2.

<p><i>Lysimachia mauritiana</i> 濱海珍珠菜 (biennial)</p>	
<p><i>Pavetta hongkongensis</i> 香港大沙葉</p>	
<p><i>Millettia oraria</i> 香港崖豆藤</p>	
<p><i>Elaeagnus tutcheri</i> 香港胡頹子</p>	<p>Invasive weeds <i>Bidens alba</i> (白花鬼針草) in/around the protection zone shall be cleared, including roots, flowers and seeds (red dotted line)</p>

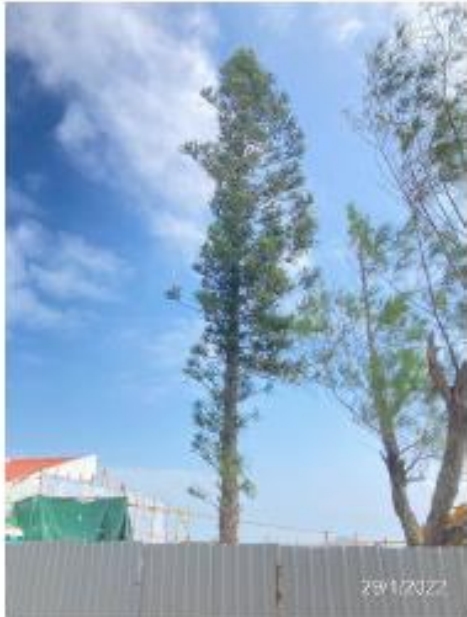
<p>A tall, slender tree with green foliage, standing behind a grey metal fence. In the background, a construction site with a green tarp is visible under a blue sky with scattered clouds. A date stamp '29/1/2022' is in the bottom right corner.</p>

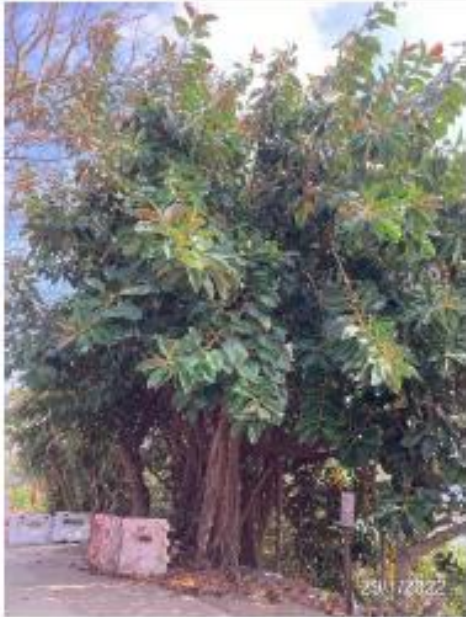
<p>A large, dense tree with thick, reddish-brown bark and lush green leaves. A pinkish-red concrete block is in the foreground. The background shows a clear sky. A date stamp '29/1/2022' is in the bottom right corner.</p>
<p>No change in condition of T5 from previous monitoring.</p>	<p>No change in condition of TA</p>

with those stubs observed in the retained tree TA, have been pruned. Any further appropriate tree treatment on the retained trees is subjected to a Tree Risk Assessment appointment. Good written and photographic records should be made before, during and after any actions of treatment for the assessed tree.

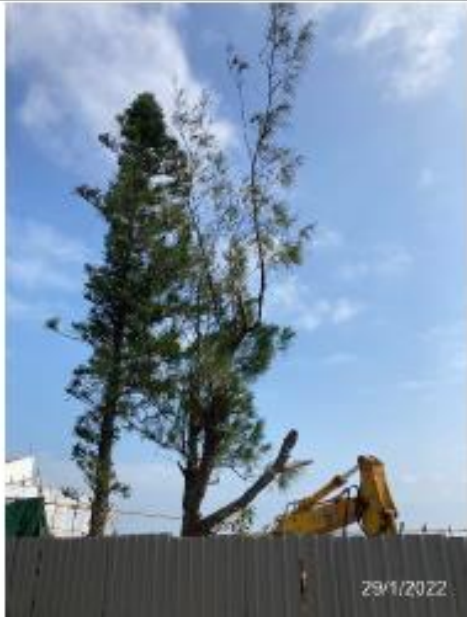
- 4.1.8. A small branch of T6 was blown down under adverse weather on 7th July 2021, as reported by the Contractor. Another branch of T6 was broken, probably by the two recent typhoons in October 2021, but overall condition of T6 is not affected. These broken branches, together

<p>A tall, slender tree with green foliage, similar to T5, behind a grey metal fence. A yellow excavator is visible in the background. A date stamp '29/1/2022' is in the bottom right corner.</p>	<p>BLANK</p>
<p>No change in condition of T6 from previous monitoring.</p>

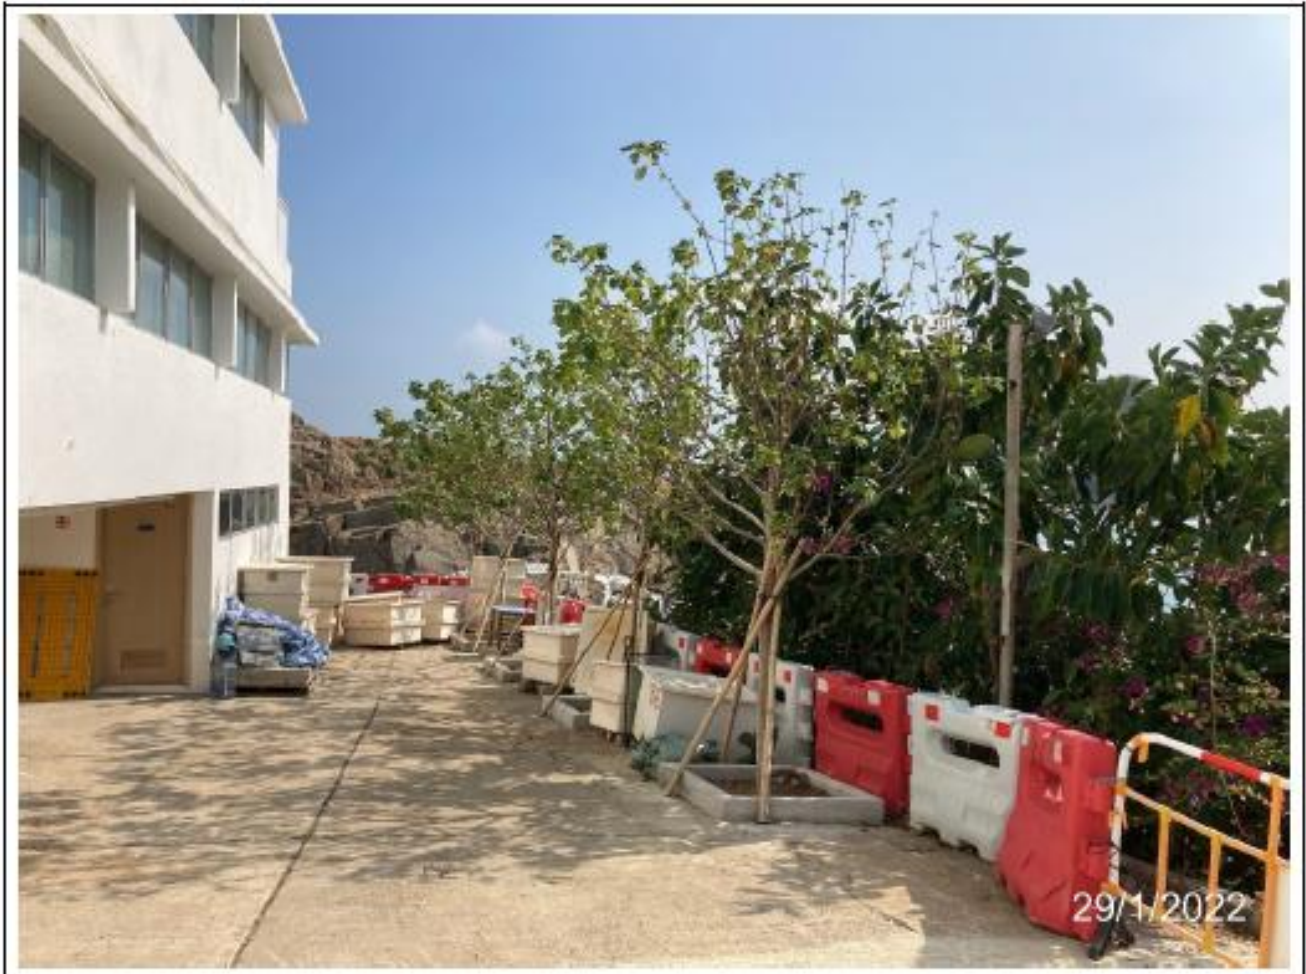
Plate 3: Five compensatory *Hibiscus tiliaceus* trees have been planted outside Academic Block.

- 2.4.10. Compensatory planting is in progress. Five *Hibiscus tiliaceus* (黃槿) trees have been planted at new tree pits outside the Academic Block (Plate 3).
