**Expansion of Research and Residential Facilities for  
The Swire Institute of Marine Science, Faculty of Science,  
The University of Hong Kong at Cape d' Aguilar, Shek O, Hong Kong  
Submission of Monthly Environmental Monitoring and Audit Report No.53**

## **MONTHLY ENVIRONMENTAL MONITORING AND AUDIT (EM&A) REPORT (NO. 53)**

**Expansion of Research and Residential Facilities for the Swire Institute of  
Marine Science, The University of Hong Kong at Cape D'Aguiar, Shek O**

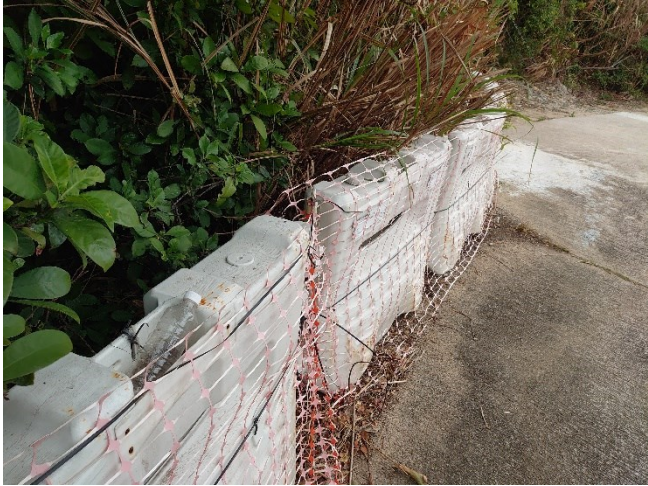
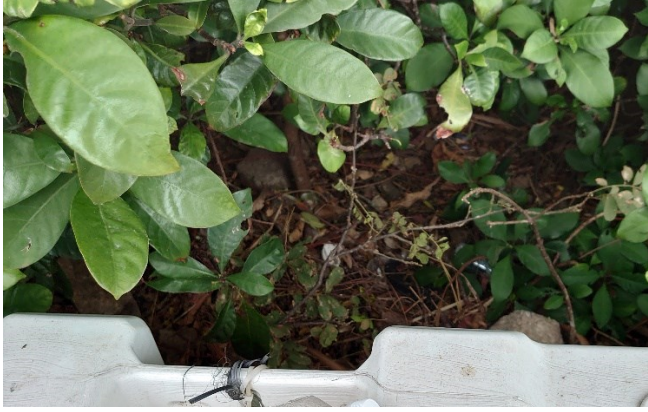
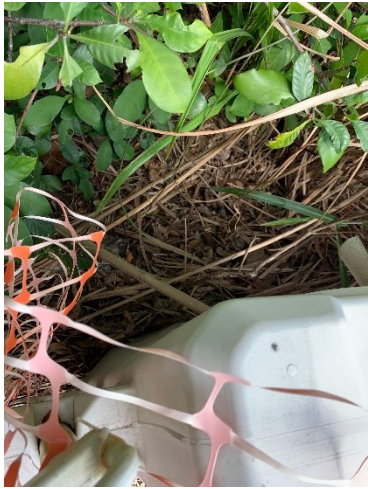
<b>Observation - Item 2</b>	
<b>Observed 23 February 2022</b>	<b>Rectified by the Contractor on 28 Feb 2022</b>
<i>At access road to Site A, rubbish should be removed such that the protective species are not disturbed.</i>	<i>Rubbish is removed from area near the protected species.</i>

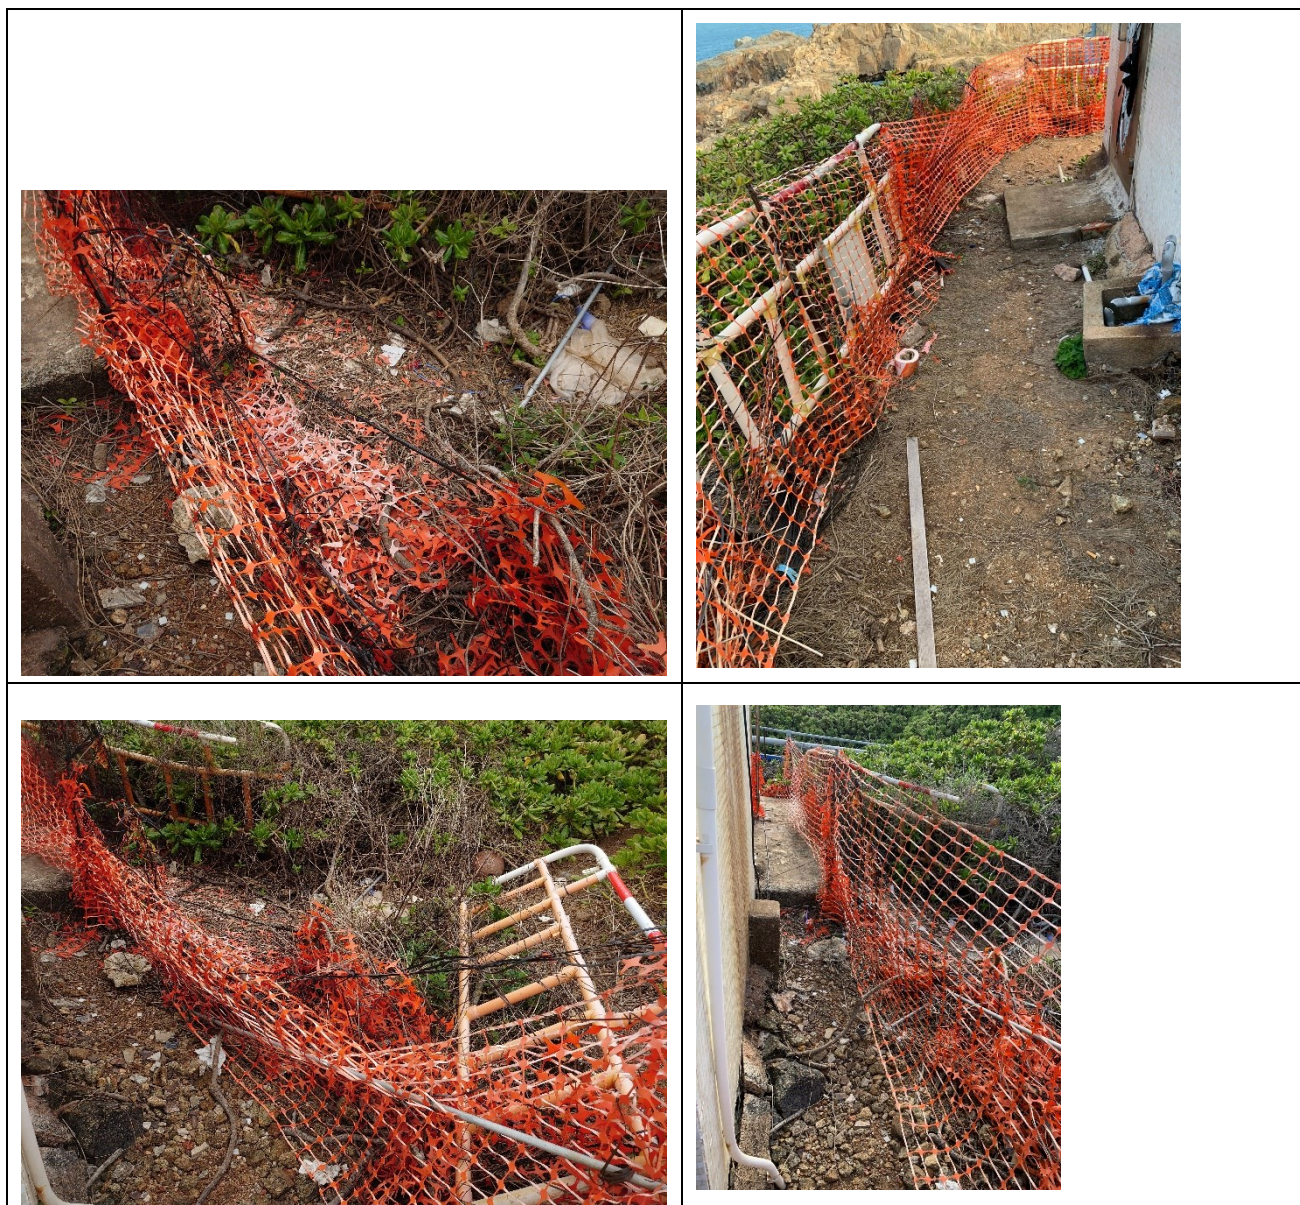
<b>Observation - Item 3</b>	
<b>Observed 23 February 2022</b>	<b>Rectified by the Contractor on 28 Feb 2022</b>
<i>At Site G, the protective species <i>Lysimachia mauritiana</i> should be properly fenced off by orange nets.</i>	<i>Orange net is repaired.</i>

- 4.1.6. Protection zone has been provided in accordance with Condition 2.6 of the Environmental Permit. Any damage of the protection zone (e.g., due to coastal weather condition or disturbance of hikers and visitors) should be repaired promptly. Warning sign should be maintained at prominent positions within the works area to encourage hikers and visitors keeping away from any no entry area or protection zone.

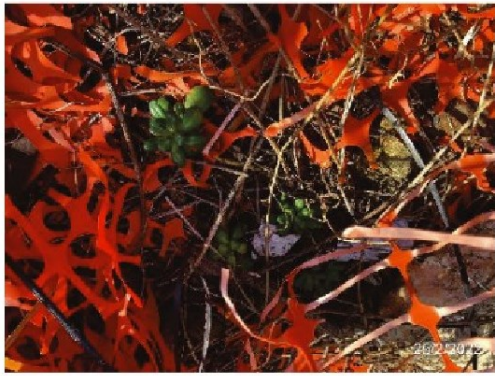
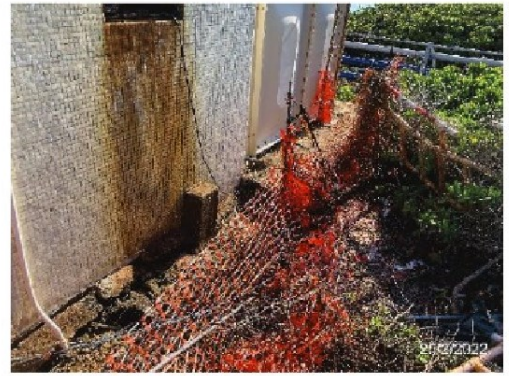
*Lysimachia mauritiana* 濱海珍珠菜 (biennial)

2.4.5. Severe damage caused by Typhoon Mangkhut in September 2018 to the coastal vegetation remained. No *Lysimachia mauritiana* (濱海珍珠菜) could be observed in one of the protection zone near Academic Block (Site A) over 41 months. The original plants in this zone have certified as dead. However, a new healthy individual was observed nearby. In contrast, A few individuals of *Lysimachia mauritiana* are observed within current protection zone (Plate 1).

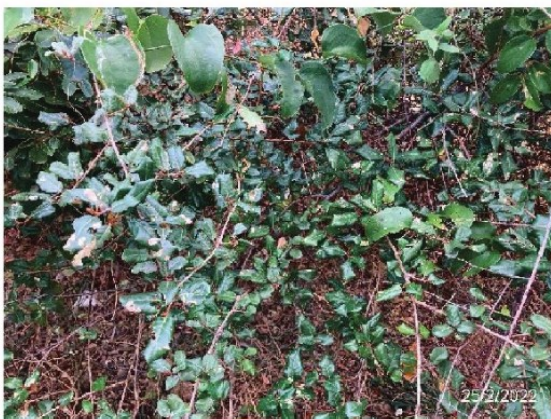
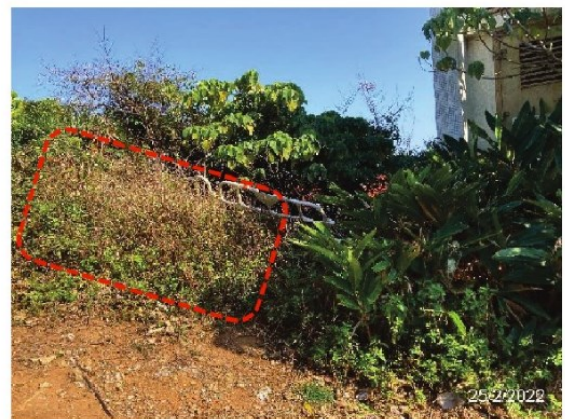
*Elaeagnus tutcheri* 香港胡頹子

- 2.4.7. Invasive species *Bidens alba* within protection zone of *Elaeagnus tutcheri* (香港胡頹子) has been cleared together with other overgrown climbers.

Invasive weeds *Bidens alba* (白花鬼針草) in/around the protection zone shall be cleared, including roots, flowers and seeds (red dotted line)

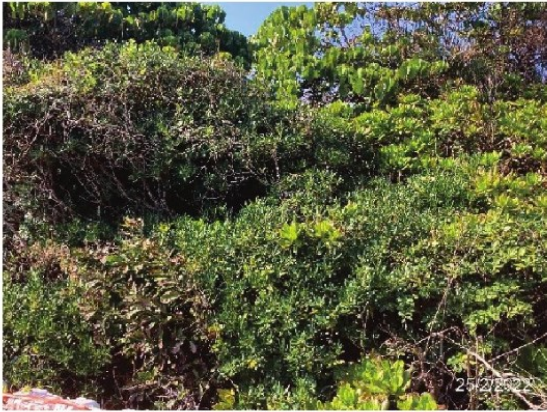
*Pittosporum tobira* 海桐

- 2.4.6. *Pittosporum tobira* (海桐) has shown slight dieback of twigs, with regeneration of young leaves. Invasive *Leucaena leucocephala* and *Lantana camara* within protection zone have been cleared but emerged again with other overgrown climbers.

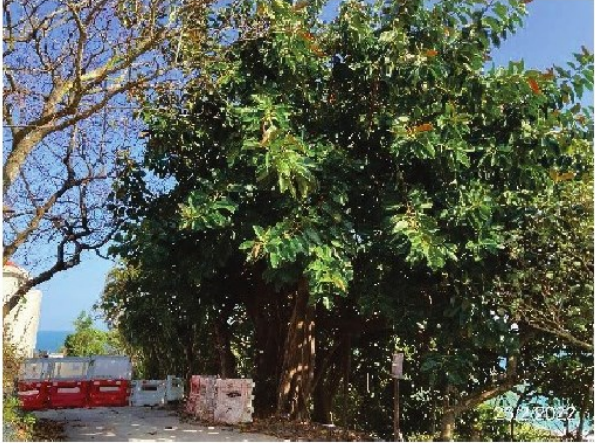
<p>A large, dense tree with thick branches and green leaves. In the background, a red and white construction barrier is visible. A date stamp '25/2/2022' is located in the bottom right corner of the image.</p>
<p>No change in condition of T5 from previous monitoring.</p>	<p>No change in condition of TA</p>

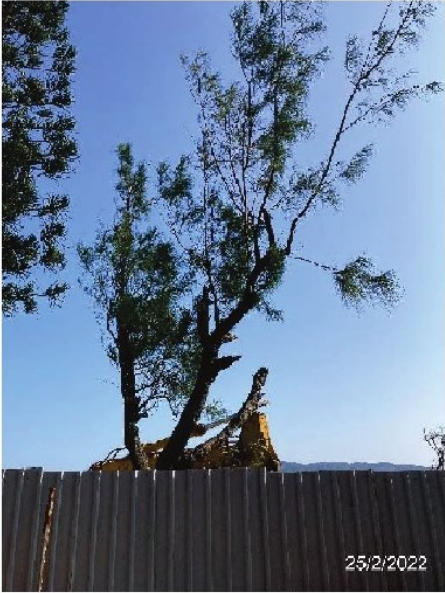
- 4.1.7. A small branch of T6 was blown down under adverse weather on 7th July 2021, as reported by the Contractor. Another branch of T6 was broken, probably by the two recent typhoons in October 2021, but overall condition of T6 is not affected. These broken branches, together with those stubs observed in the retained tree TA, have been pruned. Any further appropriate tree treatment on the retained trees is subjected to a Tree Risk Assessment appointment.

<p>A tree with a thick, gnarled trunk and green foliage. In the foreground, a grey corrugated metal fence is visible. A date stamp '25/2/2022' is located in the bottom right corner of the image.</p>	<p>BLANK</p>
<p>No change in condition of T6 from previous monitoring.</p>

Good written and photographic records should be made before, during and after any actions of treatment for the assessed tree.

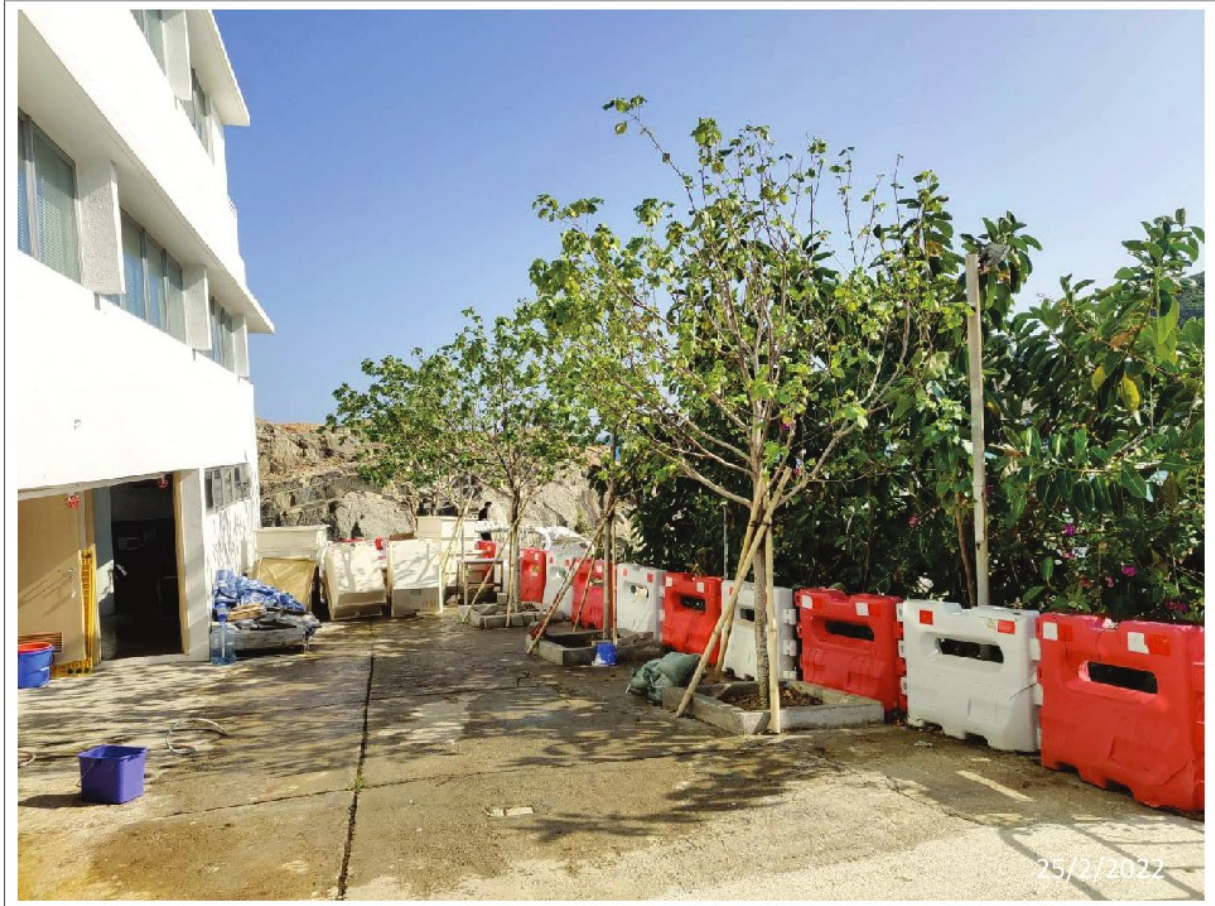
**Plate 3.** Five compensatory *Hibiscus tiliaceus* trees have been planted outside Academic Block.

- 2.4.10. Compensatory planting is in progress. Five *Hibiscus tiliaceus* (黃槿) trees have been planted at new tree pits outside the Academic Block (Plate 3).
