Environmental Permit (No. EP-537/2017)

**Expansion of Research and Residential Facilities for
The Swire Institute of Marine Science, Faculty of Science,
The University of Hong Kong at Cape d' Aguilar, Shek O, Hong Kong
Submission of Monthly Environmental Monitoring and Audit Report No.54**

MONTHLY ENVIRONMENTAL MONITORING AND AUDIT (EM&A) REPORT (NO. 54)

**Expansion of Research and Residential Facilities for the Swire Institute of
Marine Science, The University of Hong Kong at Cape D'Aguiar, Shek O**

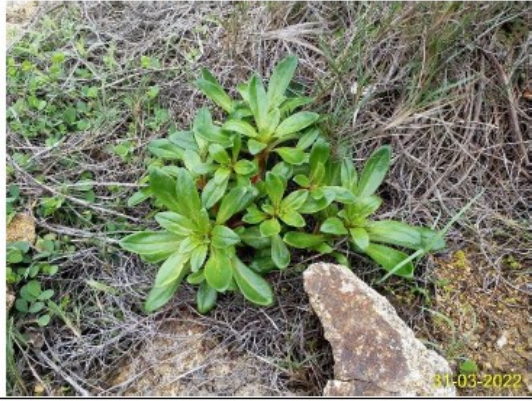
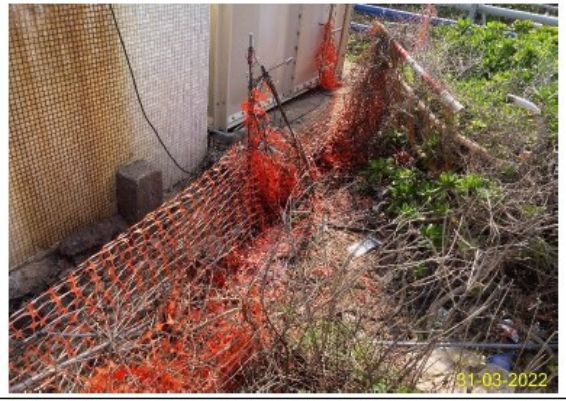
Lysimachia mauritiana 濱海珍珠菜 (biennial)

2.4.5. Severe damage caused by Typhoon Mangkhut in September 2018 to the coastal vegetation remained. No *Lysimachia mauritiana* (濱海珍珠菜) could be observed in one of the protection zone near Academic Block (Site A) over 42 months. The original plants in this zone have certified as dead. A few individuals of *Lysimachia mauritiana* are observed within current protection zone (Plate 1).

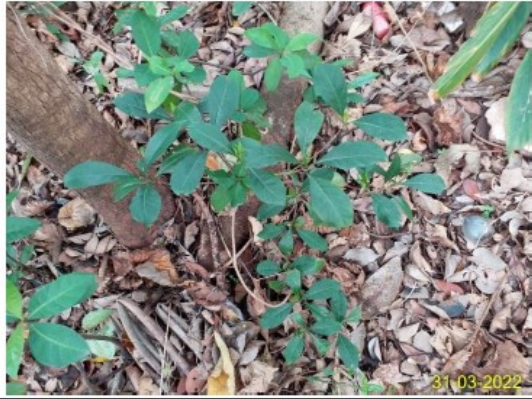
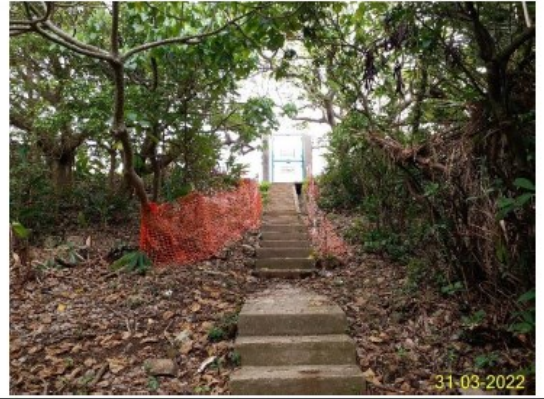
Pavetta hongkongensis 香港大沙葉

2.4.4. There is no change in form, health & structural condition and amenity value for all six recorded plant species of conservation importance.

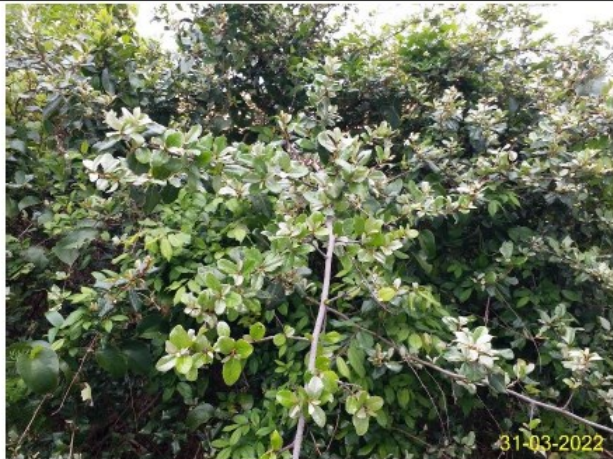
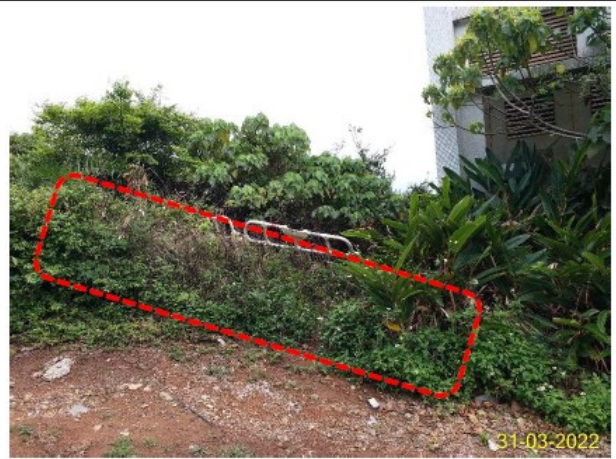
Elaeagnus tutcheri 香港胡頹子

- 2.4.7. Invasive species *Bidens alba* within protection zone of *Elaeagnus tutcheri* (香港胡頹子) has been cleared but emerged again with other overgrown climbers.

Invasive weeds *Bidens alba* (白花鬼針草) in/around the protection zone shall be cleared, including roots, flowers and seeds (red dotted line)

- 4.1.10. To avoid/ reduce potential negative impacts to local native plant community and survival of plant species of conservation important, exotic and highly invasive tree *Leucaena leucocephala* (銀合歡), shrub *Lantana camara* (馬櫻丹), herb *Bidens alba* (白花鬼針草) and climber *Mikania micrantha* (薇甘菊) should be cleared and removed in whole, including the roots, whenever encountered throughout the construction phase, and packed properly before disposed as waste to prevent regrowth and dispersal of pollens and seeds. Invasive species and other overgrown climbers observed within protection zones of *Pittosporum tobira* (海桐) and *Elaeagnus tutcheri* (香港胡頹子) have been cleared but emerged again as observed in this monitoring.

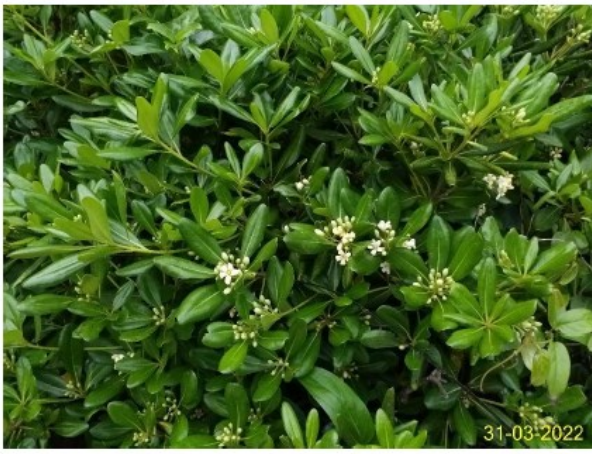
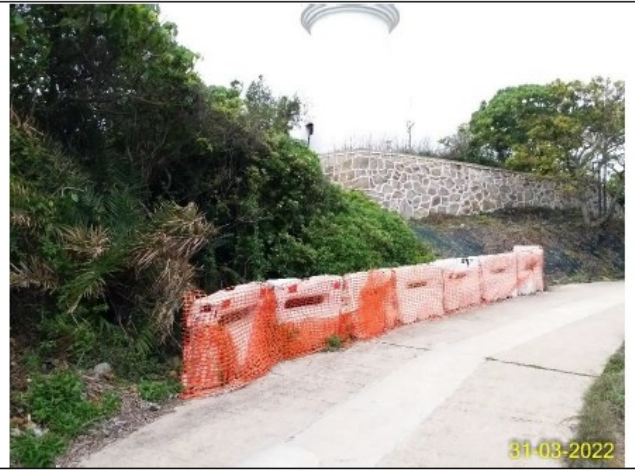
Pittosporum tobira 海桐

2.4.6. *Pittosporum tobira* (海桐) has shown slight dieback of twigs, with regeneration of young leaves. Invasive *Leucaena leucocephala* and *Lantana camara* within protection zone have been cleared but emerged again with other overgrown climbers.

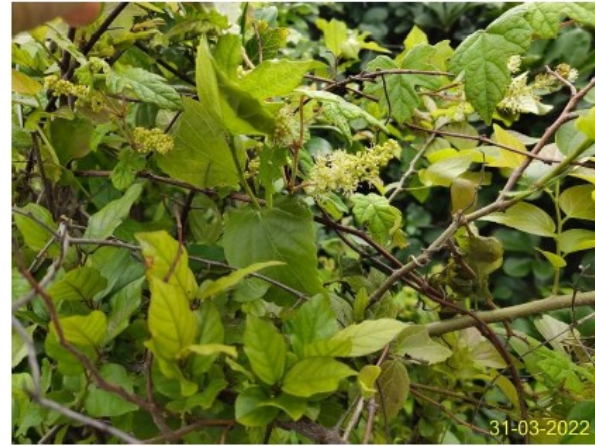
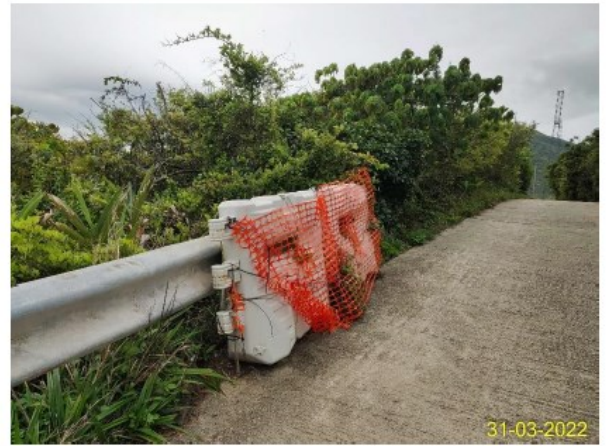
Vitis bryoniifolia 蓼萸

- 2.4.8. Leaves of the deciduous *Vitis bryoniifolia* (嬰菓) has grown with blooming of flowers.
- 2.4.9. For the three retained trees, there is no change in overall condition of T5, T6 and TA, despite a small branch of T6 was blown down under adverse weather on 7th July 2021, as reported by the Contractor. Another branch of T6 was broken, probably due to the 2 Typhoons Kompasu & Lionrock in October 2021. Several broken stubs on TA were also observed during last monitoring. These stubs due to the typhoon damage have been pruned. Alignment of pipes passing through among aerial roots of TA has been adjusted with minimum pruning of small, non supportive aerial roots. Soil excavation at the core root zone has been avoided. Since TA (*Ficus elastica*) is a species with extensive aerial root system, such minimum pruning without tearing wounds would be acceptable and unlikely results in significant impact to the tree. Corresponding photographic records T5, T6 and TA are illustrated in Plate 2.

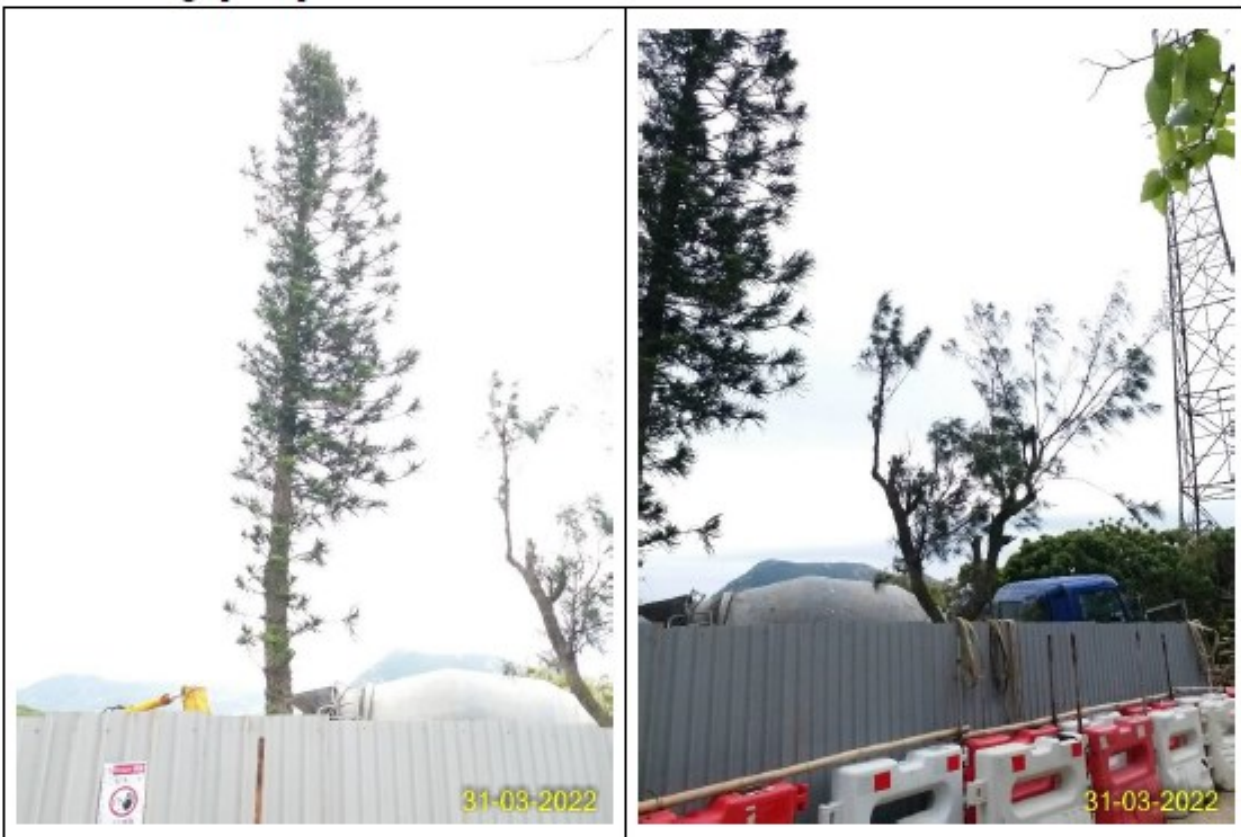
- 4.1.7. A small branch of T6 was blown down under adverse weather on 7th July 2021, as reported by the Contractor. Another branch of T6 was broken, probably by the two recent typhoons in October 2021, but overall condition of T6 is not affected. These broken branches, together with those stubs observed in the retained tree TA, have been pruned. Any further appropriate tree treatment on the retained trees is subjected to a Tree Risk Assessment appointment.

No change in condition of T5 and T6 from previous monitoring.

- 4.1.8. Construction works should be optimized to avoid encroaching into the protection zones as far as possible. Any works inevitably conducted in the protection zone of the three retained trees (e.g., removing mad made concrete surface of a path) shall be minimized its impact to the root system and avoid any damage to the anchor roots. Alignment of pipes passing though among aerial roots of TA has been adjusted with minimum pruning of small, non supportive aerial roots. Soil excavation at the core root zone has been avoided. Since TA (*Ficus elastica*) is a species with extensive aerial root system, such minimum pruning without tearing wounds would be acceptable and unlikely results in significant impact to the tree.

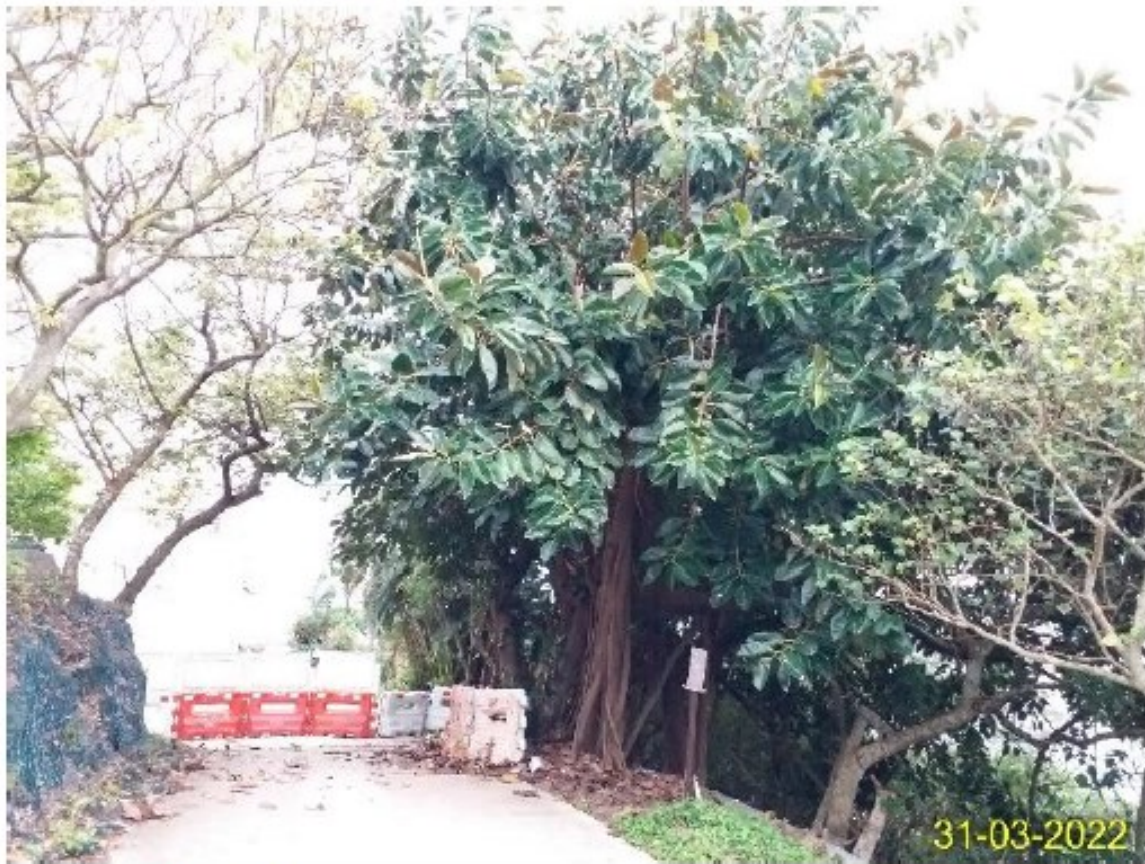
No change in condition of TA from previous monitoring.

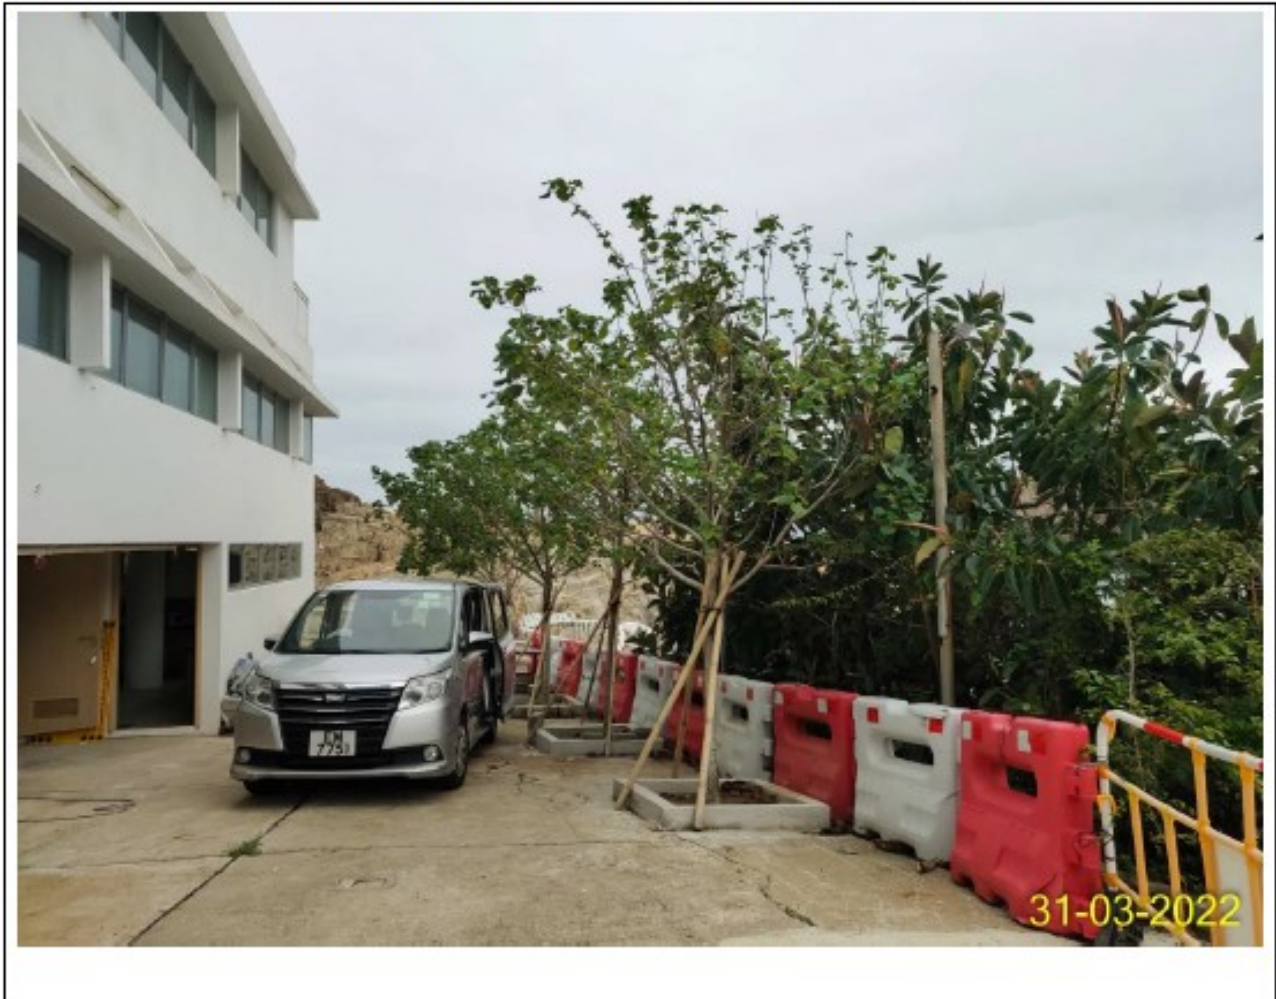
- 2.4.10. Compensatory planting is in progress. Five *Hibiscus tiliaceus* (黃槿) trees have been planted at new tree pits outside the Academic Block (Plate 3).

Plate 3. Five compensatory *Hibiscus tiliaceus* trees have been planted outside Academic Block.
