**Expansion of Research and Residential Facilities for  
The Swire Institute of Marine Science, Faculty of Science,  
The University of Hong Kong at Cape d' Aguilar, Shek O, Hong Kong  
Submission of Monthly Environmental Monitoring and Audit Report No.55**

## **MONTHLY ENVIRONMENTAL MONITORING AND AUDIT FINAL (EM&A) REPORT (NO. 55)**

**Expansion of Research and Residential Facilities for the Swire Institute of  
Marine Science, The University of Hong Kong at Cape D'Aguilar, Shek O**

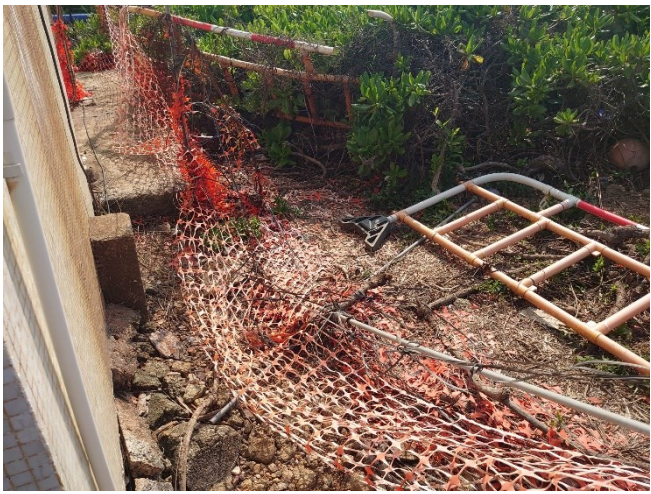
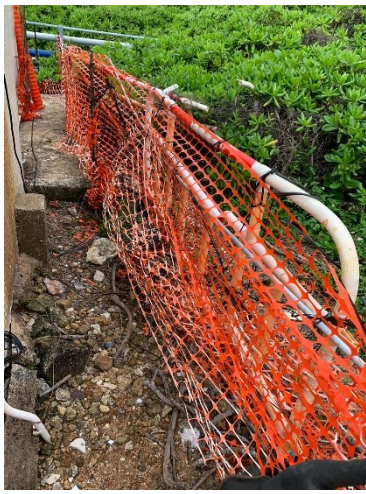
Observation - Item 1	
Observed 28 April 2022	Rectified by the Contractor on 21 May 2022
<i>At Site G, the protective species <i>Lysimachia mauritiana</i> should be fenced off by orange nets.</i>	<i>Orange net is repaired.</i>

- 3.1.1. Inspection was carried out on 28 April 2022. Minor deficiencies were observed during site inspection. The Contractor rectified the deficiencies within the timeline and was reminded to keep close checking on protective fencing for those protected plants on site. Some mitigation measures were not applicable for the current construction stage, the mitigation measures were implemented properly in general. The environmental performance of the Project was therefore considered satisfactory.

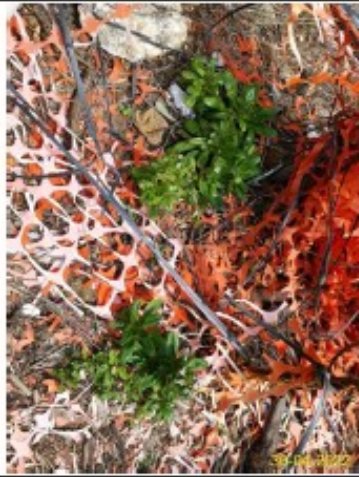
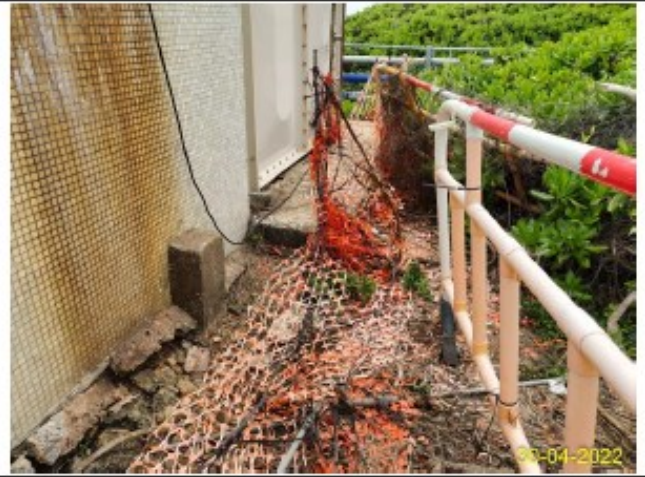
*Lysimachia mauritiana* 濱海珍珠菜 (biennial)

2.4.5. Severe damage caused by Typhoon Mangkhut in September 2018 to the coastal vegetation remained. No *Lysimachia mauritiana* (濱海珍珠菜) could be observed in one of the protection zone near Academic Block (Site A) over 43 months. The original plants in this zone have certified as dead. A few individuals of *Lysimachia mauritiana* are observed within current protection zone (Plate 1).

- 3.1.3. There is no change in form, health & structural condition and amenity value for all six recorded plant species of conservation importance.
- 3.1.4. Coastal vegetation had been wholly destroyed and removed by the Typhoon Mangkhut in September 2018, including most *Lysimachia mauritiana* (濱海珍珠菜). No individual was observed in one of the protection zones that near Academic Block (Site A) over 43 months. The original plants in this zone have certified as dead. However re establishment of *Lysimachia mauritiana* (濱海珍珠菜) is on going. A few individuals of *Lysimachia mauritiana* are observed within current protection zone. Building up additional assurance colonies by collecting seeds may still be feasible..

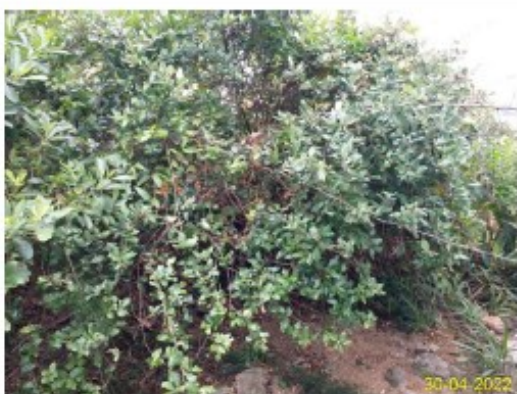
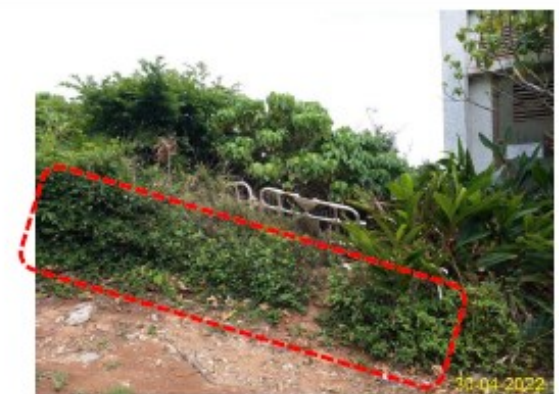
*Elaeagnus tutcheri* 香港胡頹子

2.4.7. Invasive species *Bidens alba* within protection zone of *Elaeagnus tutcheri* (香港胡頹子) has been cleared but emerged again with other overgrown climbers.

Invasive weeds *Bidens alba* (白花鬼針草) in/around the protection zone shall be cleared, including roots, flowers and seeds (red dotted line)

- 3.1.10. To avoid/ reduce potential negative impacts to local native plant community and survival of plant species of conservation important, exotic and highly invasive tree *Leucaena leucocephala* (銀合歡), shrub *Lantana camara* (馬櫻丹), herb *Bidens alba* (白花鬼針草) and climber *Mikania micrantha* (薇甘菊) should be cleared and removed in whole, including the roots, whenever encountered throughout the construction phase, and packed properly before disposed as waste to prevent regrowth and dispersal of pollens and seeds. Invasive species and other overgrown climbers observed within protection zones of *Pittosporum tobira* (海桐) and *Elaeagnus tutcheri* (香港胡頹子) have been cleared but emerged again as observed in this monitoring.

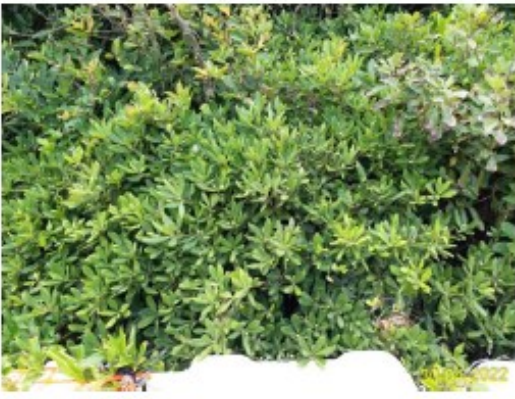
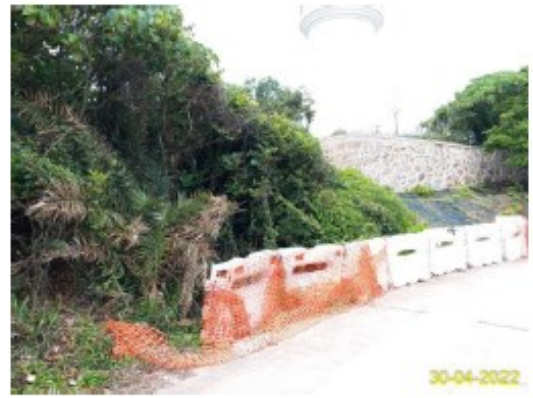
*Pittosporum tobira* 海桐

2.4.6. *Pittosporum tobira* (海桐) has shown slight dieback of twigs, with regeneration of young leaves. Invasive *Leucaena leucocephala* and *Lantana camara* within protection zone have been cleared but emerged again with other overgrown climbers.

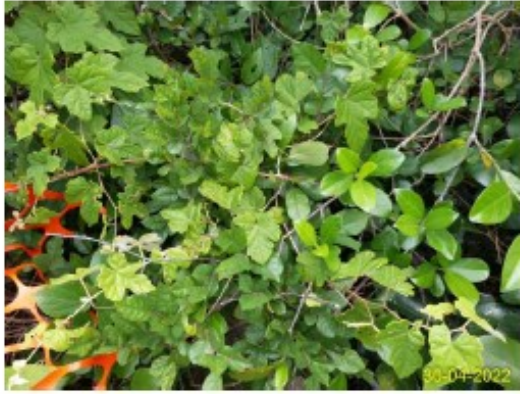
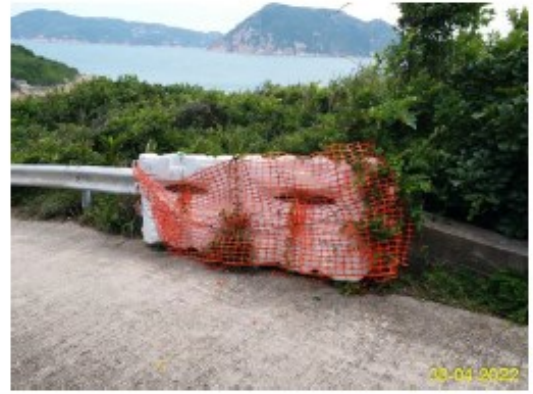
*Vitis bryoniifolia* 藜蘆

2.4.8. Leaves of the deciduous *Vitis bryoniifolia* (蘗蘗) has grown out.

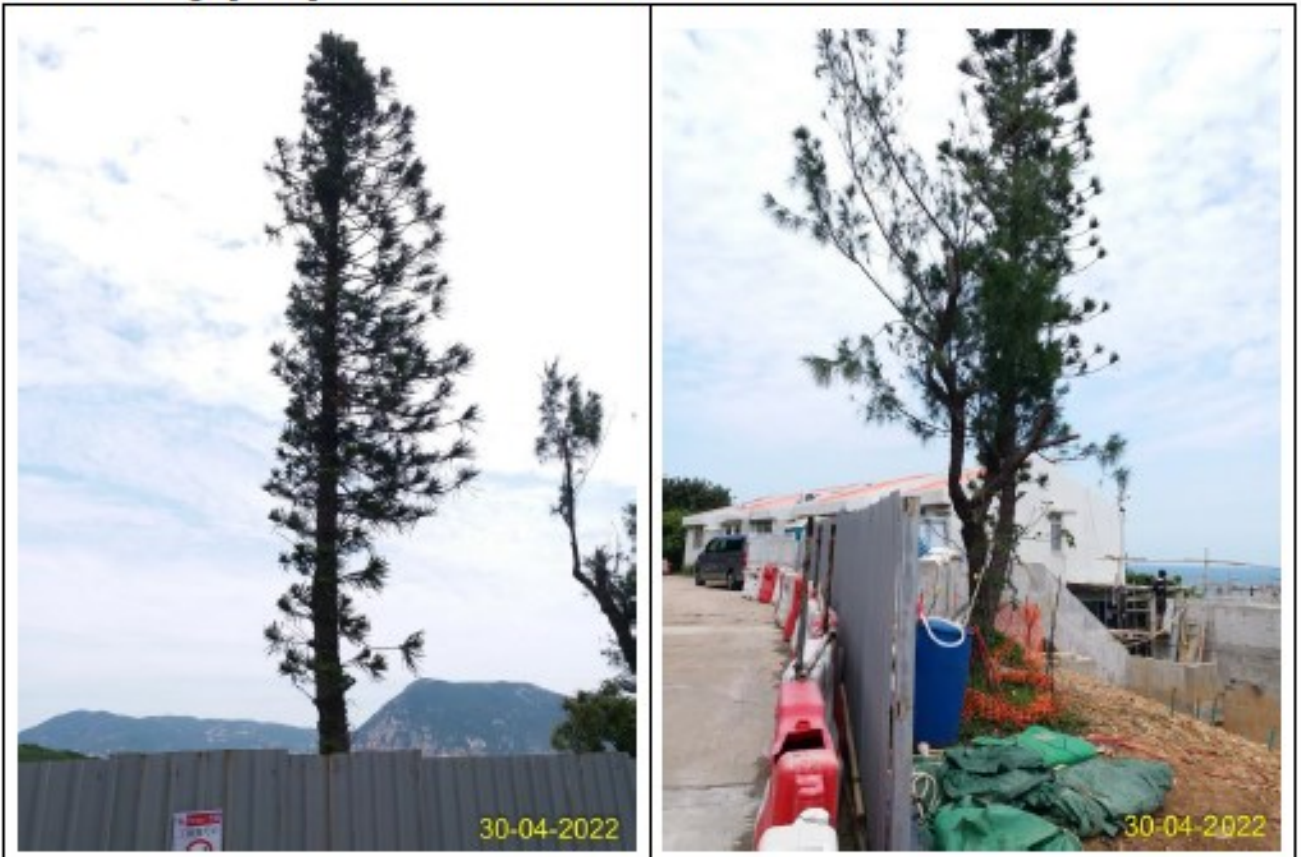
2.4.9. For the three retained trees, there is no change in overall condition of T5, T6 and TA, despite a small branch of T6 was blown down under adverse weather on 7th July 2021, as reported by the Contractor. Another branch of T6 was broken, probably due to the 2 Typhoons Kompasu & Lionrock in October 2021. Several broken stubs on TA were also observed

No change in condition of T5 and T6 from previous monitoring.

- 3.1.7. A small branch of T6 was blown down under adverse weather on 7th July 2021, as reported by the Contractor. Another branch of T6 was broken, probably by the two recent typhoons in October 2021, but overall condition of T6 is not affected. These broken branches, together with those stubs observed in the retained tree TA, have been pruned. Any further appropriate tree treatment on the retained trees is subjected to a Tree Risk Assessment appointment.

Good written and photographic records should be made before, during and after any actions of treatment for the assessed tree.

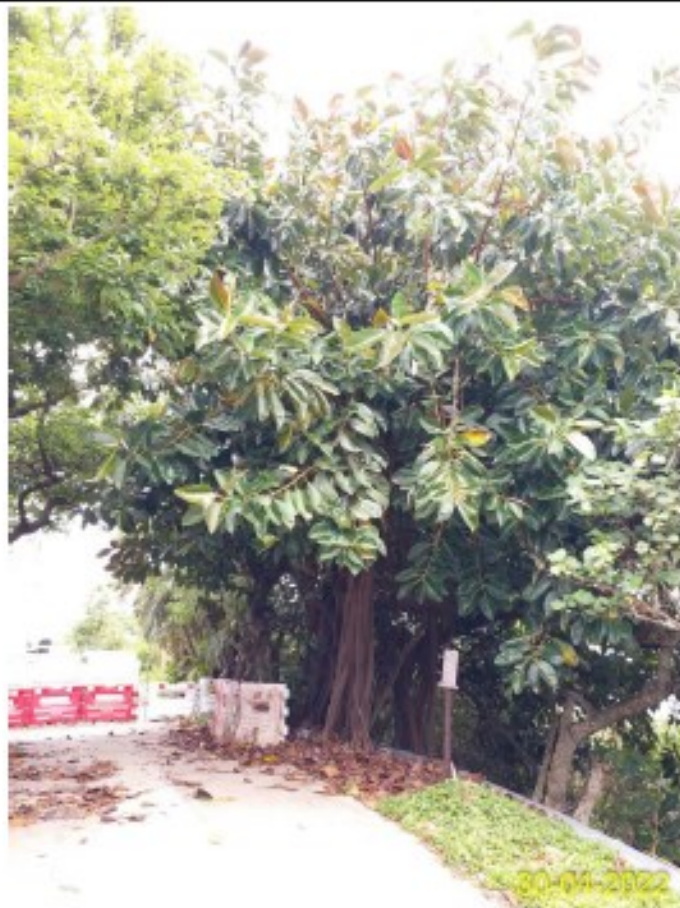
during last monitoring. These stubs due to the typhoon damage have been pruned. Alignment of pipes passing through among aerial roots of TA has been adjusted with minimum pruning of small, non-supportive aerial roots. Soil excavation at the core root zone has been avoided. Since TA (*Ficus elastica*) is a species with extensive aerial root system, such minimum pruning without tearing wounds would be acceptable and unlikely results in significant impact to the tree. Corresponding photographic records T5, T6 and TA are illustrated in Plate 2.

No change in condition of TA from previous monitoring.

- 3.1.8. Construction works should be optimized to avoid encroaching into the protection zones as far as possible. Any works inevitably conducted in the protection zone of the three retained trees (e.g., removing made concrete surface of a path) shall be minimized its impact to the root system and avoid any damage to the anchor roots. Alignment of pipes passing through among aerial roots of TA has been adjusted with minimum pruning of small, non supportive aerial roots. Soil excavation at the core root zone has been avoided. Since TA (*Ficus elastica*) is a species with extensive aerial root system, such minimum pruning without tearing wounds would be acceptable and unlikely results in significant impact to the tree.

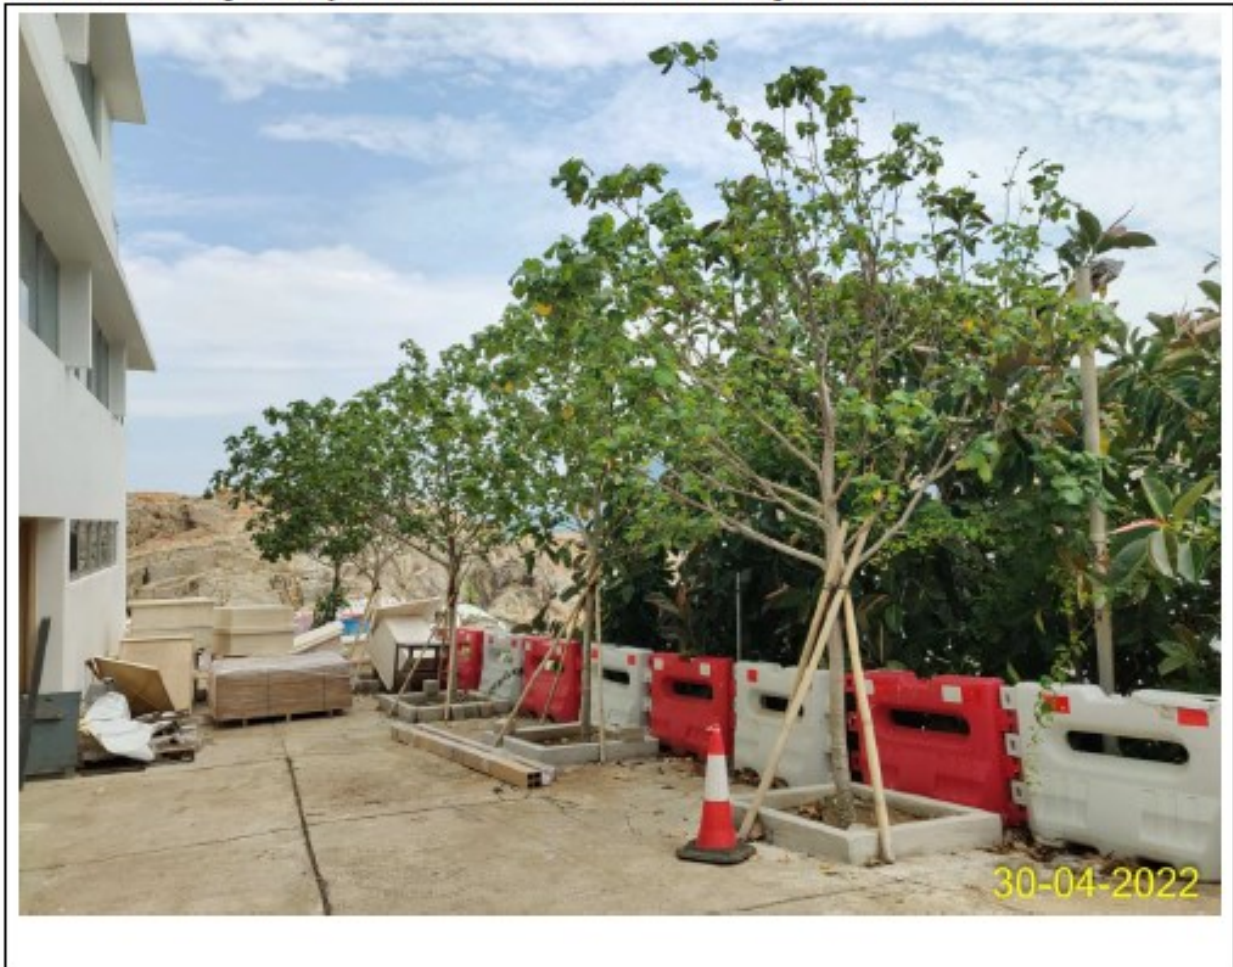
2.4.10. Compensatory planting is in progress. Five *Hibiscus tiliaceus* (黃槿) trees have been planted at new tree pits outside the Academic Block (Plate 3).

**Plate 3.** Five compensatory *Hibiscus tiliaceus* trees have been planted outside Academic Block.
