Ecological Verification Survey Report – July 2017

*Expansion of Research and Residential Facilities for the Swire
Institute of Marine Science, The University of Hong Kong at
Cape D'Aguilar, Shek O*

Ecological Verification Survey

30th August 2017

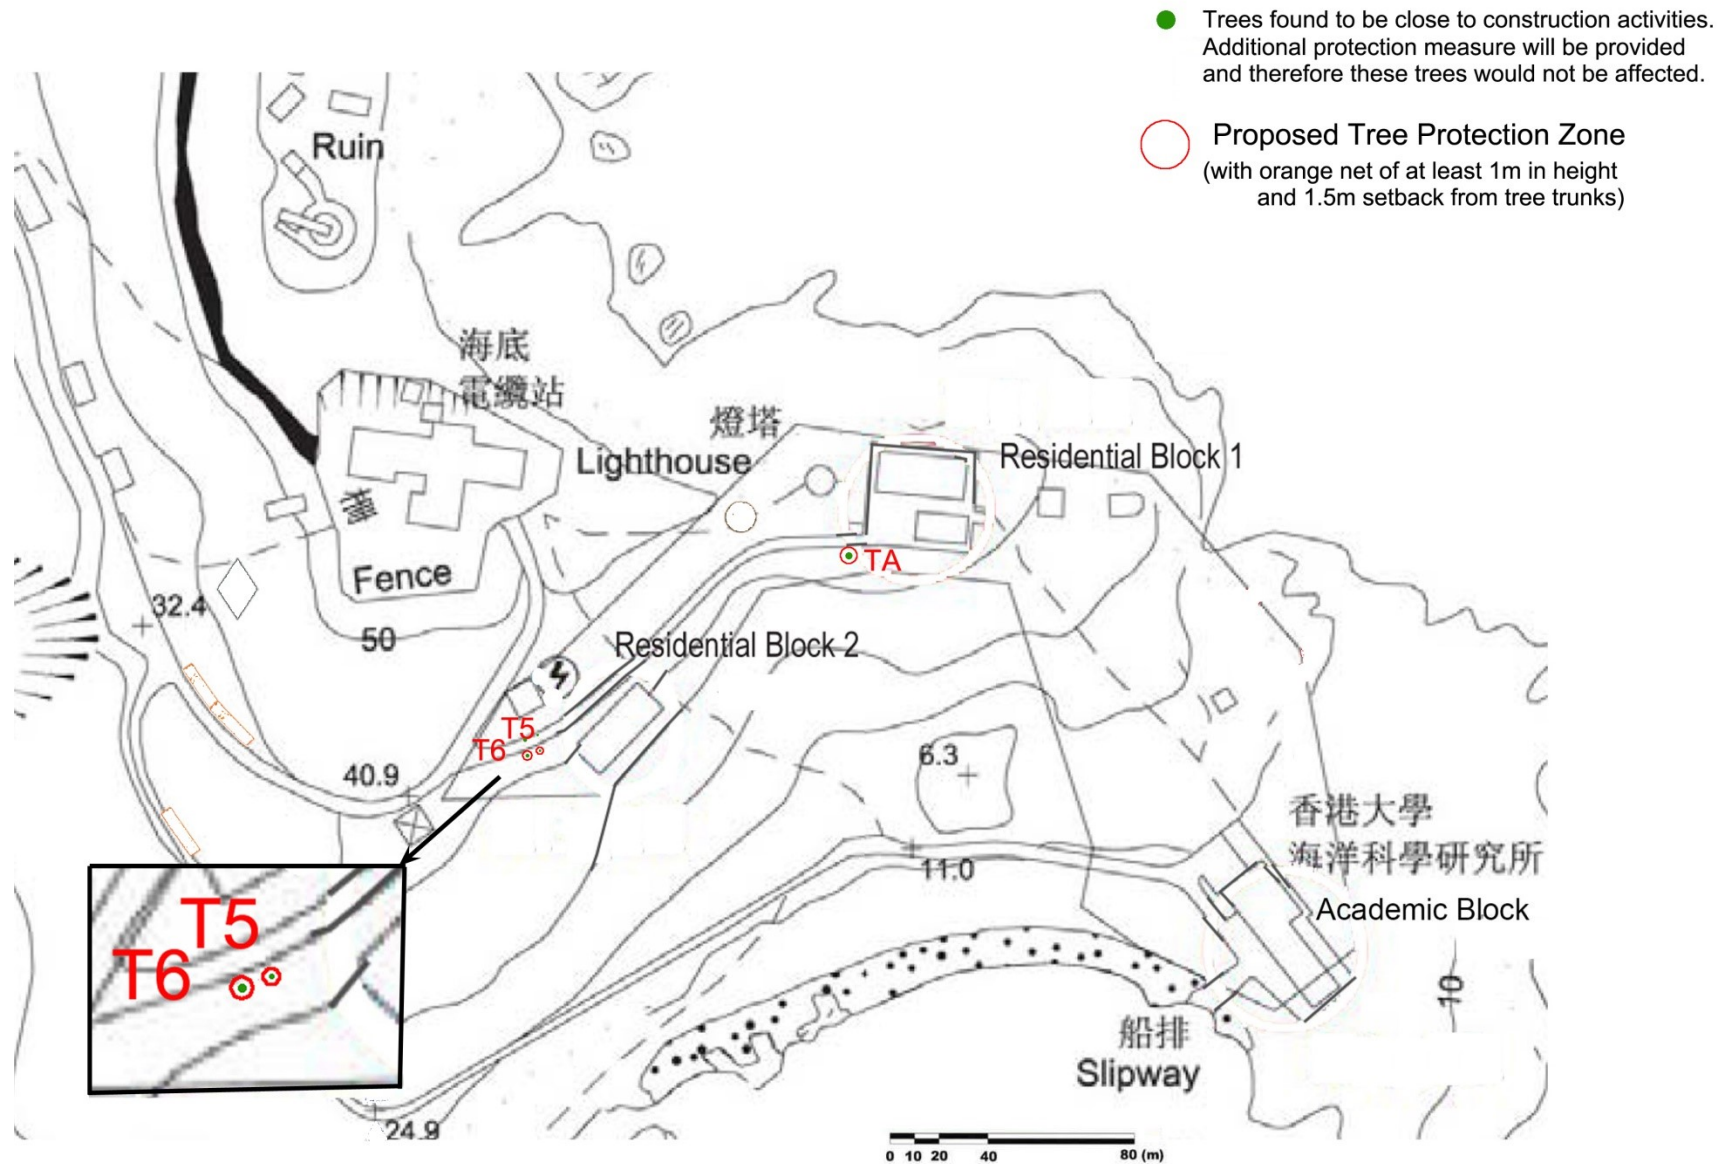
- 3.4. Besides, three other trees of common and exotic species were found close to construction activities from the survey. They included one *Araucaria heterophylla* (異葉南洋杉; T5), one *Casuarina equisetifolia* (木麻黃; T6) at roadside near Residential Block 2; and one *Ficus elastica* (印度榕; TA) at roadside opposite to the lighthouse (**Figure 3; Plate 4**). Conditions of these three trees are detailed in **Table 4**. Additional joint site visit was then carried out with the contractor on 11th August 2017. From the finding of the site visit, it is anticipated that these trees would not be affected. To minimize the potential impacts, additional protection measure such as setting up tree protection zone will be provided, as detailed in paragraph 4.4.

Figure 3. Indicative locations of the three trees of common and exotic species that found to be close to construction activities. They would not be affected due to additional protection measure provided.

- 4.4. Besides, three other trees of common and exotic species were found close to construction activities from the survey. They included one *Araucaria heterophylla* (異葉南洋杉; T5), one *Casuarina equisetifolia* (木麻黃; T6) at roadside near Residential Block 2; and one *Ficus elastica* (印度榕; TA) at roadside opposite to the lighthouse (**Figure 3**). Additional joint site visit was then carried out with the contractor on 11th August 2017. From the finding of the site visit, it is anticipated that these trees would not be affected. To minimize the potential impacts, additional protection measure will be provided. These trees should be protected and preserved by fencing off with orange net of at least 1m in height. Such protection zone should be at least 1.5m setback from tree trunks (**Figure 4**). They would be followed up in subsequent monitoring. Works should be optimized to avoid encroaching into the protection zone as far as possible. Any works inevitably conducted in the protection zone of these three trees (e.g. removing mad-made concrete surface of a path) shall be minimized its impact to the root system and avoid any damage to the anchor roots. On the other hand, the 15 trees applied for felling are awaiting approval by Lands Department.

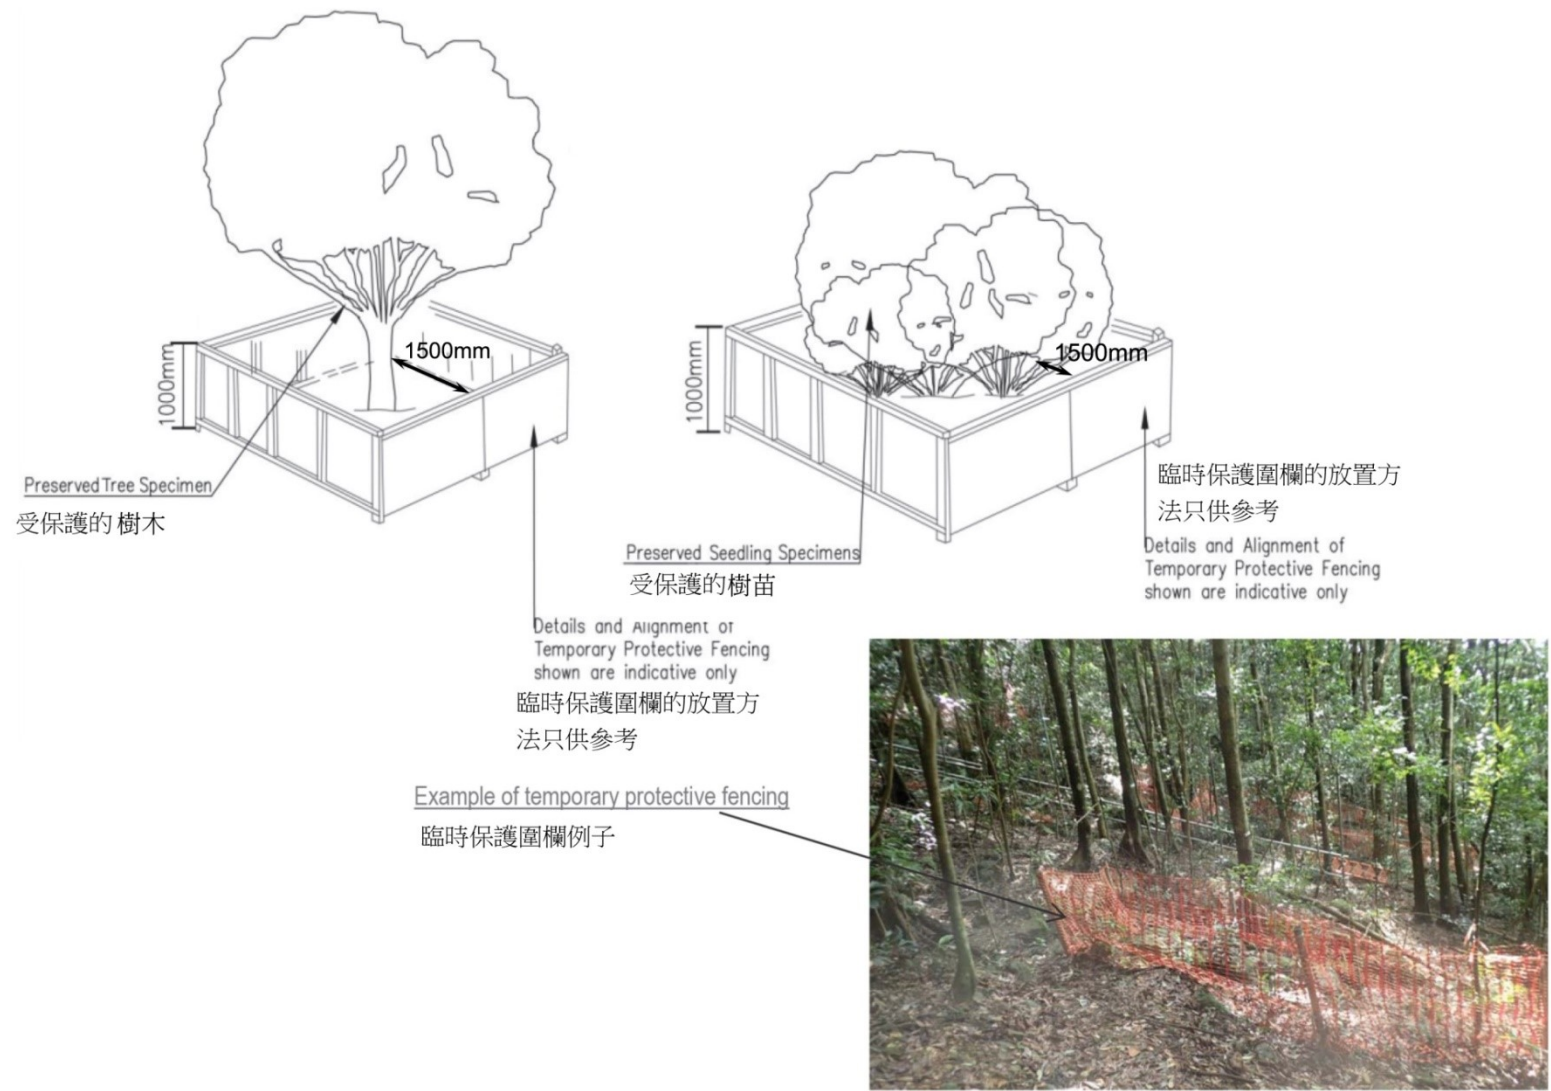
Figure 4. Indicative plan of temporary protective fencing for the three retained trees of common and exotic species. (Prepared based on Figure 4 of Environmental Permit No.: EP-537/2017)

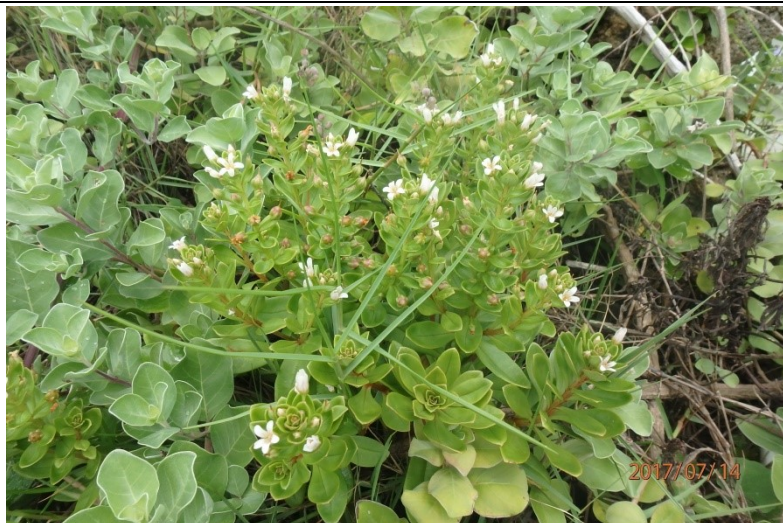
Lysimachia mauritiana (濱海珍珠菜). Mature individual in flowers and fruits.

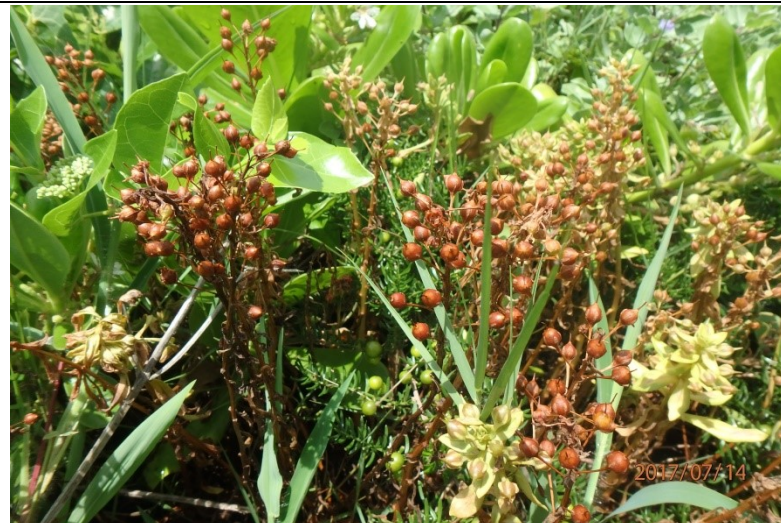
Lysimachia mauritiana (濱海珍珠菜) is biennial or perennial with annual-like nature. Leaves become yellow when most fruits are maturing.

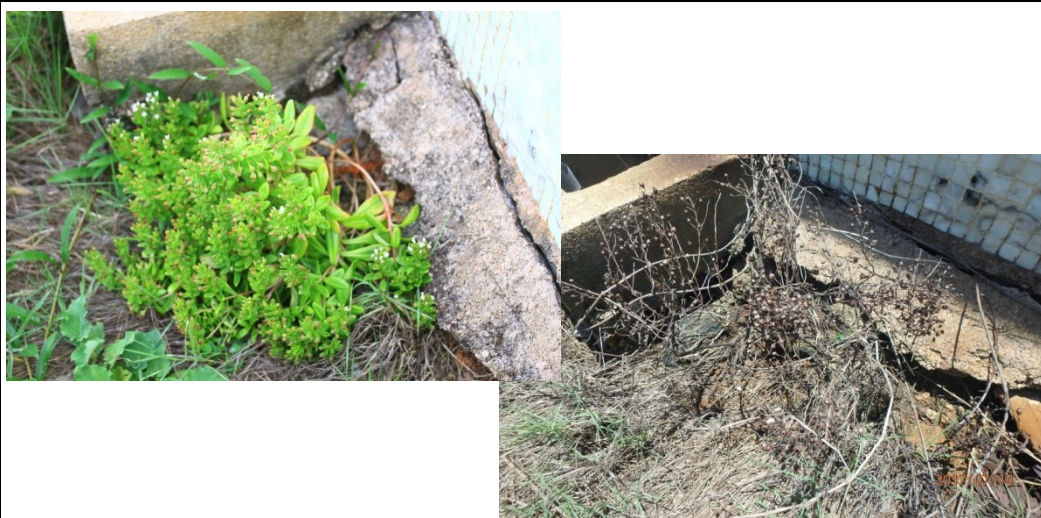
This same individual was alive by then in July 2016. It was found dead naturally during this verification survey.

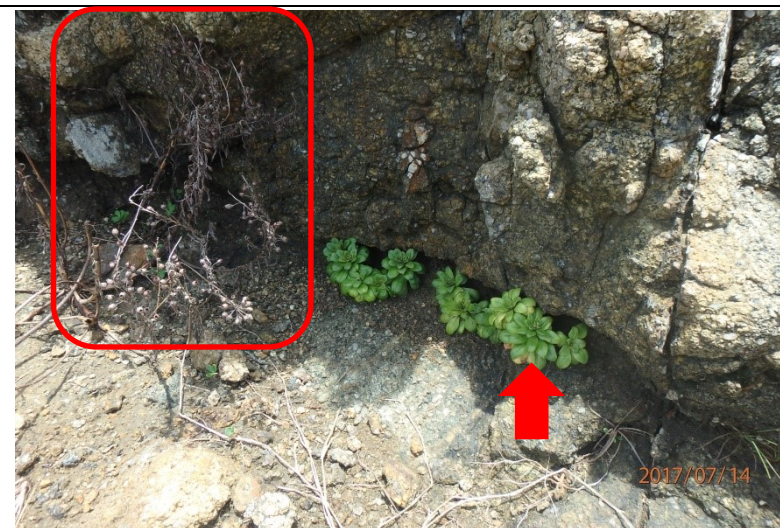
Life span is short for this species (usually < 5 years). Cycle in dying of old (red frame) and regeneration of young individuals (arrow) were happening at the same patch of suitable habitat.

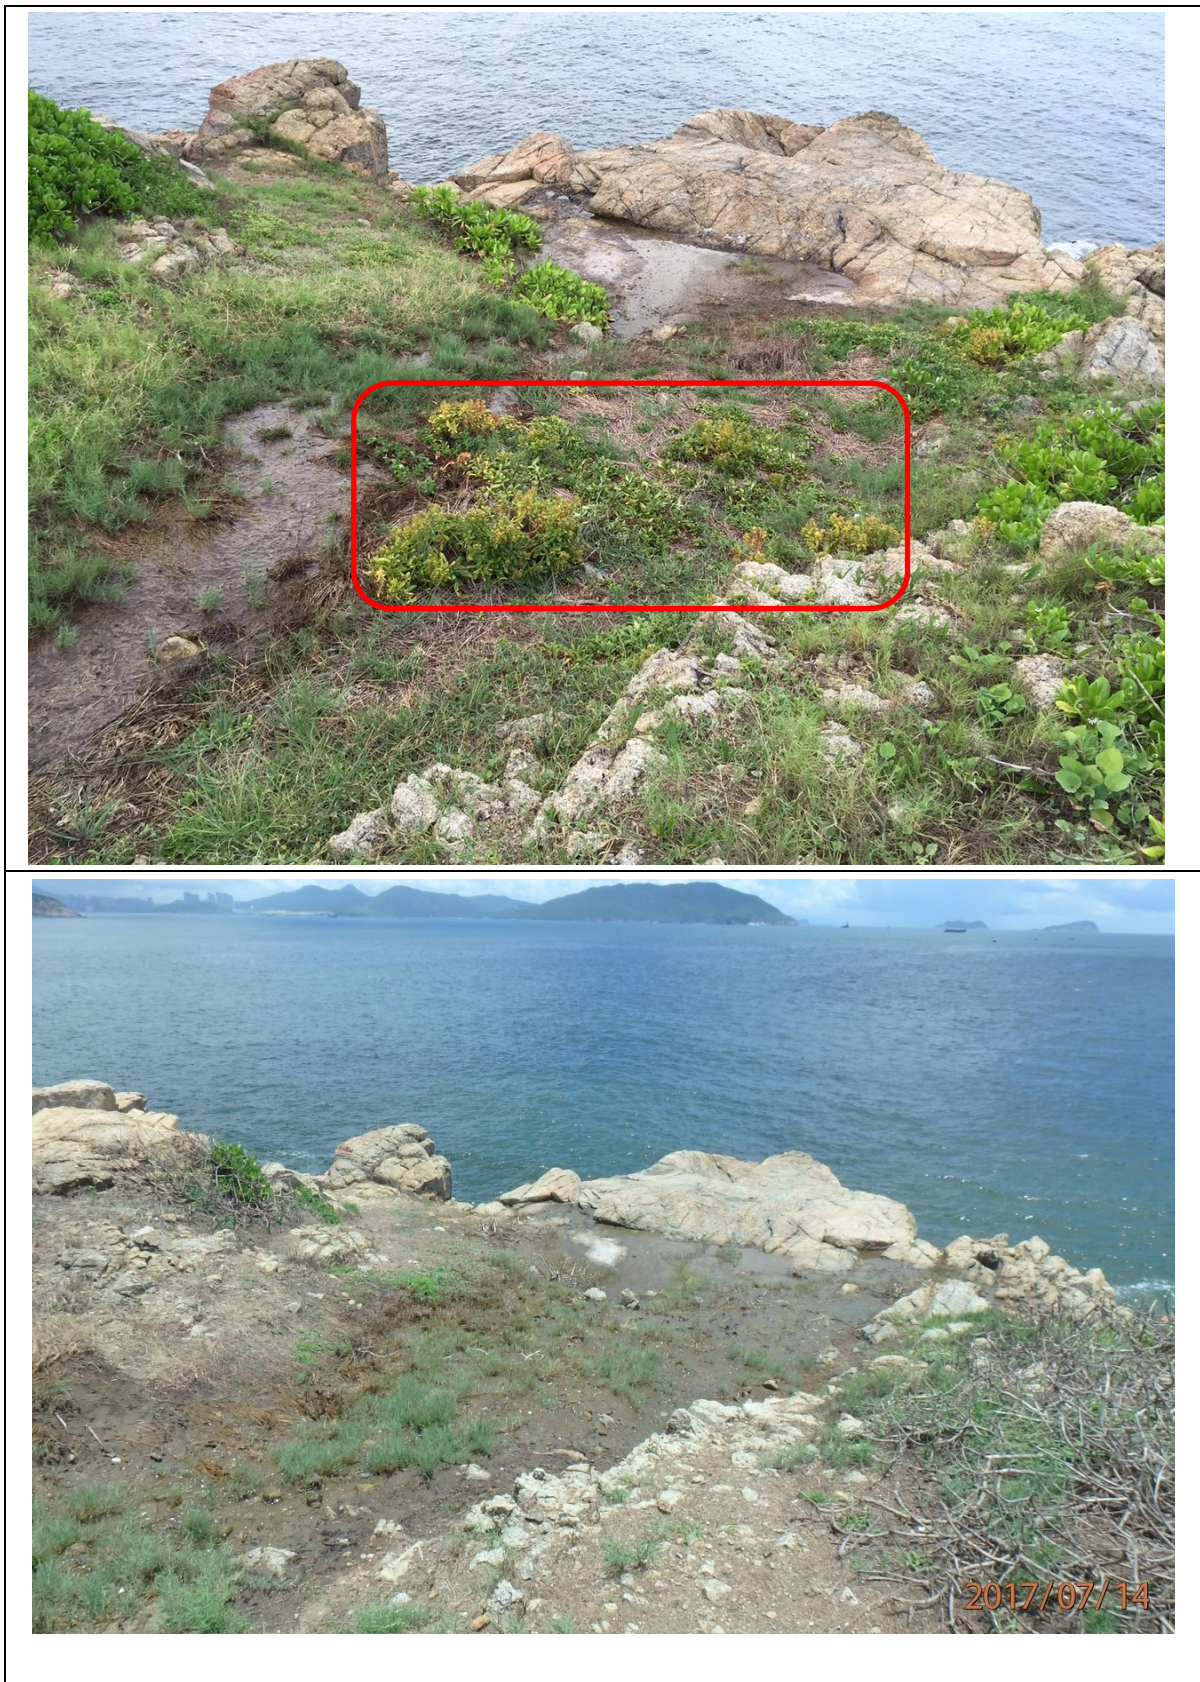
- 4.2. No additional plant species with conservation importance are detected. A patch of *Lysimachia mauritiana* (濱海珍珠菜) occurring by then in July 2016 was found disappeared without obvious regeneration of seedlings during present survey a year later.

Plate 2. The patch of *Lysimachia mauritiana* (濱海珍珠菜) observed at coastal area in July 2016 (top; red frame) was found disappeared without obvious regeneration of seedlings during present survey, which was conducted in July 2017 (bottom). Note the death of perennial evergreen *Scaevola taccada* (草海桐; shrub at the margin of this photo).

- 4.3. All plant species of conservation important should be protected, retained *in-situ* and not be disturbed in accordance with Condition 2.5 of the Environmental Permit. In order to better preserve the very rare plant species of conservation importance *Lysimachia mauritiana* (濱海珍珠菜) against unpredictable human or natural disturbance, it is feasible to build up additional assurance colonies by collecting seeds year round and growing them in suitable habitat.

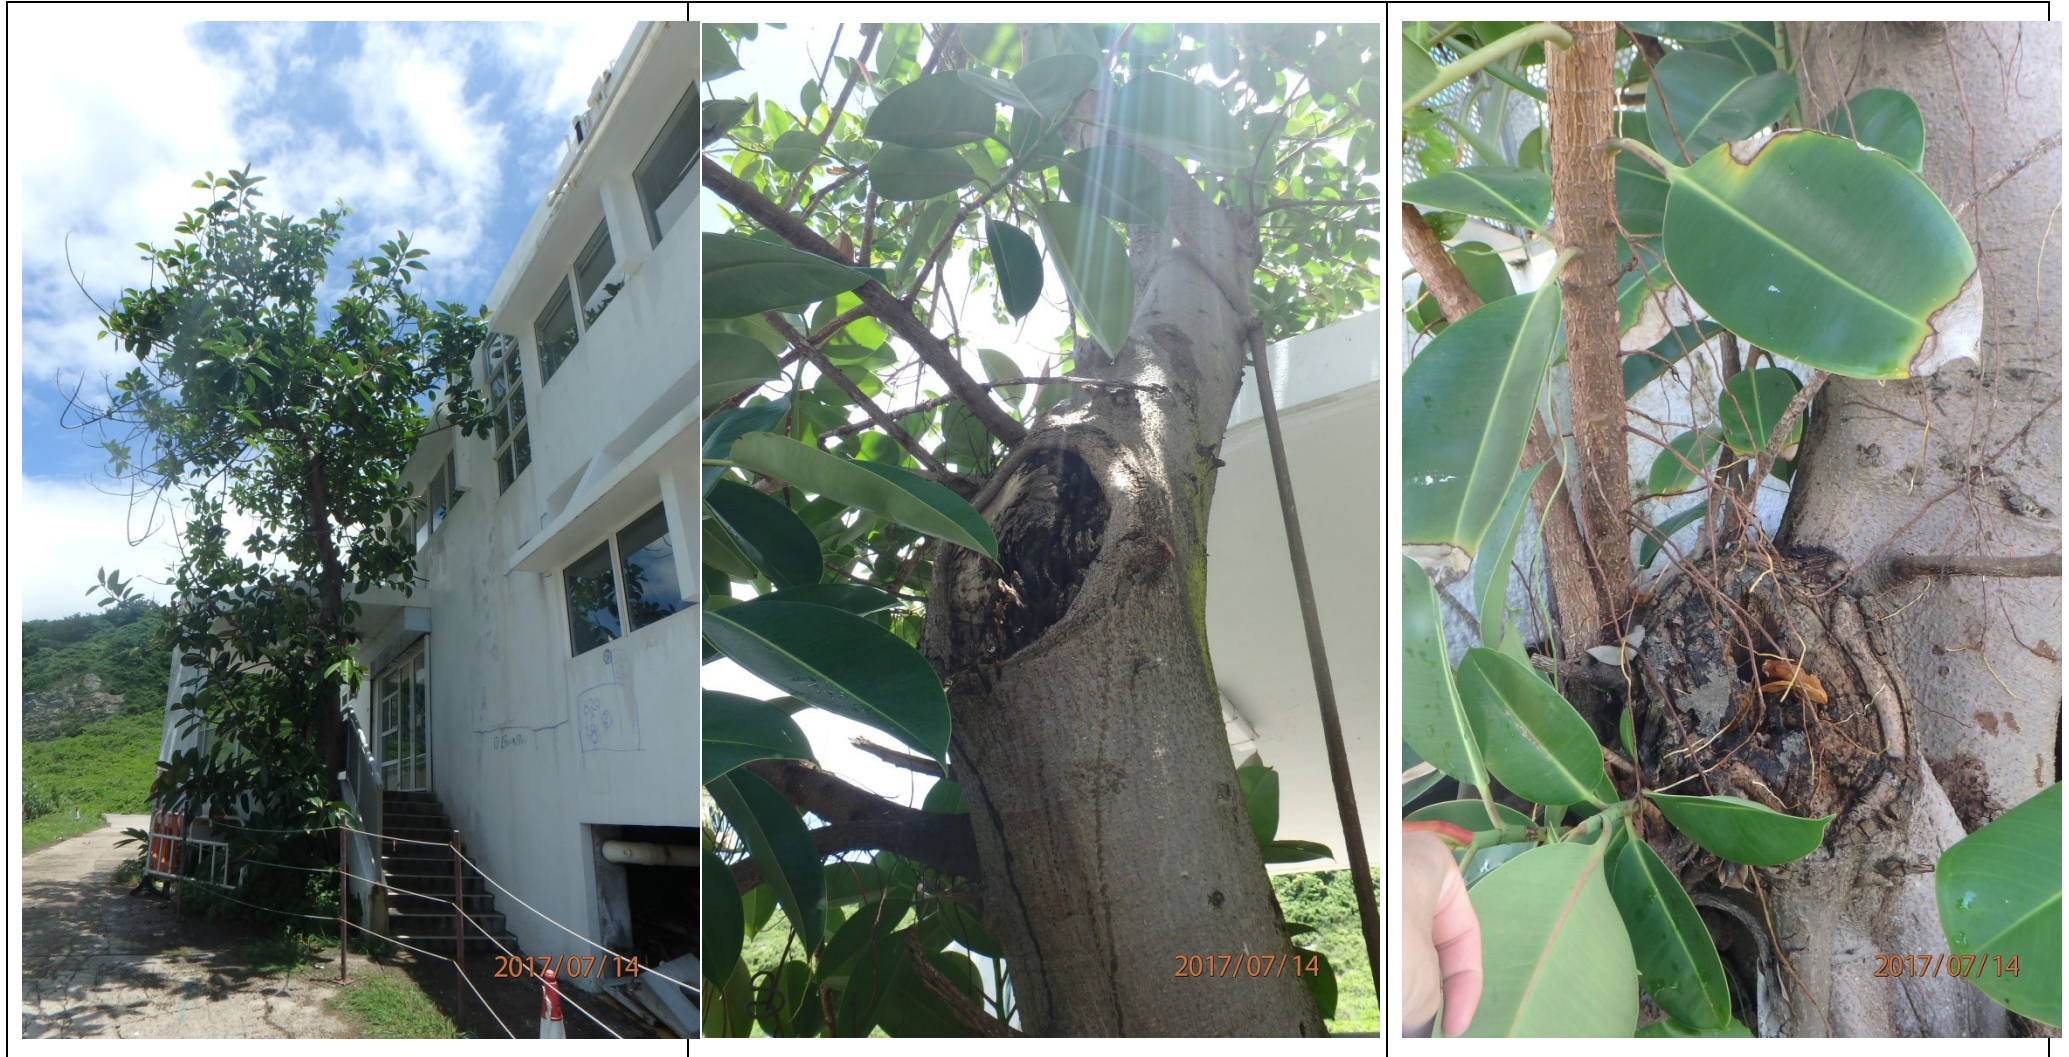
3.3. As for the trees that were found to have direct conflict with the proposed construction works in the Project Profile, the only *Ficus elastica* tree (印度榕; T1) growing at the Academic Block was poor in form, health, and amenity value as stated in previous Tree Survey Report (**Plate 3**). Observations on the 14 trees at the Residential Block 2 found no felling against natural factors (e.g. typhoon).

Plate 3. The *Ficus elastica* (印度榕; T1) growing at the Academic Block is poor in form, health and amenity value.

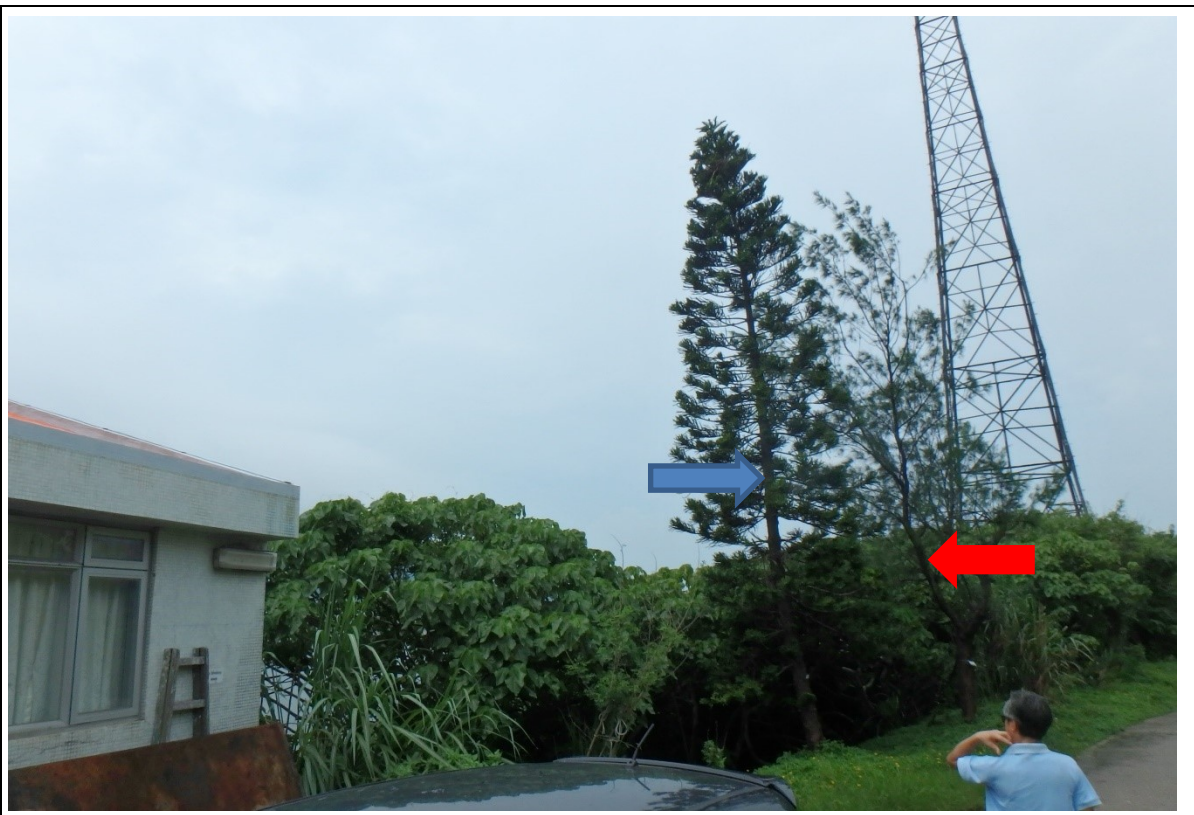
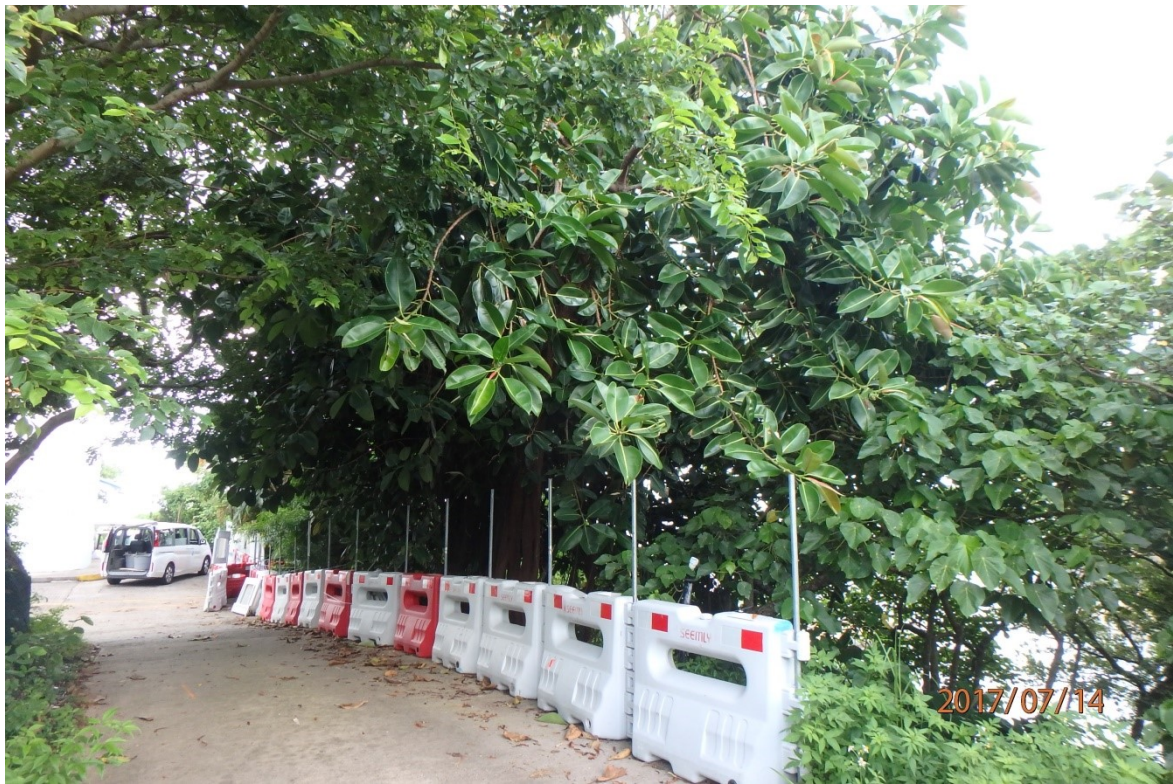
Plate 4. Three trees were found to be close to construction activities. Additional protection measure will be provided and therefore these three trees will not be affected. They included *Araucaria heterophylla* (異葉南洋杉; T5, blue arrow), *Casuarina equisetifolia* (木麻黃; T6, red arrow) near Residential Block 2; and *Ficus elastica* (印度榕; TA) at roadside leading to the lighthouse (bottom).
