Contract No. DC/2018/02
Upgrading of Sewage Pumping
Stations and Sewerage Along
Ting Kok Road

Condition Survey Report on a
Grade 3 Historical Building
(Yu Cheung Tong)

P19076/CSR/002 (Issue 7)

June 2021

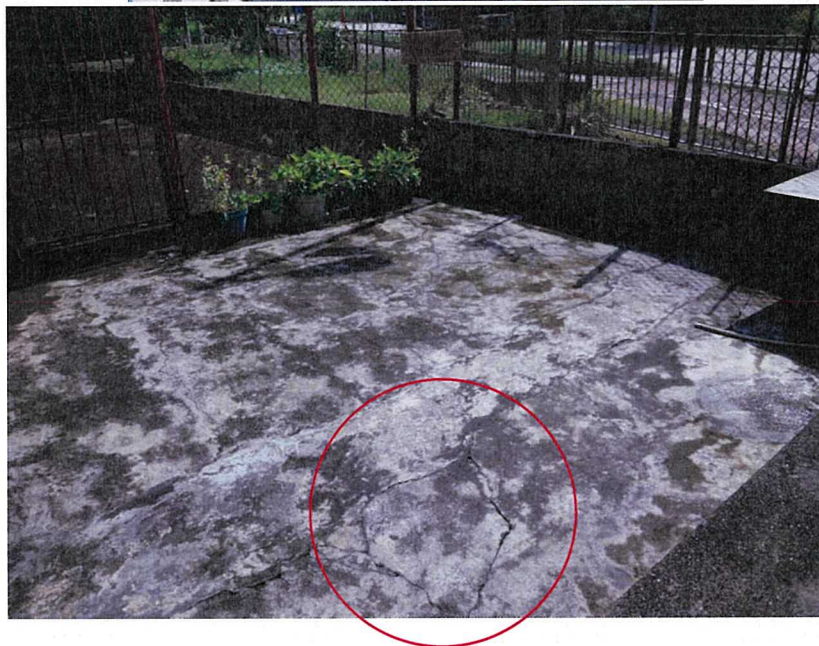
Photo No:
008

Photo description:
Wide cracks are identified on
the front ground of the
3rd Block of
Yu Cheung Tong
(indicated by red circle in the
photo)

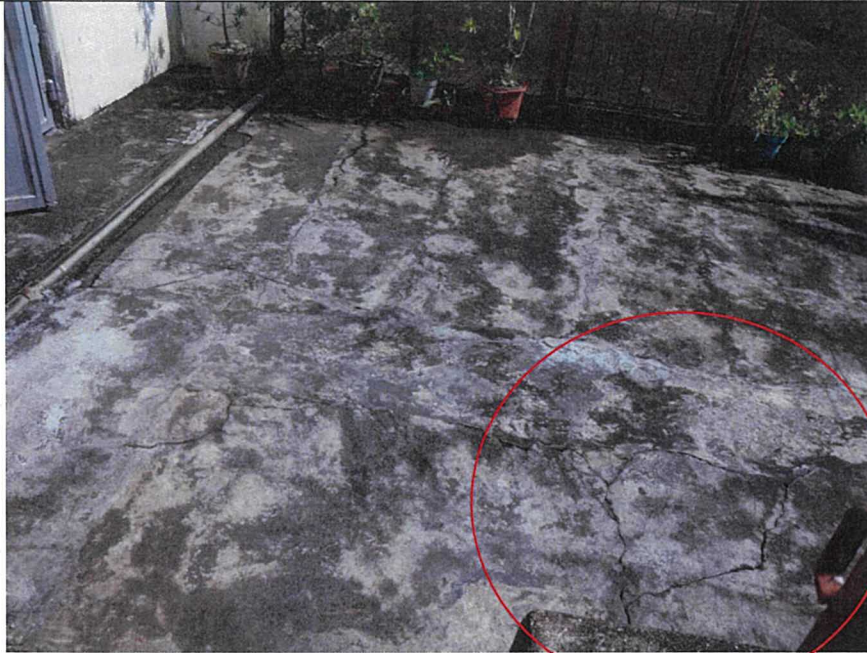
Photo No:
009

Photo description:
Wide cracks are identified on
the front ground of the 3rd
Block of Yu Cheung Tong
(indicated by red circle in the
photo)

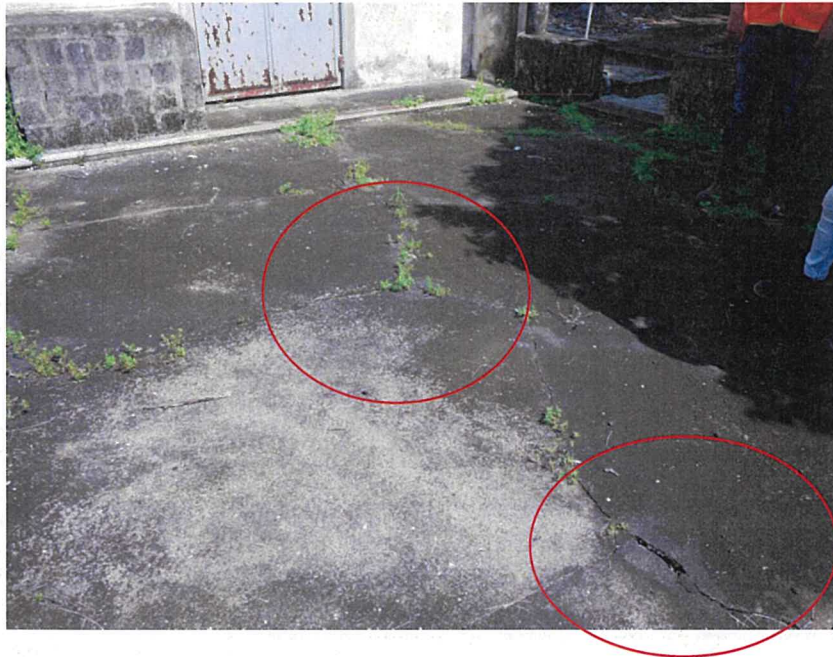
Photo No:
026

Photo description:
Wide cracks are found on
the wall adjacent to
the 1st Block
of Yu Cheung Tong
(indicated by red circle in
the photo)

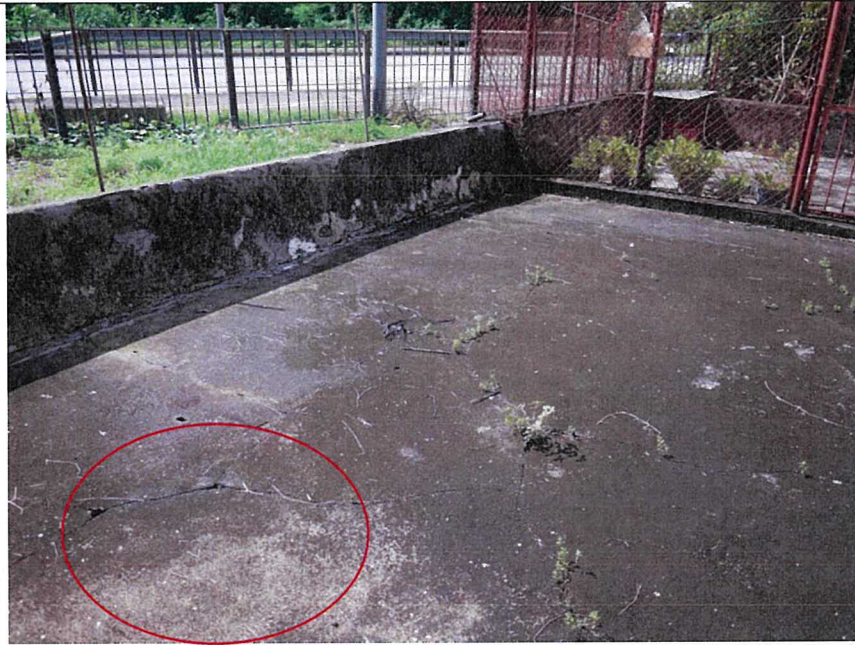
Photo No:
027

Photo description:
Wide cracks are found on
the wall adjacent to
the 1st Block
of Yu Cheung Tong
(indicated by red circle in
the photo)

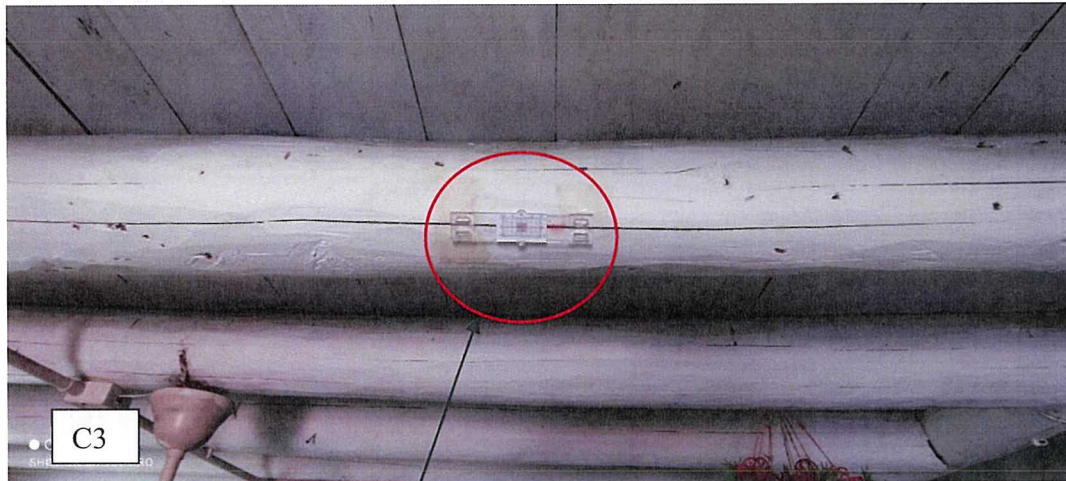
Crack Meter No.: C3

C3 Original Crack Widths – 3mm

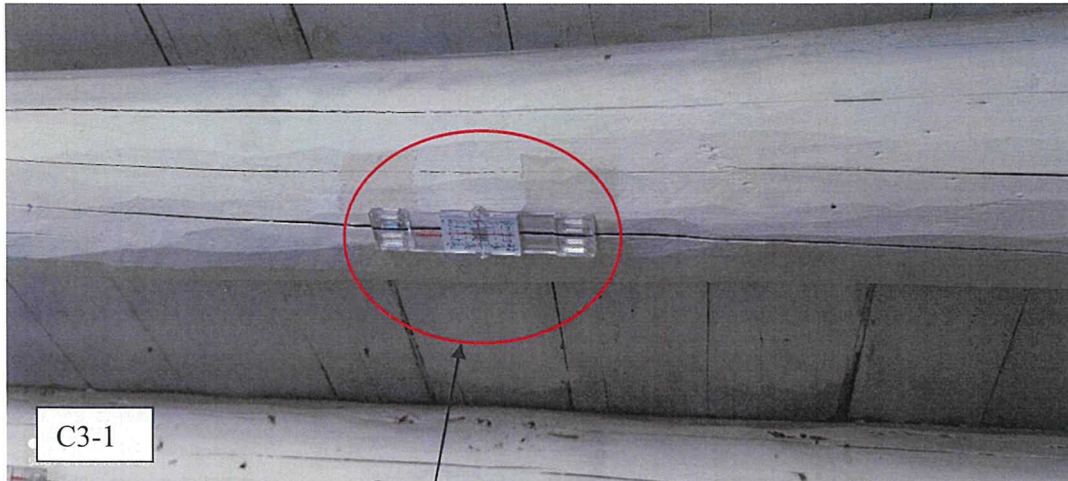
Location: Inside 3rd Block of Yu Cheung Tong G/F
Crack Meter No.: C3-1

C3-1 Original Crack Widths – 3mm

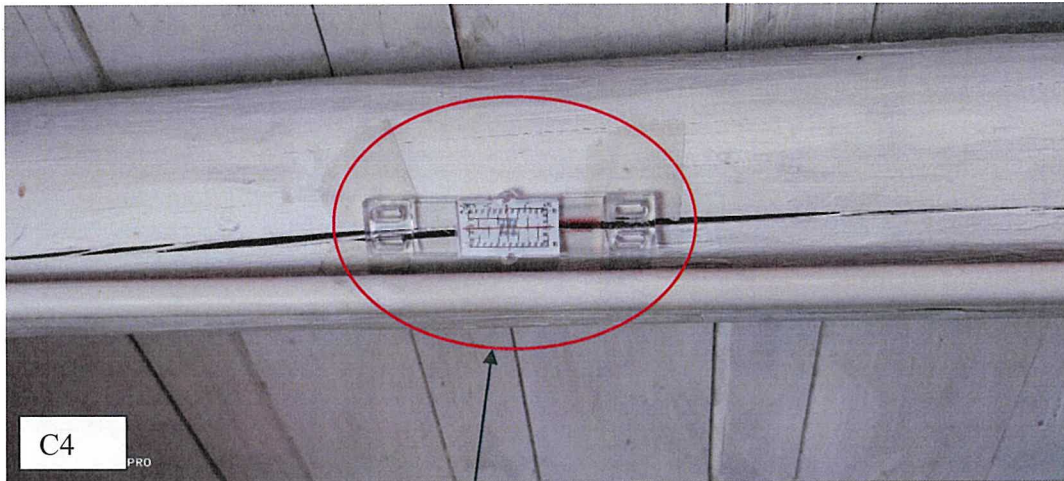
Location: Inside 3rd Block of Yu Cheung Tong G/F
Crack Meter No.: C4

C4 Original Crack Widths – 4mm

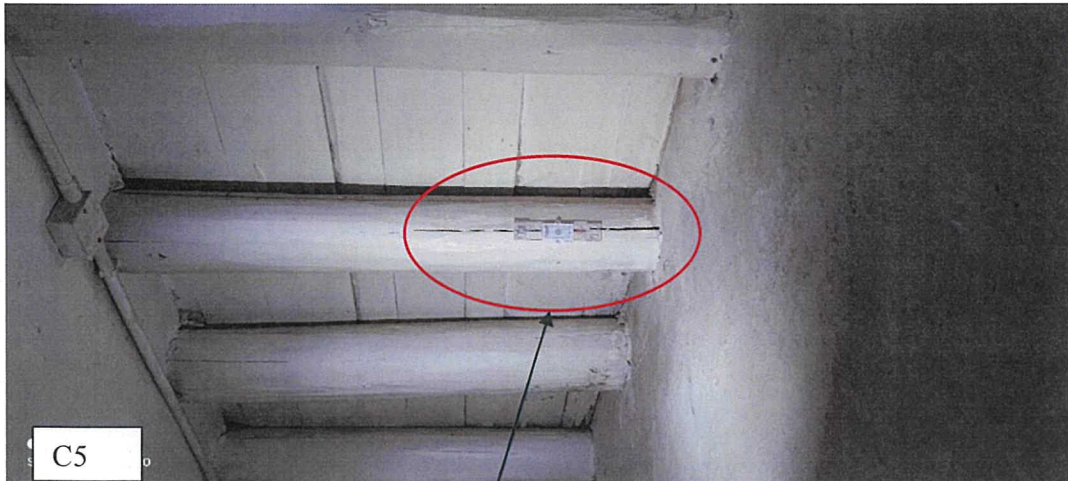
Location: Inside 3rd Block of Yu Cheung Tong G/F
Crack Meter No.: C5

C5 Original Crack Widths – 4mm

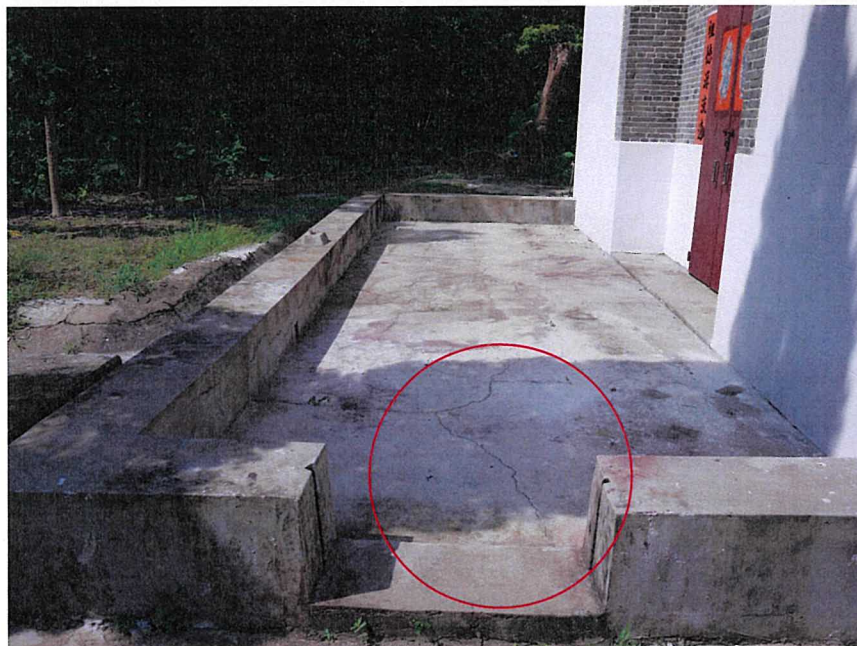
Photo No:
004

Photo description:
Wide cracks are identified in
the front ground of
the building
(indicated by red circle
in the photo)

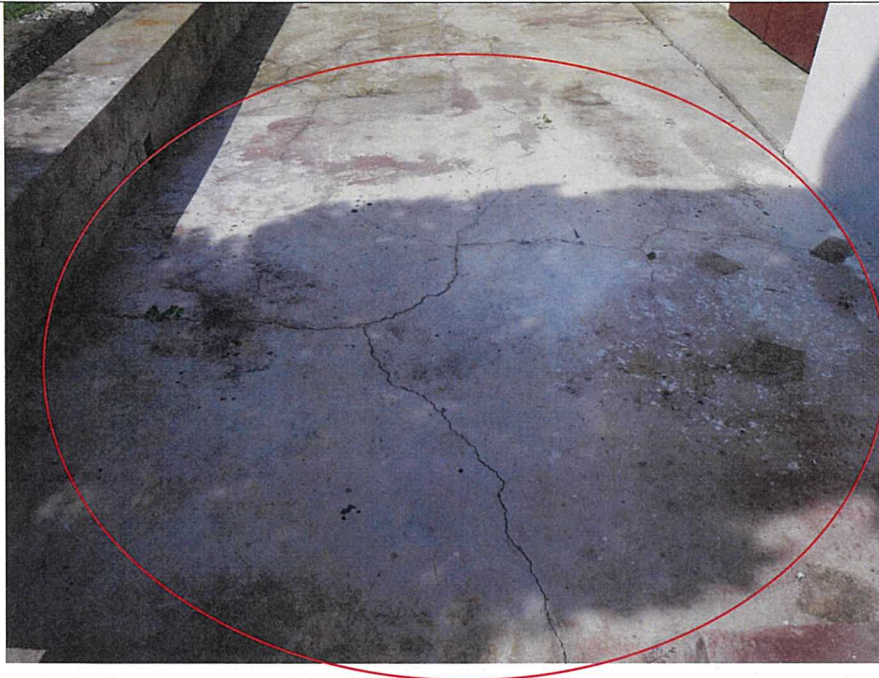
Photo No:
005

Photo description:
Wide cracks are identified
in the front ground of
the building
(indicated by red circle
in the photo)

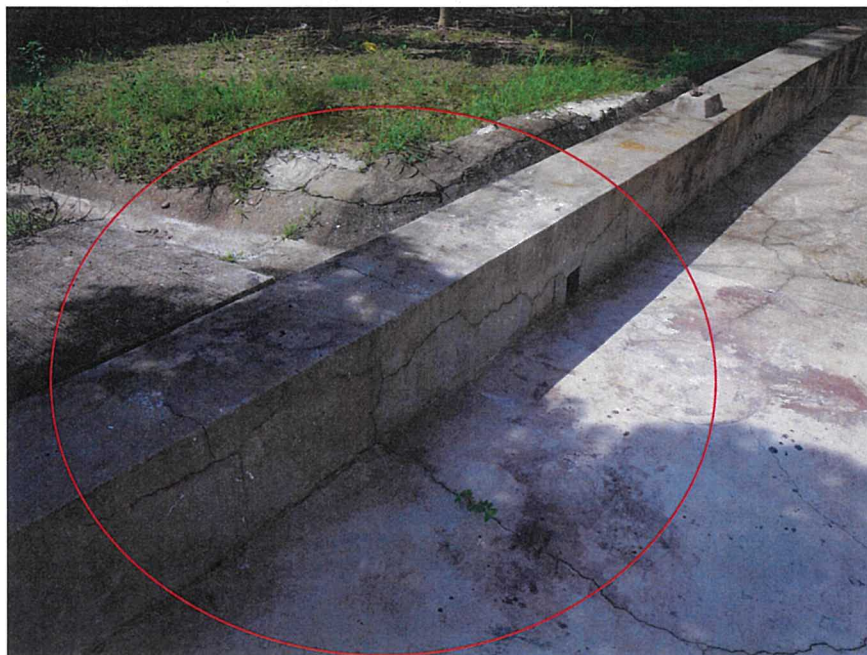
Photo No:
006

Photo description:
Wide cracks are identified
in the front ground of
the building
(indicated by red circle
in the photo)

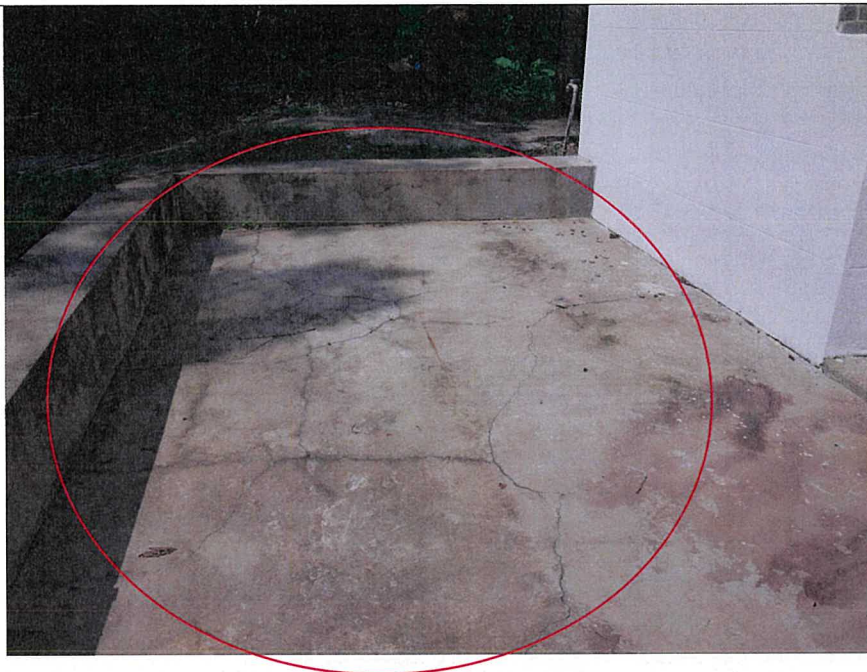
Photo No:
007

Photo description:
Wide cracks are identified
in the front ground of
the building
(indicated by red circle
in the photo)

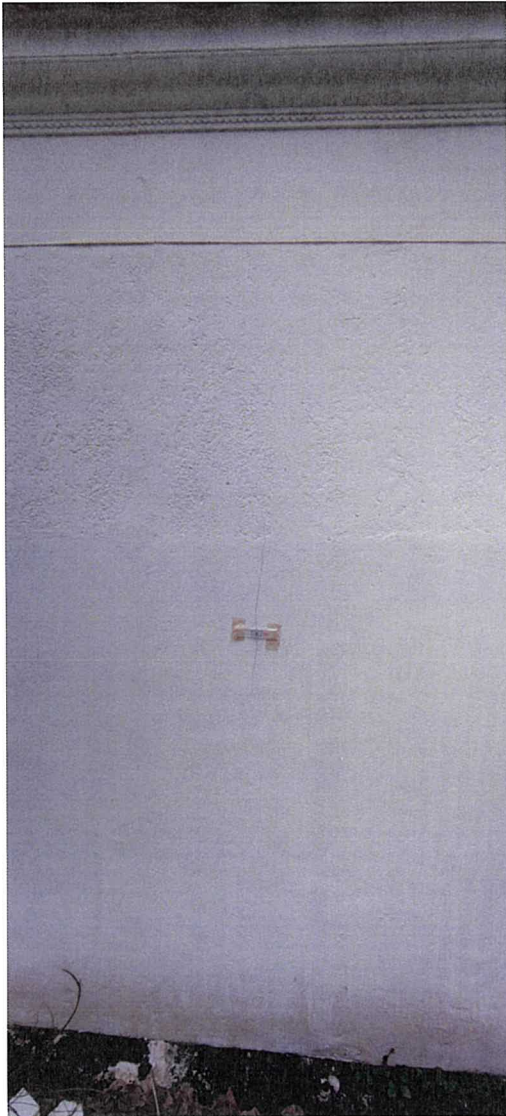
Location: Inside Law Ancestral Hall
Crack Meter No.: C4

Original Crack Width – 1mm
