# Kowloon-Canton Railway Corporation

## West Rail

## Pre-operation Environmental Audit Report

### December 2003

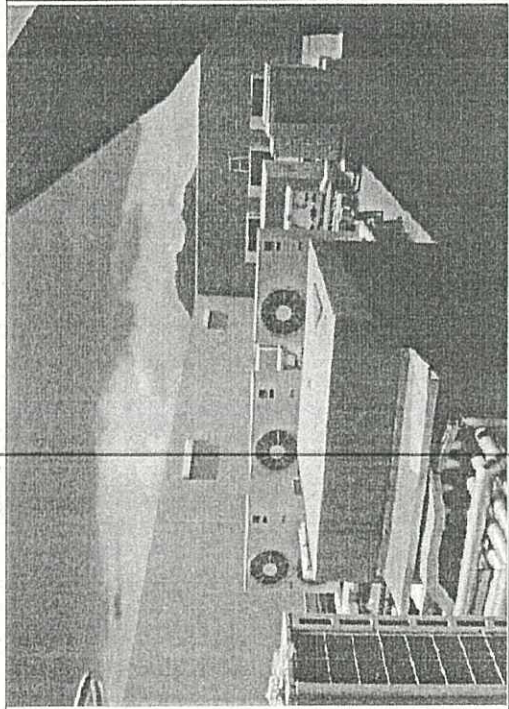
Photo 3.25: chiller system in form of air conditioning at the vent building of the north portal of Tai Lam Tunnel

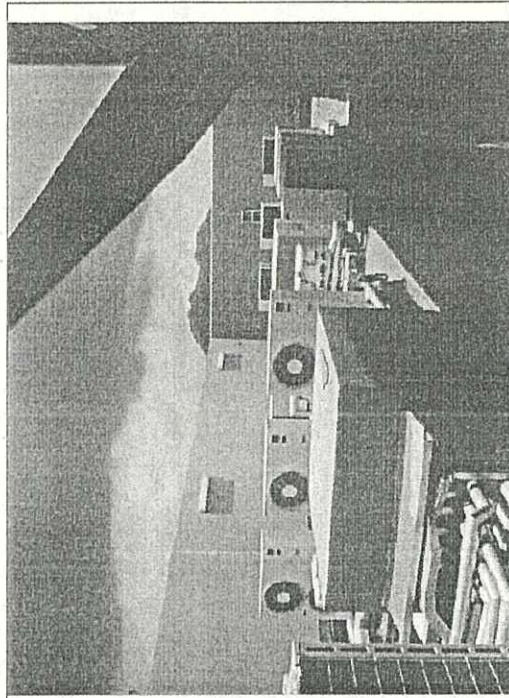
Photo 3.26: chiller system at the vent building of the Tai Lam Tunnel north portal

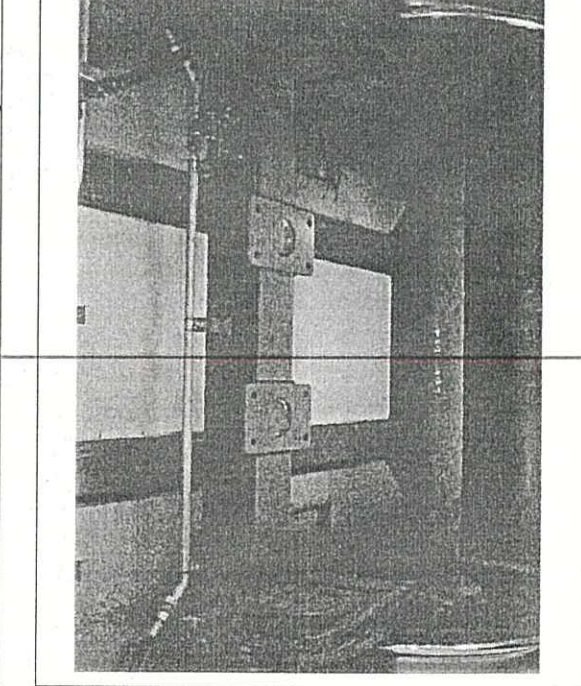
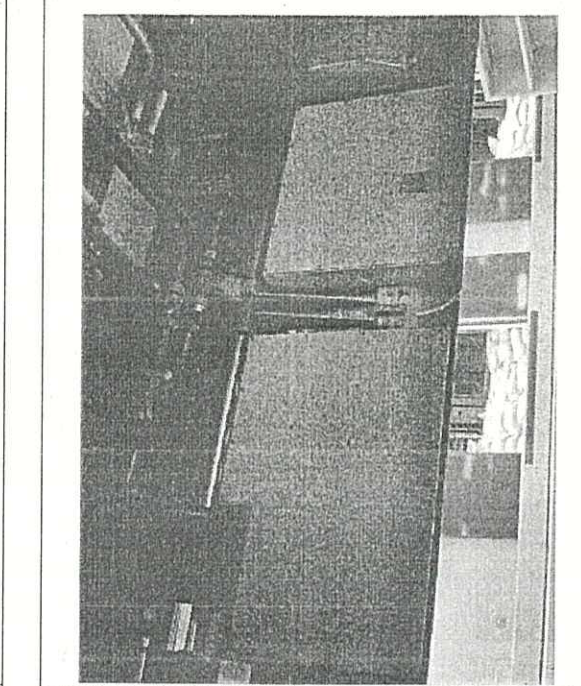
<p>Photo 4.19: Gap was Filled But Further Filling is Required to Completely Seal the Gap</p>	<p>Photo 4.20: Gap was Completely Filled with Acoustic Material</p>	<p>Photo 4.21: MPS on Twins Viaduct Approaching Yuen Long</p>

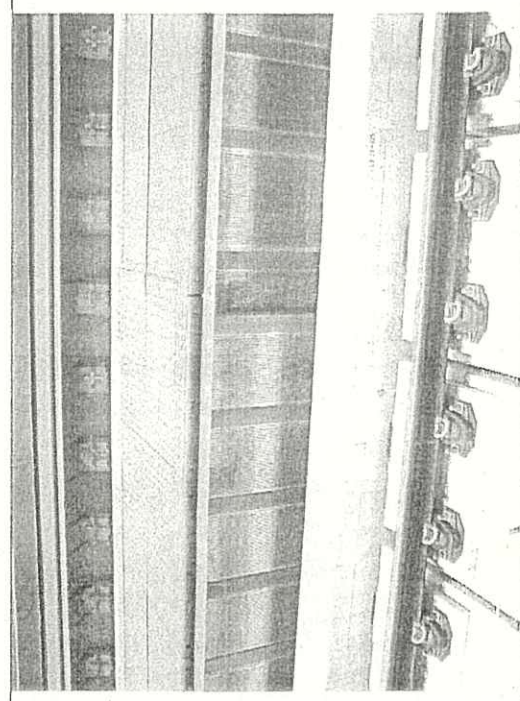
Photo 5.6: Gap was Filled at Central Plenum (U9 28+925)

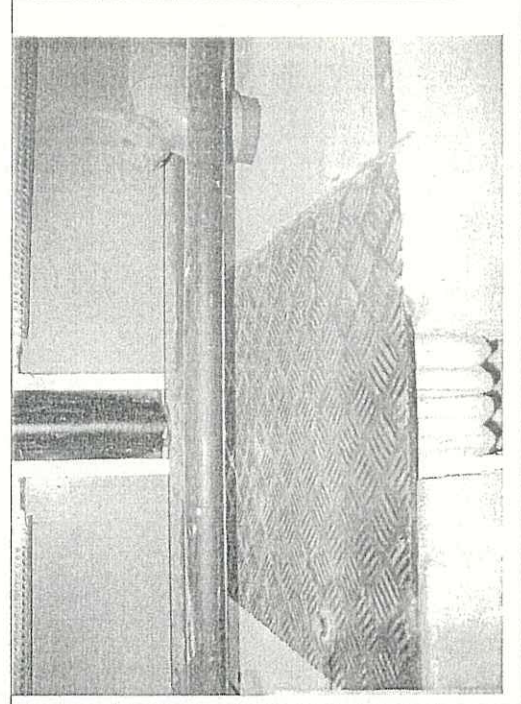
Photo 5.24: Gap was Filled Insider Enclosure (Side)

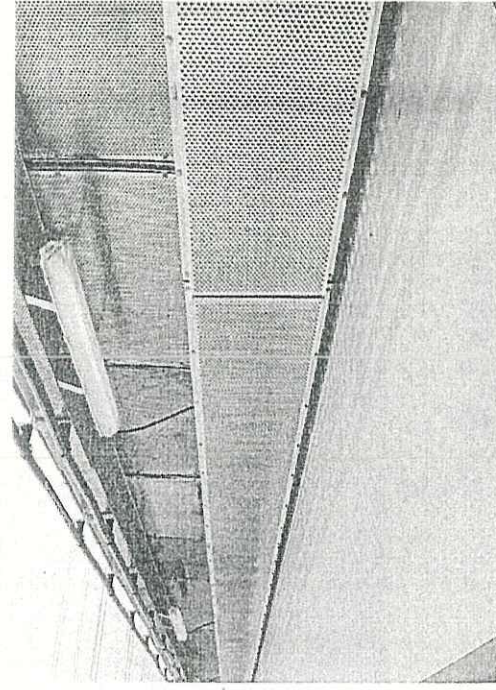
Photo 5.32: Acoustic Panels at CH35+218 was Repaired

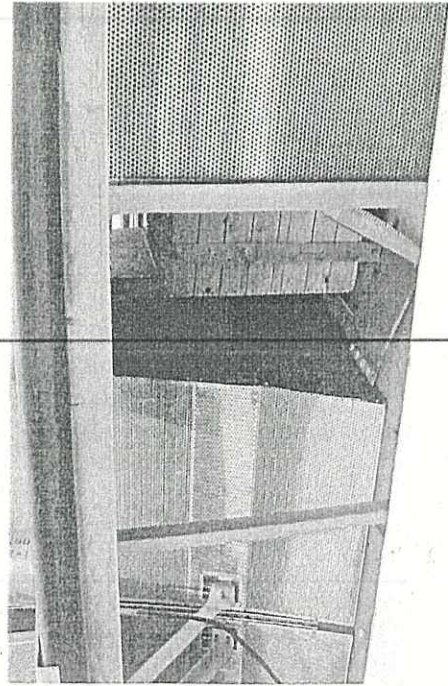
Photo 5.34: Gap observed at the Central Pleum near SIH at CH35+216

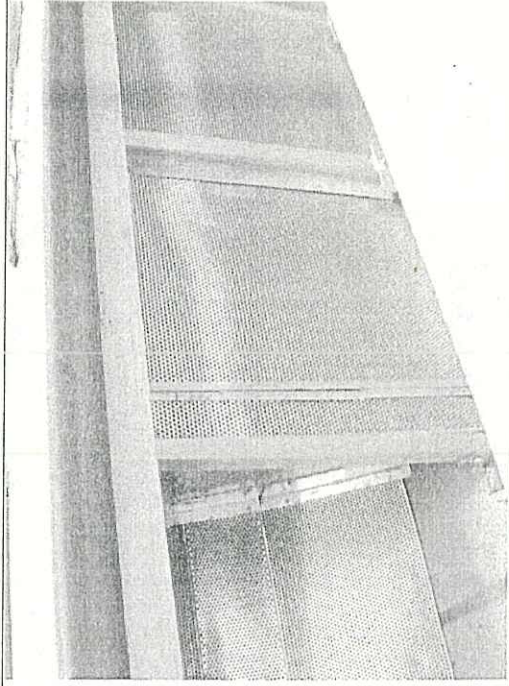
Photo 5.34: Acoustic Panel was installed at the Central Pleum near SIH at CH35+216

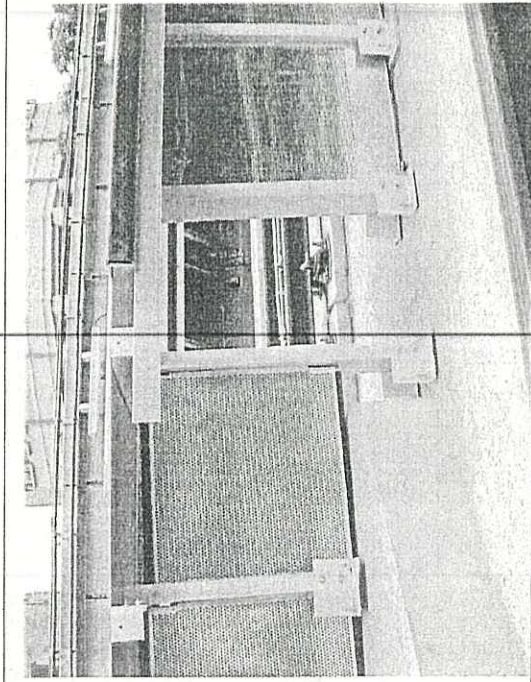
Photo 5.41: Hole Identified at Nosing bay CH36+965

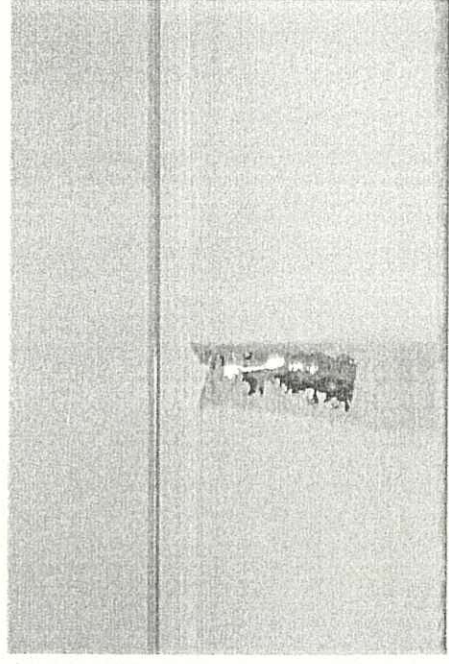
Photo 5.51: Some Sealant between the Parapet Walls was Damaged

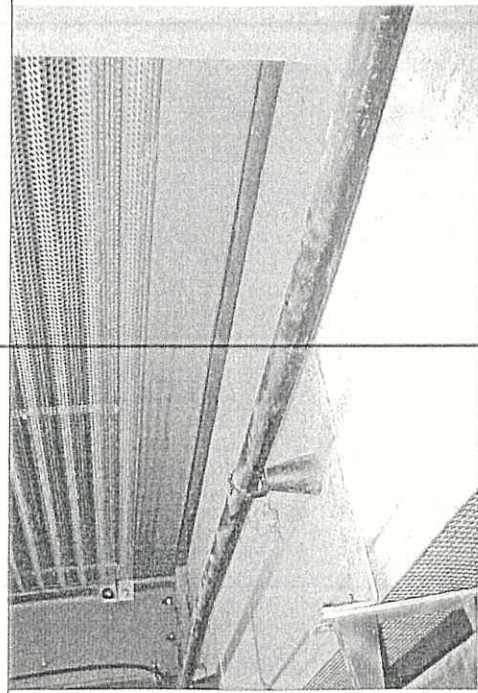
Photo 5.54: Gap was sealed
