Contract No. EP/SP/58/08

Sludge Treatment Facilities

**Environmental Monitoring and Audit Report
for
December 2010**

MaterialLab Ref No.: 100440EN101012

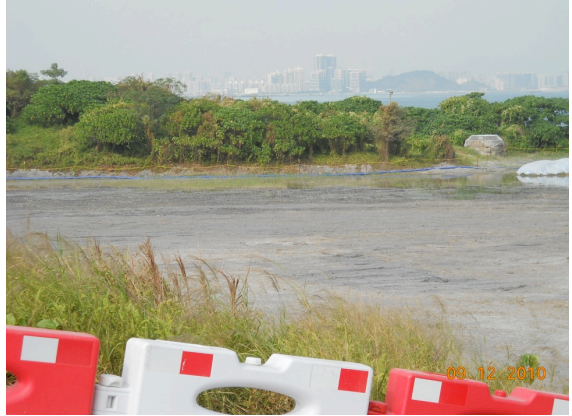
Topsoil found within the project site is PFA, which consist of heavy metals and toxic contaminants that it is not suitable to be re-used as soil mix for landscape softwork. Photographic record of topsoil is shown in Table 4.9.

<p data-bbox="188 837 762 902">Topsoil within the site was PFA, which is not suitable to be re-used in landscape softwork.</p>

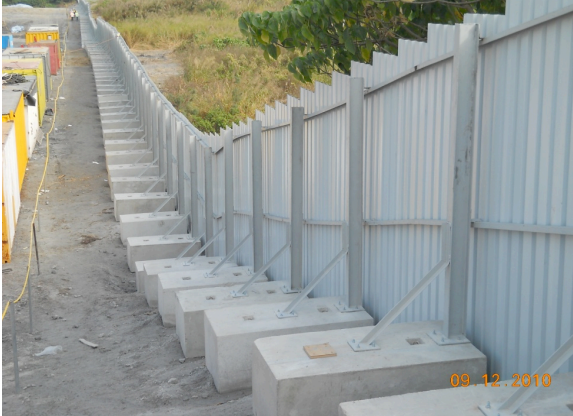
<p data-bbox="794 837 1369 902">Screen hoarding is being erected along the site boundary in December 2010.</p>
3. Photographic record of trees

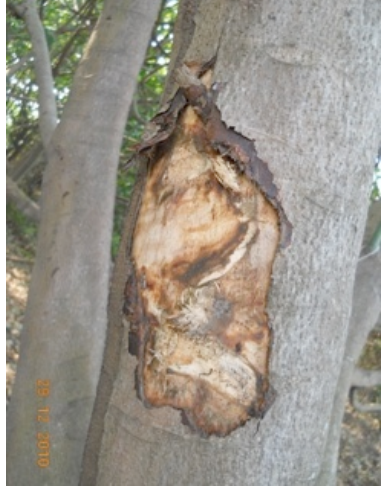
CM2 - Existing trees to be retained on site should be carefully protected during construction. In general the existing trees are being fenced off on site and they are in healthy condition. Only a few trees retained on site being found with wounds on the tree bark and branches. As the tree wounds are in general close to the trunk, tree compartmentalization would occur at the wound area, which would limit the spread of decay from the wound to the inner tissue, application of sealing compound is not required and considered not necessary as they cannot stop any decay activities. To avoid further damage on the existing tree, it is recommended to limit the construction activities outside the tree protection zone (dripline of the crown), or taking precaution measure to inspect and conduct minor pruning of tree crown, in particular in area with construction activities and traffic in the close vicinity. In addition, all pruning work should be supervised by landscape field officer to ensure the trees are properly pruned. Photographic records of some of the wounds on trees are shown in Table 4.9.

<p data-bbox="188 1442 571 1464">Wound on the bark.</p>

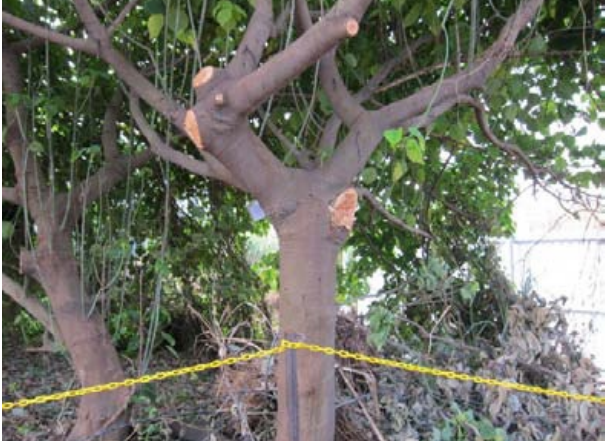
<p data-bbox="794 1397 1401 1464">Tree with minor pruning cut with irregular end</p>
