Contract No. EP/SP/58/08

Sludge Treatment Facilities

**Environmental Monitoring and Audit Report
for
February 2011**

Materialab Ref No.: 100440EN110259

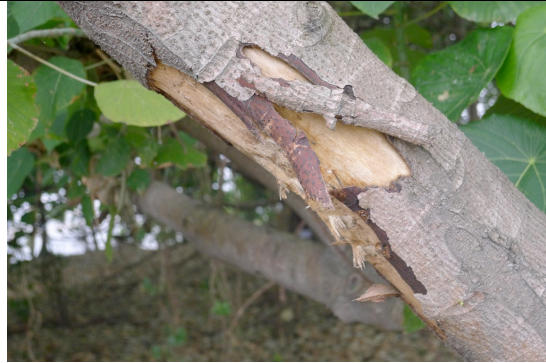
CM2 - Existing trees to be retained on site should be carefully protected during construction. In general the existing trees are being fenced off on site and they are in healthy condition. The few trees identified with hanging and broken branches have been pruned according to our comments. Some of the trees are found to be toppled naturally. To avoid further damage on the existing tree, it is recommended to limit the construction activities outside the tree protection zone (dripline of the crown), or taking precaution measure to inspect and conduct minor pruning of tree crown, in particular in area with construction activities and traffic in the close vicinity. In addition, all pruning work should be supervised by landscape field officer to ensure the trees are properly pruned. Photographic records of some of the wounds on trees are shown in Table 4.10.

Damaged bark is observed. To avoid further damage on the existing tree, it is recommended to limit the construction activities outside the tree protection zone

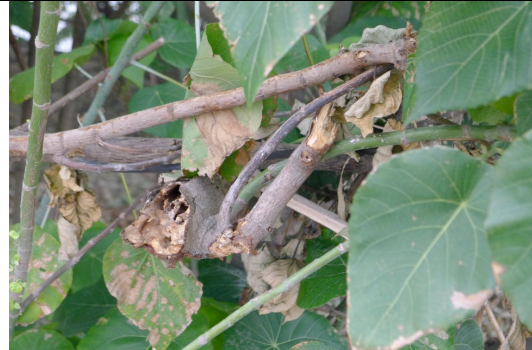
Hanging and broken branch need to be removed.

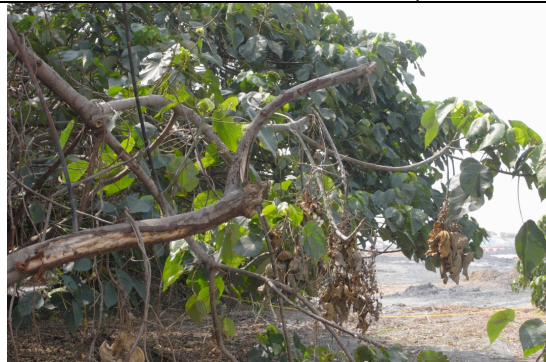
Hanging and broken branch need to be removed.

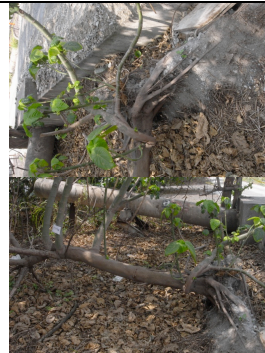
A tree is found to be toppled naturally.
