CONTRACT HY/2009/15

CENTRAL – WAN CHAI BYPASS TUNNEL (CAUSEWAY BAY TYPHOON SHELTER SECTION)

Landscape Plan

Submission Status: For Approval

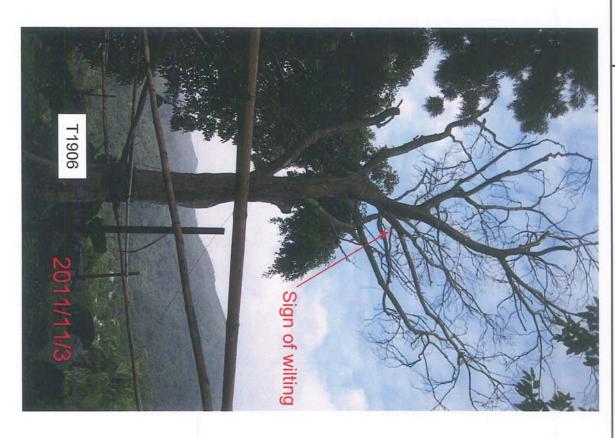
The photographical records are appended in Annex A. were both identified dead during our routine inspection for the month in November 2011. transplanted from Portion IV of the Site to the temporary holding nursery in Yuen Long, Pursuant to PS Clause 3.101(3)(b), we report that the trees T1906 and T1907,

- The trees grew near the seaside of the rocky embankment of the East Breakwater concrete and rock breaking around their root balls could not be avoided. holding nursery, they intended to grow unhealthily and became week gradually and process, we also found that the root balls were not intact attached with soil and before they were transplanted. died as a consequence hence no pruning works were done for the transplanting. After transplanted to the During the transplanting works in early 2011, During the
- 2 Referring to the specialist had already highlighted the following: Submission ref CCW/CSF/LDS/000037B dated 23 December 2010, our landscape Tree Survey Report submitted under cover of Contractor's
- (a) between rock. For tree No. T1906, the root system distorted due to confined growing space Preparation of root ball was unfeasible
- **b** transplanting.

For tree No. T1907, the root system distorted due to rock and limited root system coverage for stability.

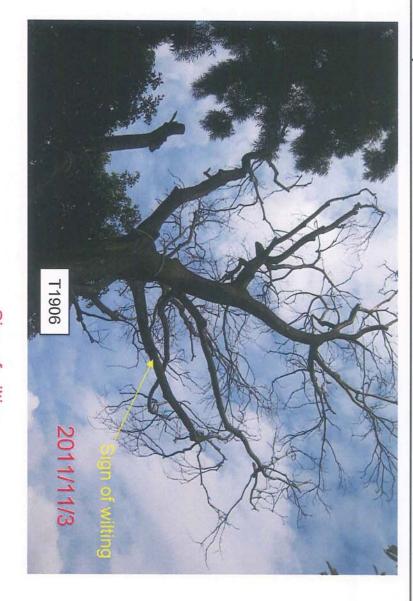
Sign of wilting

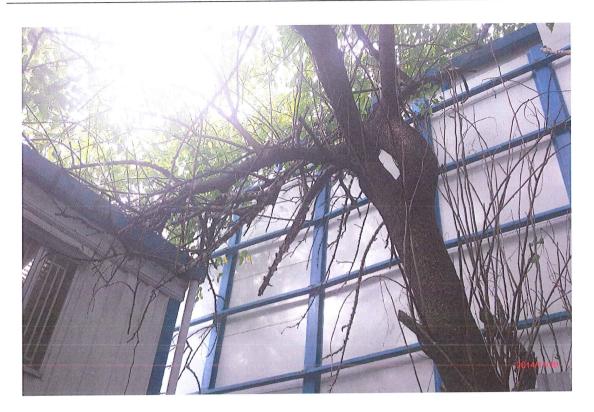
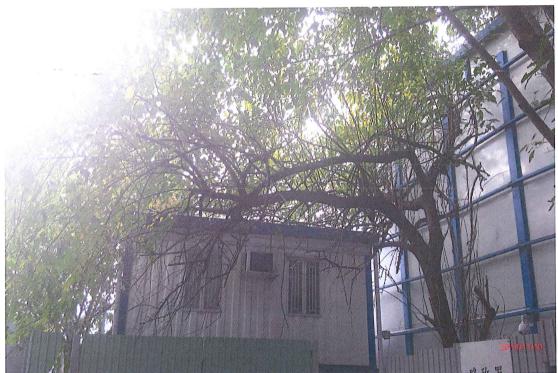
T1921:
Sign of
decay –
Minor
(Tree
condition
under close
observation)
