DECOMMISSIONING AND DISPOSAL OF CLINICAL WASTE INCINERATORS FOR THE REDEVELOPMENT OF QUEEN MARY HOSPITAL SITE AUDIT REPORT

SITE AUDIT REPORT

THE UNIVERSITY OF HONG KONG

DATE: 22 OCTOBER 2018

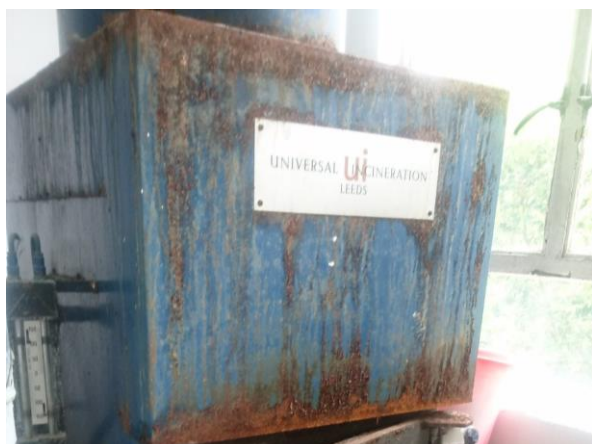
Figure 3.1 The incinerator at 5/F of UPB

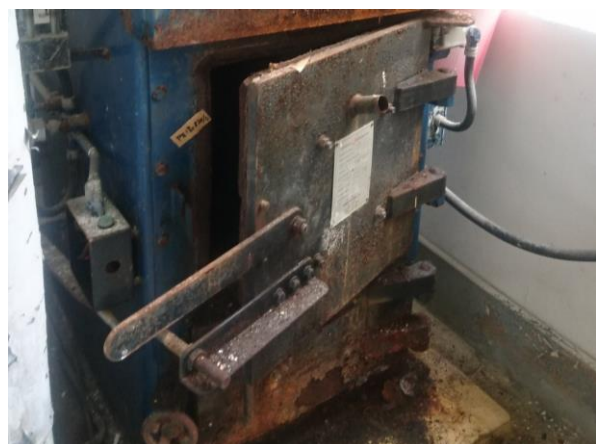
Figure 3.2 The incineration chamber door (top) and the bottom ash collection door (bottom) of the incinerator

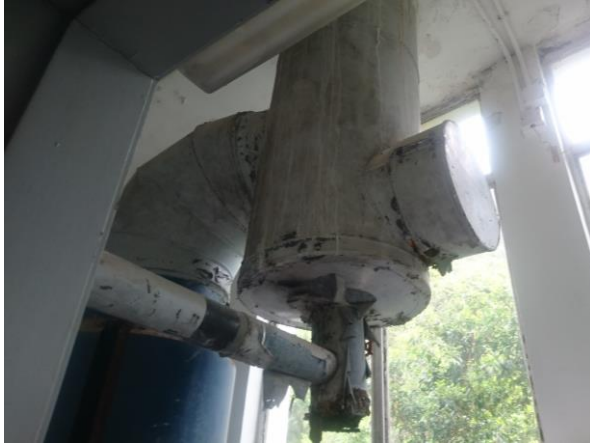
Figure 3.3 Chimney of the Incinerator

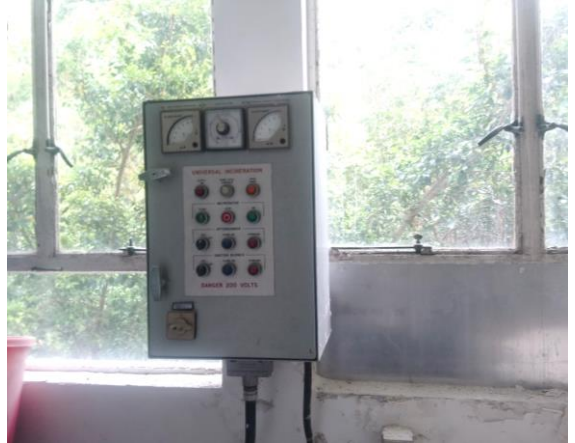
Figure 3.4 Wall-mounted control panel for the Incinerator

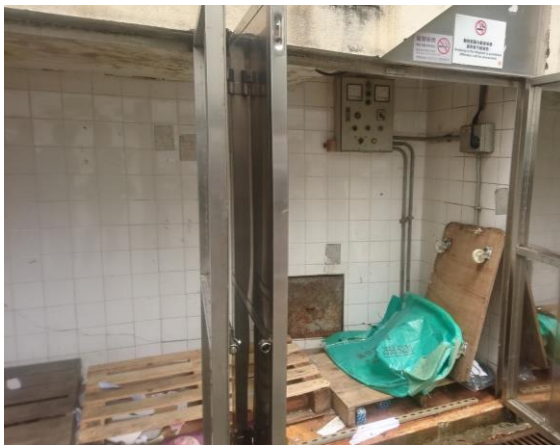
Figure 3.5 Area for refuse storage

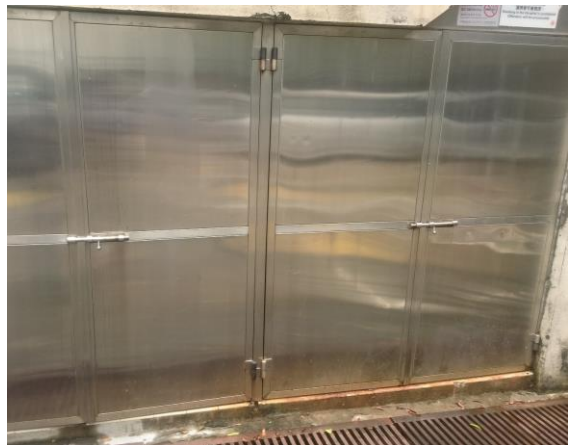
Figure 3.6 Area for refuse storage

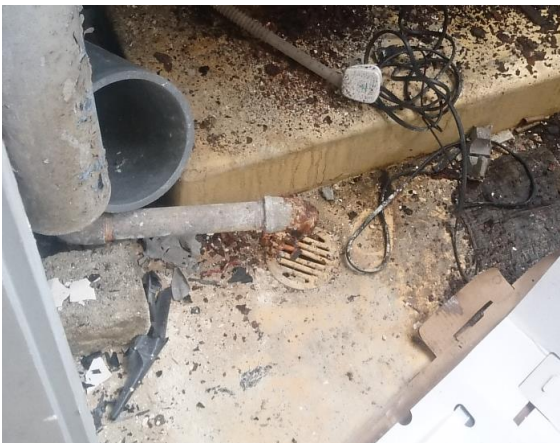
Figure 3.7 Drain to be sealed up at the Incinerator Room

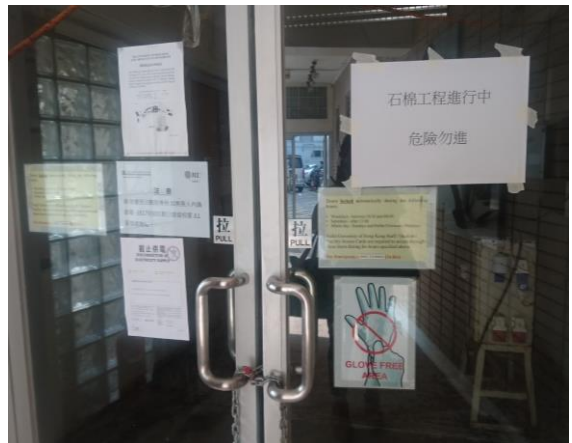
Figure 3.8 Lock is provided for the entrance of UPB

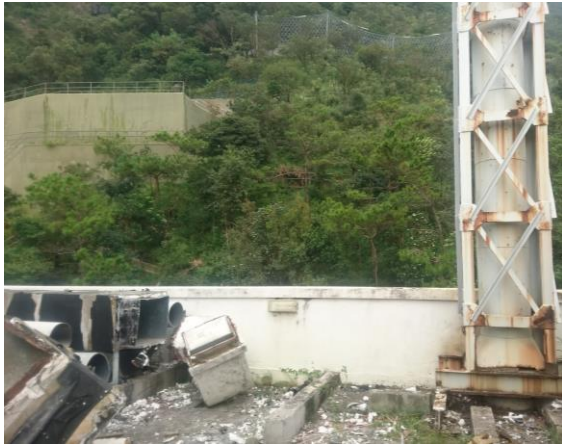
Figure 3.9 Ductworks in front of the chimney of the incinerator were removed

3.2.3 Ductworks in front of the chimney were removed to avoid obstructing work activities.

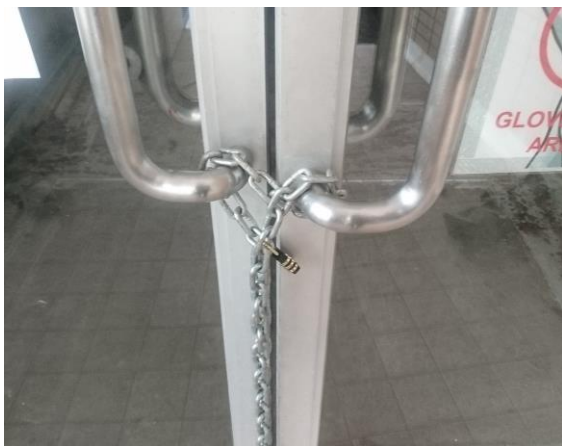
Figure 3.10 Entrance of the site is locked

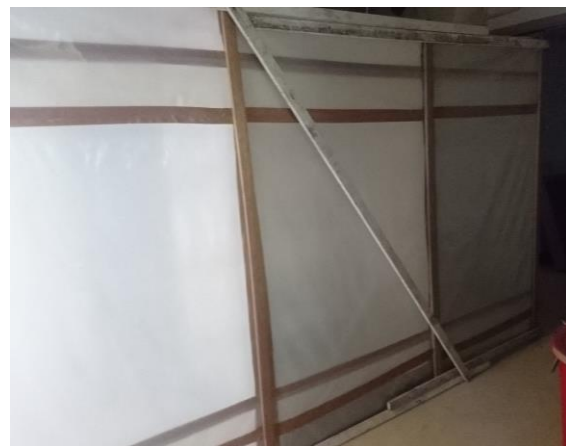
Figure 3.11 Three-compartment decontamination unit for entry and exit into the works area

- 3.2.5 Two temporary structures were built at the Incinerator Room to enclose the incinerator units and at the Rooftop to enclose the associated chimney. Two three-compartment decontamination units were constructed for entry and exit in to the works areas at 5/F and Rooftop.

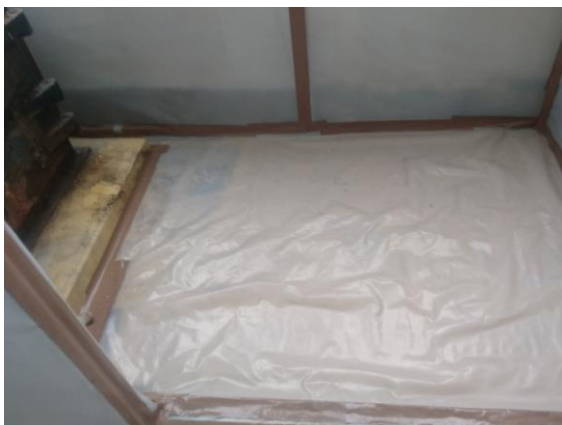
Figure 3.12 Overview of the Incinerator Room

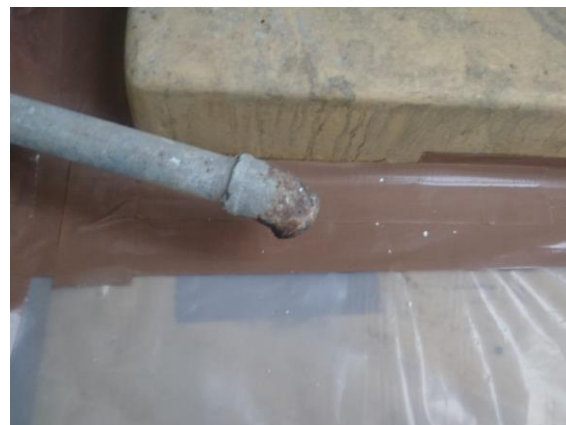
Figure 3.13 Sealed drain

- 3.2.4 The floor drain in the incinerator room was covered with a temporary seal. All openings were sealed with three-layers of fire retardant polythene sheets.

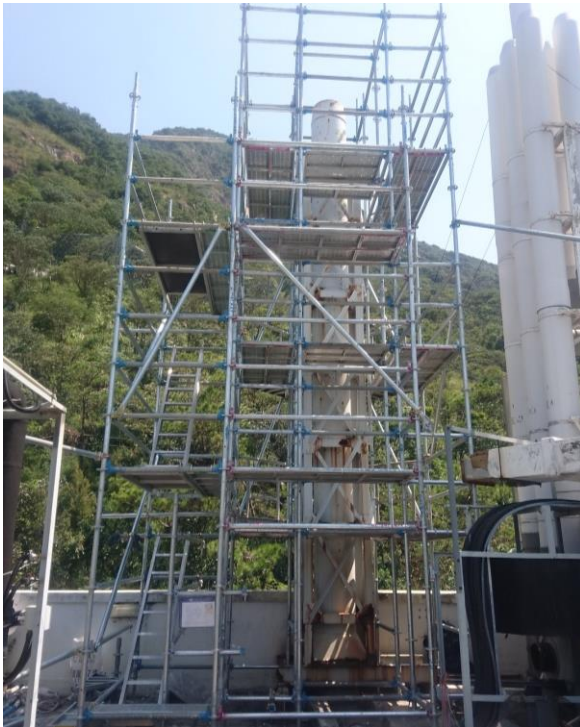
Figure 3.14 Scaffold at the Rooftop

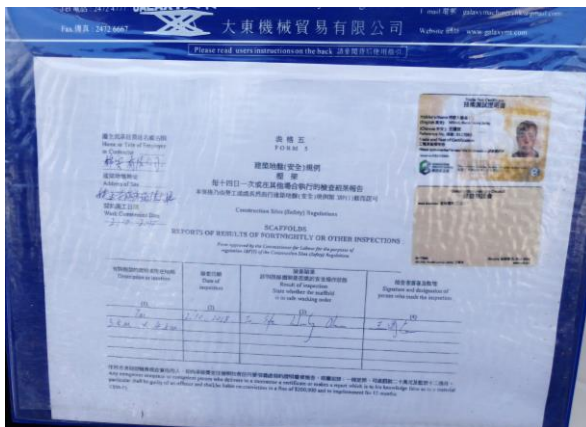
Figure 3.15 Inspection record for the scaffold

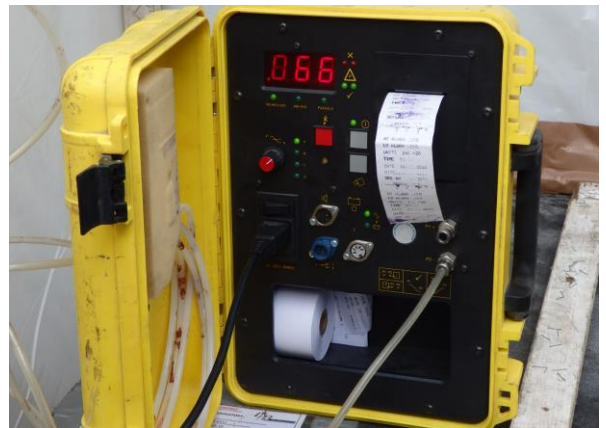
Figure 3.16 Smoke test was conducted for the containment at Rooftop

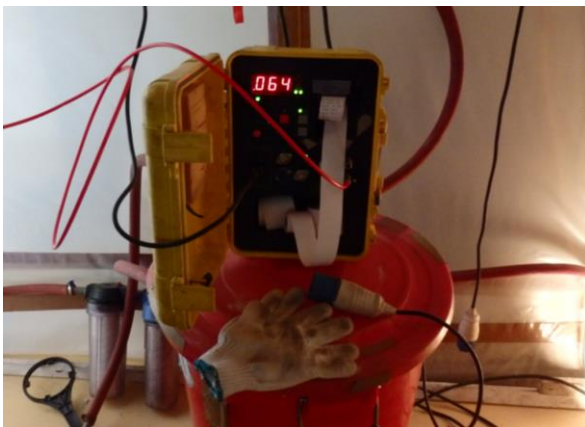
Figure 3.17 Smoke test was conducted for the containment at 5/F

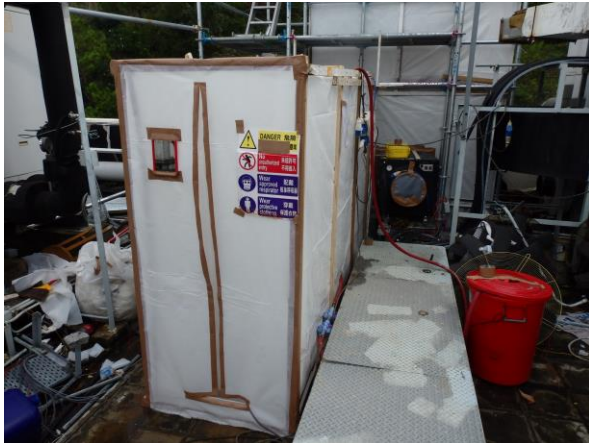
Figure 3.18 Three-compartment decontamination unit for entry and exit into the works area at Rooftop

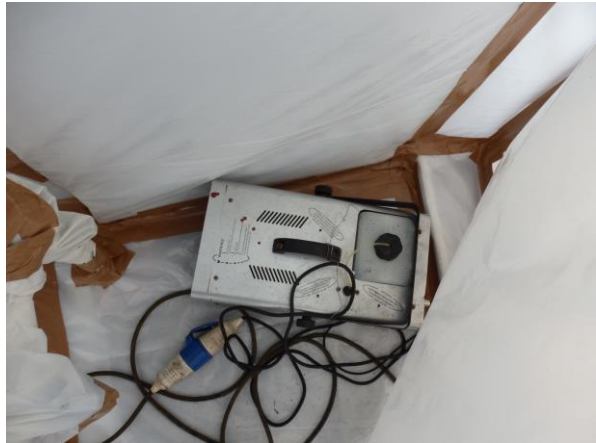
Figure 3.19 Smoke generator used for the smoke test at the containment of Rooftop

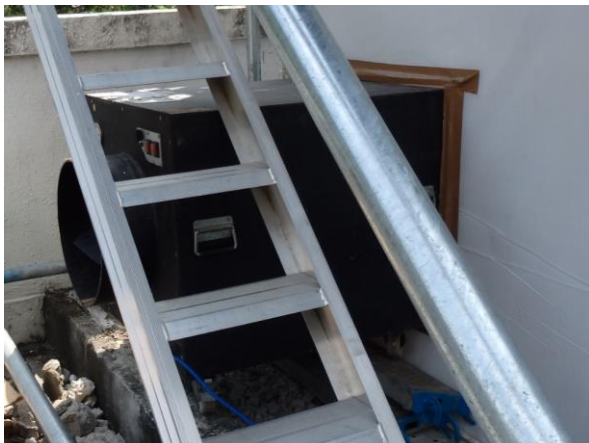
Figure 3.20 Air mover for the works area at Rooftop

- 3.2.7 Air movers were installed at the works areas of 5/F and Rooftop to exhaust air from the works area. Stand-by air movers were also installed.
- 3.2.8 Two smoke tests were carried out on 8 October 2018 and 9 October 2018 with non-toxic smoke to ensure the tightness of the containment and to check whether there are any stagnant pockets of air.

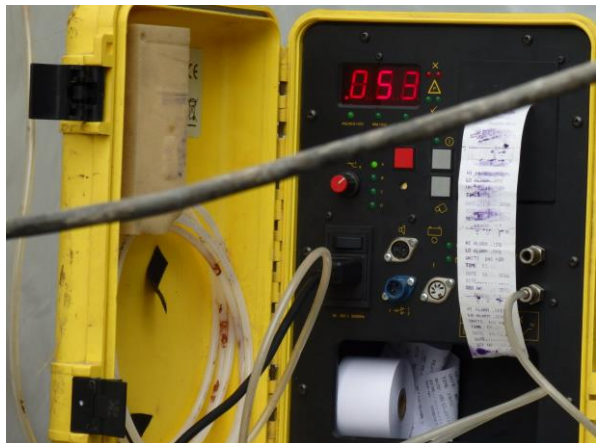
Figure 3.21 Pressure monitor used for the smoke test at Rooftop with audible alarm and records printing out

- 3.2.9 After a successful test, air mover was switched on to exhaust smoke from the containment, and to visually check that the absolute filters screen out the smoke effectively and that the pressure gauges read normal. The pressure was kept within the normal range from 0.05 to 0.15 inch of water (negative pressure). The audible alarm's integrity was ensured with the trigger level of 0.05 inch of water (negative pressure).

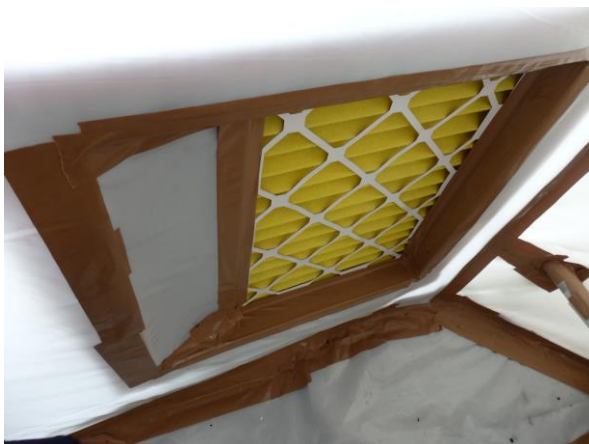
Figure 3.22 Filters of the air mover at Rooftop

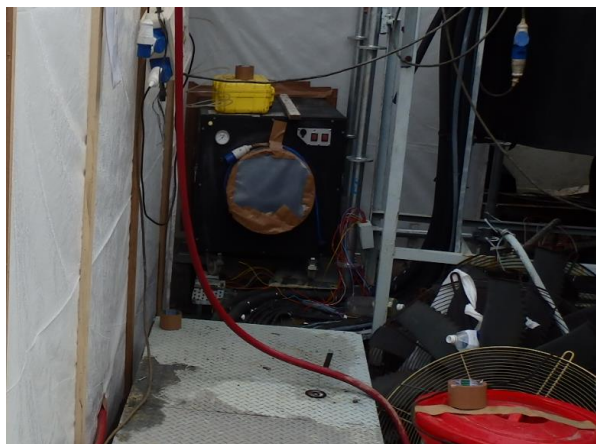
Figure 3.23 Stand-by air mover for the works area at Rooftop

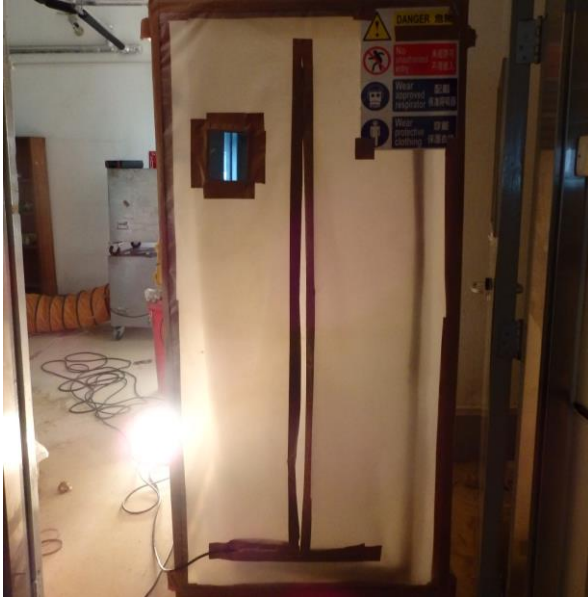
Figure 3.24 Three-compartment decontamination unit for entry and exit into the works area at 5/F

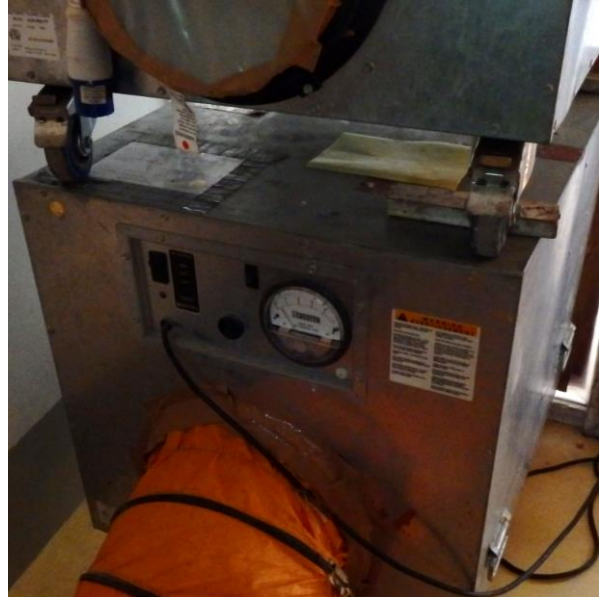
Figure 3.25 Air movers for the works area at 5/F

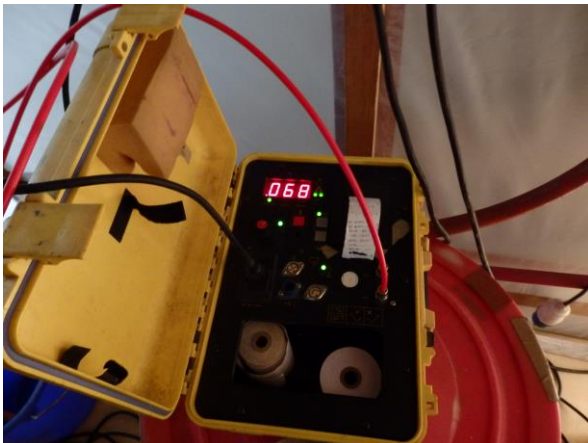
Figure 3.26 Pressure monitor used for the smoke test at 5/F with audible alarm and records printing out

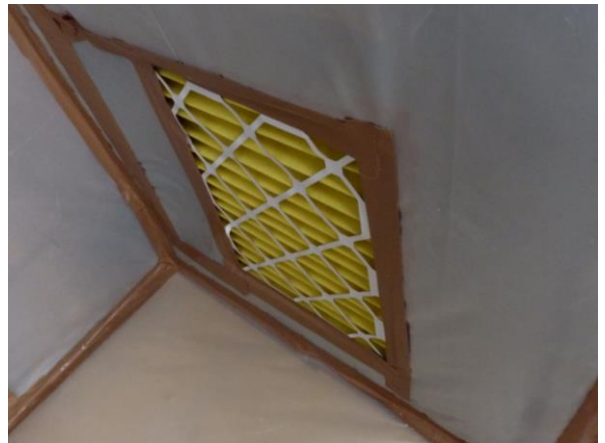
Figure 3.27 Filters of the air mover at 5/F

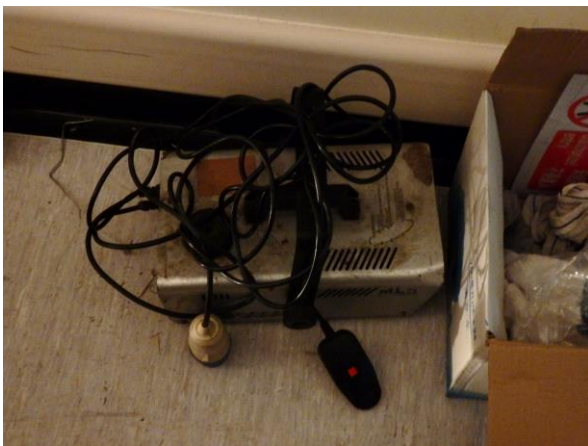
Figure 3.28 Smoke generator used for the smoke test at 5/F Incinerator Room

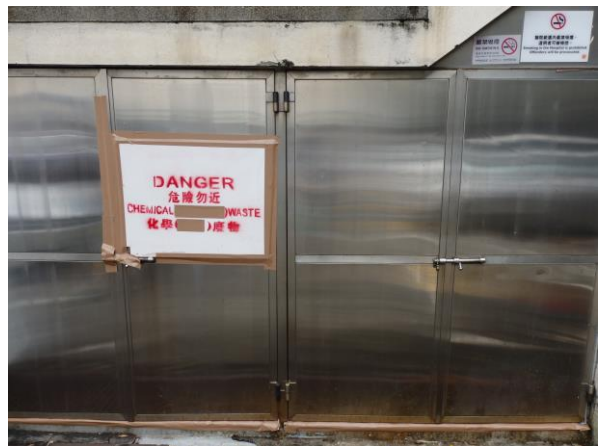
Figure 3.29 Lock is provided for the refuse storage area

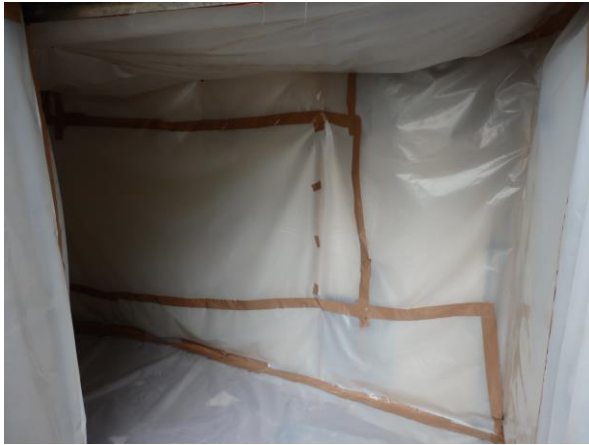
Figure 3.30 Refuse storage area

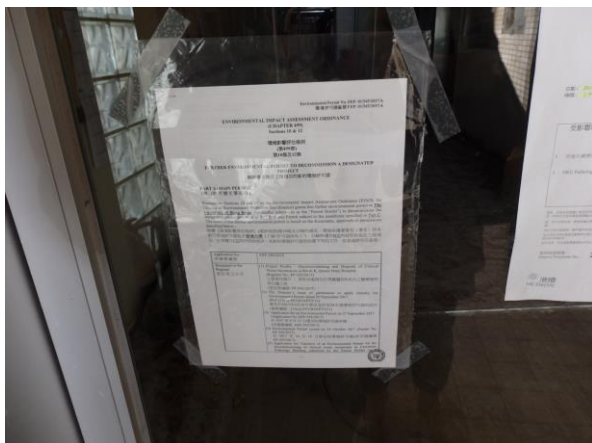
Figure 4.1 Copy of Further Environmental Permit is provided in conspicuous locations at the Project Site

- 4.2.2 Environmental and safety notices, copies of the environmental permit, as well as warning signs were provided in conspicuous locations at the entrance of the works areas.
- 4.2.3 Steel framework and outer steel shell of the chimney were cut to smaller pieces for recycling.

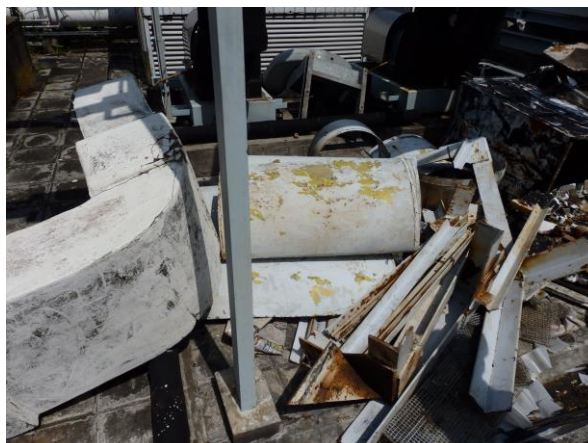
Figure 4.2 Steel framework and outer steel shell were cut to smaller pieces

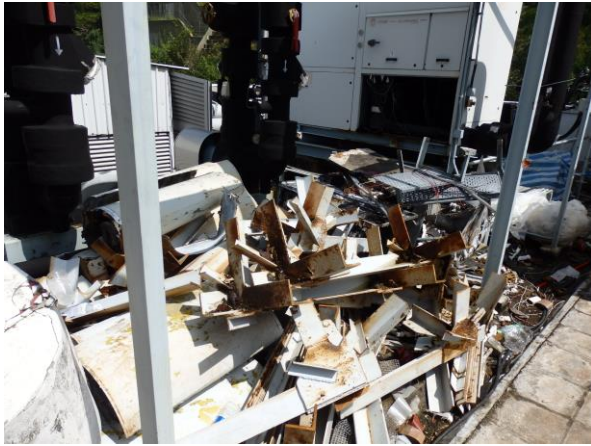
Figure 4.3 Steel framework and outer steel shell were cut to smaller pieces

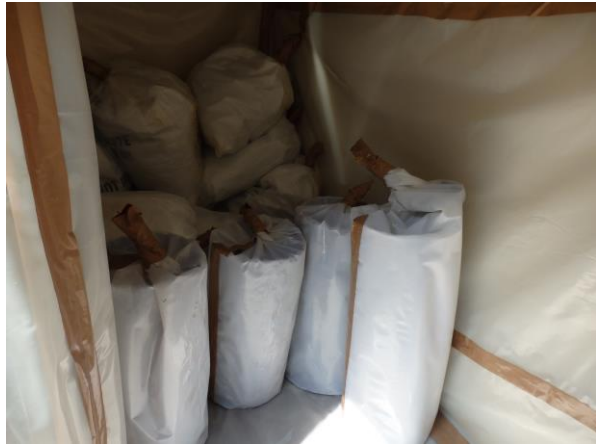
Figure 4.4 Dismantled chimney stored at the locked refuse storage area

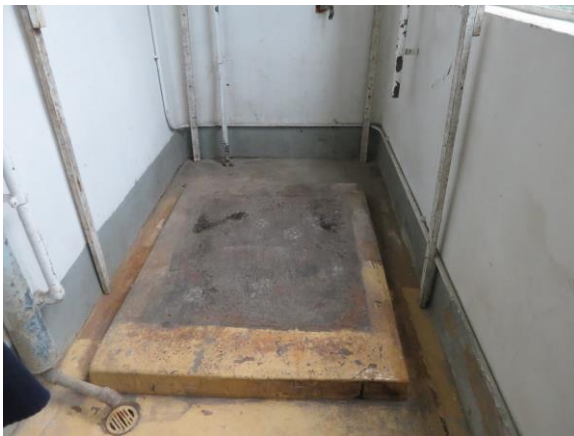
Figure 5.1 Demolition of incinerator was completed

- 5.2.4 The residual ash inside the incinerator was removed by scrabbling. All inner walls of incinerator were cleaned using a High Efficiency Particulate Air (HEPA) vacuum cleaner and the wet wipes. The scrabbled material and the filtered materials from the HEPA vacuum cleaner were packed on site. The residual ash would be stored in polythene-lined steel drums provided by the Chemical Waste Treatment Centre (CWTC) for collection by licensed waste collector monitored by the Trip Ticket System and disposal of at the designated treatment facility.

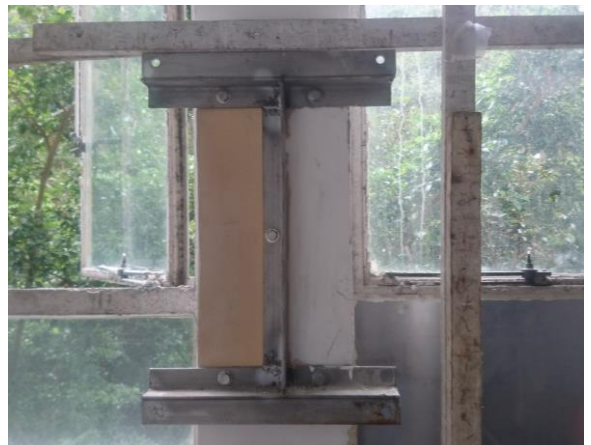
Figure 5.2 Wall-mounted control panel for incinerator was demolished

- 5.2.9 Steel framework and outer steel shell of the chimney and the wall-mounted control panel of the incinerator were segregated from the chemical waste for collection by recycler.
- 5.2.10 Based on the findings of the site audit during the reporting period, the overall EM&A performance of the Project is satisfactory.

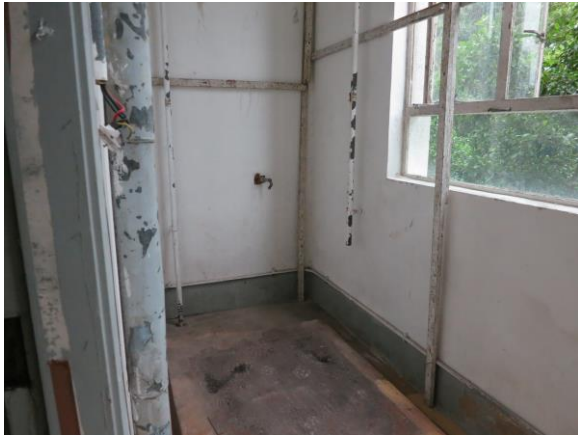
Figure 5.3 View of Incinerator Room

- 5.2.6 Following the completion of the demolition work, all surfaces in the incinerator room were decontaminated by HEPA vacuuming and wet wiping. Then the innermost polythene sheet was sprayed with Polyvinyl Alcohol (PVA) and upon drying, the inner polythene sheet was peeled off. The PVA decontamination process was repeated for the second and third layers of the polythene sheets.

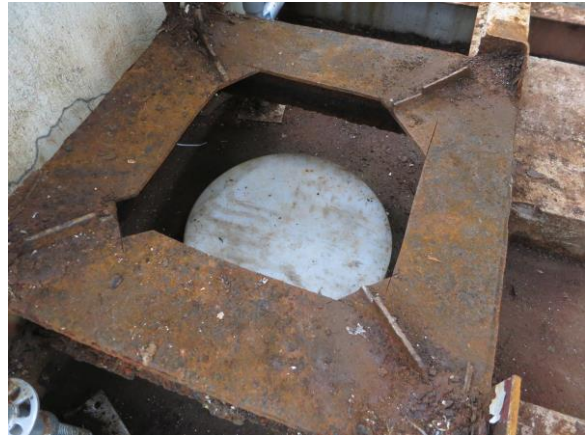
Figure 5.4 Demolition of the associated chimney of the incinerator was completed

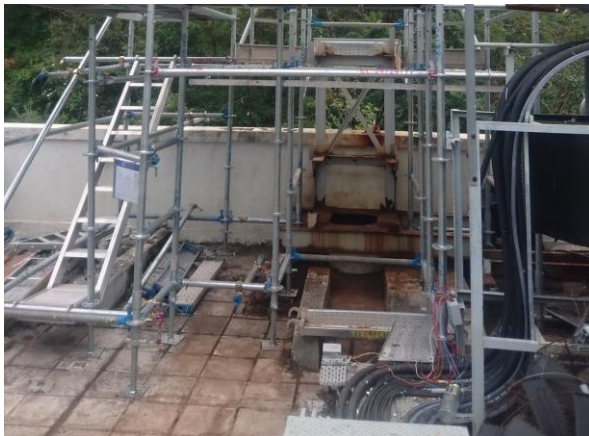
Figure 5.5 View of Rooftop

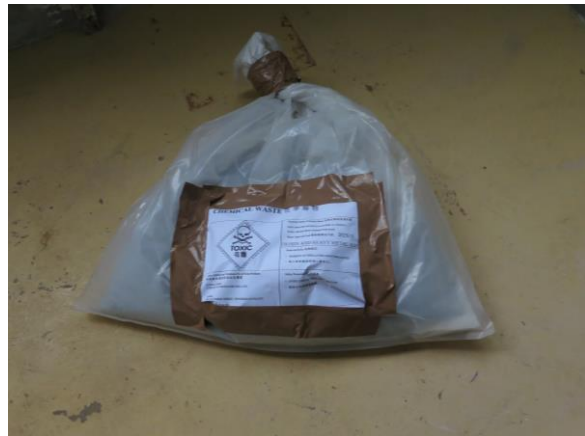
Figure 5.6 Chemical waste to be disposed of at Chemical Waste Treatment Centre

- 5.2.7 EPD's Direction for Disposal under Section 17 of Waste Disposal Ordinance was obtained prior to the disposal of the chemical waste (**Appendix A**).

chimney, polythene wrapping sheets, used PPE, waste generated from the dismantling work of the containment and cloths used for wet wiping were properly stored for collection and disposal by licensed waste collector monitored by the Trip Ticket System.
