**CONTRACT NO. DC/2006/15 BUILDING AND
CIVIL MAINTENANCE AND MINOR WORKS OF
DSD PLANTS AND FACILITIES (2007-2009)**

**GROUNDWATER MONITORING AT
NGONG PING STW AND EFFLUENT EXPORT
PIPE**

MONTHLY EM&A REPORT

(OCTOBER 2007)

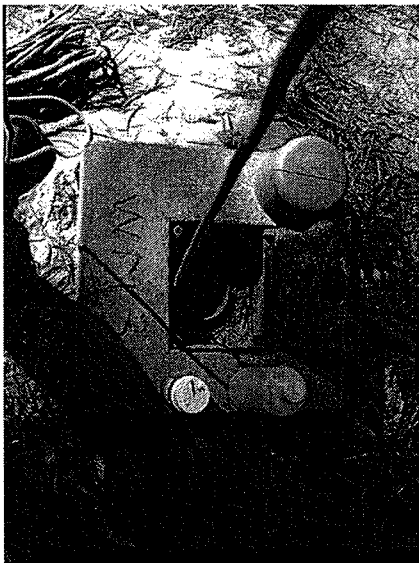
Remark (if any) : The tests marked with "*" indicated the tests were sub-contract to ALS Technichem (HK) Pty Ltd and HOKLAS accredited. Ground water monitoring was only carried out at Borehole WM3 only since other boreholes were observed to be dry during the monitoring.
