**Landslide Preventive Works at Po Shan Road,
Mid-Levels – Design and Construction
(Natural Terrain Risk Mitigation Works)**

**Monthly Operation Phase Landscape and
Visual Audit Report No. 6**

June 2010

Monthly Inspection Report No. 06

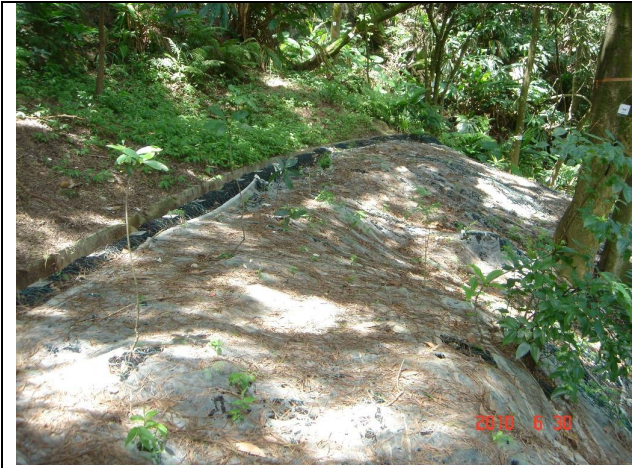
Photo 1

- Typical site inspection photos of the hydroseeded grass and plants under establishment were enclosed under Appendix-B.
- It was generally observed that the shrubs and palm trees under establishment were found to be in healthy conditions and well established (Photos 1 to 6 refers).
