**Landslide Preventive Works at Po Shan Road,
Mid-Levels – Design and Construction
(Natural Terrain Risk Mitigation Works)****Monthly Operation Phase Landscape and
Visual Audit Report No. 7**

July 2010

**Re: Agreement No. CE28/2004 (GE)
Landslide Preventive Works at Po Shan, Mid-levels
Monthly Inspection Report (July 2010)
for Landscape & Visual Audit and Monitoring**

Monthly Inspection Report No. 07
(July 2010)

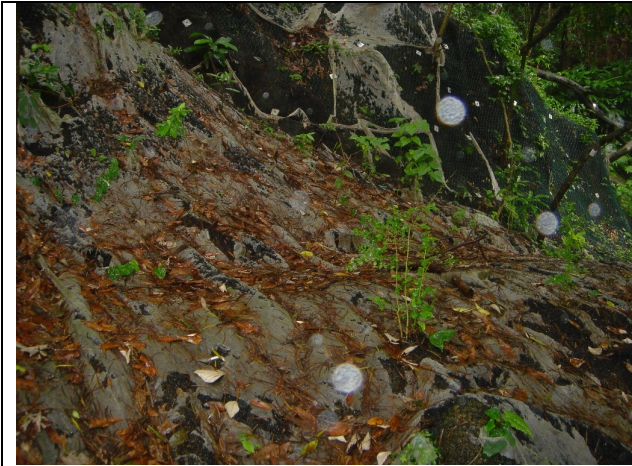
Photo 1

- Typical site inspection photos of the hydroseeded grass and plants under establishment were enclosed under Appendix-B.
- It was noted that overgrown weeds had affected the shrubs at location as shown on Photo 3. The Contractor was requested to carry out weeding to ensure the healthy growth of the shrubs.
- It was generally observed that the shrubs and palm trees under establishment were found to be in healthy conditions and well established (Photos 1 to 6 refers).
