**Landslide Preventive Works at Po Shan Road,  
Mid-Levels – Design and Construction  
(Natural Terrain Risk Mitigation Works)**

**Monthly Operation Phase Landscape and  
Visual Audit Report No. 8**

**Monthly Inspection Report No. 08**

**(August 2010)**

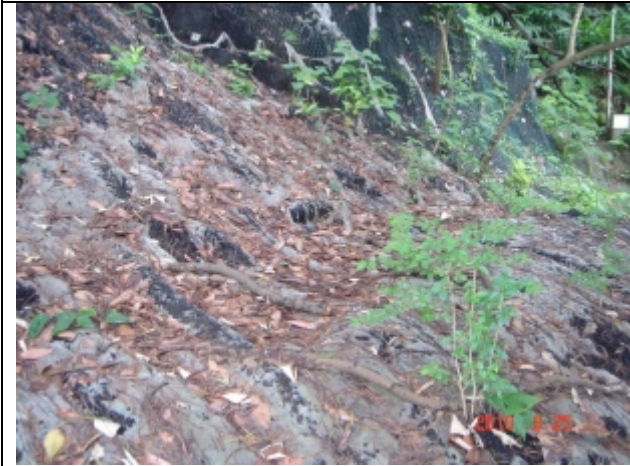
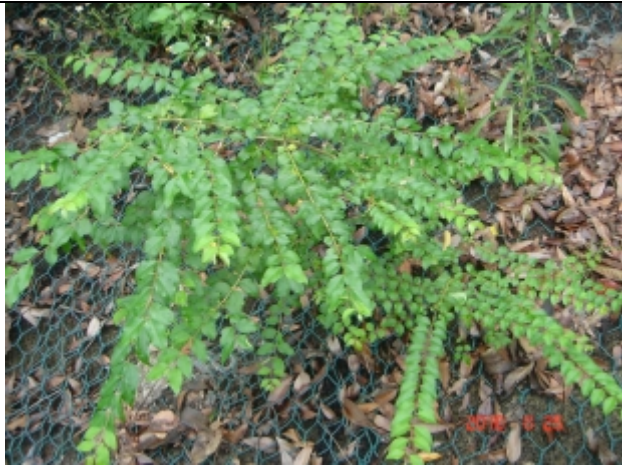
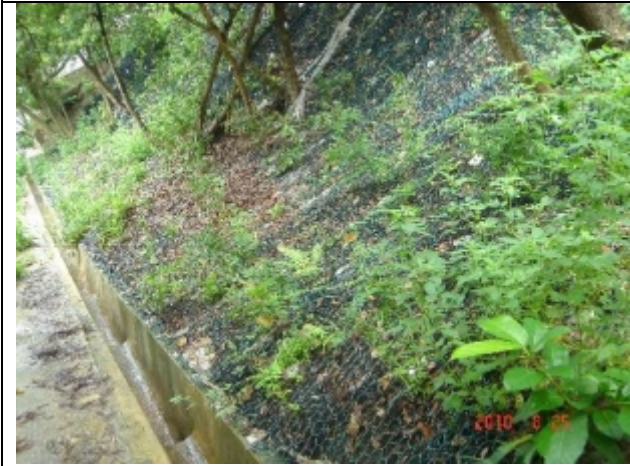
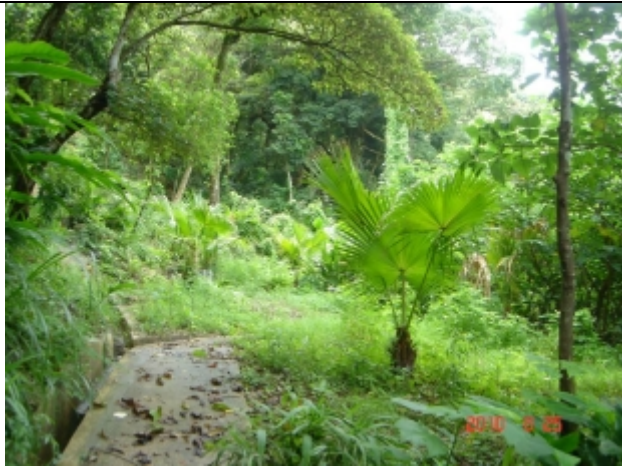
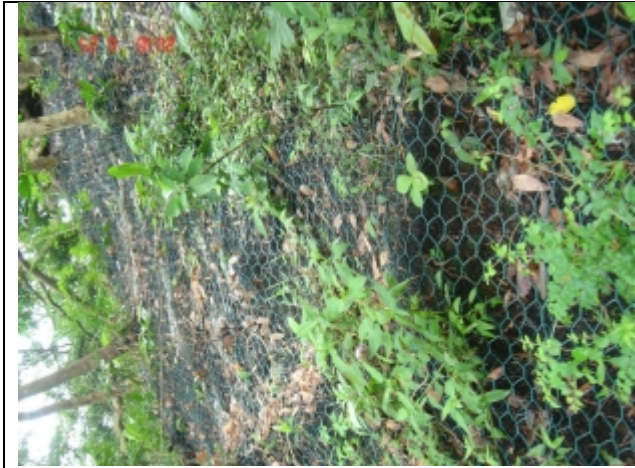
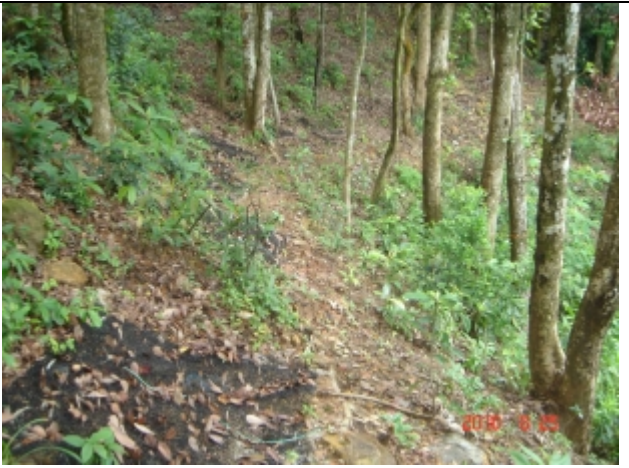
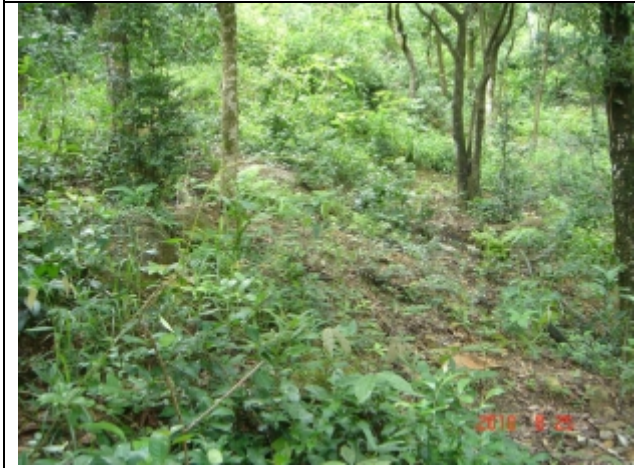
- It was observed that no weeding works was carried out as identified at the last site inspection with the weeds now found grown taller than the plants which would have an affect on its growth. The Contractor was requested to urgently carry out weeding works, which should be done manually in order not to accidentally cut off the plants (Photo 1 refers).
- It was observed that condition of one of the palm trees had deteriorated, with the fronds turned yellow. The Contractor is required to apply fertilizer and watering of the palm to improve its condition (Photo 2 refers).
- The shrubs and other palm trees under establishment were generally observed to be healthy and well established. Please refer to typical site inspection photos 3 to 9 enclosed under Appendix-B.

- The Contractor was recommended to carry out weeding to slope area where overgrown weeds had affected the healthy growth of shrubs.
- The Contractor was recommended to carry out fertilizing of the palm trees and provide regular watering to ensure healthy growth of the plants.
