**Landslide Preventive Works at Po Shan Road,
Mid-Levels – Design and Construction
(Natural Terrain Risk Mitigation Works)**

**Monthly Operation Phase Landscape and
Visual Audit Report No. 9**

September 2010

Monthly Inspection Report No. 09

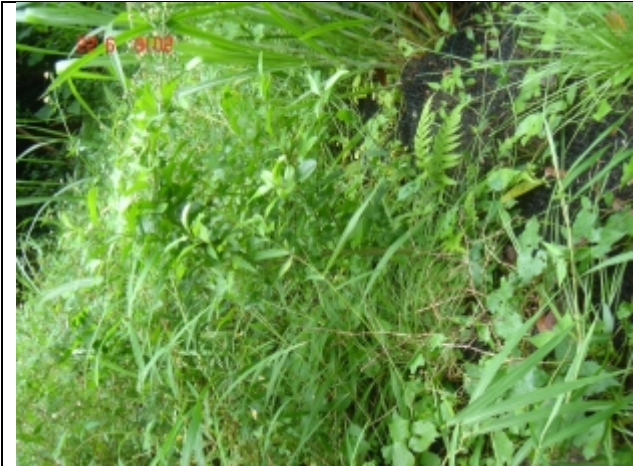
Photo 1

- The Contractor had carried out some weeding works around some of the shrubs (Photo 1 refers). However, the overgrown weed condition was still observed and the Contractor was again reminded to carry out further weeding in order to minimize affect on the growth of plants. (Photo 2 refers).
- The condition of one of the palm trees had seriously deteriorated, with all the fronds turned yellow and wilted, including leading shoots die back. Replacement of the palm tree is required. (Photo 3 refers).

- The Contractor was recommended to carry out weeding to slope area where overgrown weeds had affected the healthy growth of shrubs.
- The Contractor was recommended to carry out replacement of the palm tree found in poor condition and provides regular watering to ensure its healthy growth and establishment.

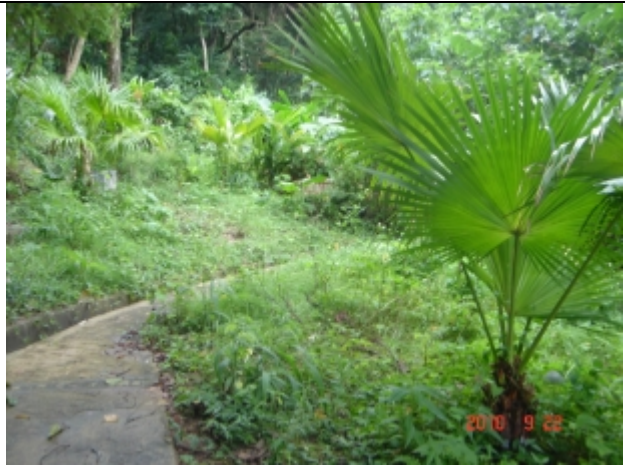
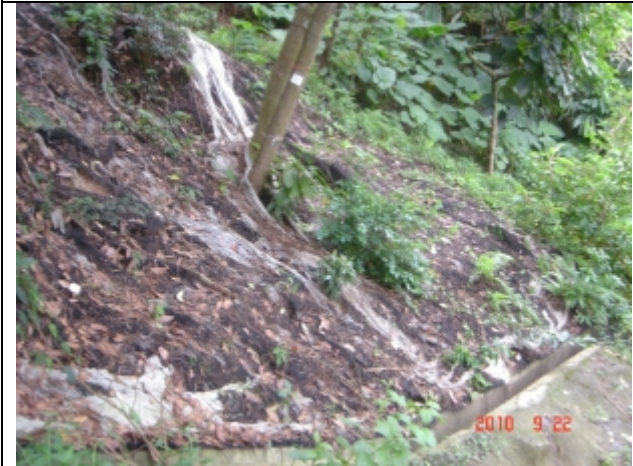
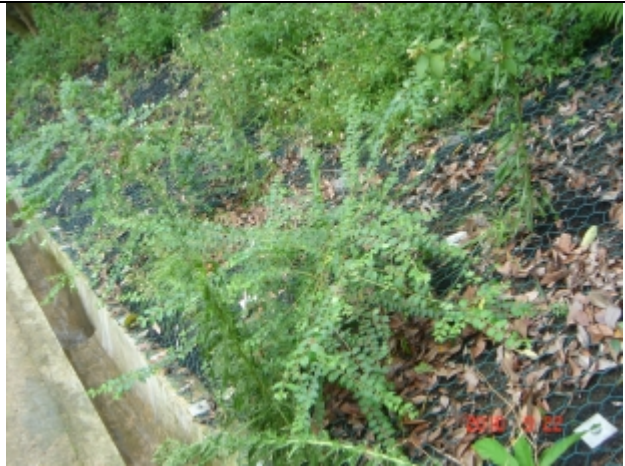
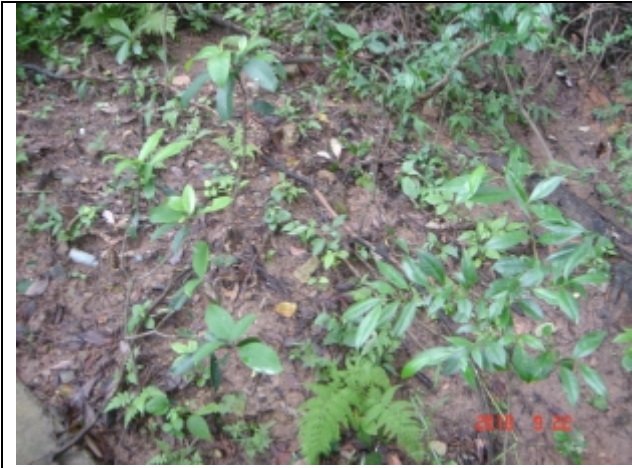
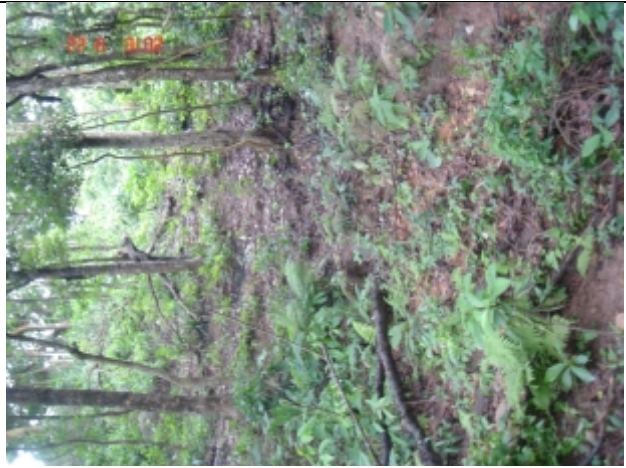
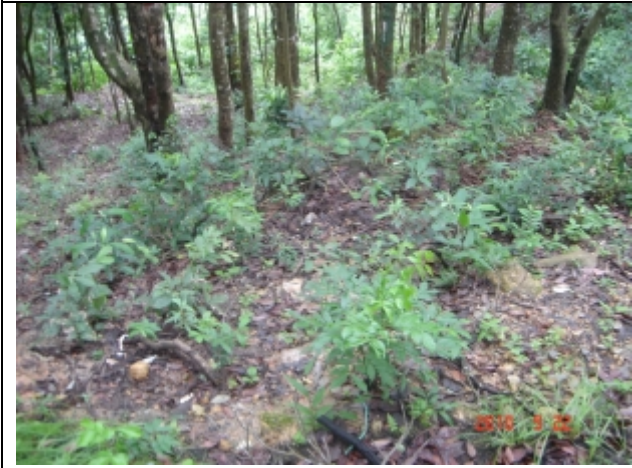
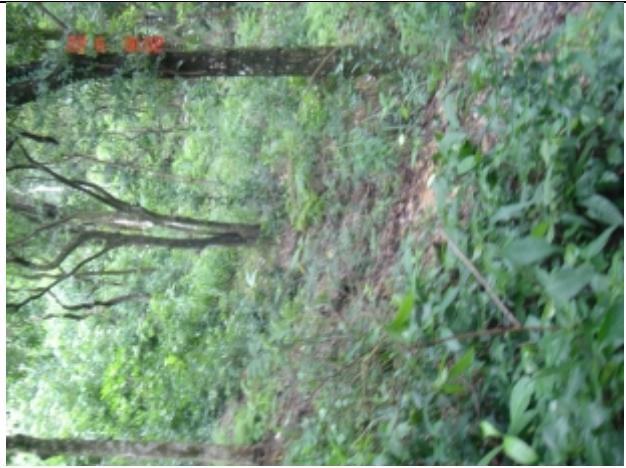
- The shrubs and other palm trees under establishment were generally observed to be healthy and well established. Please refer to typical site inspection photos 4 to 10 enclosed under Appendix-B.
