CE 28/2004 (GE)

**Landslide Preventive Works at Po Shan Road,
Mid-Levels – Design and Construction
(Natural Terrain Risk Mitigation Works)****Monthly Operation Phase Landscape and
Visual Audit Report No. 10**

October 2010

Monthly Inspection Report No. 10
(October 2010)

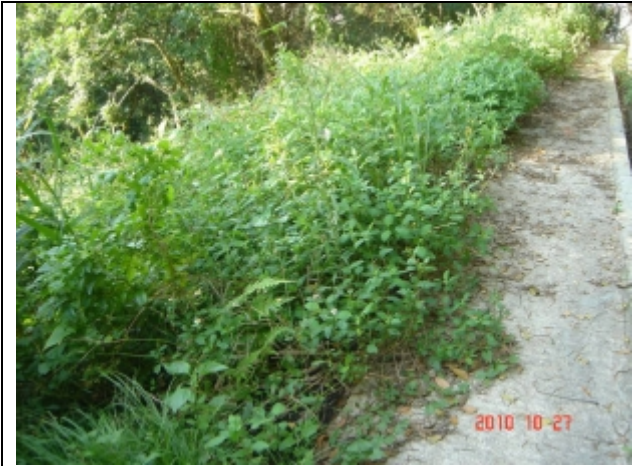
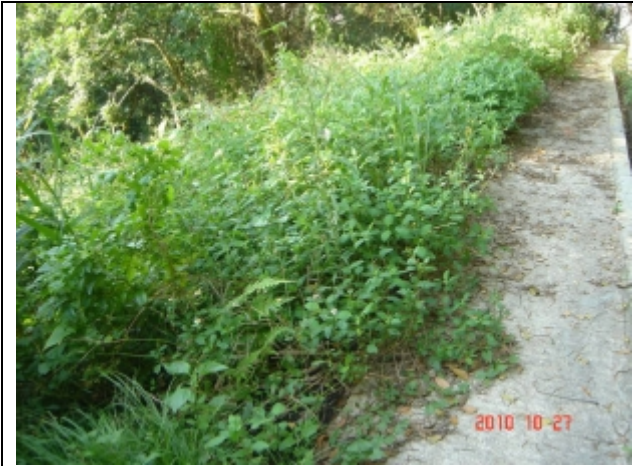
Photo 1

- It was observed no weeding works was carried out since the last inspection (Photo 1 refers). The Contractor was again reminded to carry out further weeding in order to not affecting the growth of plants.
- The palm tree identified with deteriorated conditions in the last inspection was found dead (Photo 2 refers). The Contractor was required to carry out replacement of the palm tree as soon as possible. Also, weeds and climbers were found to start overwhelmed the palm trees, the Contractor was requested to remove the weeds and climbers without delay (Photo 3 refers).

- The Contractor was recommended to carry out weeding of overgrown weeds which had affected the healthy growth of shrubs and palm trees.
- The Contractor was recommended to carry out replacement of the dead palm tree as soon as possible.

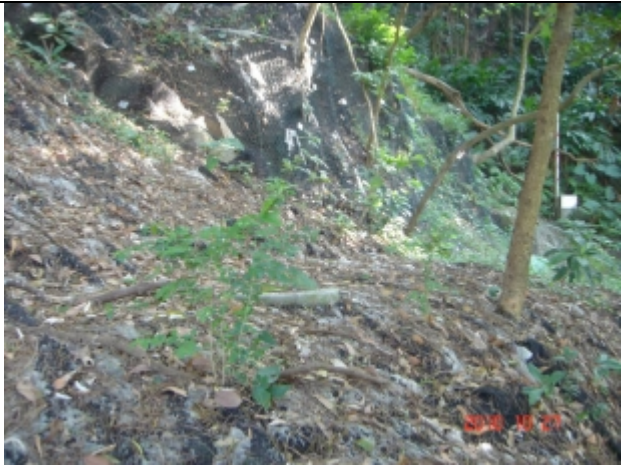
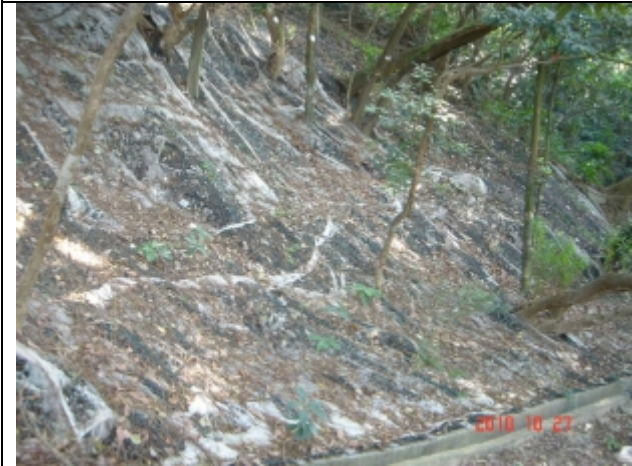
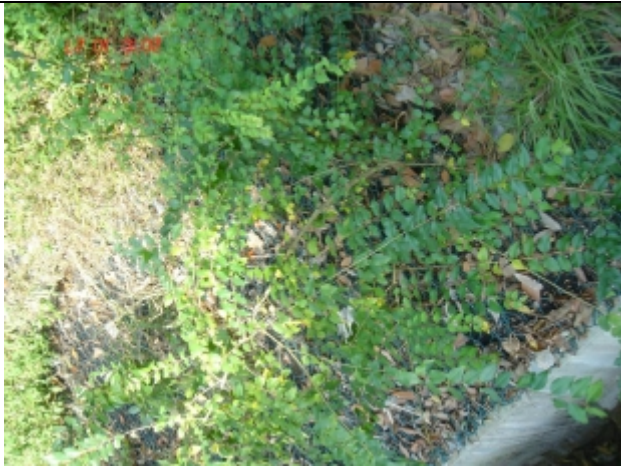
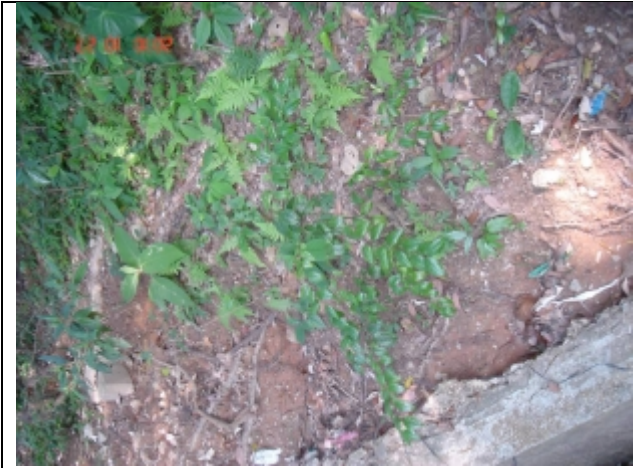
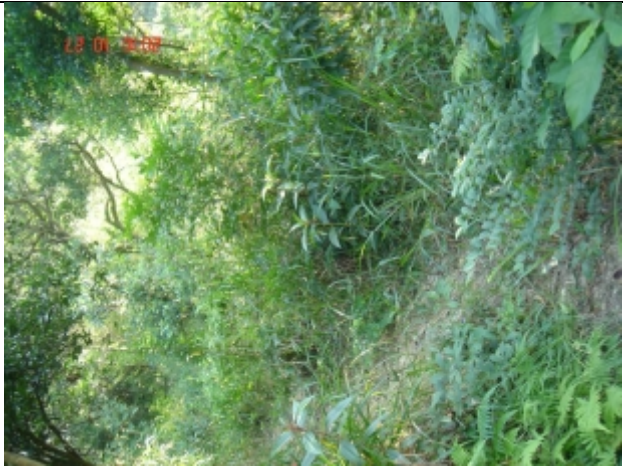
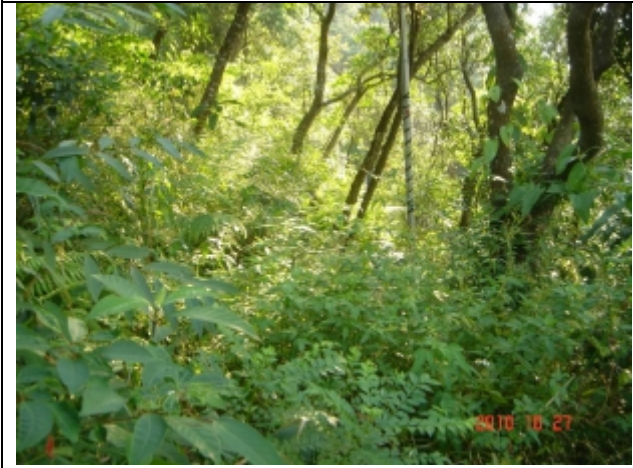
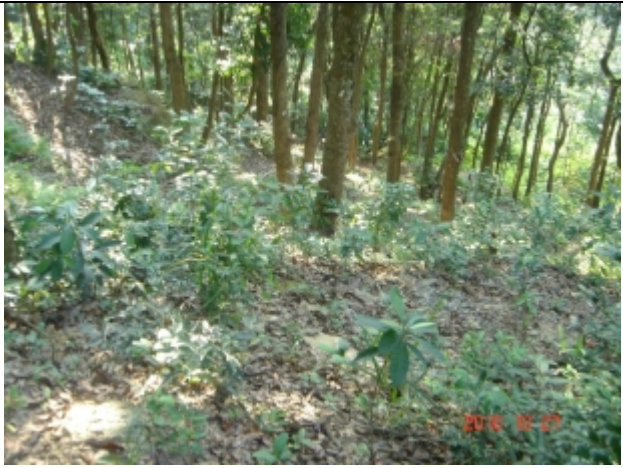
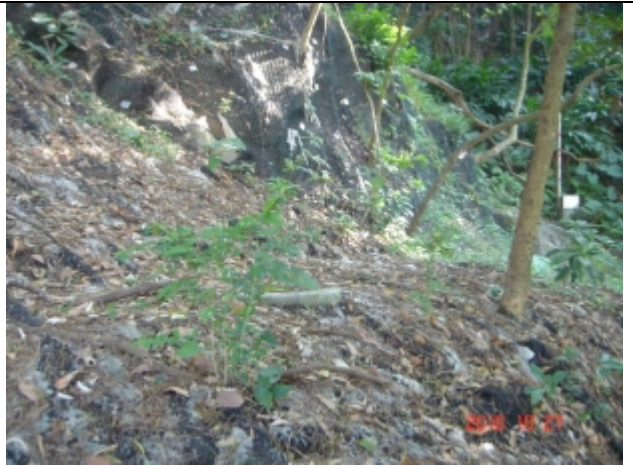
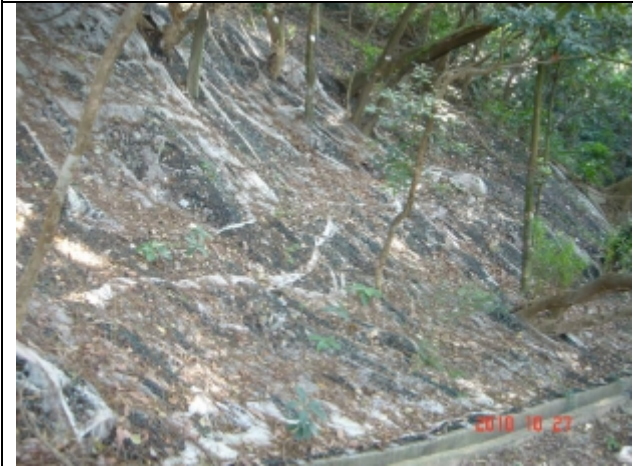
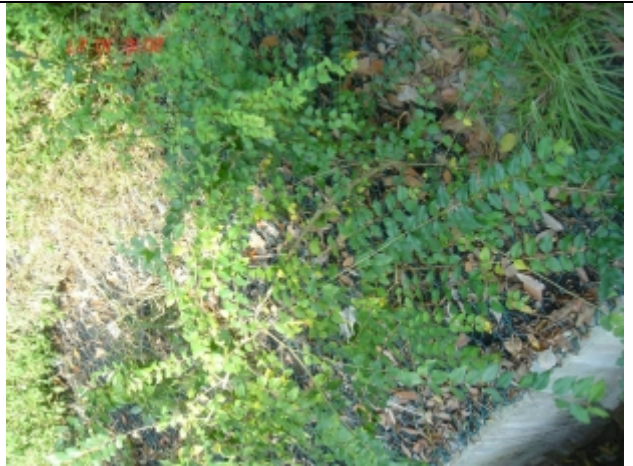
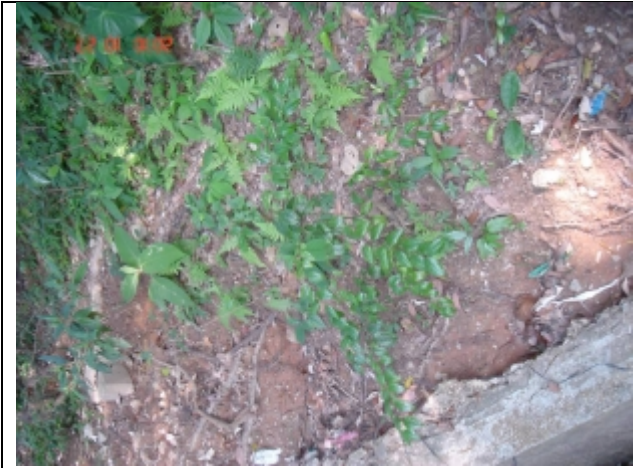
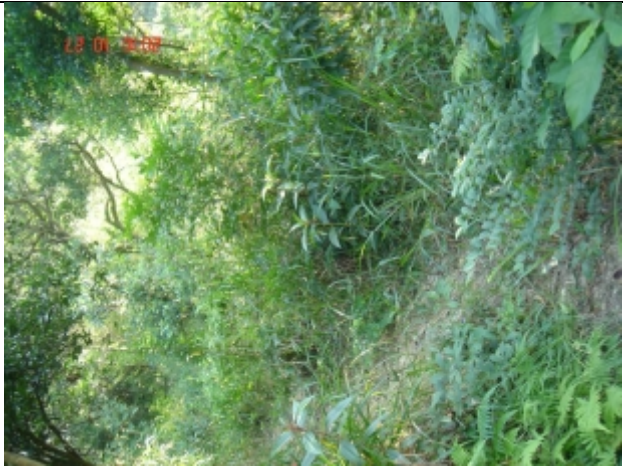
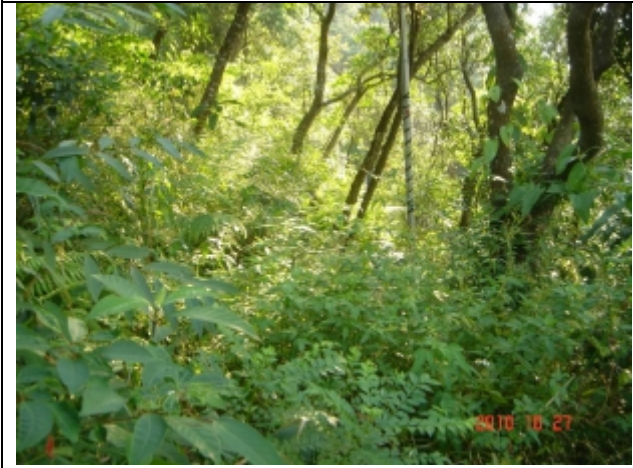
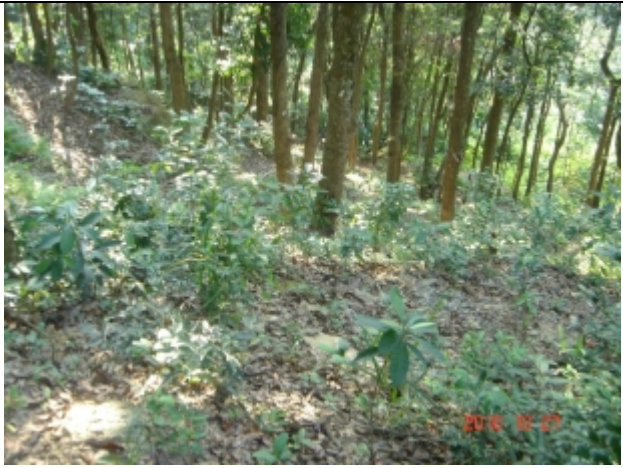
- The shrubs and other palm trees under establishment were generally observed to be healthy and well established. Please refer to typical site inspection photos 4 to 10 enclosed under Appendix-B.
