**Landslide Preventive Works at Po Shan Road,
Mid-Levels – Design and Construction
(Natural Terrain Risk Mitigation Works)**

**Monthly Operation Phase Landscape and
Visual Audit Report No. 11**

November 2010

Monthly Inspection Report No. 11

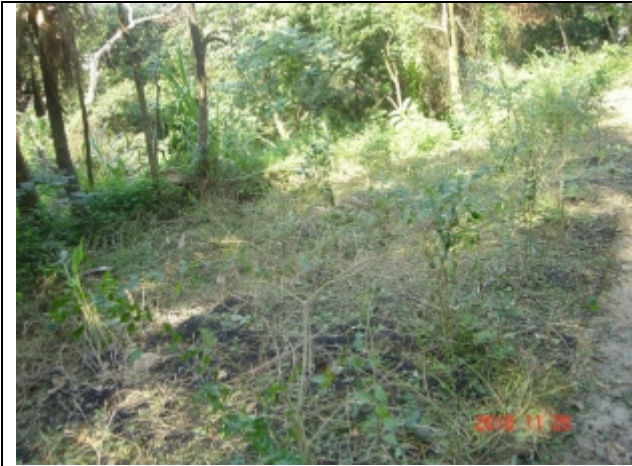
Photo 1

- The Contractor had carried out weeding works as previously identified in the last inspection (Photo 1 refers).
- The Contractor had carried out the replacement planting for the dead palm tree identified in the last inspection (Photo 2 refers). The Contractor had also removed all weeds and climbers found on other palm trees (Photo 3 refers).

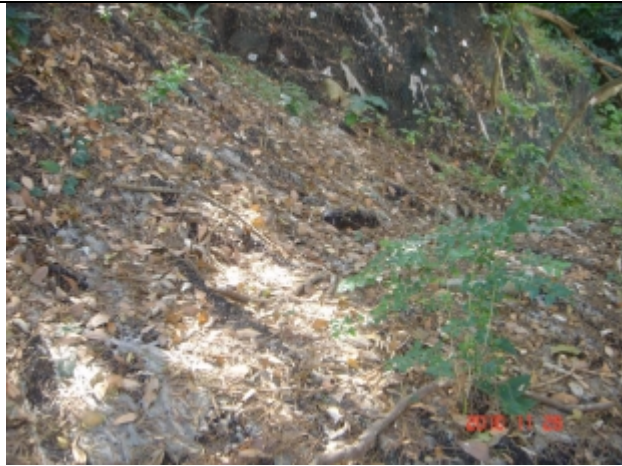
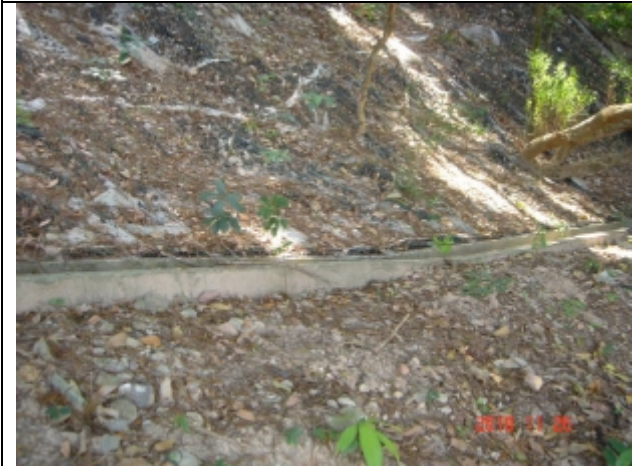
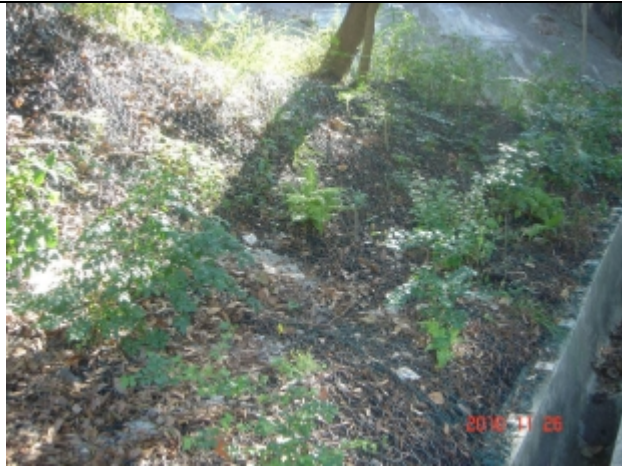
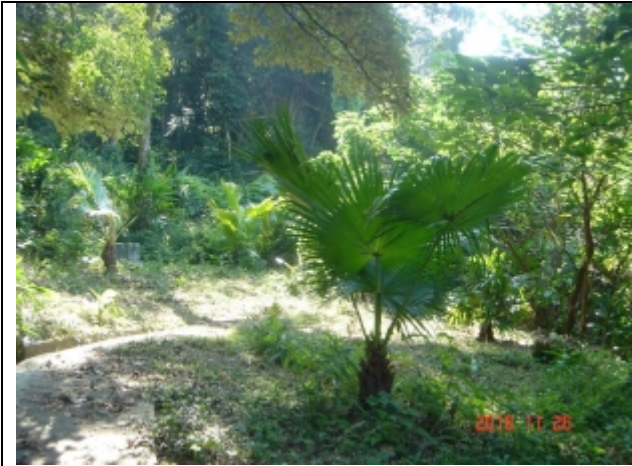
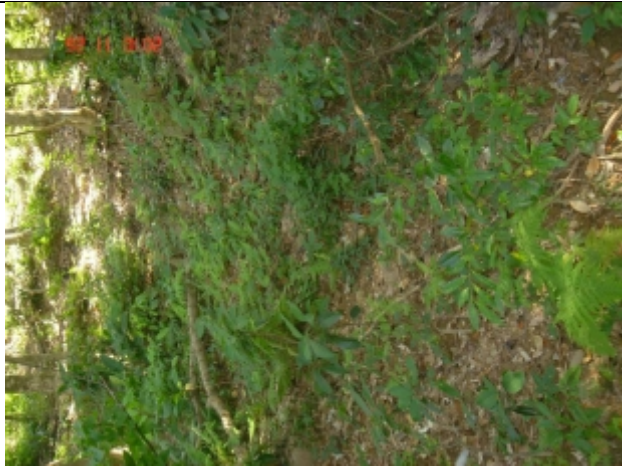
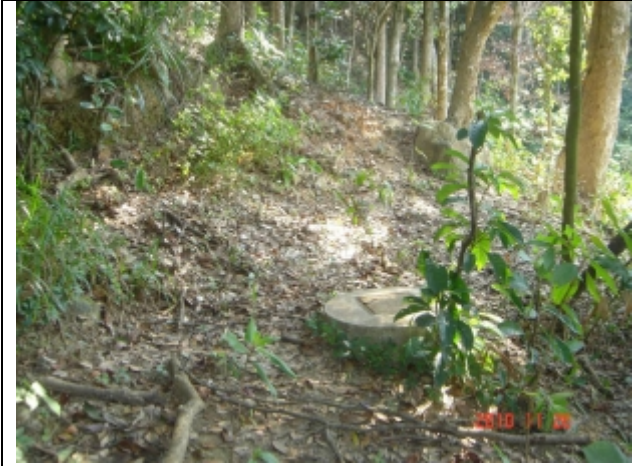
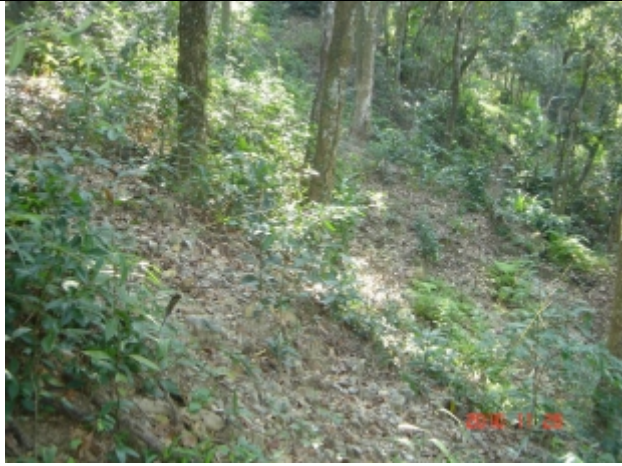
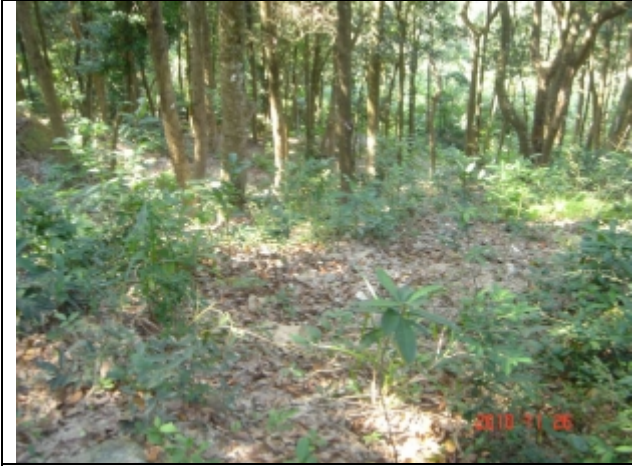
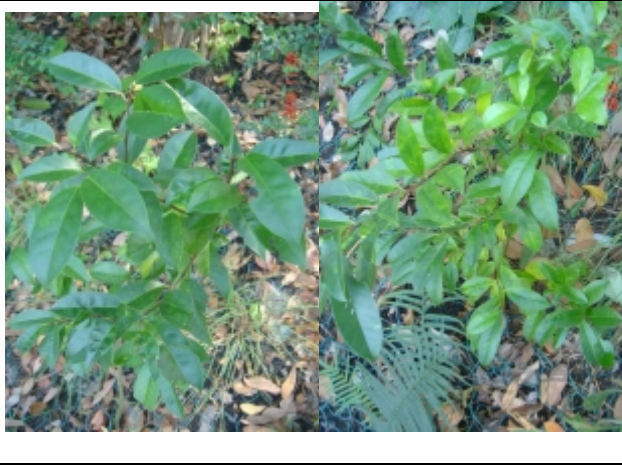
- The shrubs and other palm trees under establishment were generally observed to be in healthy condition and well established. Please refer to typical site inspection photos 4 to 12 enclosed under Appendix-B.
