**Landslide Preventive Works at Po Shan Road,  
Mid-Levels – Design and Construction  
(Natural Terrain Risk Mitigation Works)**

**Monthly Operation Phase Landscape and  
Visual Audit Report No. 12**

December 2010

**Monthly Inspection Report No. 12**

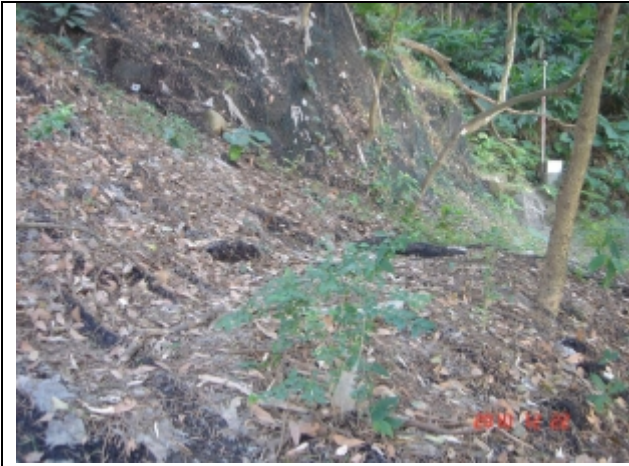
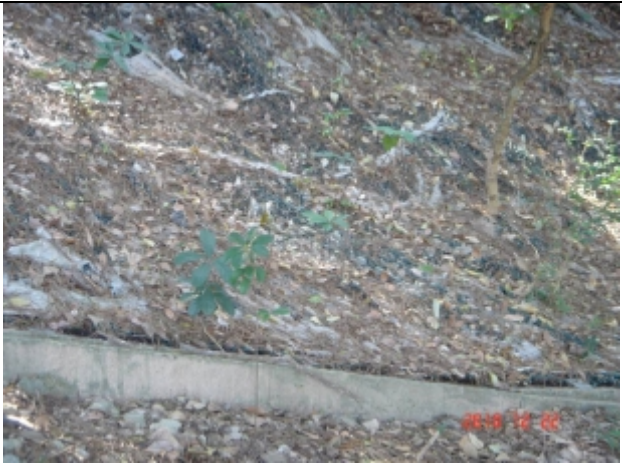
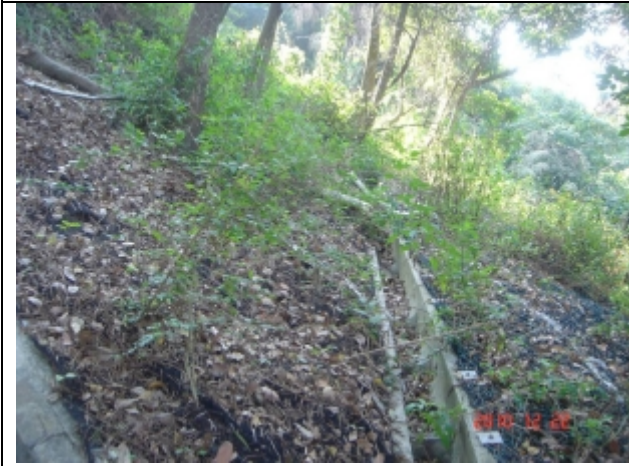
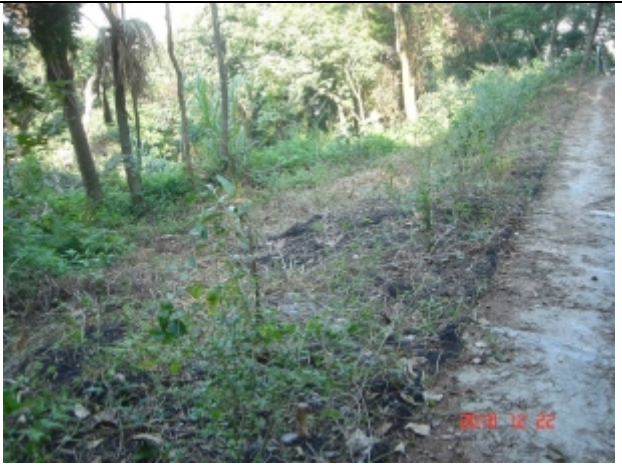
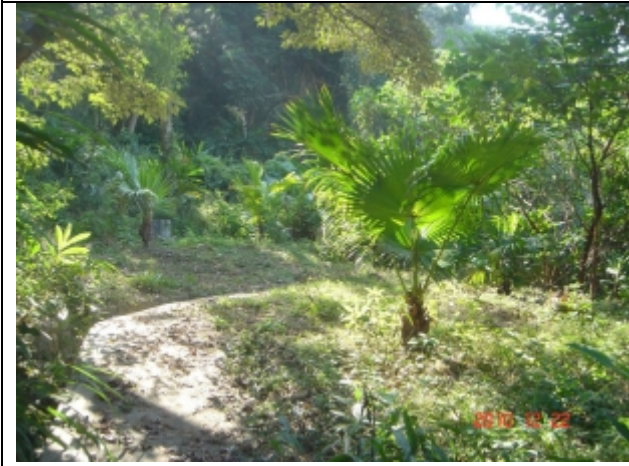
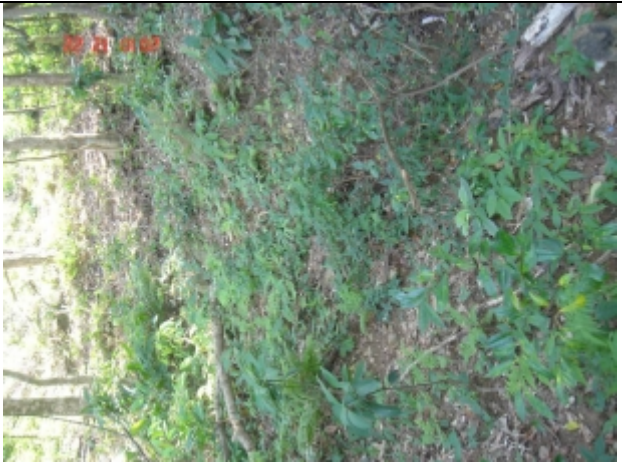
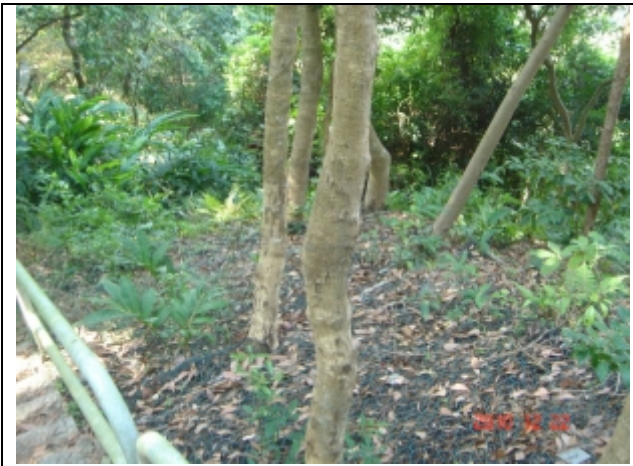
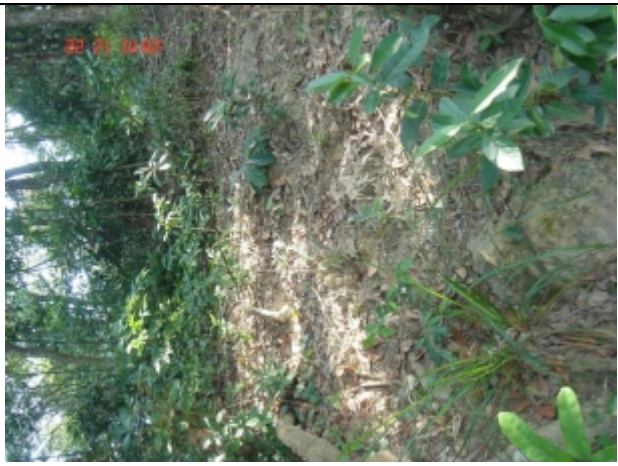
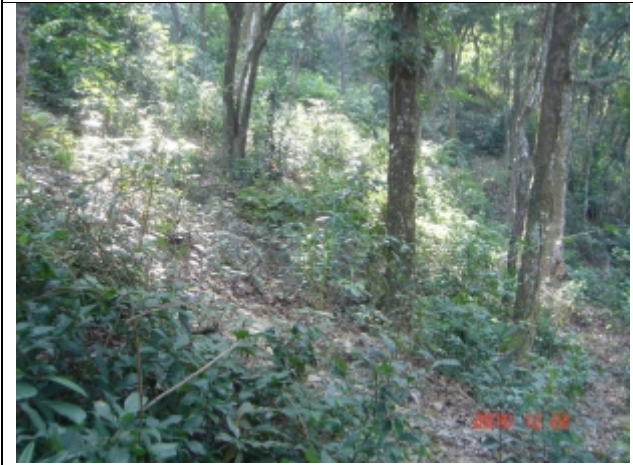
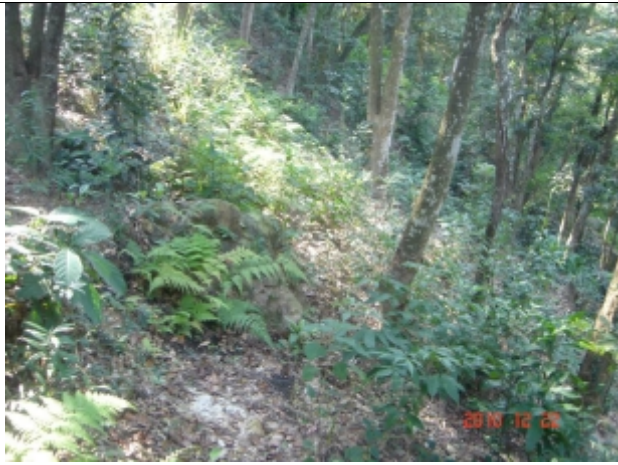
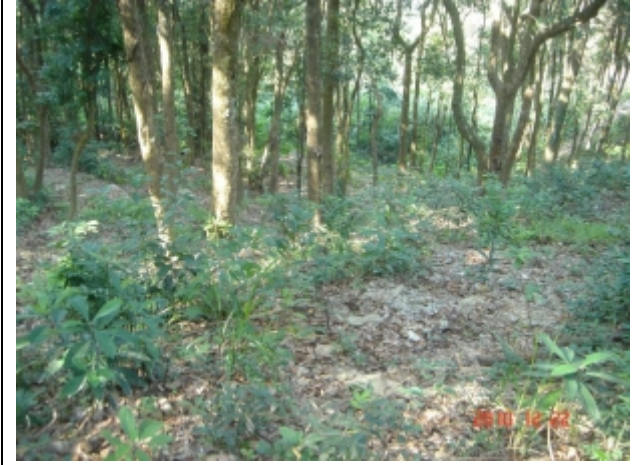
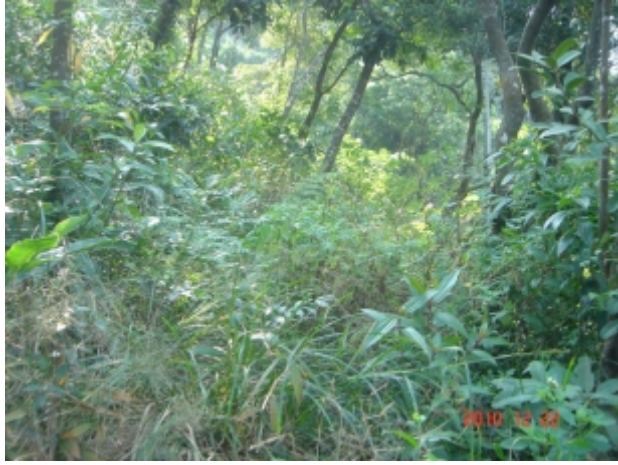
- It was generally observed that the shrubs and palm trees under establishment were in healthy condition and well established. Please refer to typical site inspection photos 1 to 12 enclosed under Appendix-B.
- The inspection was the last monthly inspection of the 12-month Establishment Period and no outstanding works was found.
