PERMANENT AVIATION FUEL FACILITY

ANNUAL AUDIT REPORT

**Environmental Permit
EP-262/2007/B**

Date of Audit : 1 – 22 March 2018

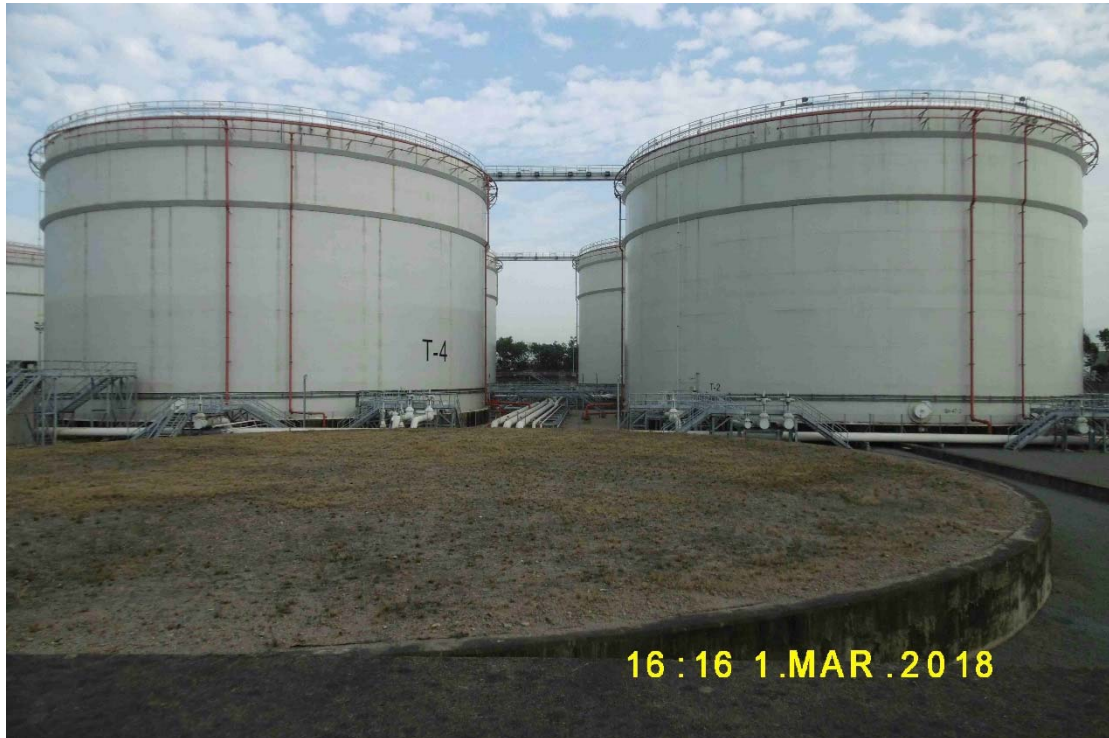
(1) Four tanks are located within bunded compound – Phase 1a

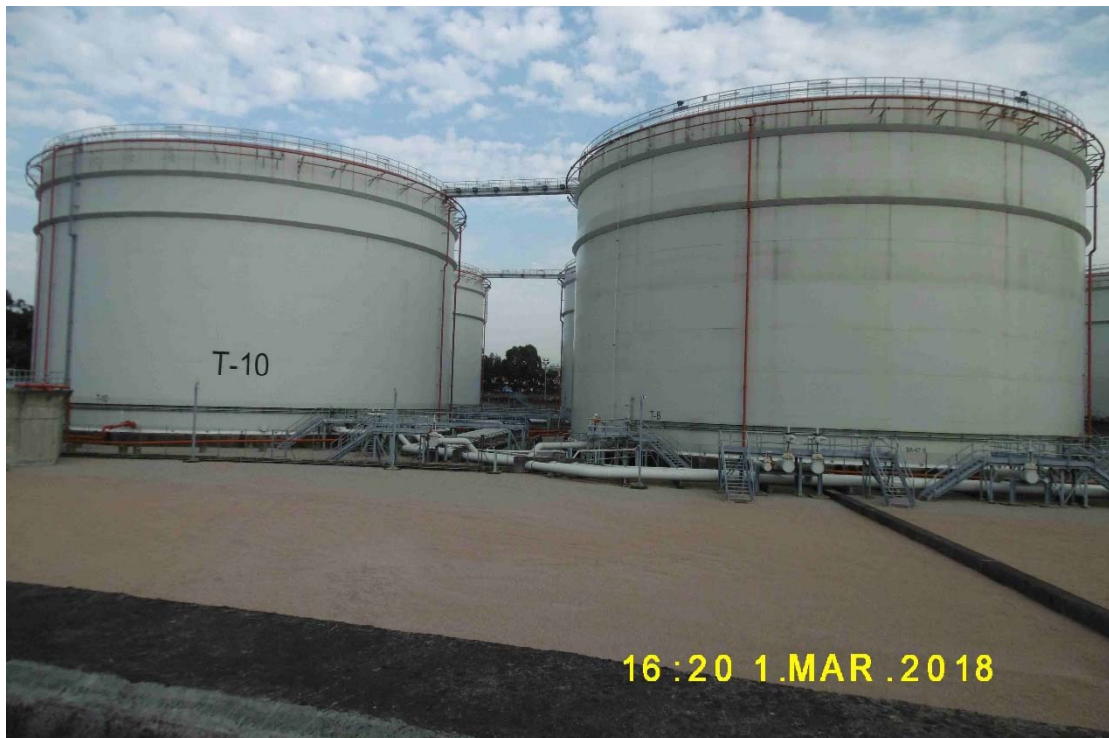
(2) Four tanks are located within bunded compound – Phase 1b

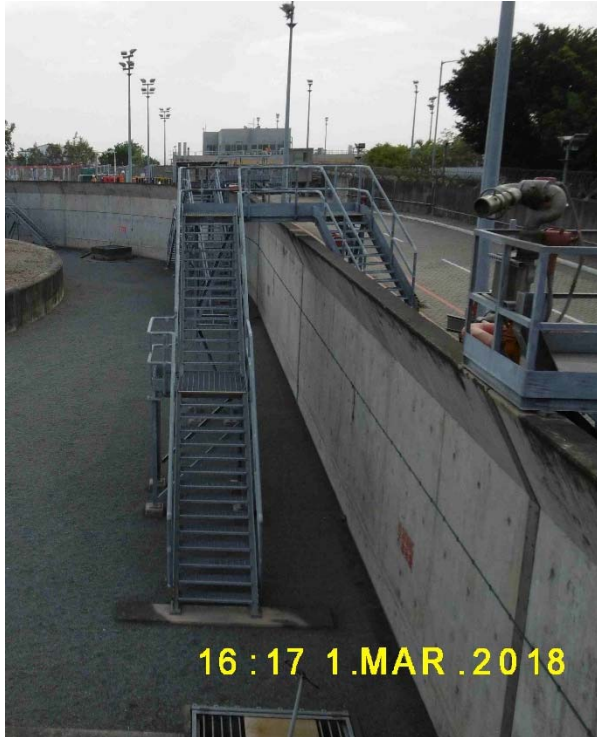
(3) Phase 1a bunded compound is lower than the ground level outside the bunds

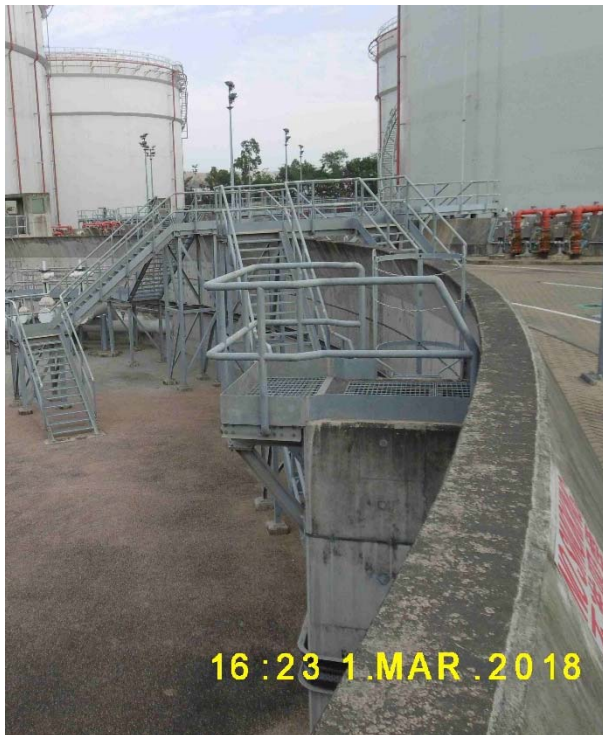
(4) Phase 1b bunded compound is lower than the ground level outside the bunds

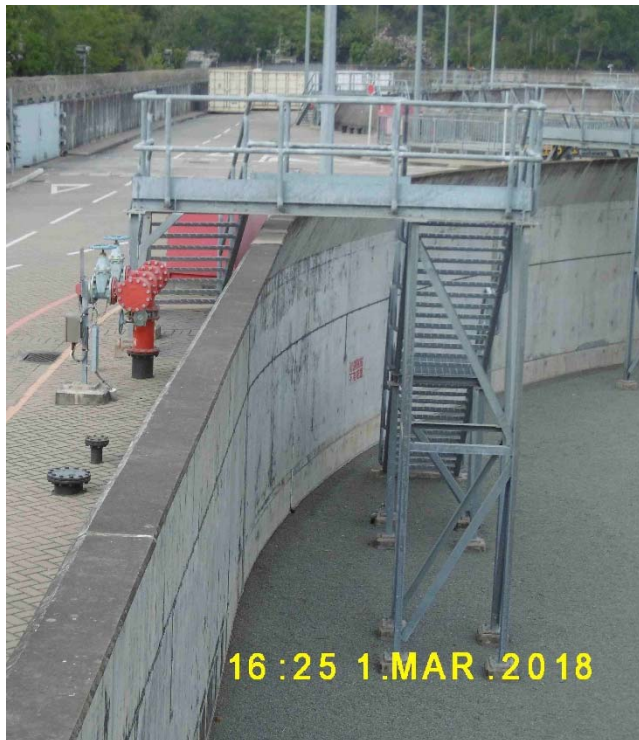
(5) Wave deflector are installed at top of the bunds

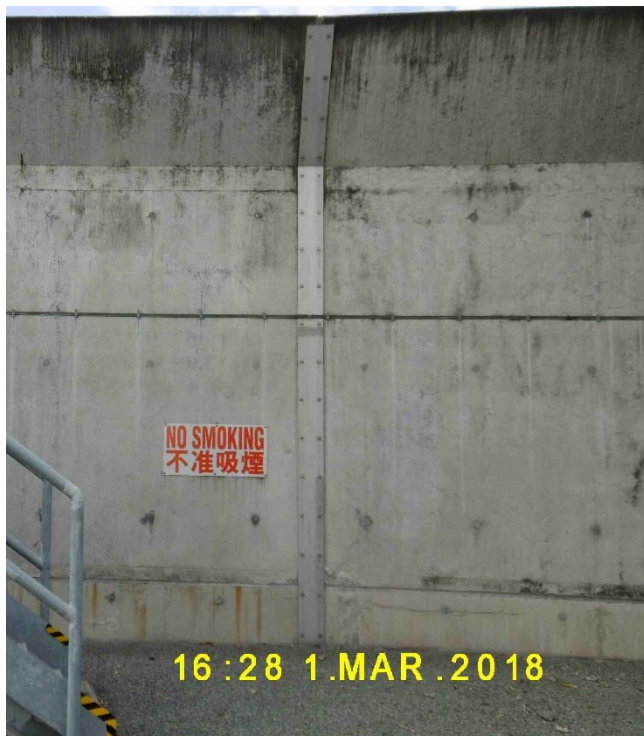
(6) Visible parts of the joints are covered by stainless steel plates on the inside at phase 1a bund

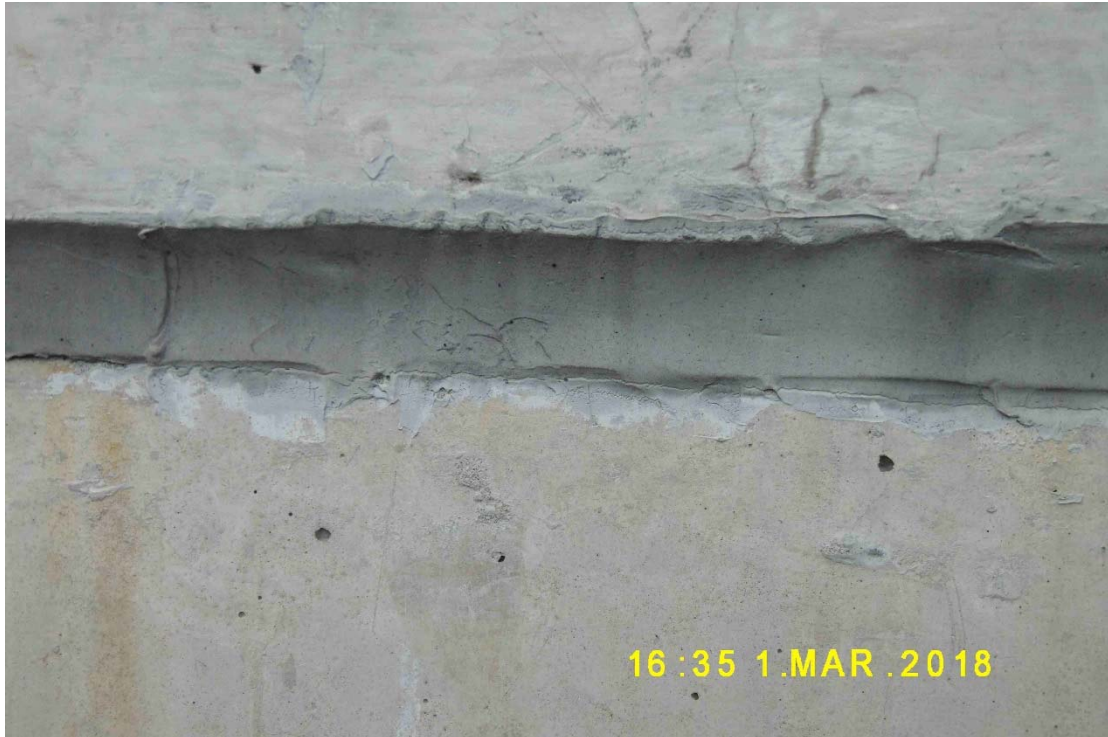
(7) Maintenance works have been performed on sealant at joints

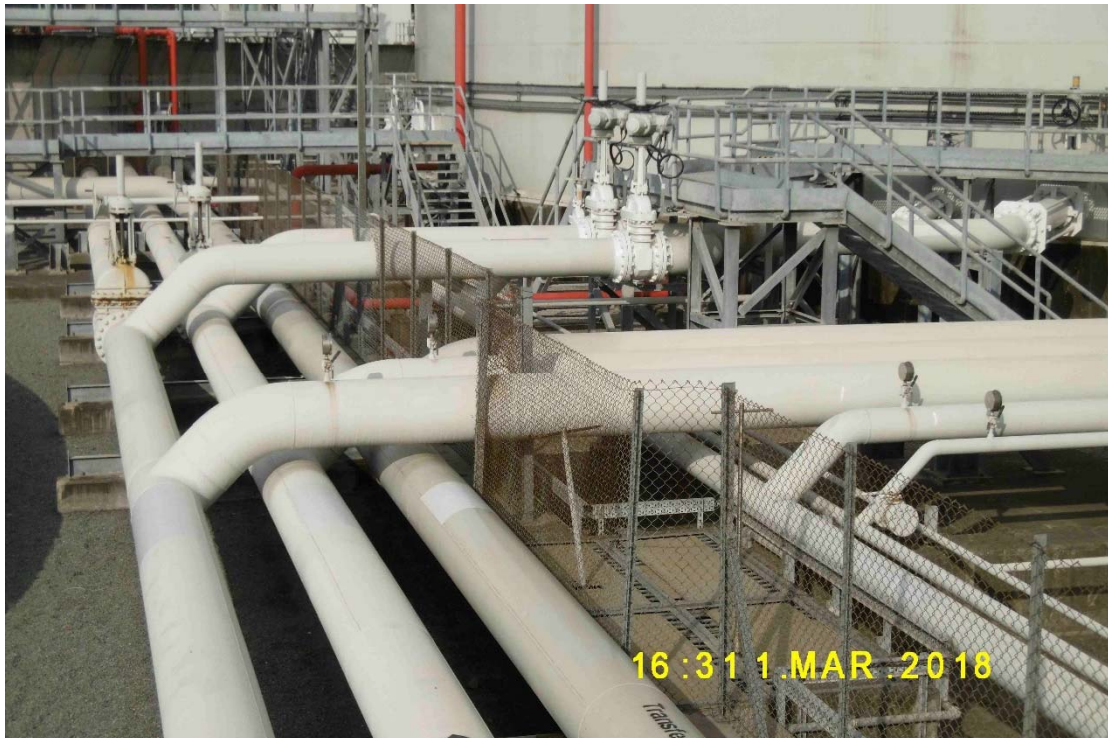
(8) Intermediate bund walls are provided in place near T-01-004

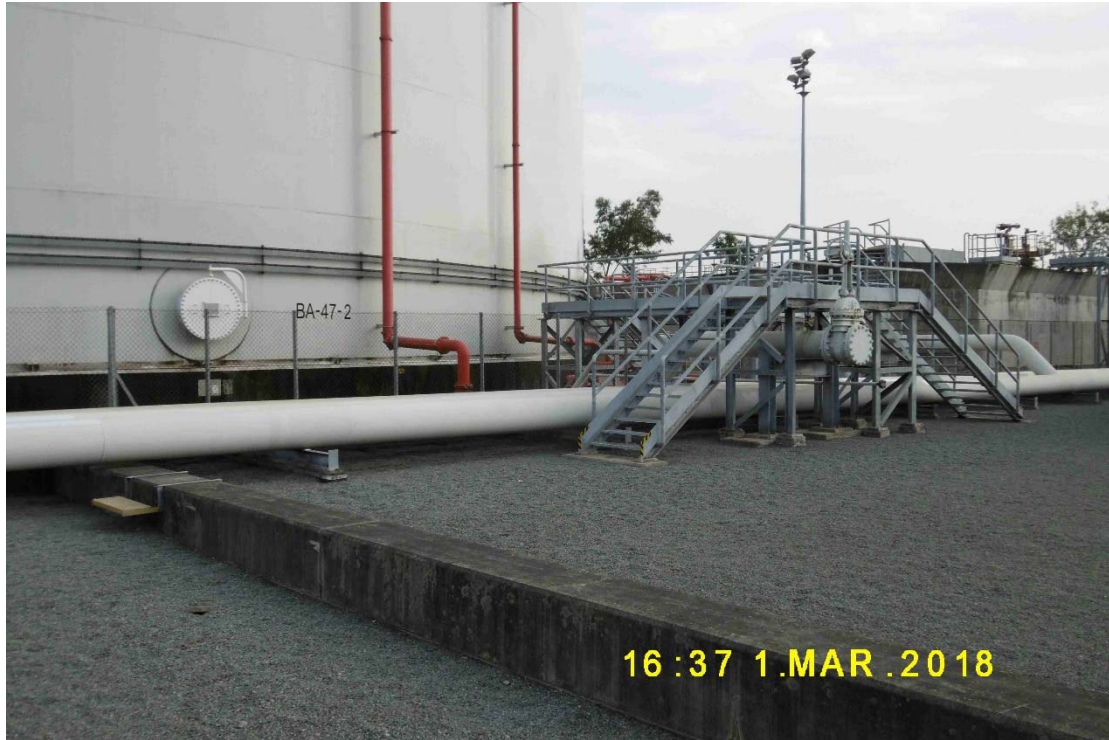
(9) Intermediate bund walls are provided in place near T-01-002

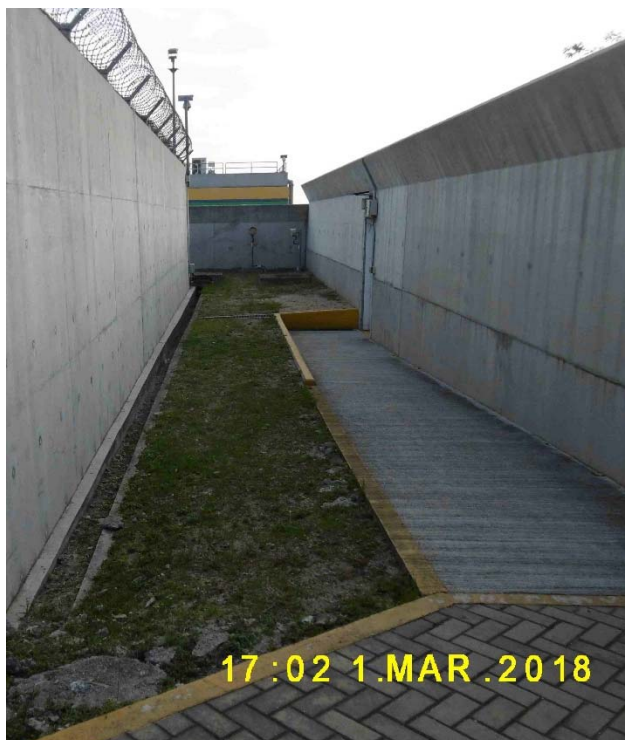
(10) Two impervious security walls are provided outside the bunded compounds

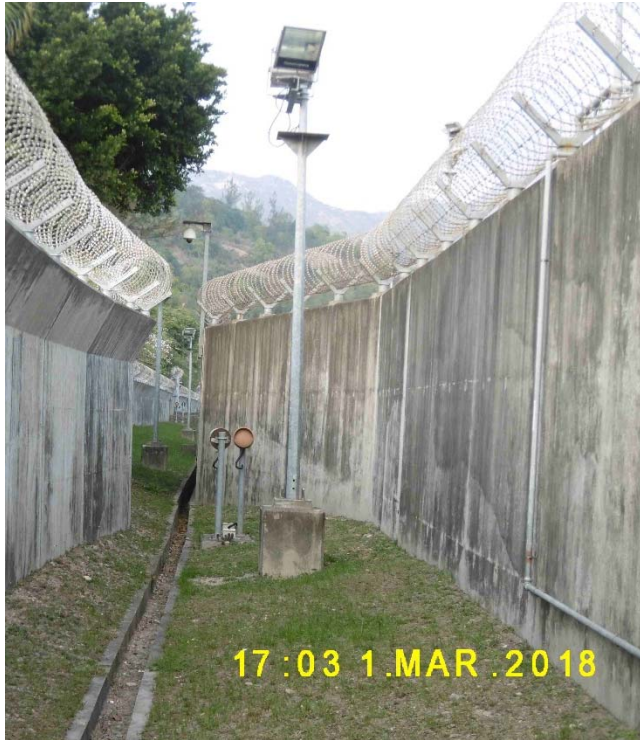
(11) Two impervious security walls are provided outside the bunded compounds

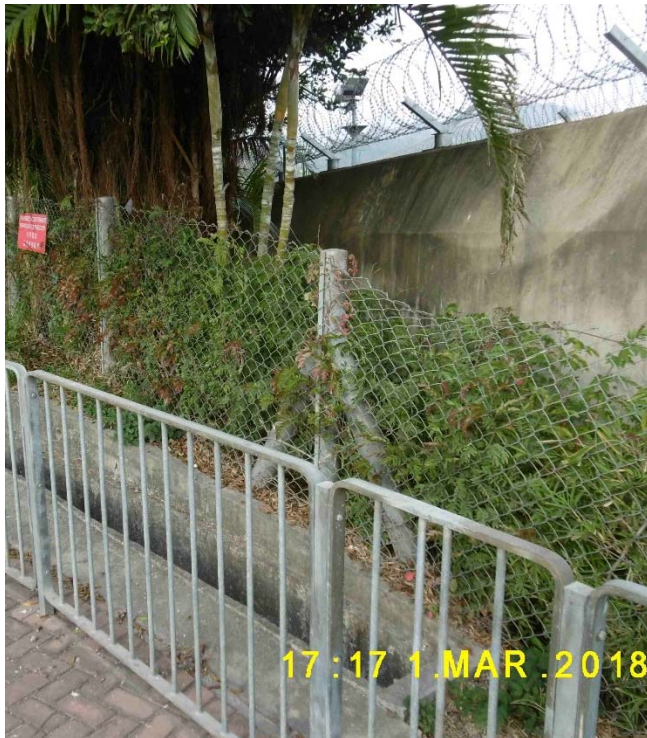
(12) Landscaped berm is maintained at least 1.5m high

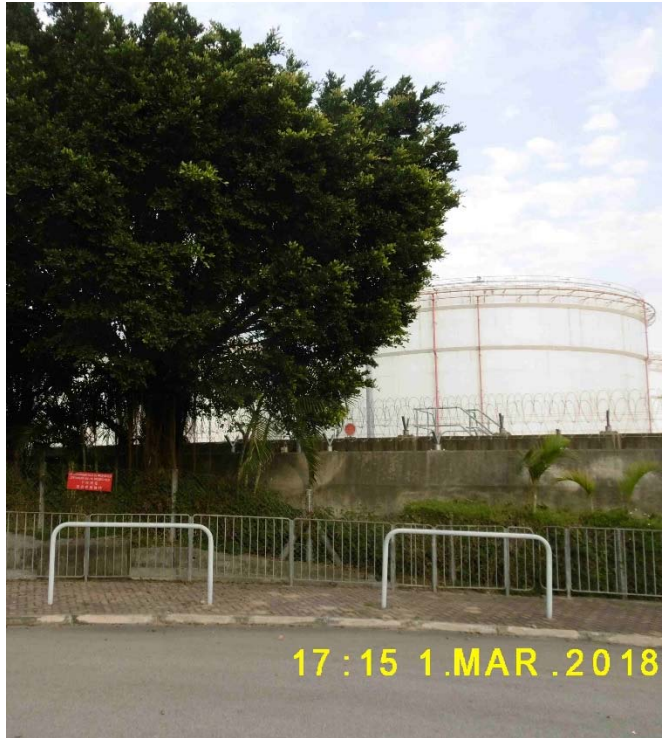
(13) Landscaped berm is maintained at least 1.5m high

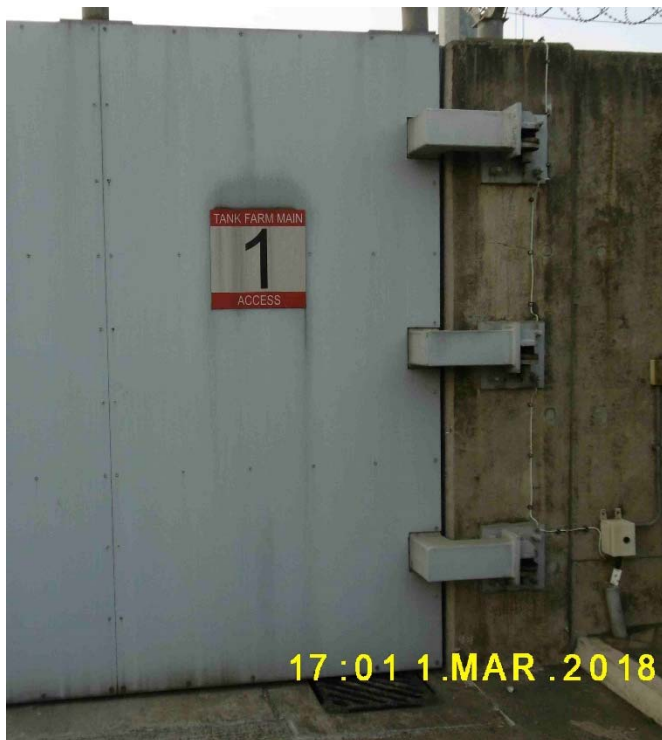
(14) Gates at security walls with sealant are maintained in good condition

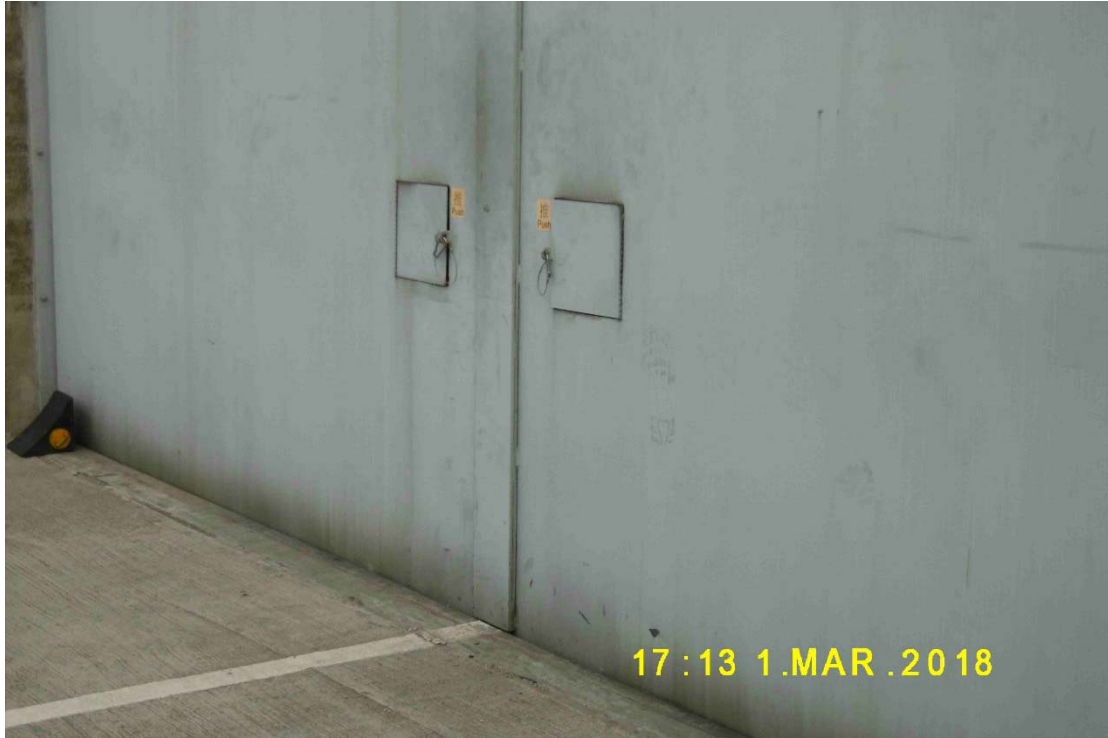
(15) Gates at security walls with sealant are maintained in good condition

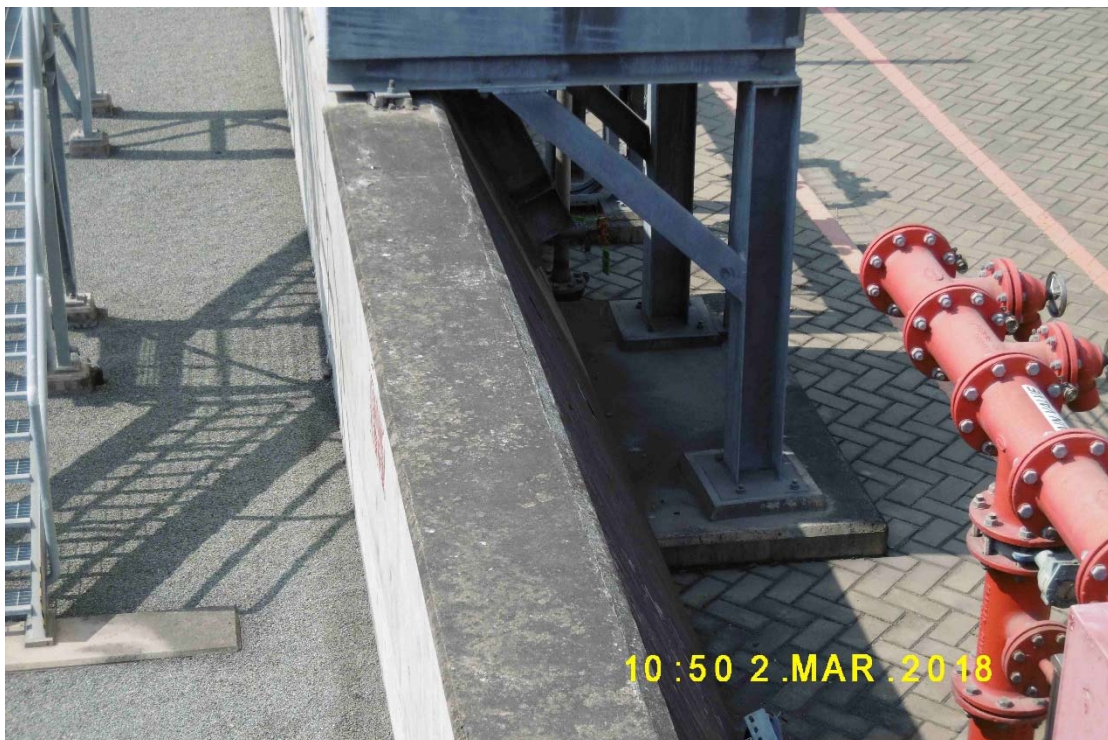
(16) This shows the thickness of the bund wall provided

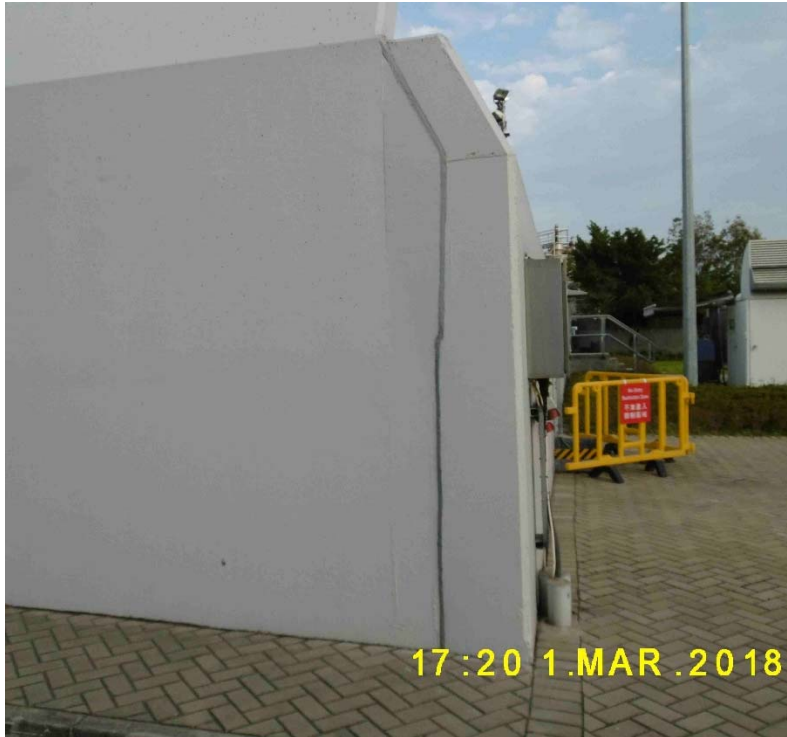
(17) This shows the thickness of the security wall provided

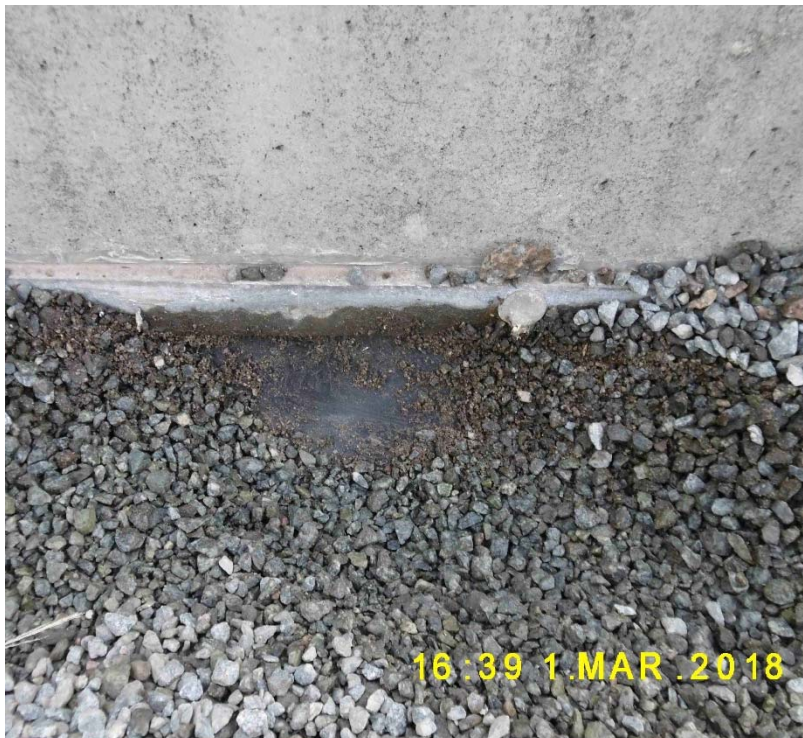
(18) Impervious lining are maintained in good condition

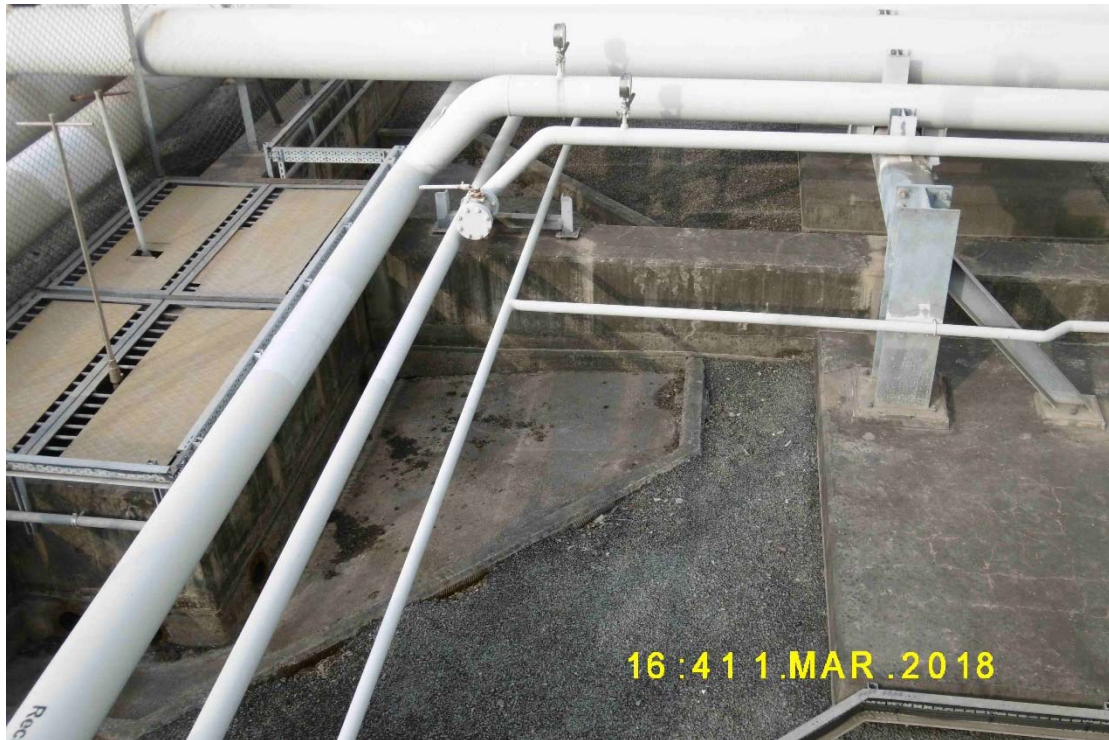
(19) Tank farm is with appropriate gradient and the drainage falls to interceptor for collection

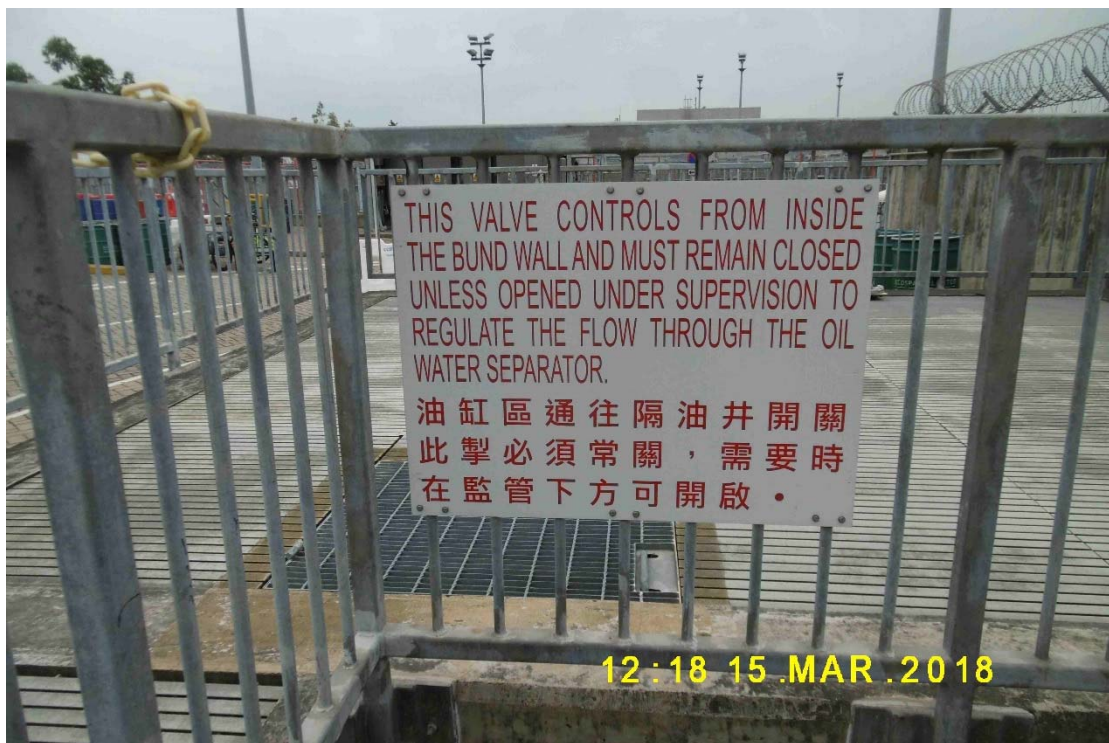
(20) Outlet valve provided for Phase 1a Interceptor with instruction sign to keep “normally closed”

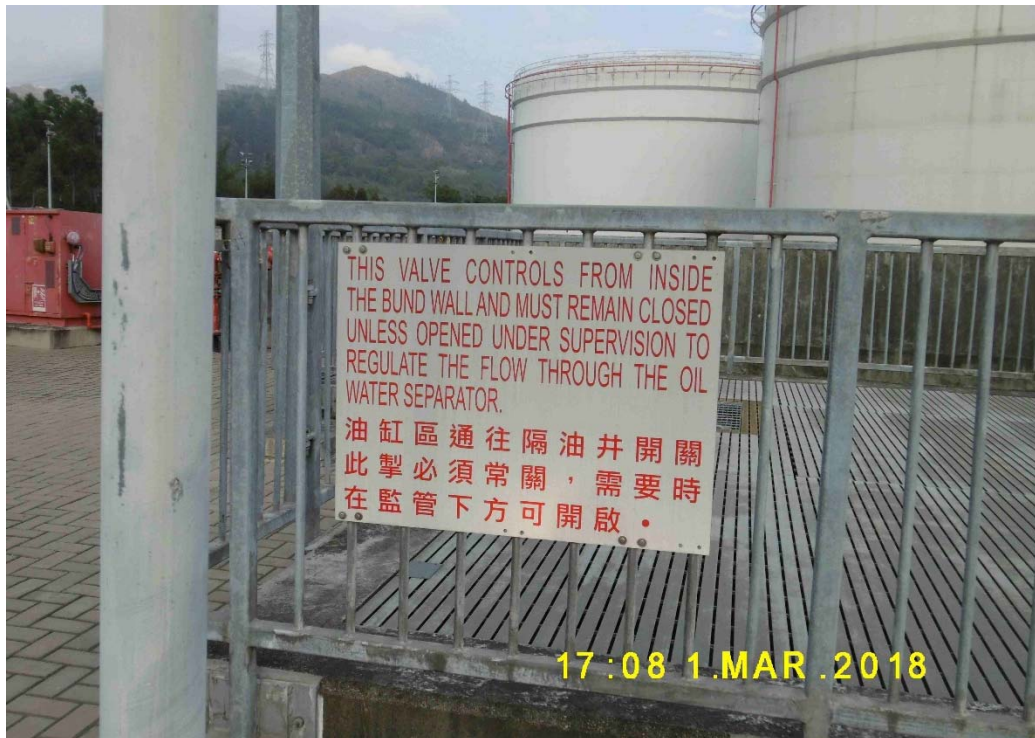
(21) Outlet valve provided for Phase 1b Interceptor with instruction sign to keep “normally closed”

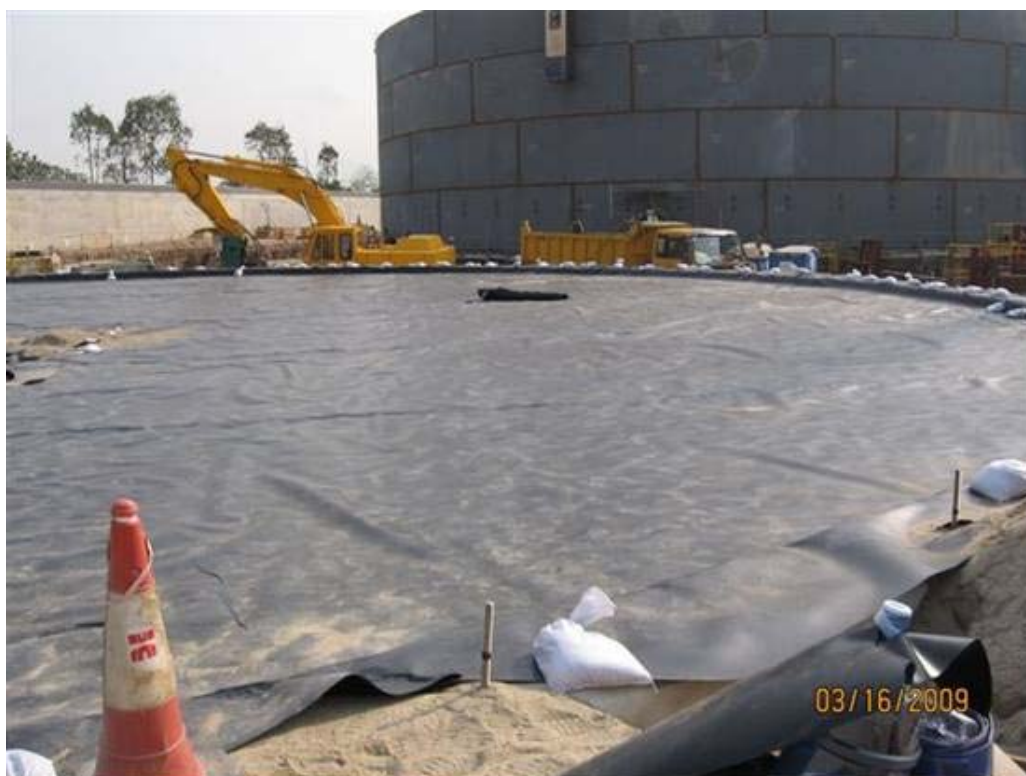
(22) Record photo shows impervious membrane being installed on top of tank foundation

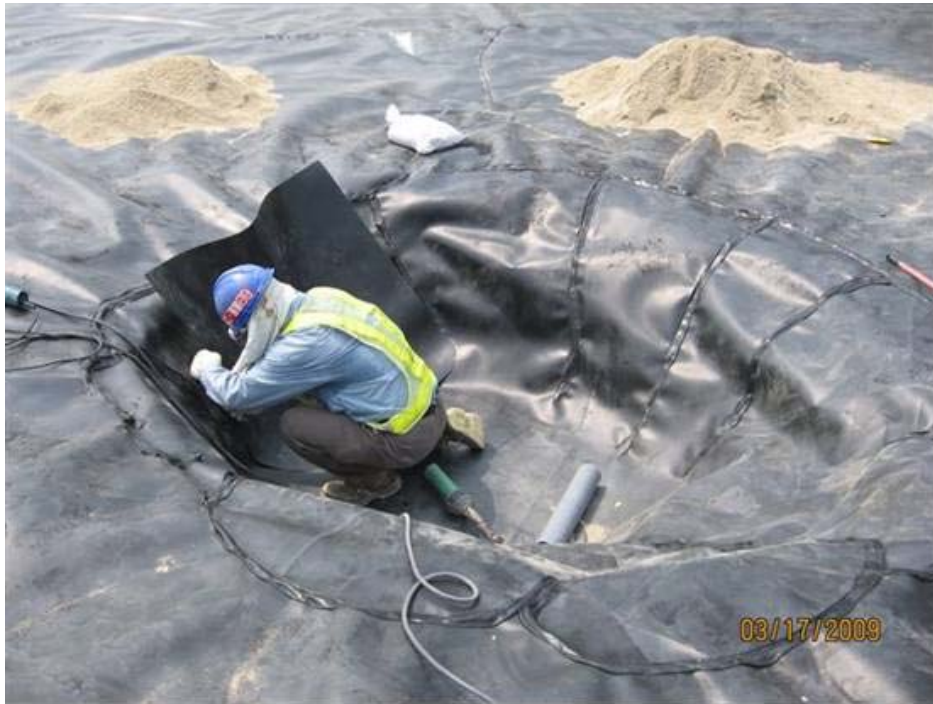
(23) Record photo shows imperious membrane laid at tank center sump with tell-tale pipe embedded for leak detection

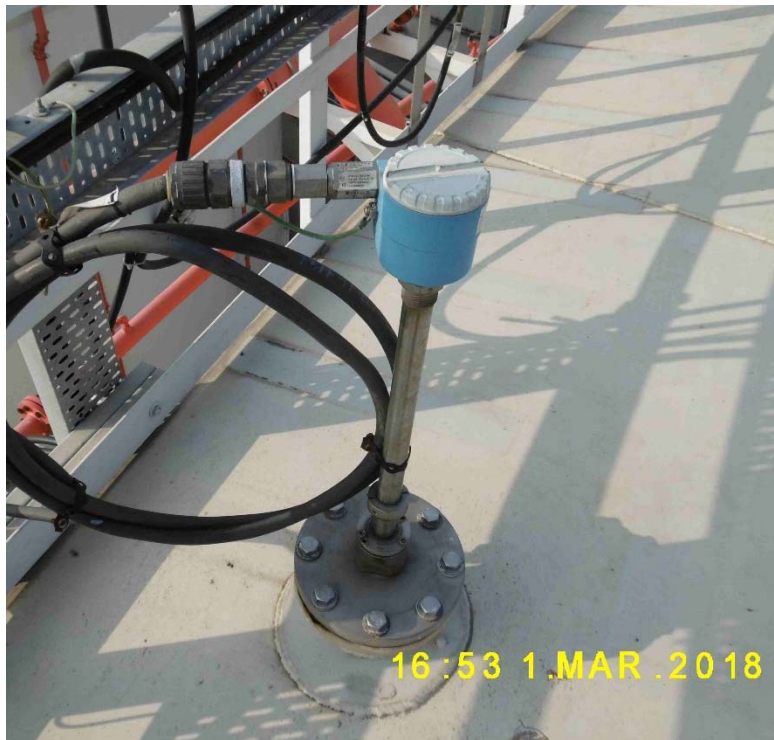
- (25) Regular inspection performed on overfilling monitoring device (High-High Level Alarm)

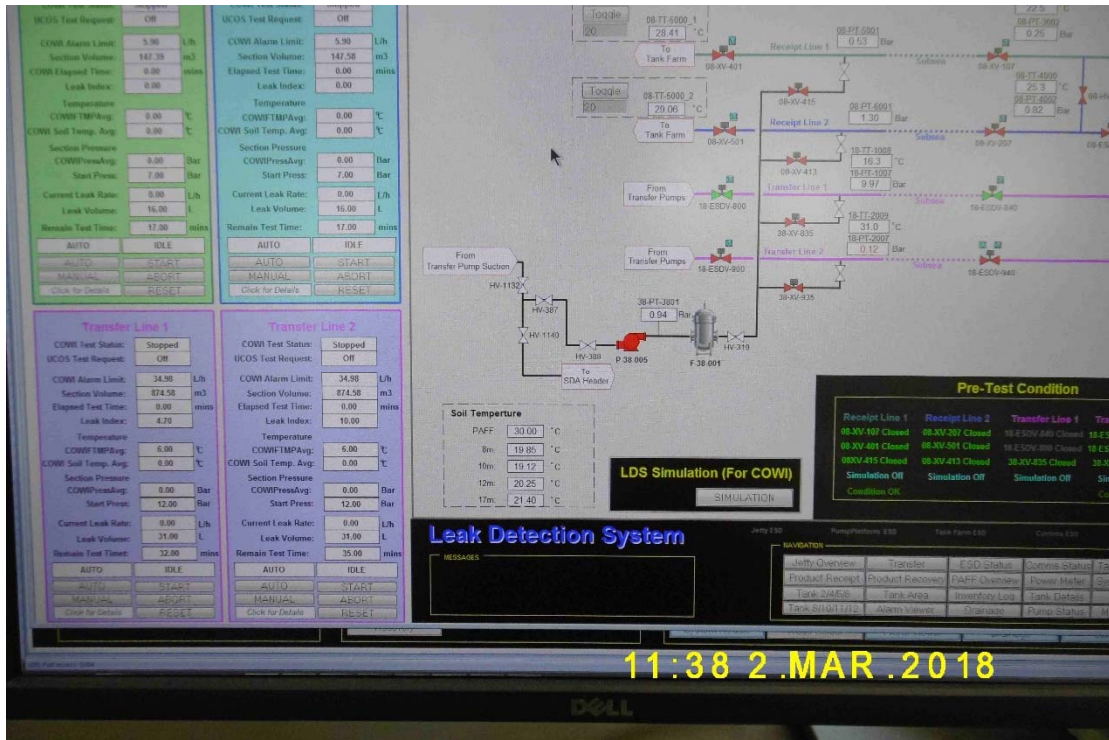
(27) Leak detection “COWI Stat Leak System” installed into computer

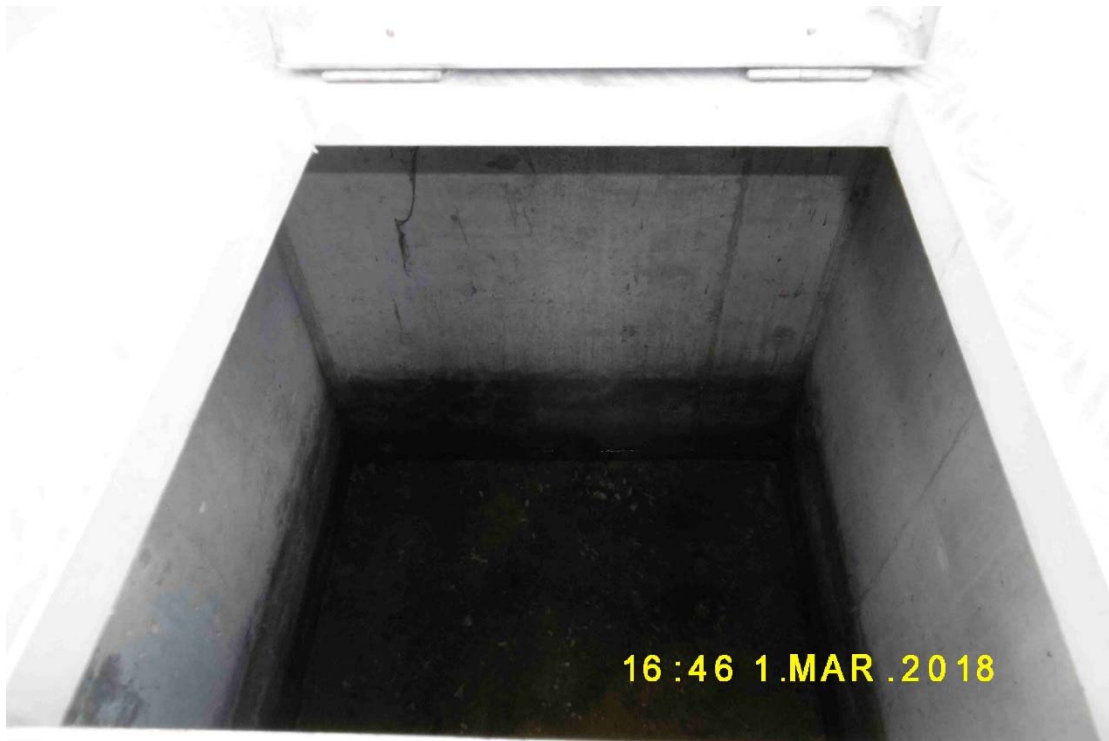
(28) Leak detection tell-tale pipe underneath the storage tank opens out to a collection chamber

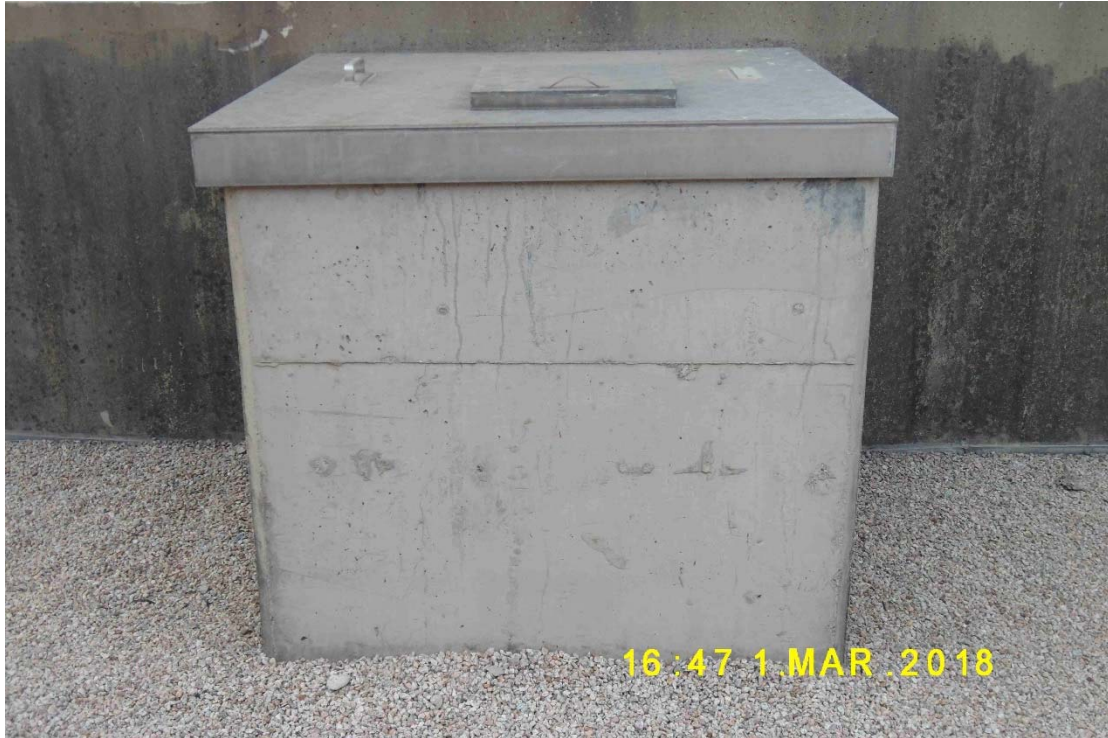
- (29) Collection chamber located adjacent to tank foundation is maintained in good condition with periodic inspection

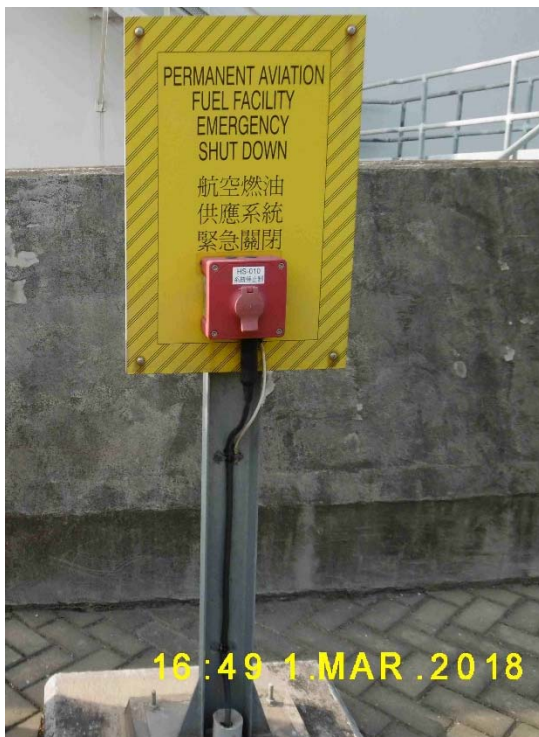
- (30) ESD device is maintained in good condition and being tested periodically

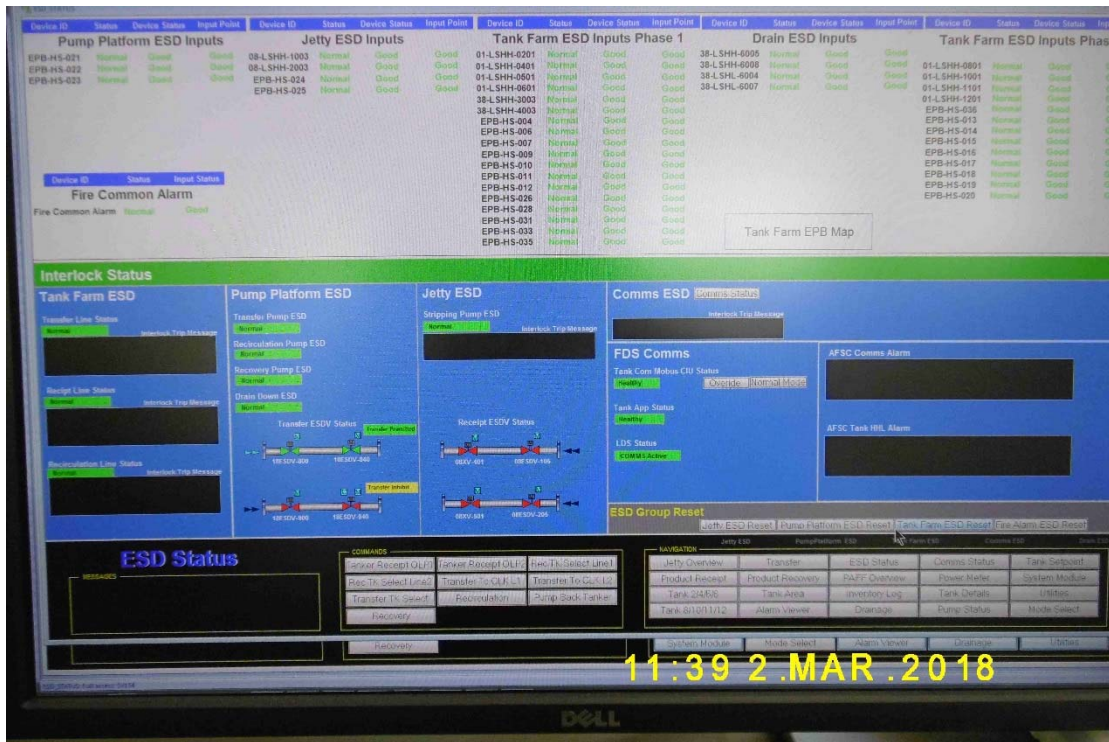
(31) The ESD regular testing as shown in SCADA System

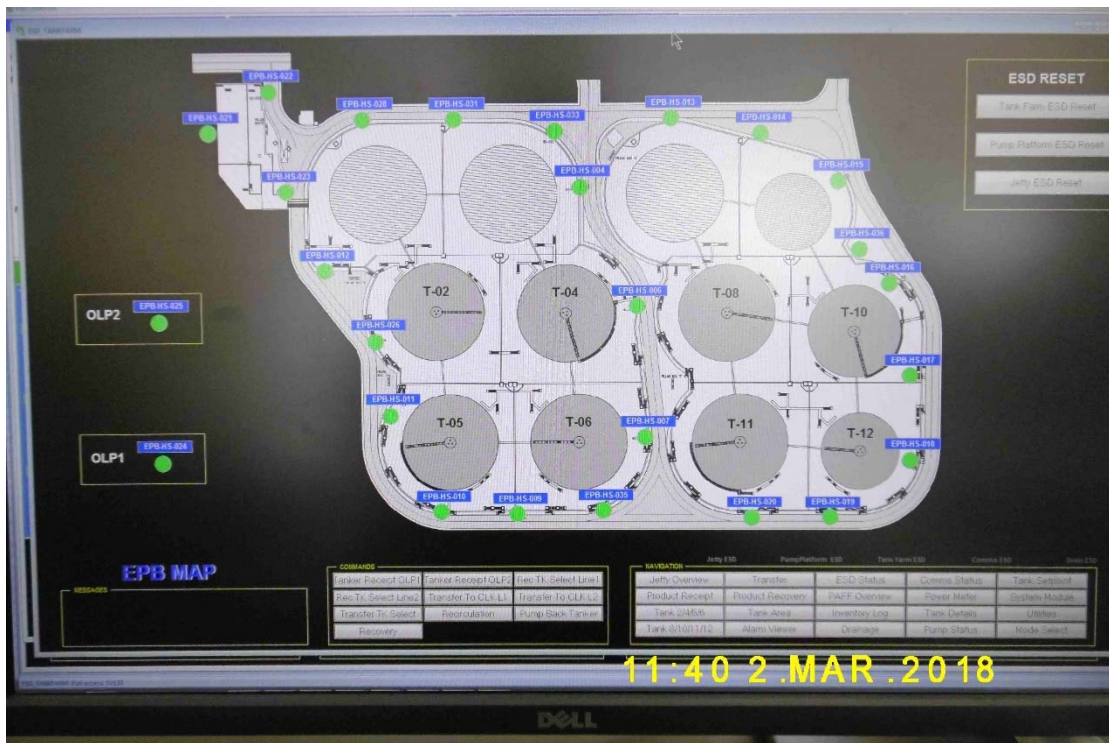
(32) The ESD regular testing as shown in SCADA System

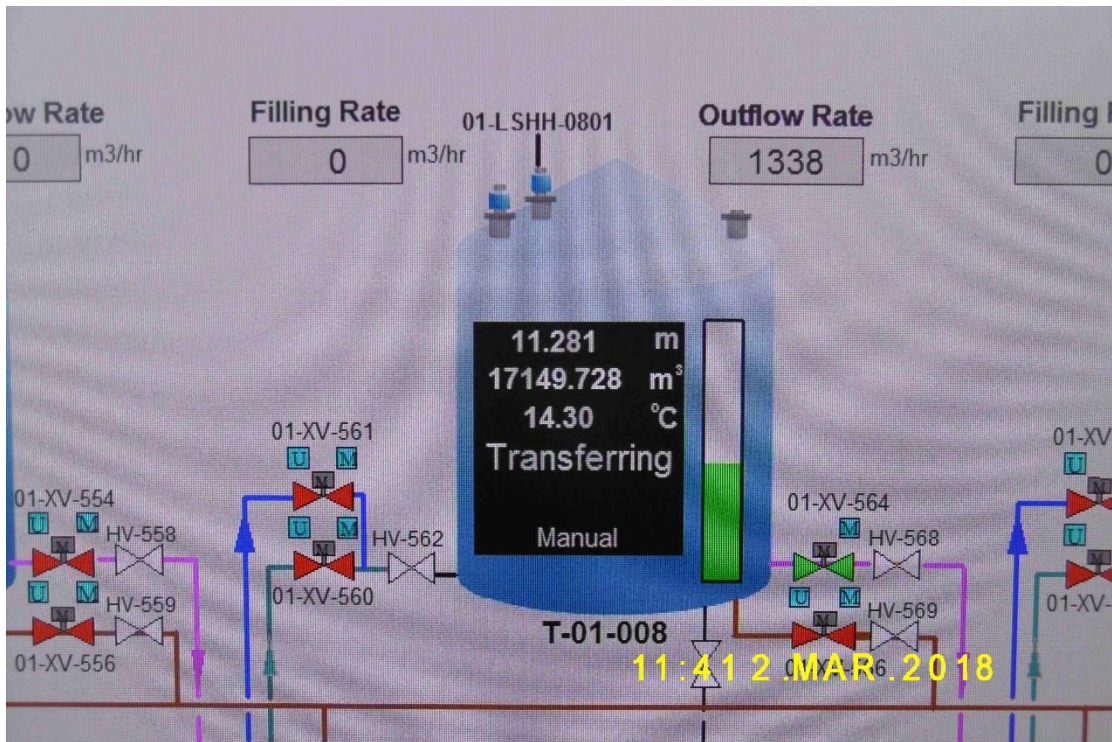
(33) The ESD test signal as shown in SCADA System

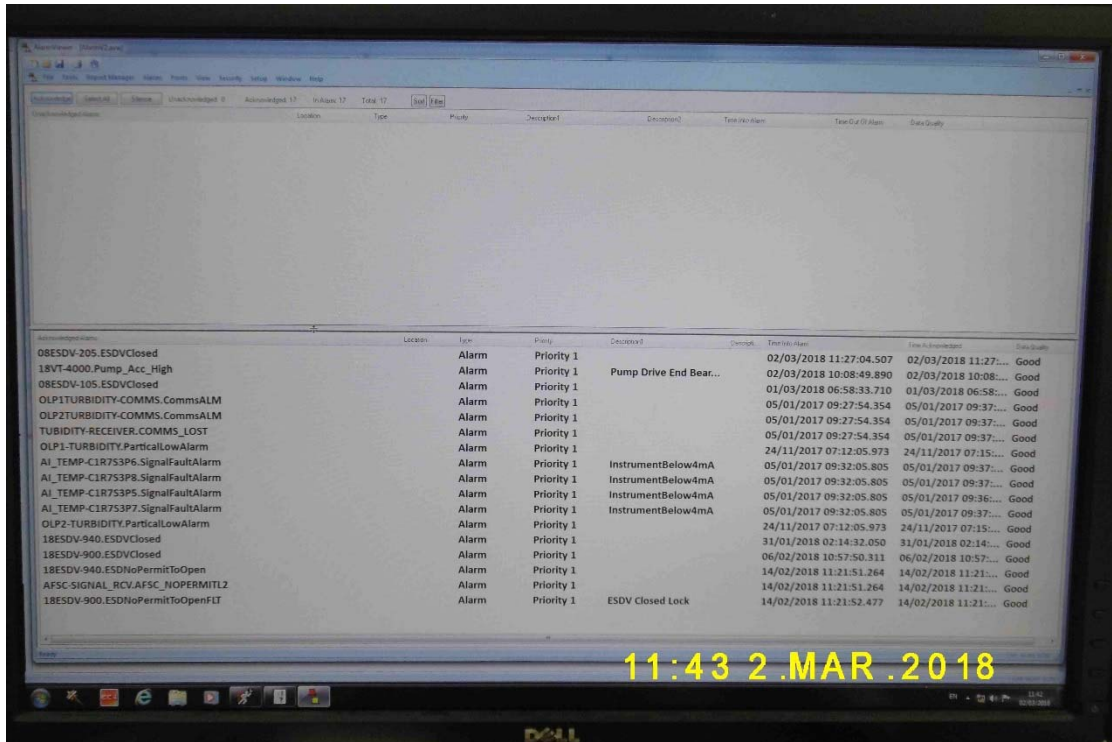
(34) Once the system received ESD test signal, the valves will be closed automatically and shut down the operation as shown in SCADA System

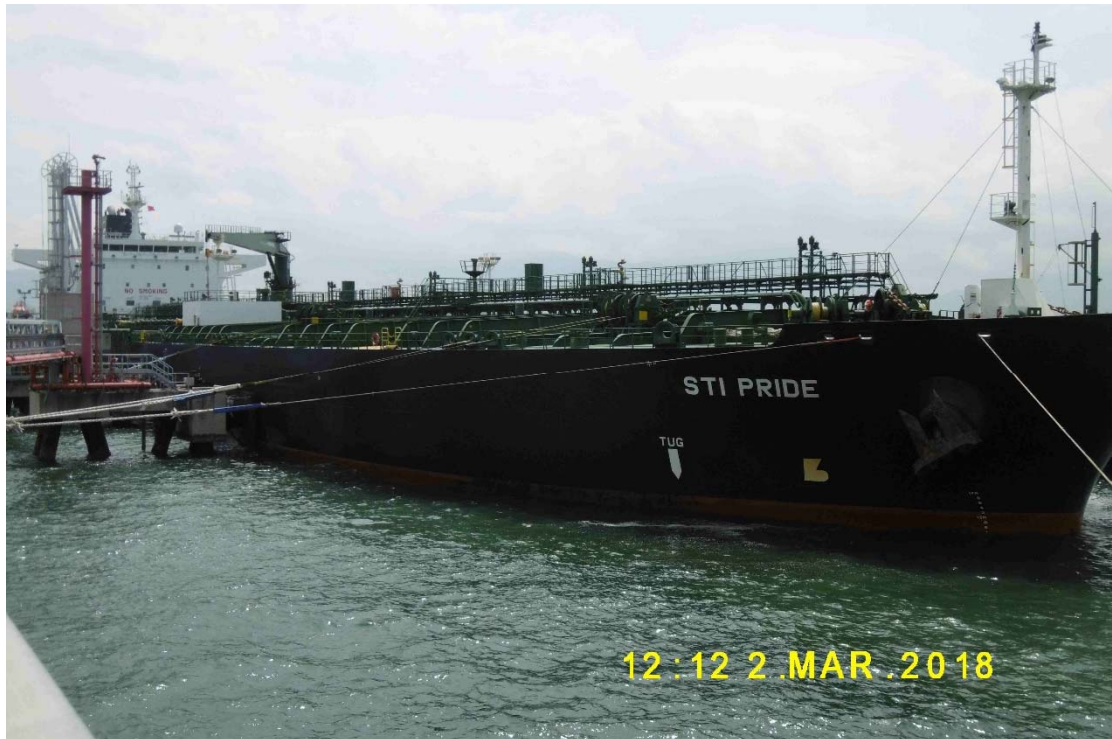
(36) Fenders are installed at sea side of the jetty
