PERMANENT AVIATION FUEL FACILITY

ANNUAL AUDIT REPORT

**Environmental Permit
EP-262/2007/B**

Date of Audit : 1 – 22 March 2018

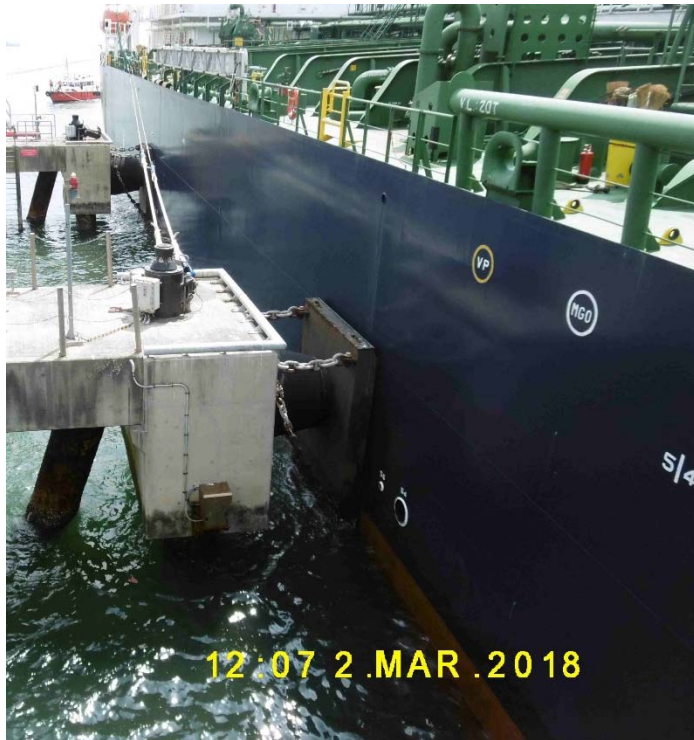
(37) Fenders are installed at sea side of the jetty

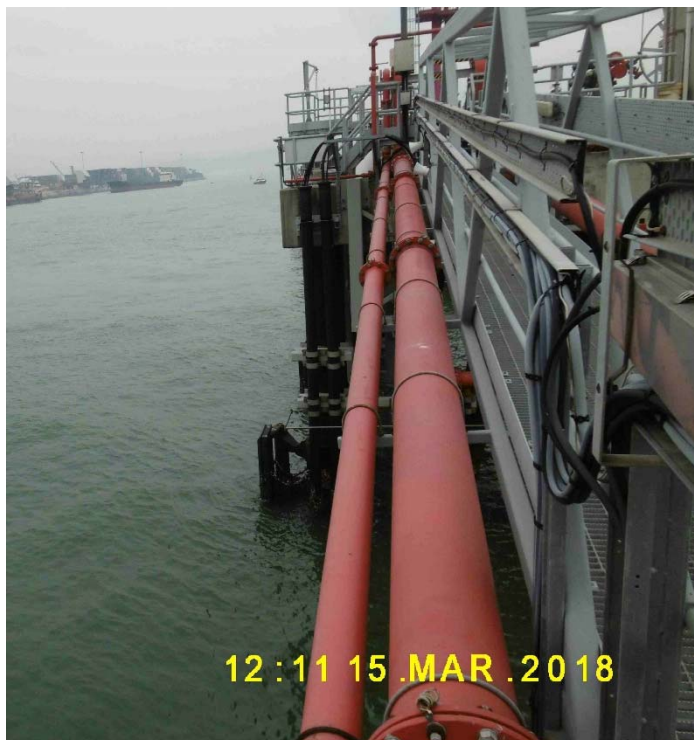
(38) Fenders are installed at shore side of the jetty

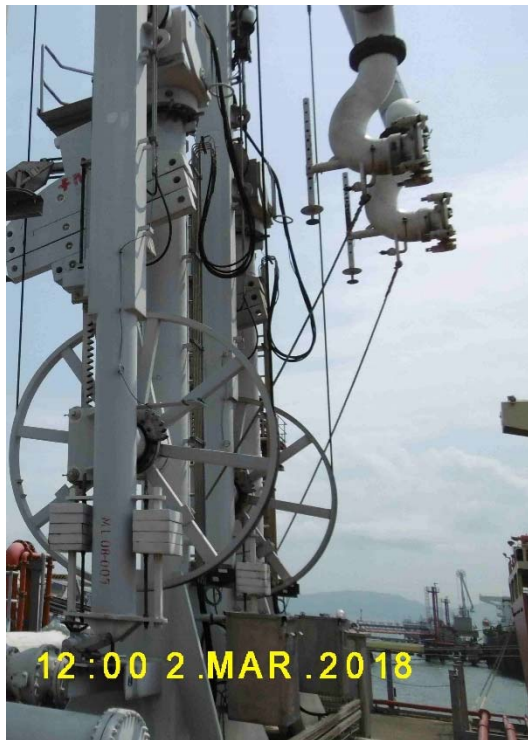
- (39) Slop collection utilities are used for coupling and de-coupling of the loading arms
