MONTHLY ENVIRONMENTAL MONITORING & AUDIT REPORT

Highways Department

Route 8
Between Tsing Yi and Cheung Sha Wan
Phase 2b East Tsing Yi Viaduct

*Monthly Environmental
Monitoring & Audit Report
(29th November 2008 - 28th December 2008)*

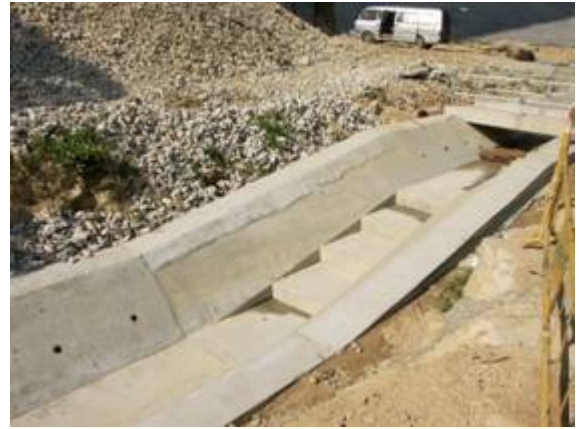
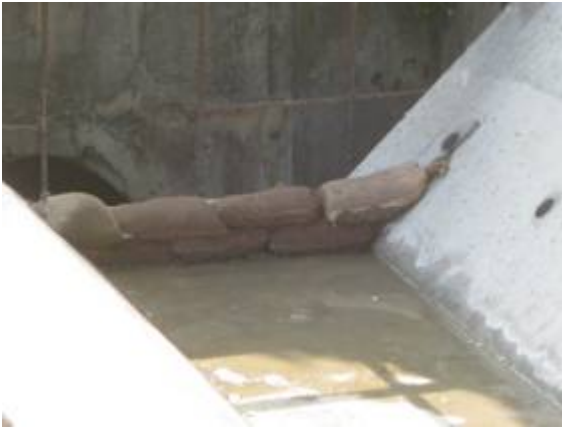
Photo 02 (area P2-SA6B (next to Gate 4))

2.	Silt and sand were accumulated in the trapezoidal channel adjacent to Gate 4 at area P2-SA6B. DCBJV was reminded to clean up the channel without further delay and provide adequate protection (such as aggregate filter with geotextiles) to the channel in order to avoid loose construction material entering into the storm drains.	Labours have been allocated to clean up the drainage system on site regularly. In addition, sandbag barriers were provided inside the trapezoidal channel in order to prevent sub-standard effluent and loose material from entering the storm drain.	Completed and closed. (Please refer to Appendix Q Photo 02 & 03).

- ii. Silt and sand were accumulated in the trapezoidal channel adjacent to Gate 4 at area P2-SA6B. DCBJV was reminded to clean up the channel without further delay and provide adequate protection (such as aggregate filter with geotextiles) to the channel in order to avoid loose construction material entering into the storm drains.

Corrective and Preventive Actions – Labours have been allocated to clean up the drainage system on site regularly. In addition, sandbag barriers were provided inside the trapezoidal channel in order to prevent sub-standard effluent and loose material

from entering the storm drain. DCBJV was recommended to further enhance the water quality mitigation measures on site before the coming wet season. (Please refer to *Appendix Q* Photo 02 & 03).

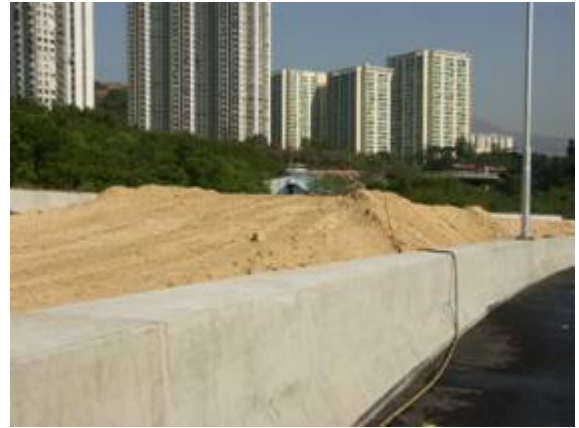
Photo 04 (area P2-SA6B (RW7))

Item	Findings	DCBJV's Corrective and Preventive measures	Effectiveness of measures
	with sufficient water in order to maintain the entire surface moist, in particular at area P2-SA6B (RW7 and under the bridge C2/D2).	remaining stockpiles shall be sprayed with sufficient water in order to minimize the dust impact generated from site.	(Please refer to Appendix Q Photo 04 & 05).

- iii. All open stockpiles of dusty material shall be covered entirely by impervious sheeting or to be sprayed with sufficient water in order to maintain the entire surface moist, in particular at area P2-SA6B (RW7 and under the bridge C2/D2).

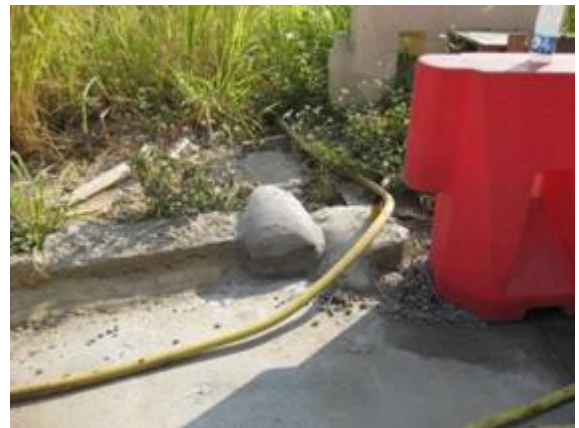
Photo 06 (area P2-SA6B)

4.	Part of the concrete bund adjacent to Gate 4 at area P2-SA6B was damaged. DCBJV was reminded to repair the damaged bund to avoid un-treated surface runoff entering into existing storm drain.	Sandbags were deployed as a bund to avoid un-treated surface runoff entering into existing storm drain.	Completed and closed. (Please refer to Appendix Q Photo 06).

- iv. Part of the concrete bund adjacent to Gate 4 at area P2-SA6B was damaged. DCBJV was reminded to repair the damaged bund to avoid un-treated surface runoff entering into existing storm drain.

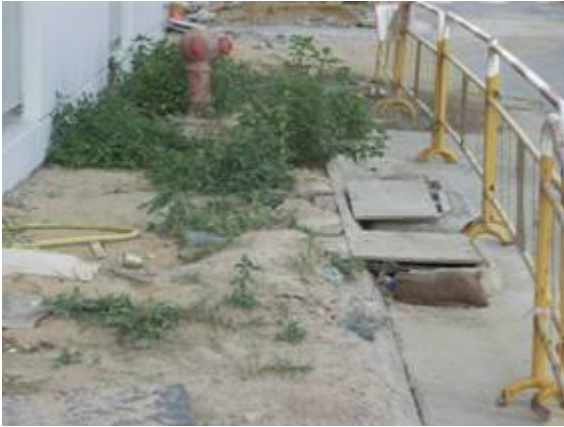
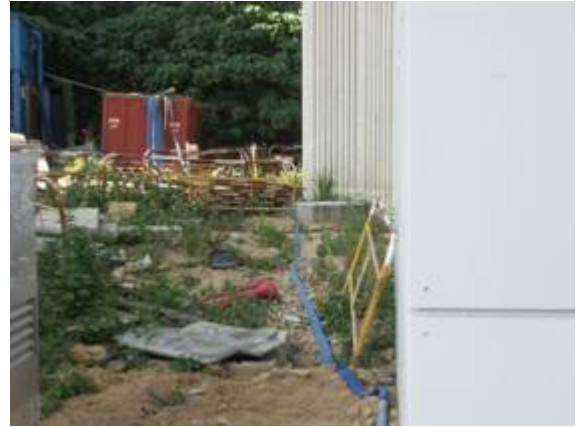
Photo 07 (area P2-SA6E)

3	Part of the concrete bund adjacent to Gate 4 at area P2-SA6B was damaged. DCBJV was reminded to repair the damaged bund to avoid un-treated surface runoff entering into existing storm drain.	Sandbags were deployed as a bund to avoid un-treated surface runoff entering into existing storm drain.	Completed and closed. (Please refer to Appendix Q Photo 06).
4	The outlet pipe of the pump for the wastewater collecting pit was connected to the gully at the site entrance of area P2-SA6E. DCBJV was reminded that all construction effluent including surface runoff should be diverted to adequate designed treatment facilities prior to discharge.	The outlet pipe was removed from the existing gully immediately during the site inspection. All surface runoff / wastewater from the collecting pit has been diverted to the sedimentation tank on site prior to discharge.	Completed and closed. (Please refer to Appendix Q Photo 07 & 08).

- iii. Part of the concrete bund adjacent to Gate 4 at area P2-SA6B was damaged. DCBJV was reminded to repair the damaged bund to avoid un-treated surface runoff entering into existing storm drain.
