CONSTRUCTION OF YUEN LONG SOUTH BRANCH SEWERS AND EXPANSION OF HA TSUEN SEWAGE PUMPING STATION

THE NINTH RESULTS OF LANDSCAPE AND VISUAL IMPACT MONITORING FOR OCTOBER 2010 (NO.9)

Site Inspection Cl	hecklist	t			
Co	ntract No.:	DC/2009/08					
Co	ontract title:	Construction of Yuen Long South Sewer and Expansion	n of Ha Ta	suen Sew	age Pum	ping Station	
Co	ontractor:	China State Construction Engrg. (HK) Ltd.					
Lo	cation:	Ha Tsuen Sewage Pumping Station					
Ins	spection Date:	15-Oct-2010

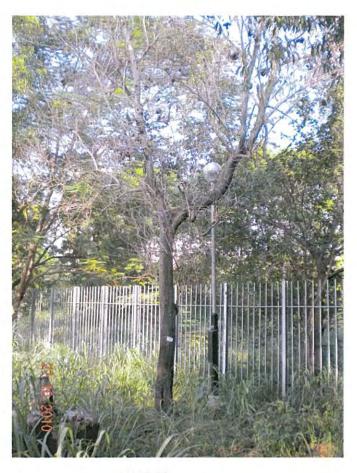
Tree Nos.	Health	Tree Form	Comments	Suggested treatment
HA260	Poor	Poor	Dying	Water more frequently
HA265	Poor	Poor	Dying	Water more frequently
HA245	Dead	Dead	Removed from the site	To plant a new tree
T3519	Dead	Dead	Removed from the site	To plant a new tree
T3591	Dead	Dead	Removed from the site	To plant a new tree
T3596	Dead	Dead	Removed from the site	To plant a new tree
