Harbour Area Treatment Scheme Stage 2A

Construction of Sewage Conveyance System from Aberdeen to Sai Ying Pun

Monthly Environmental Monitoring and Audit Report No.12

Construction of Sewage Conveyance System from Aberdeen to Sai Ying Pun Condition 4.4 – Submission of Monthly EM&A Report for December 2010 (no. 12)

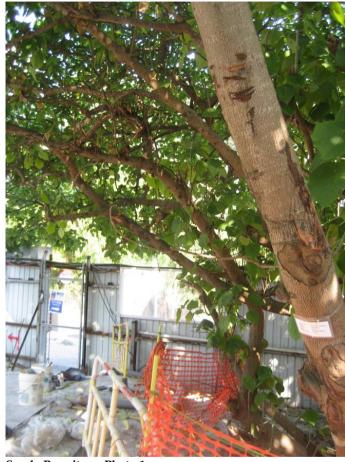
As observed at the Sandy Bay site, leaves on several branches of Tree T038 fell off while remaining rich in other sections. The Contractor is recommended to seek advice from tree consultant and check whether mitigation measures would be necessary to maintain the health of the tree.

Sandy Bay site --- Photo 1
The retained tree T038(R) is showing signs of deterioration in health.

At Sandy Bay site, the contractor is recommended to seek advice from tree consultant and check whether mitigation measures to retain the health of tree.

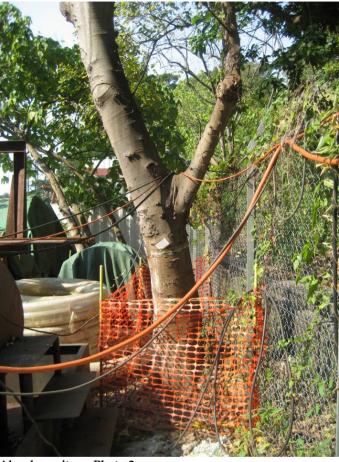
Aberdeen site --- Photo 2
Wires were observed to be hanging on tree branches on tree T81 (R). .

The landscape and visual site audit was undertaken on 22 December 2010 to check the design, implementation and maintenance of L&V mitigation measures at work sites. The Contractor is recommended to avoid using retained trees as support means for work on site to avoid damages to health of retained trees on site, especially the Tree T081 in Aberdeen.

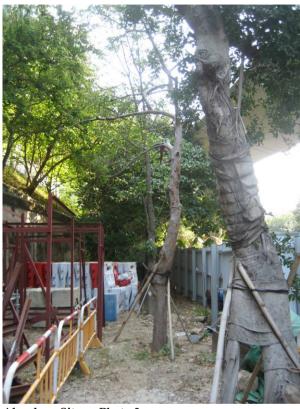
According to the tree consultant of the Contractor, the transplanted tree T004 at Aberdeen site was reported to be in poor health condition. There is no improvement in health condition of the tree since the last site audit. The Contractor is advised to consult their tree consultant immediately and take appropriate actions to restore the health condition of the tree.

Aberdeen Site --- Photo 3
The health condition of the transplanted tree T004 has not been improved since site audit in September 2010.

According to the tree consultant of the Contractor, the transplanted tree T004 at Aberdeen site was reported to be in poor health condition. There is no improvement in health condition of the tree since the last site audit. The Contractor is advised to consult their tree consultant immediately and take appropriate actions to restore the health condition of the tree.
