Document Details					
Client Drainage Services Department					
Project Contract No. DC/2007/24 Harbour Area Treatment Scheme Stage 2A Construction of Sewage Conveyance System from Aberdeen to Sai Ying Pun					
Document Title Monthly Environmental Monitoring and Audit Report No. 22 Covering the Period from 1 October 2011 to 31 October 2011					
Document No. EMA/027					
Distribution					
Copy No.	Issued To	Copy No.	Issued To		
01-02	Leighton-LNS JV	10	Metcalf & Eddy-AECOM JV		
03	Mott MacDonald Hong Kong Ltd	11	ACL (Project Office)		
04-08	EPD	12	ACL (Head Office)		
09	DSD				
Submission Ref			Controlled Copy No.		
SUBM Ref.	DC/2007/24/31.20/OG3180/EC/SH/EY				
Atkins Ref.(s)					
Revision History					
B	17 November 2011	Submission to IEC and ER for Further Review	Various	Susana Halliday	Eric Chui
A	14 November 2011	Submission to IEC and ER for Review	Various	Susana Halliday	Eric Chui
Rev.	Date	Description	Prepared	Checked & Reviewed	Approved

Contract No. DC/2007/24
Harbour Area Treatment Scheme Stage 2A
Construction of Sewage Conveyance System from Aberdeen to Sai Ying Pun

Contract No. DC/2007/24
Construction of Sewage Conveyance System from Aberdeen to Sai Ying Pun
Condition 4.4

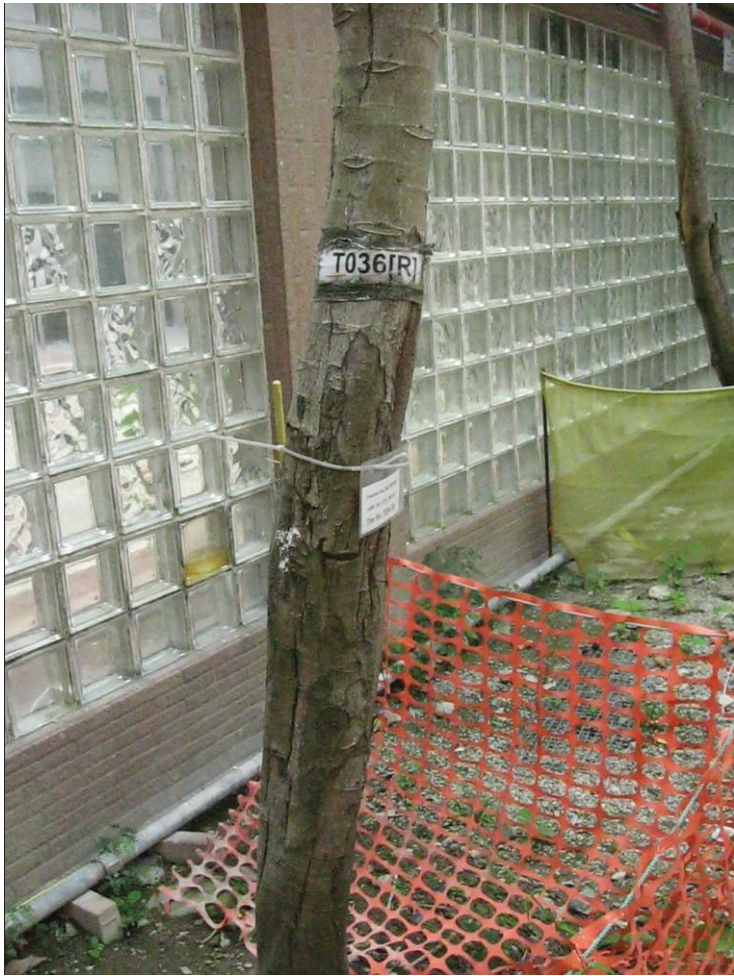
Sandy Bay site --- Photo 1

Retained trees T036(R), T037(R) and T020(R) in Sandy Bay were still observed in poor health condition and may have been dead since July 2011. The Contractor was advised to check the overall health condition of the retained trees and to take immediate and necessary mitigation measures to revive their health conditions or replaced all affected trees if confirmed dead. Retained trees T036(R) and T037(R) were affected by the formation of stagnant water observed during the site audit and T020(R) was observed to be in poor health condition since the site audit in June 2011.

Retained trees T036(R) were still in poor health condition and it might be dead since the last audit.

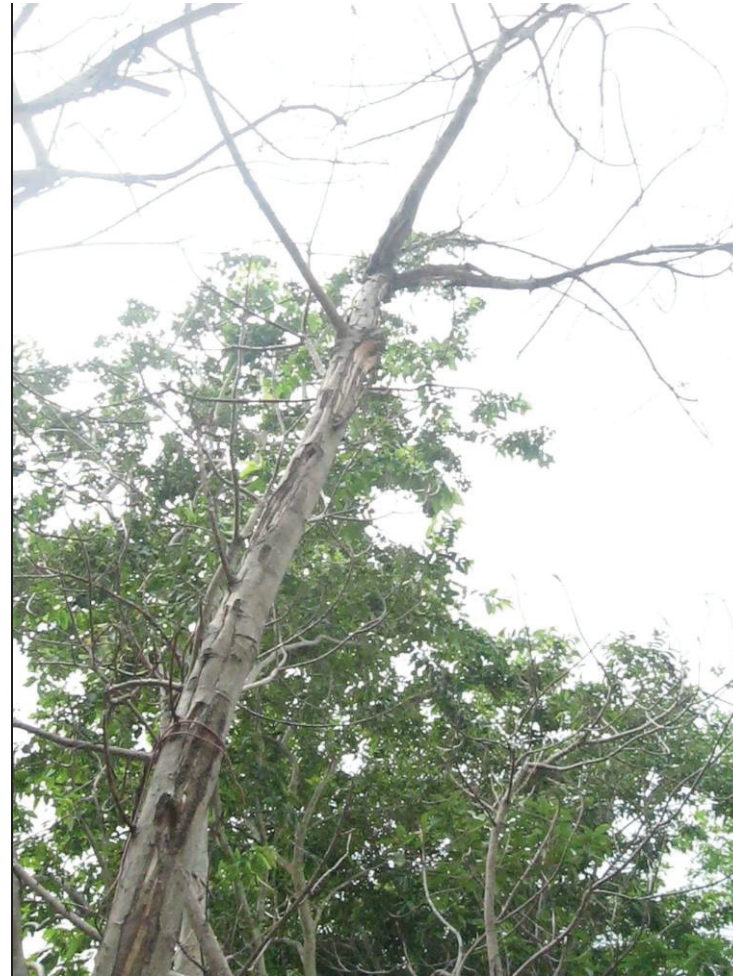
Sandy Bay site --- Photo 2

Close-up photo for retained trees T036(R) were still in poor health condition and it might be dead since the last audit.

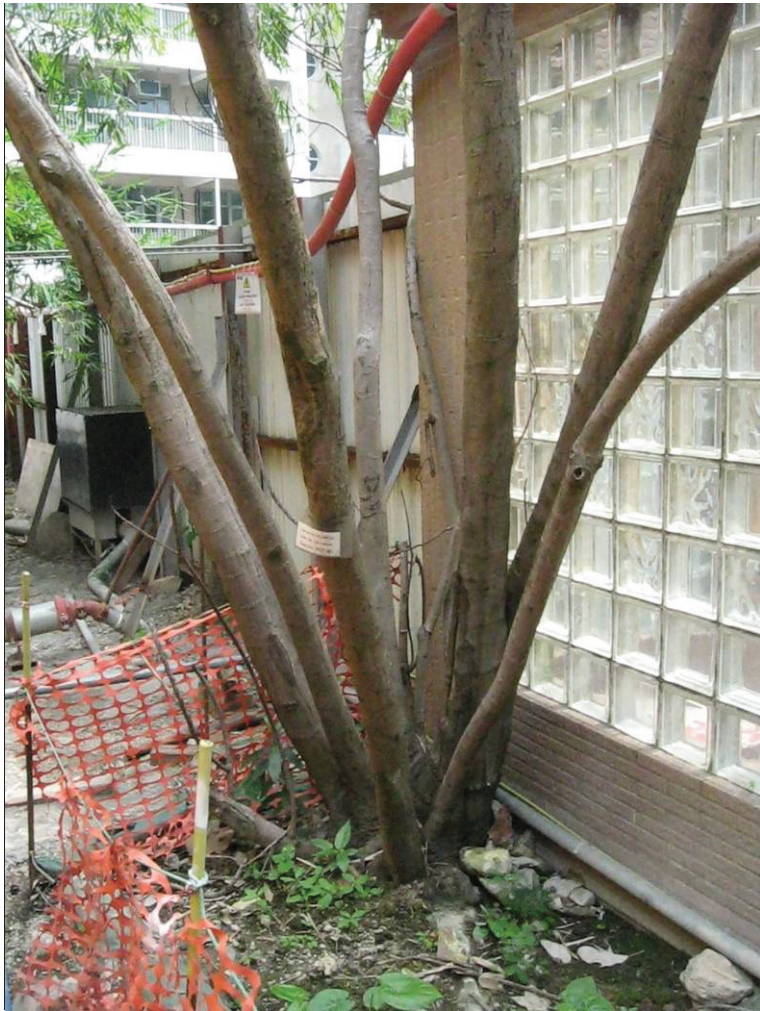
Sandy Bay site --- Photo 3

Retained tree T037(R) were still in poor health condition and it might be dead since the last audit.

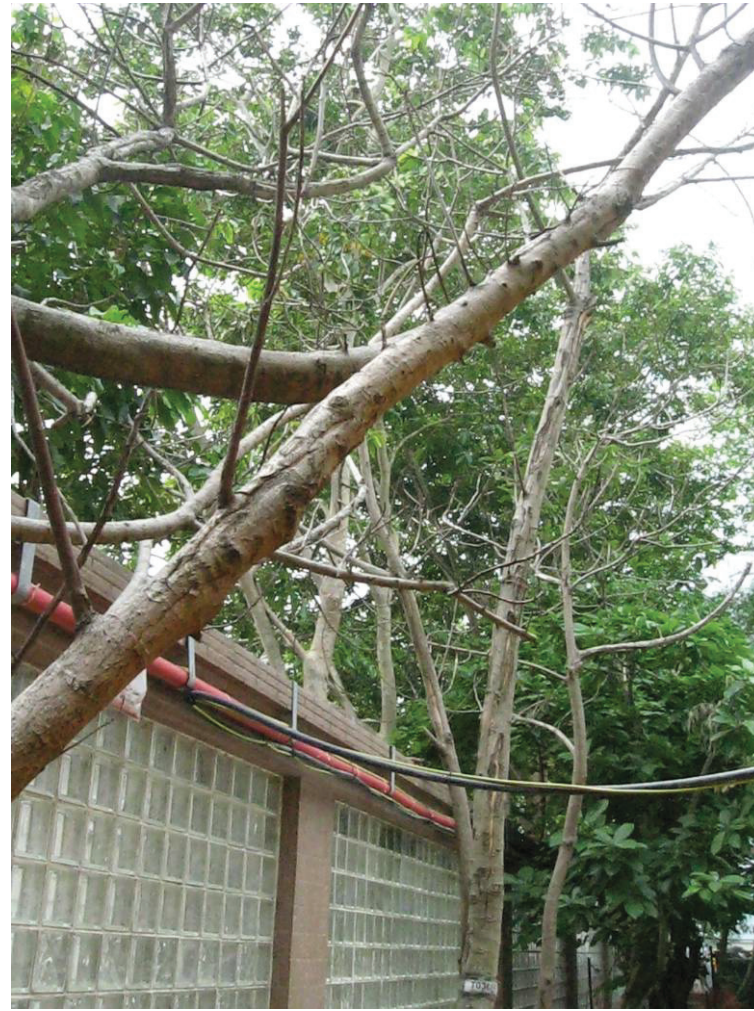
Sandy Bay site --- Photo 4

Close-up photo for retained tree T037(R) were still in poor health condition and it might be dead since the last audit.

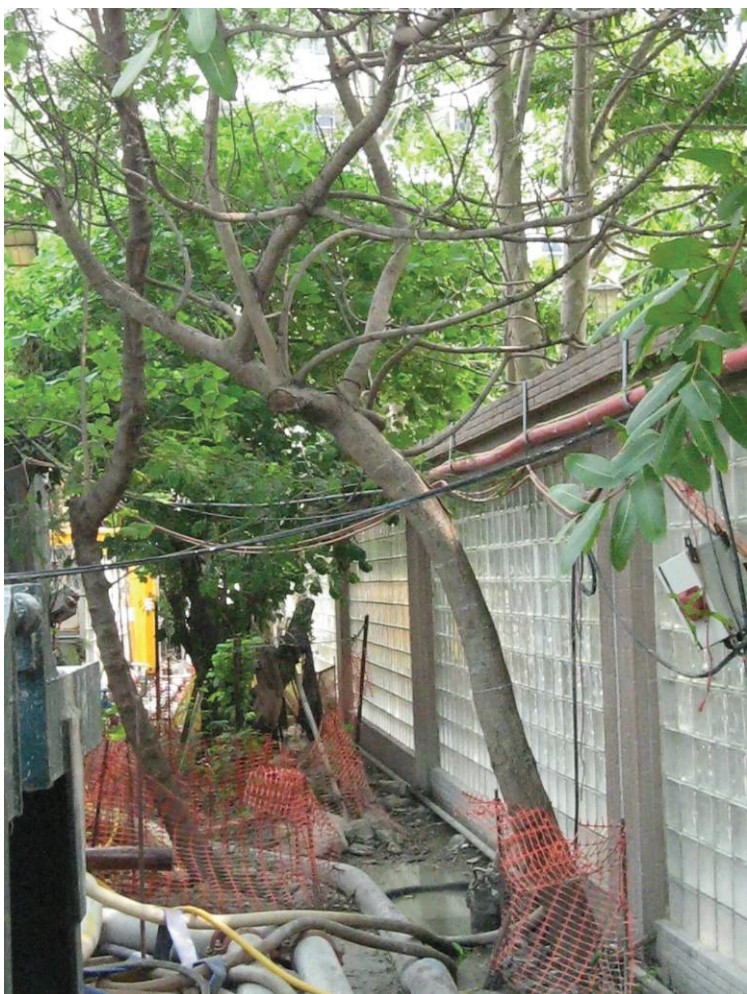
Sandy Bay site --- Photo 5

Retained tree T020(R) was still observed to be in poor health condition.

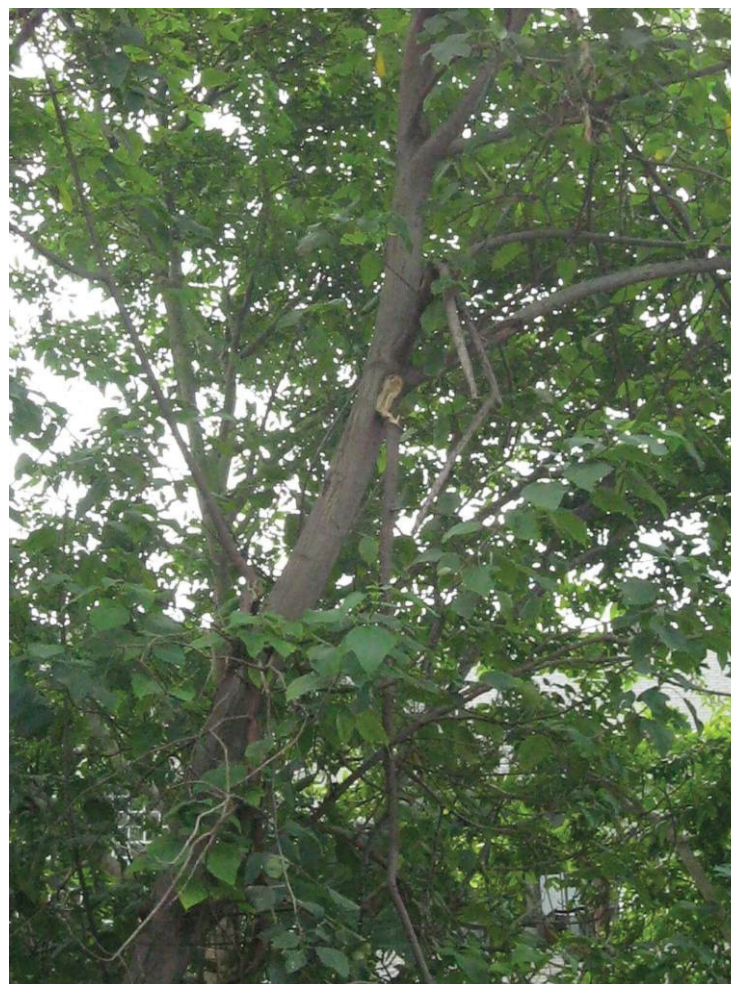
Sandy Bay site --- Photo 6

The retained trees T028(R) and T038(R) exhibited some deterioration and damage to the branches and had dried leaves falling-off from the affected areas.

The retained Trees T028 (R) was still observed some deterioration and damages on the stems.

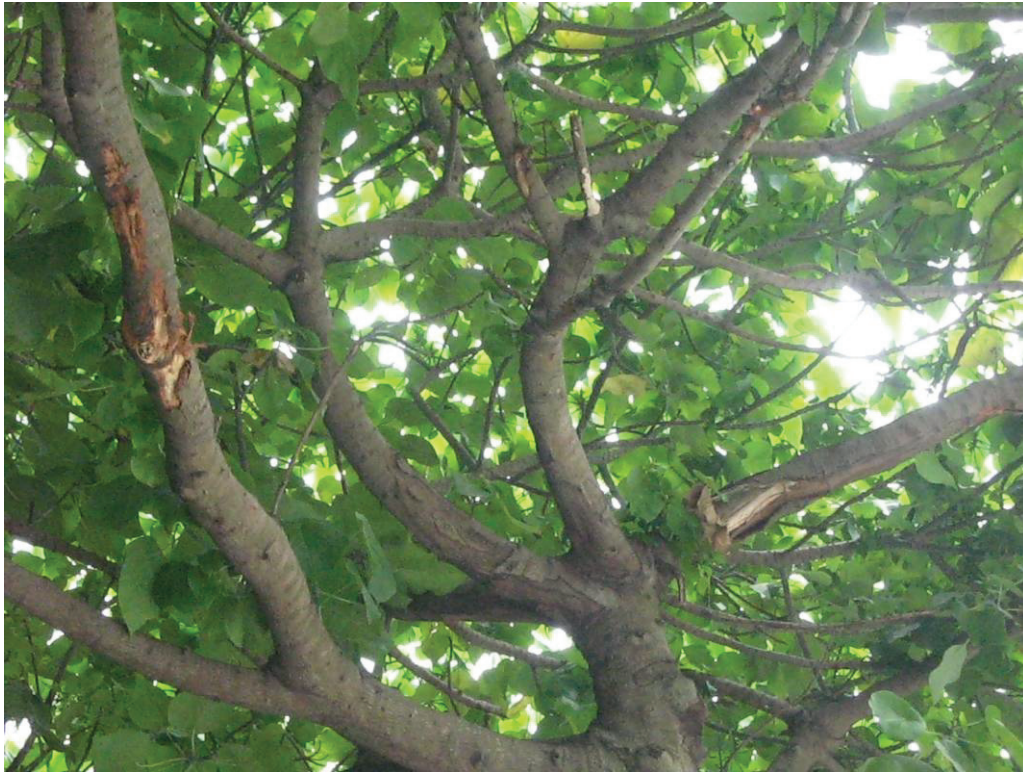
Sandy Bay site --- Photo 7

The retained Tree T038 (R) was still observed some deterioration on its health.

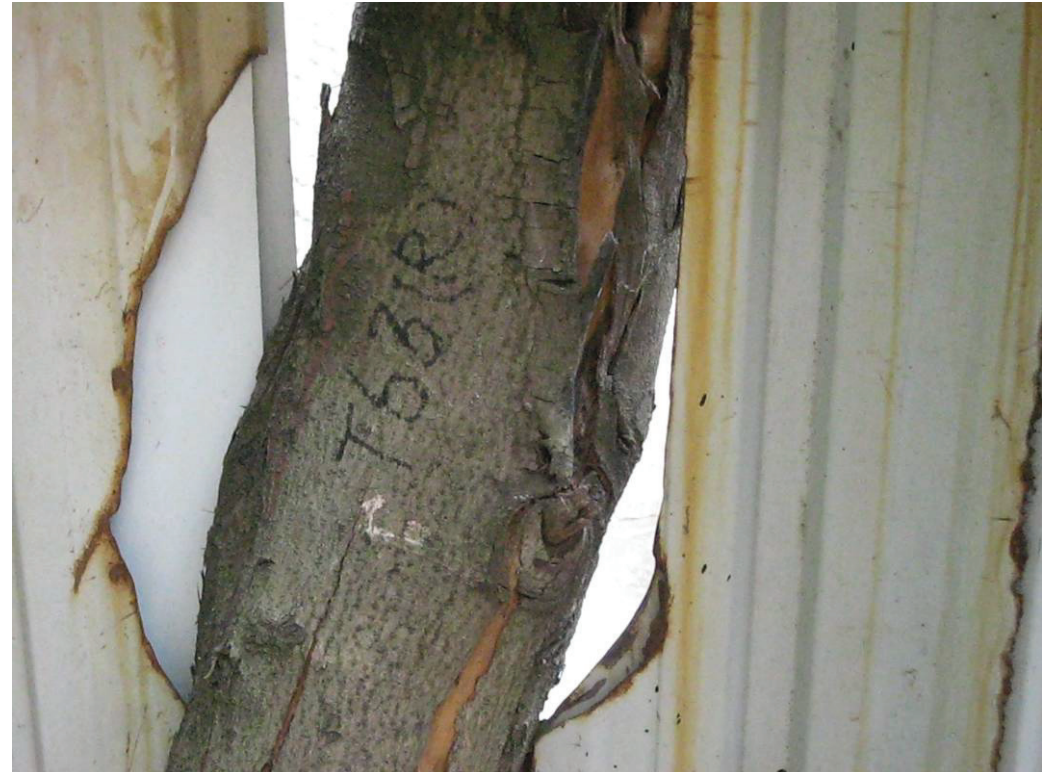
Sandy Bay site --- Photo 8

ERM also spotted a tree within the boundary that protrudes from the adjacent site with the tree name T063 (R). This tree was observed in a very poor health condition and is likely dead. The Contractor was recommended to check if this tree was part of the original tree survey, and if the tree is confirmed to be part of the original tree survey report, the Contractor was advised to properly tag the tree and take immediate action to revive its health condition or replace if confirmed dead.

Tree T063 (R) was spotted protruding at the adjacent site. This tree needs verification.

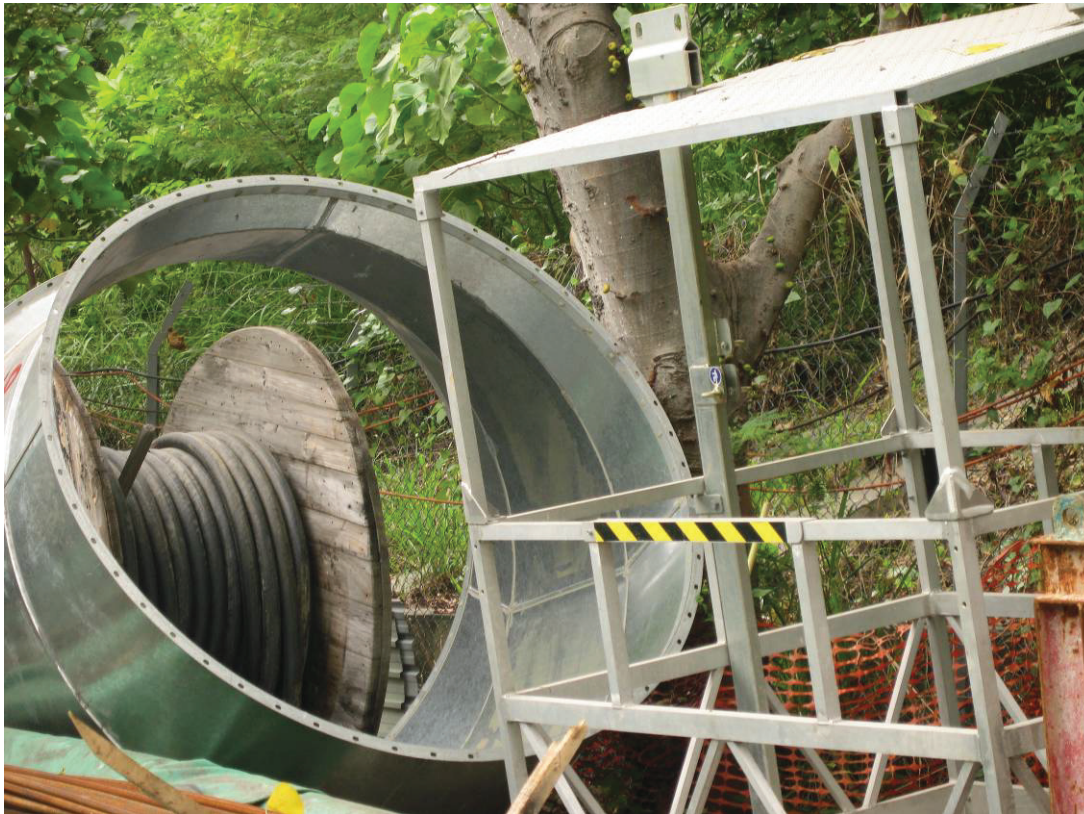
Aberdeen site --- Photo 9

Construction material directly leaning on the stems of retained tree T081(R) was observed.

Construction material in Aberdeen site was observed to be leaning directly on the stem of retained tree T081(R) and a bag of garbage was stored very near to the roots of T083(T). The Contractor was advised to relocate the construction materials away from the retained tree and remove all garbage bags from the roots of the transplanted tree.

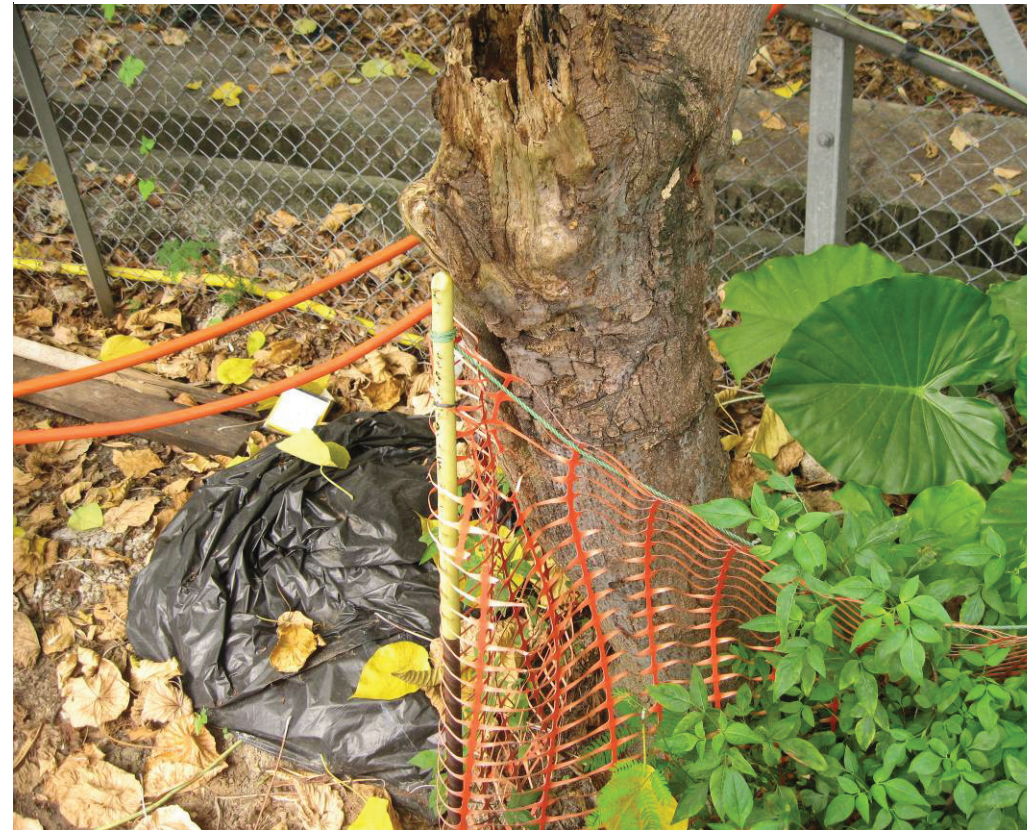
Aberdeen Site --- Photo 10

Garbage bag was found at the roots of the transplanted Trees T083 (T).

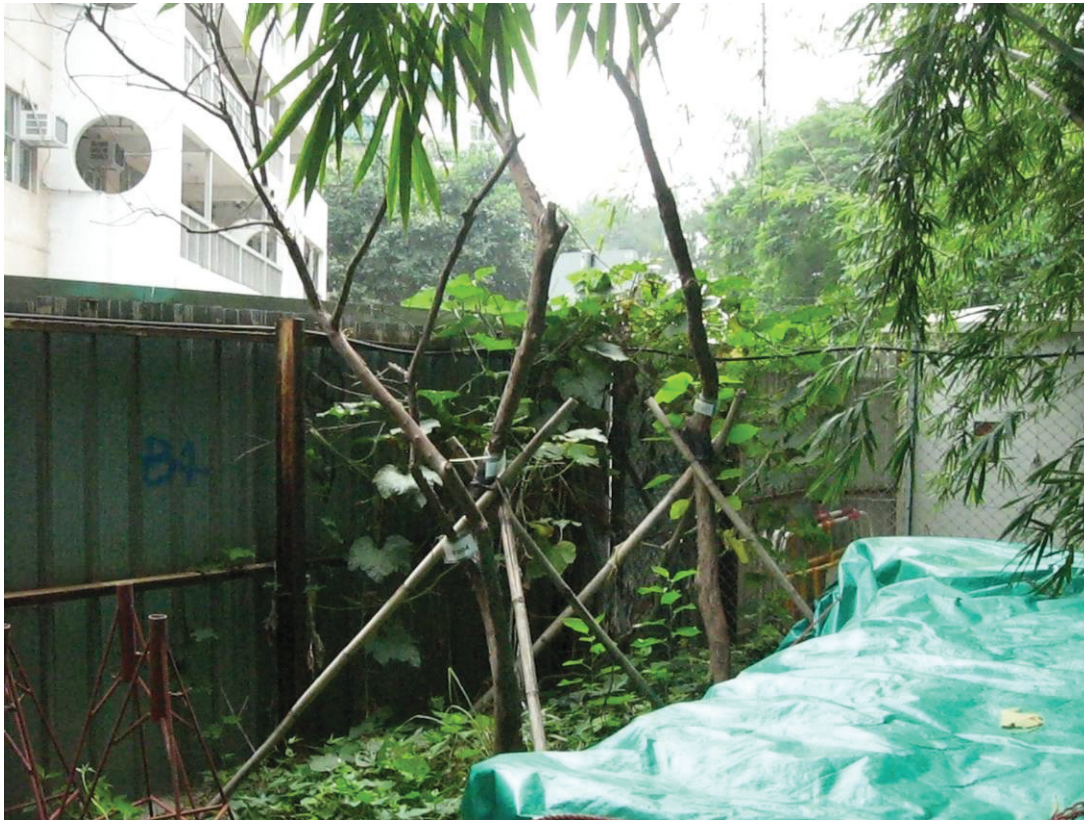
Sandy Bay site --- Photo 11

The transplanted trees T004 (T) and T005 (T) were still observed to be in very poor health condition and may have been dead since the 10th monthly audit undertaken in December 2010.

The transplanted Trees T004 (T) and T005 (T) were still observed in poor health condition and might be dead.

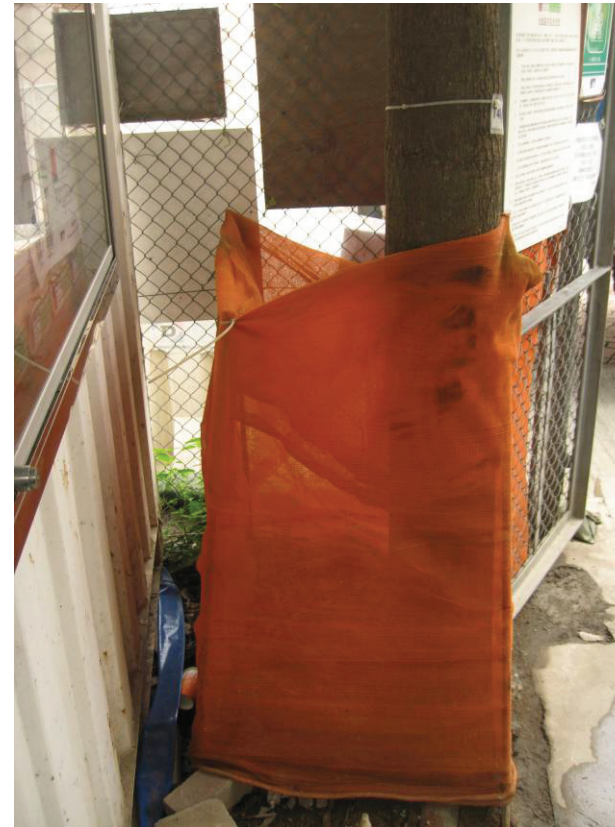
Cyberport site --- Photo 12

Besides, all landscape and visual mitigation measures listed out in the Project EM&A Manual have been implemented CM2 at Cyberport site, CM2 at Aberdeen Site, and, CM2 and CM3 at the Sandy Bay site. Formation of stagnant water was still observed at the Cyberport site since the audit undertaken in July and the water may affect the overall health condition of the retained tree T048(R).

Formation of stagnant water was still observed around retained tree T048(R).

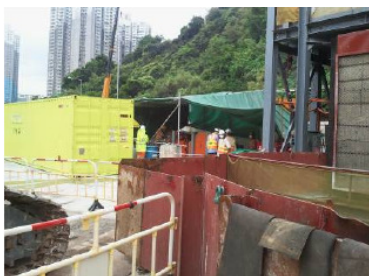
Photo 1 The 3-sides cover at the cement mixing area was found improperly.

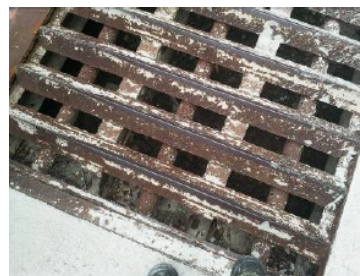
Photo 2 The general refuses were found in the wheel-washing machine.

The contractor was reminded to remove the refuses in wheel washing machine regularly.

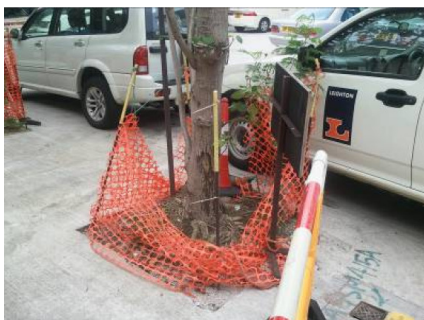
Photo 1 The protection fencing for the tree was found damage at the car park area

1. The contractor was reminded to provide the protection fencing for tree properly.

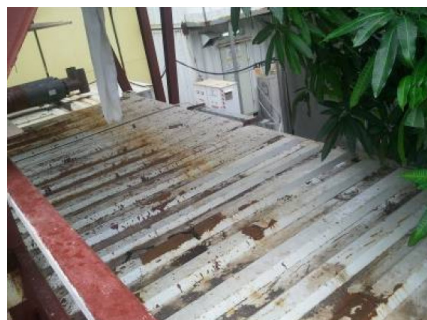
Photo 2 The accumulated water was found on the top of container.

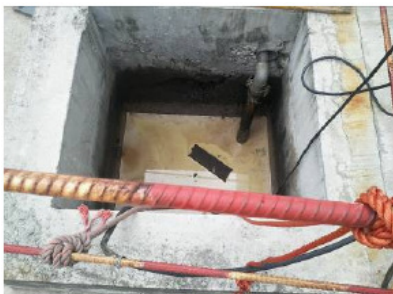
Photo 1 The accumulated silt and muddy water was found in the gully pot near the site entrance.

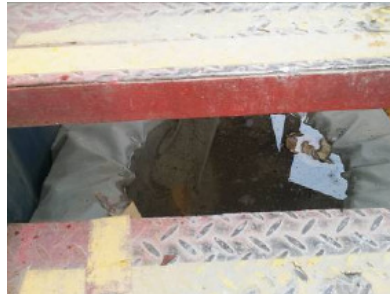
Photo 2 The accumulated water was found on the cover of the used tire.

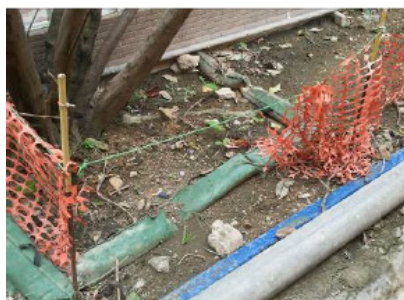
Photos 3 The tree protective fence was broken behind the sedimentation tank since last inspection.

1. 1. The contractor was reminded to renew the tree's protective fence behind the sedimentation tank

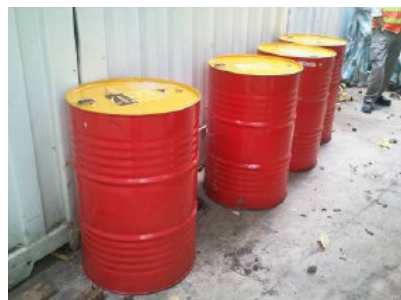
Photo 4 Waste oil drum near chemical storage was found without drip tray.

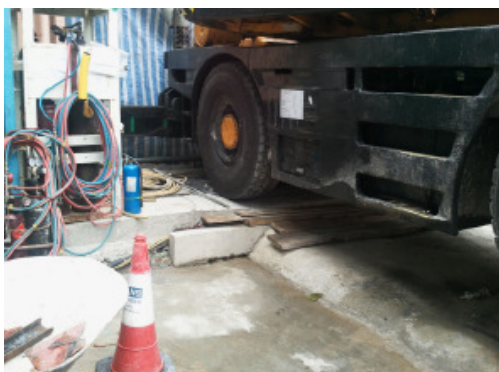
Water accumulation near mobile crane was found(Photo 1)

Photo 1 Water accumulation near mobile crane was found

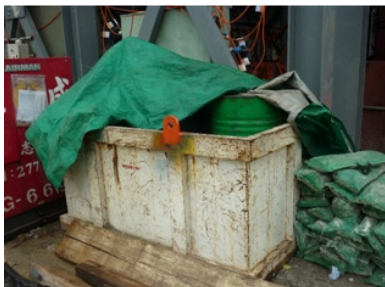
Photo 1 A chemical drum without labels was found

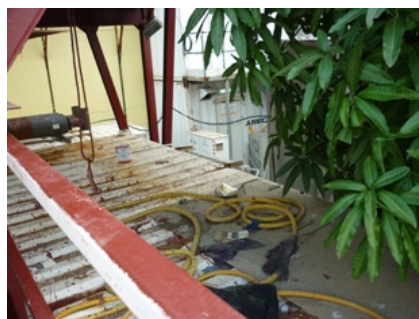
Photo 2 Unused chemical materials were found on roof of workers resting area

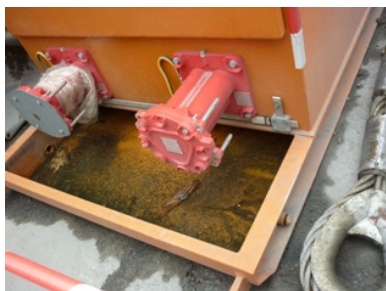
Photo 1 and 2 Water accumulation was found in generator 's drip tray and next to noise enclosure

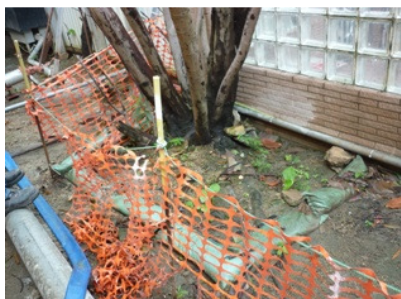
Photos 3 The tree protective fence was broken behind the sedimentation tank since last inspection

1. To renew the tree's protective fence behind the sedimentation tank.

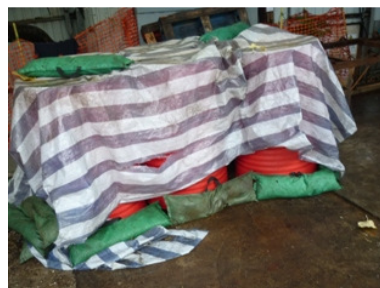
Photo 4 Chemical drum near chemical storage was found without drip tray

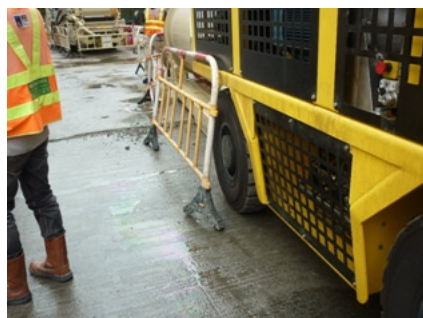
Photo 5 Oil spot was found around the site, especially near the wheel entrance

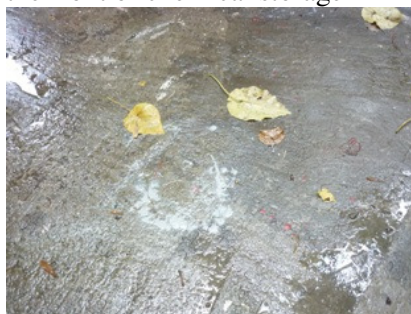
Photo 6 A unknown chemical spot was found in the front of chemical storage

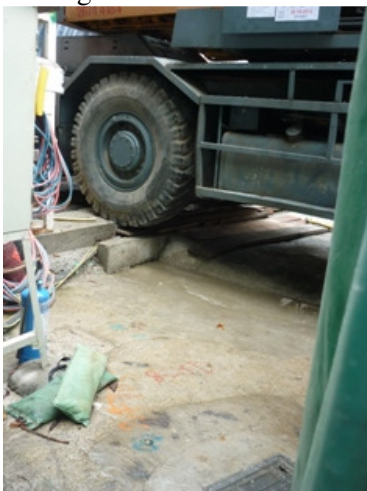
Photo 1 The contractor is recommended to provide drainage for site runoff

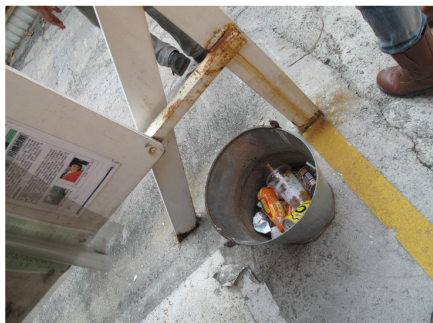
Photo 1 Rubbish found in sand bucket

Notes / Issues Recorded On Site:
Waste Management: 1. Rubbish found in sand bucket (Photo 1)
Corrective Actions – Mitigation Measures Implemented or Proposed (if any):
Previous Environmental Site Inspection Checklist – Report No. 111011
Nil
Current Environmental Site Inspection Checklist – Report No. 111018
Waste Management: 1. Clear the rubbish in the sand bucket.

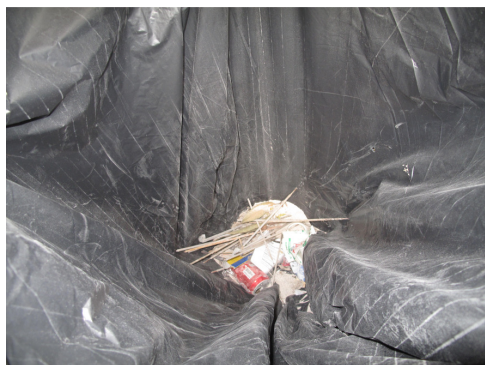
Photo 1 Improper use of recycle bin for metal

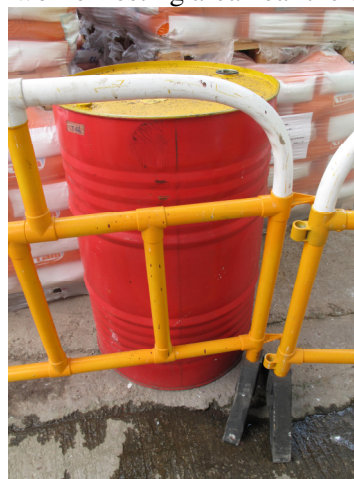
Photo 2 Chemical drum without drip tray found in worker resting area near the entrance

1. The Contractor is reminded to avoid chemical storage in the worker resting area.

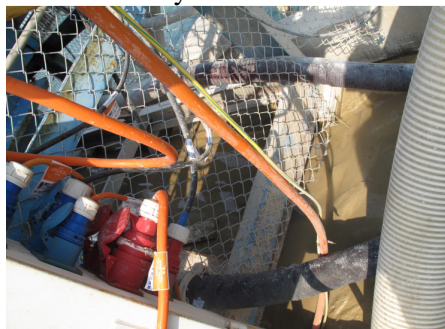
Photo 1 Mud was found underneath the treatment tank and may wash into the sea

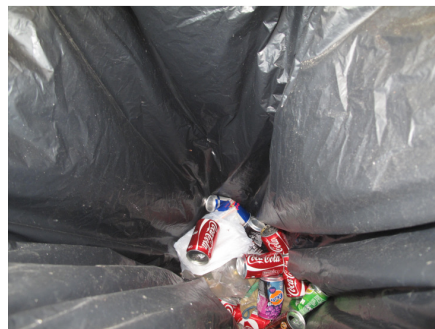
Photo 2 Improper use of recycle bin for metal

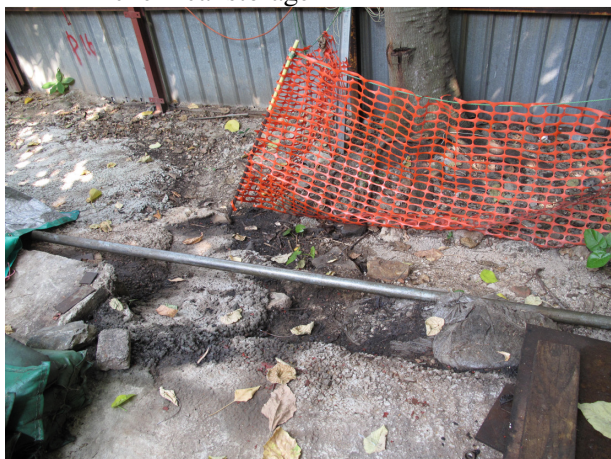
Photo 1 Oil spots were found in the soil near the chemical storage

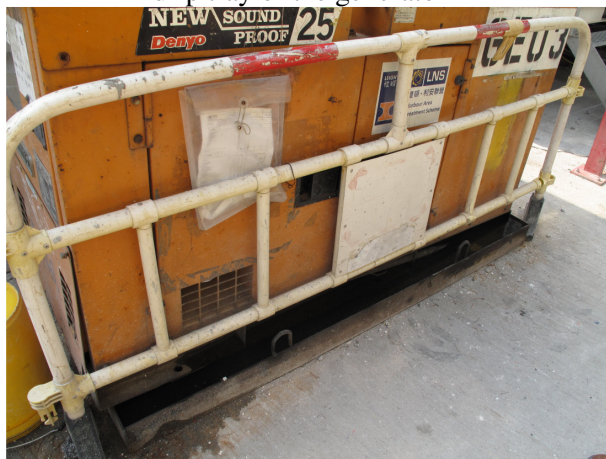
Photo 2 Water accumulation was found in the drip tray of the generator

1. To clear the accumulated water in the drip tray of the generator.

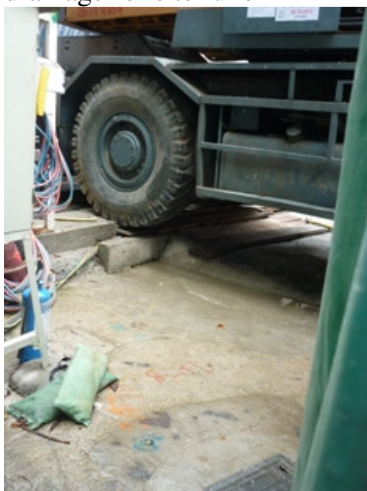
Photo 1 The contractor is recommended to provide drainage for site runoff

The contractor is recommended to provide drainage for site runoff. (Photo 1)

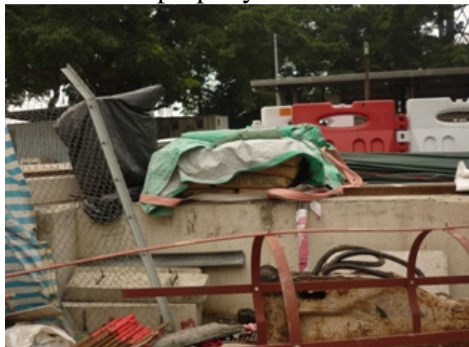
Photo 1 Cement bags were found near site entrance and PTW without properly cover

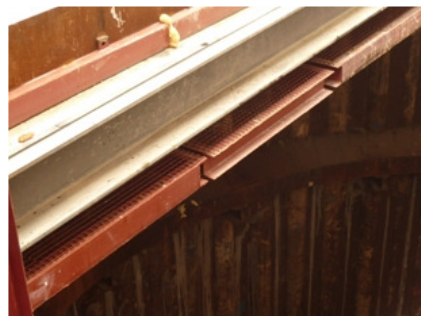
Photo 2 Some acoustic material missing was observed between the noise cover

1. According to contractor, the acoustic material between noise cover had been removed since some instillation works before. And those acoustic materials will be provided before next inspection.

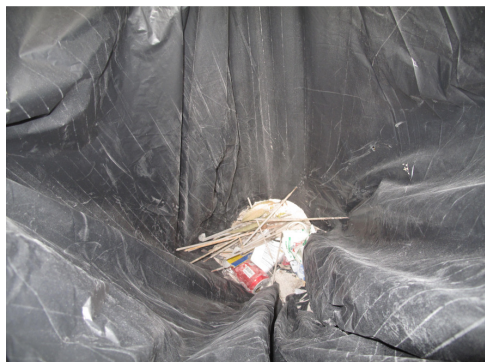
Photo 1 Improper use of recycle bin for metal

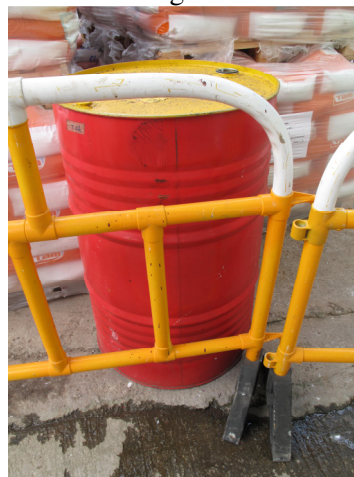
Photo 2 Chemical drum without drip tray found in worker resting area near the entrance

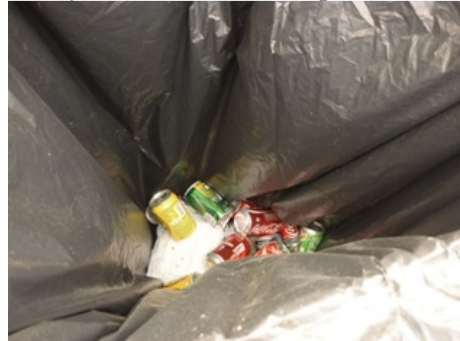
Photo 2 PVC box still had been found in metal recycle bin since last inspection

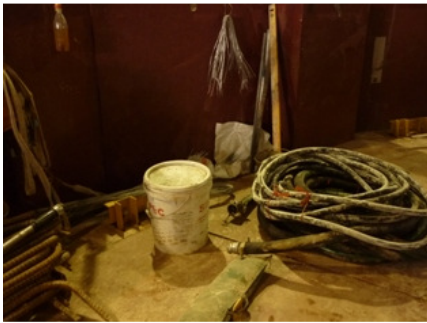
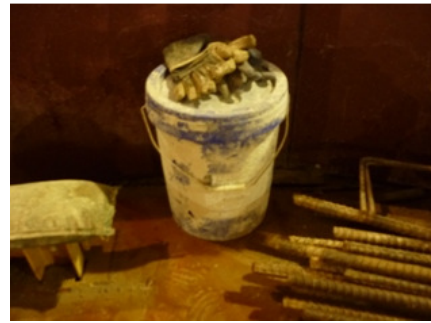
Photos 3 and 4 Two chemical drums were found on cover panel were missing proper labels

1. To provide suitable and clear chemical labels to chemical drums.

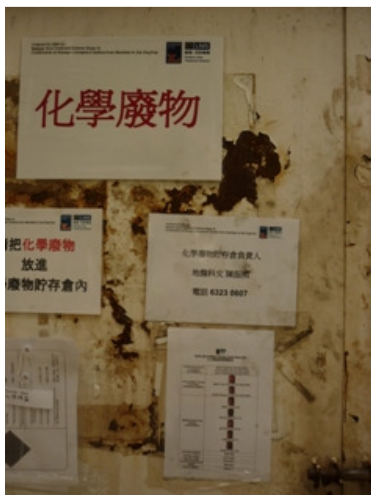
Photo 1 The responsible person of chemical waste storage was not updated

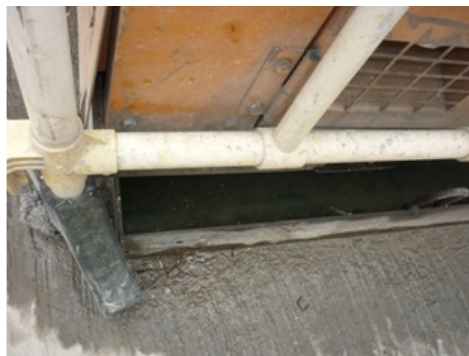
Photo 2 Water accumulation was found in the drip tray of the generator near the noise enclosure

1. To clear the accumulated water in the drip tray of the generator.

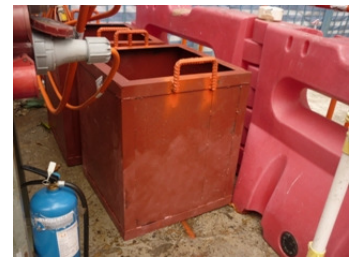
Photo 2 Trashes were found in metal case near water barriers

1. The contractor is reminded to clear trashes in metal case and drip tray and cover the metal case to prevent water accumulation.
