Document Details					
Client <b>Drainage Services Department</b>					
Project <b>Contract No. DC/2007/24 Harbour Area Treatment Scheme Stage 2A Construction of Sewage Conveyance System from Aberdeen to Sai Ying Pun</b>					
Document Title <b>Monthly Environmental Monitoring and Audit Report No. 26 Covering the Period from 1 February 2012 to 29 February 2012</b>					
Document No. <b>EMA/032</b>					
Distribution					
Copy No.	Issued To	Copy No.	Issued To		
01-02	Leighton-LNS JV	10	Metcalf & Eddy-AECOM JV		
03	Mott MacDonald Hong Kong Ltd	11	ACL (Project Office)		
04-08	EPD	12	ACL (Head Office)		
09	DSD				
Submission Ref				Controlled Copy No.	
SUBM Ref.					
Atkins Ref.(s)		DC/2007/24/31.20/OG3513/EC/SH/EY			
Revision History					
B	14 March 2012	Submission to IEC and ER for Further Review	Various	Susana Halliday

Contract No. DC/2007/24  
Harbour Area Treatment Scheme Stage 2A  
Construction of Sewage Conveyance System from Aberdeen to Sai Ying Pun

## Environmental Certification Sheet – 36

**Contract No. DC/2007/24  
Construction of Sewage Conveyance System from Aberdeen to Sai Ying Pun  
Condition 4.4 – Submission of Monthly EM&A Report for February 2012 (no. 26)**

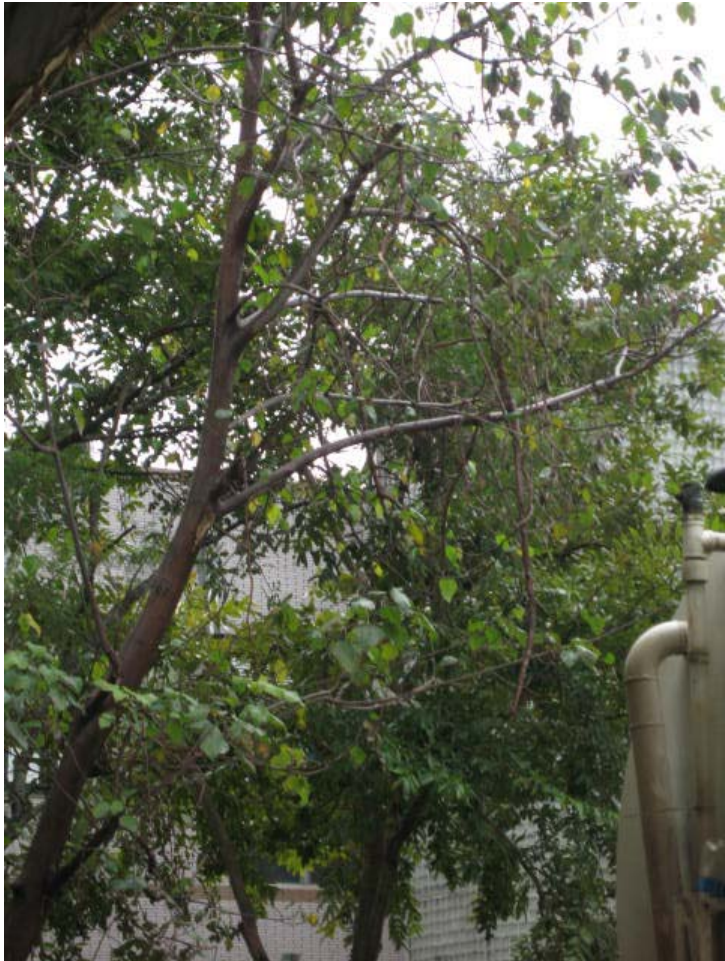
**Sandy Bay site --- Photo 5**

The retained Tree T028 (R) was still observed deterioration and damages on the branches and leaves.

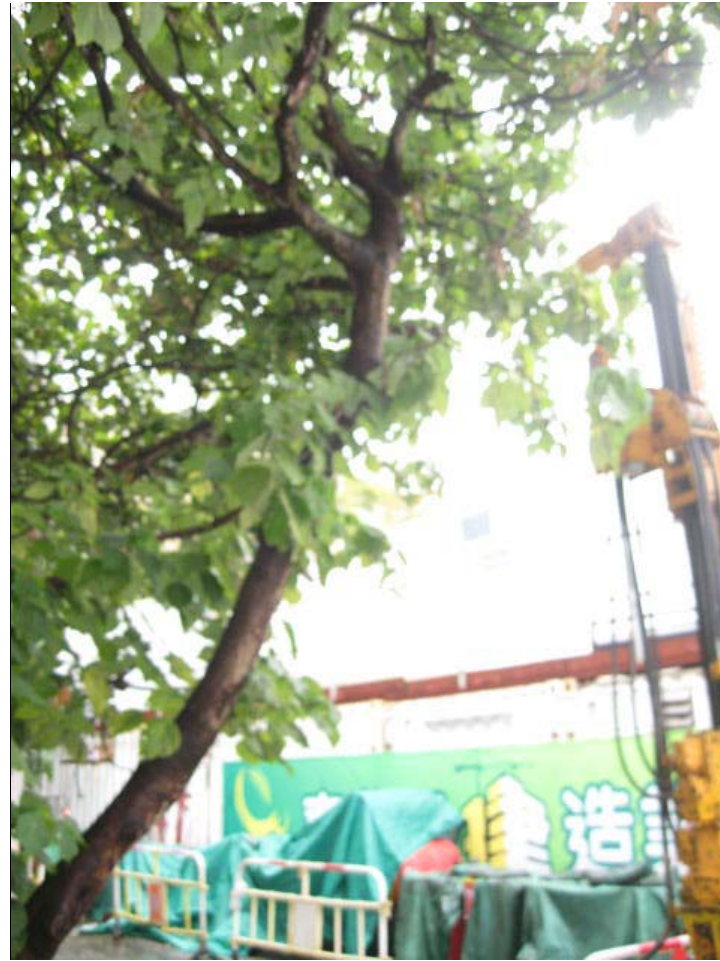
**Sandy Bay site --- Photo 6**

The retained Tree T038 (R) was still observed deterioration on its health.

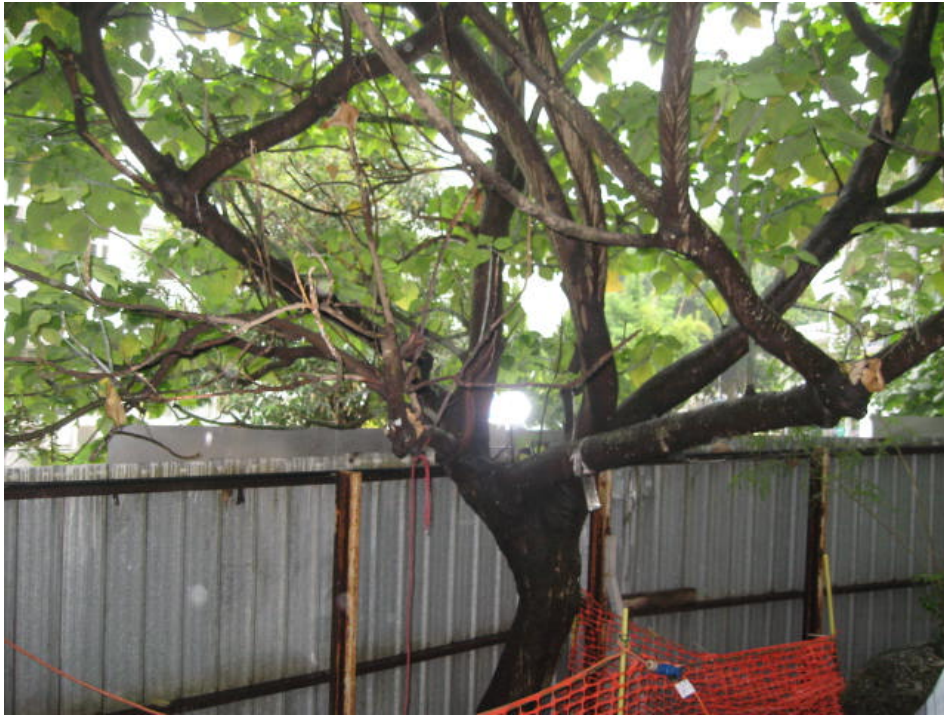
**Sandy Bay site --- Photo 7**

The retained Tree T053 (R) was still observed some deterioration on its health.

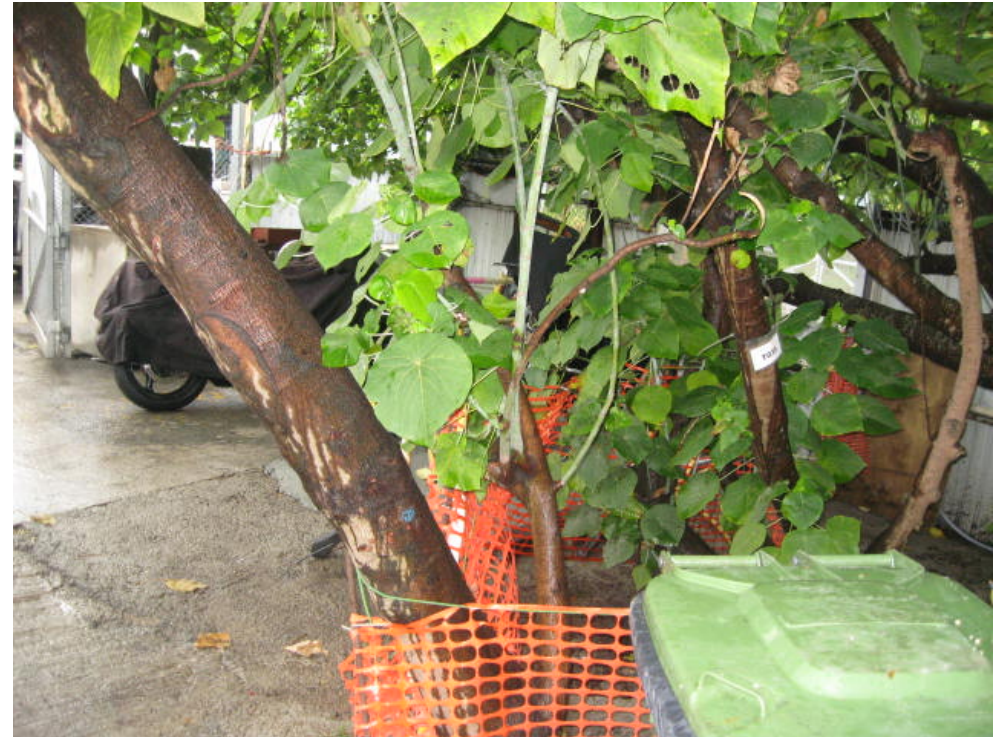
**Sandy Bay site --- Photo 8**

Tree identification tag is still missing for retained tree T038 (R).

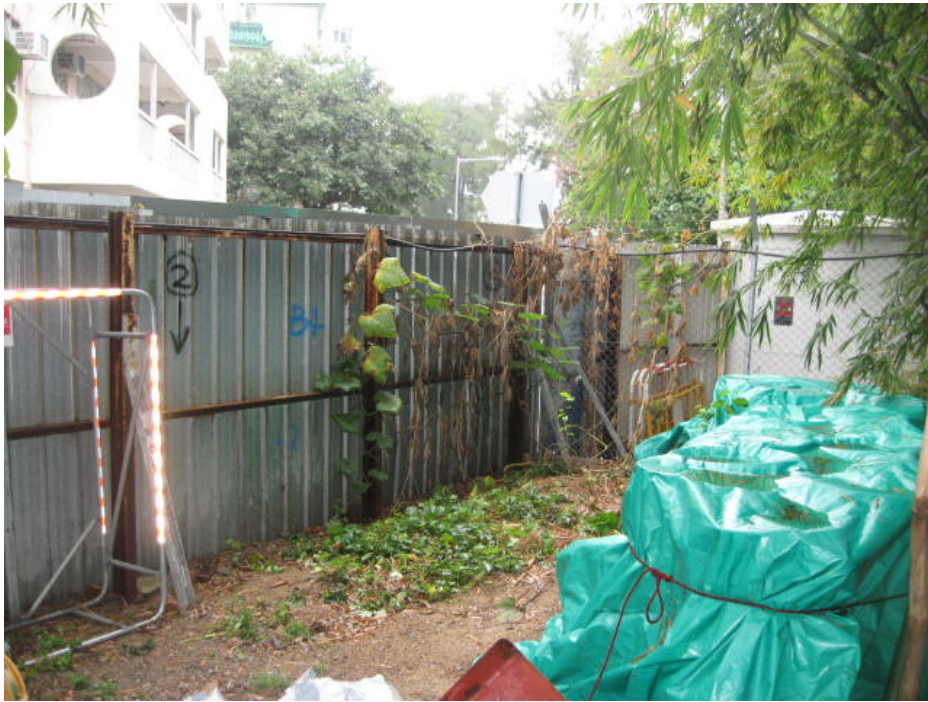
**Sandy Bay site --- Photo 9**

The transplanted Trees T004 (T) and T005 (T) were confirmed dead  
In December 2011 and it was removed on February 23, 2012.

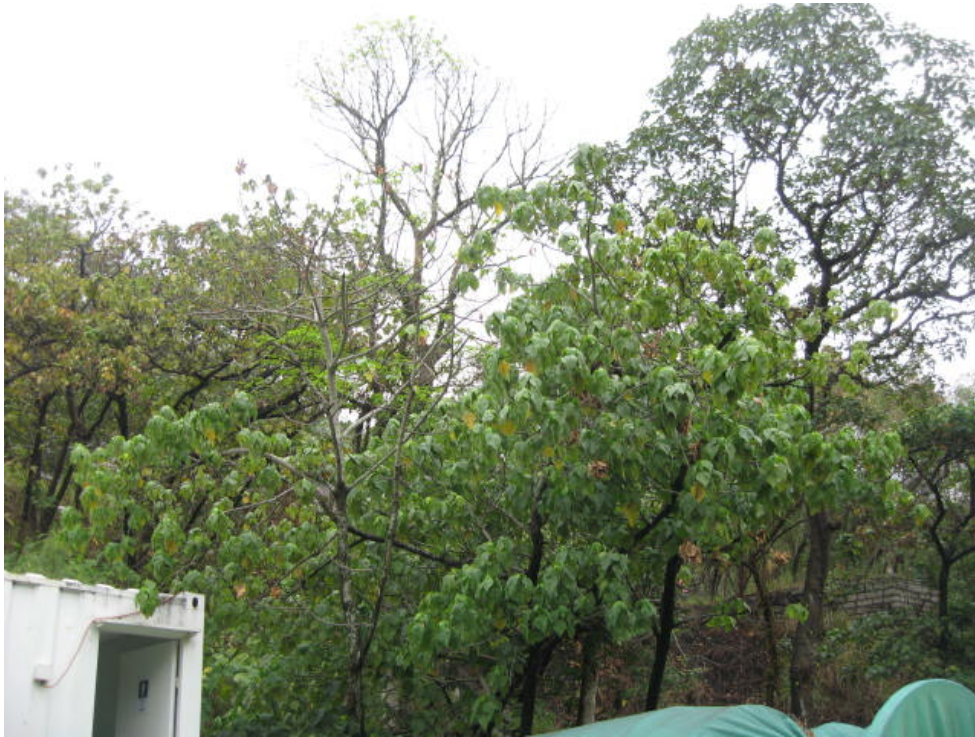
**Aberden site --- Photo 11**

The retained tree T076 (R) was still showing deterioration on its stems and leaves..

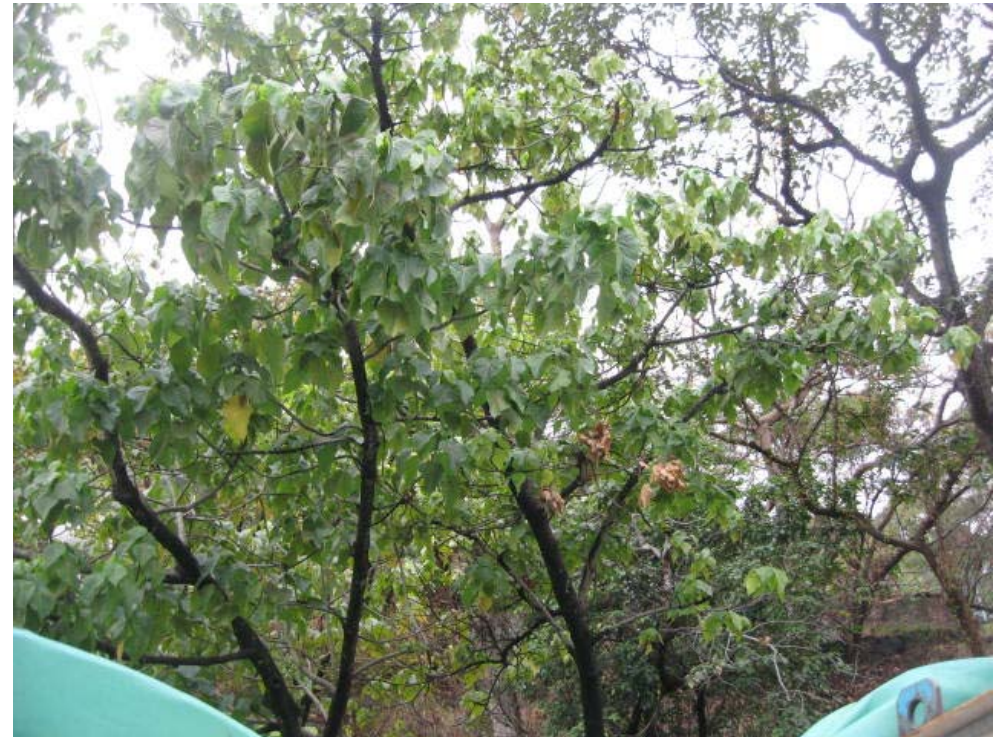
**Aberden site --- Photo 12**

The retained tree T079 (R) was still showing deterioration.

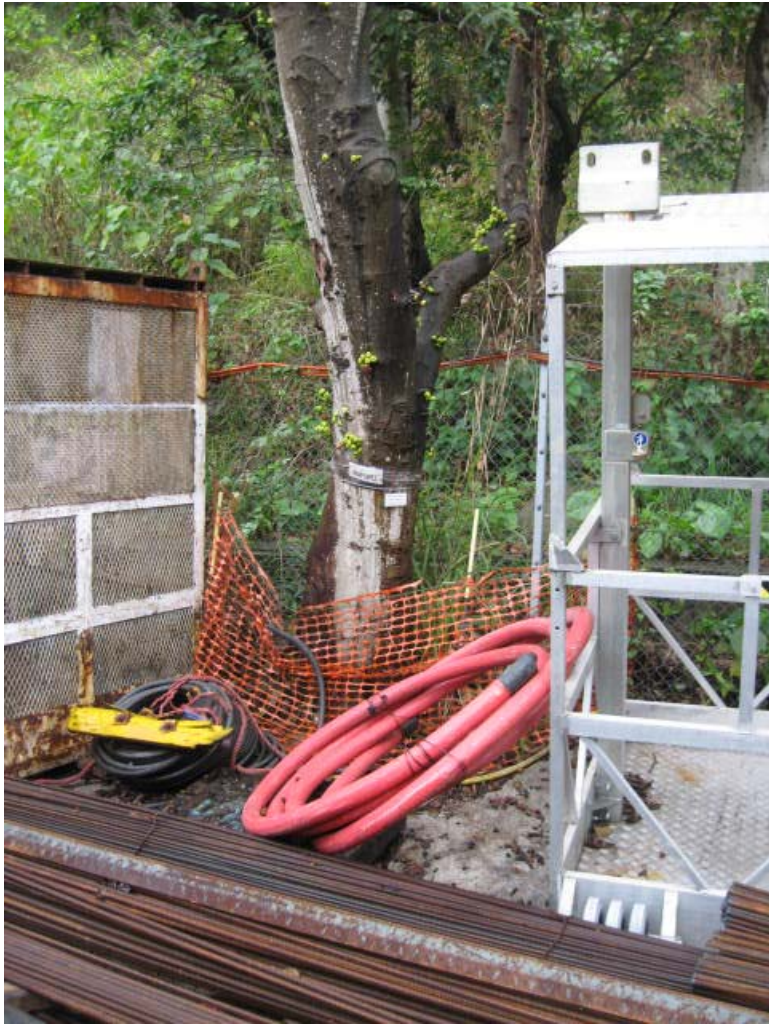
**Aberden Site --- Photo 13**

Construction materials were closely stored on the roots of the retained tree T081 (R).

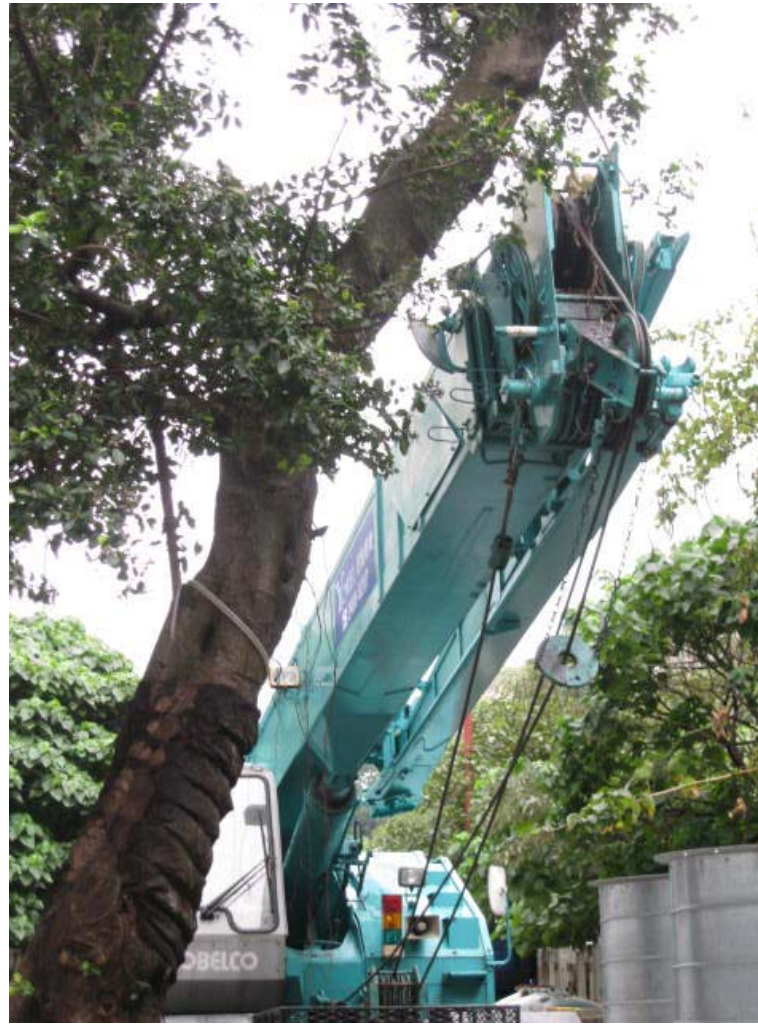
**Aberden site --- Photo 14**

Machine truck lift was still observed to be closely park at Transplanted tree T003(T).

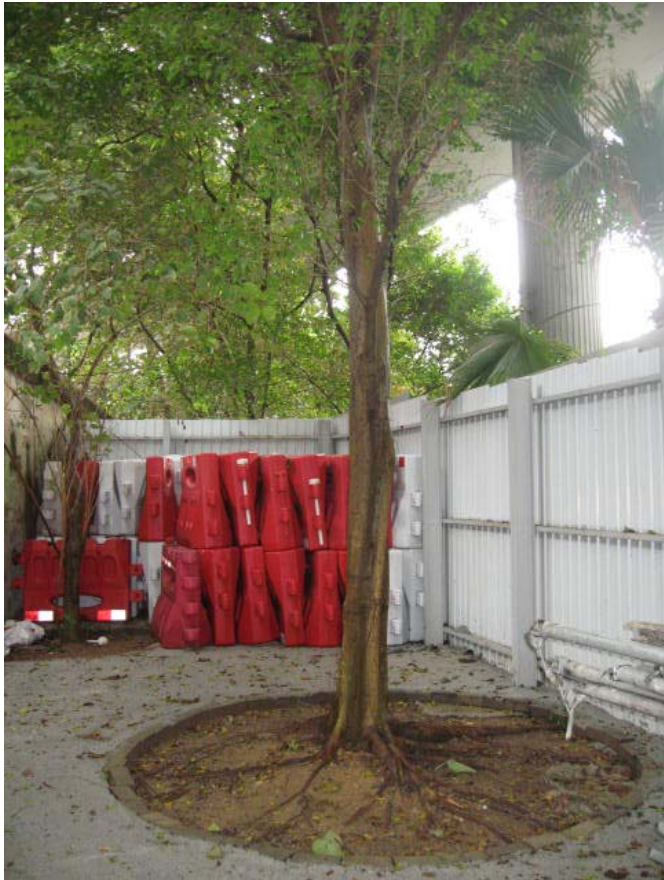
**Aberden Site --- Photo 15**  
Two trees without proper identification tag.

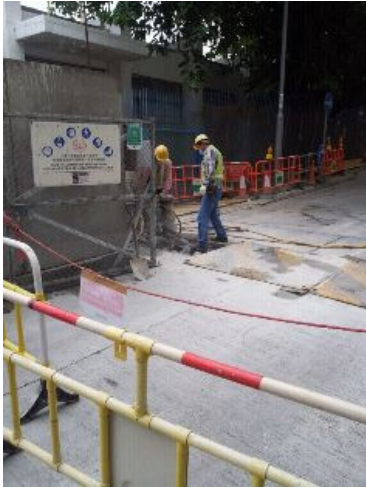
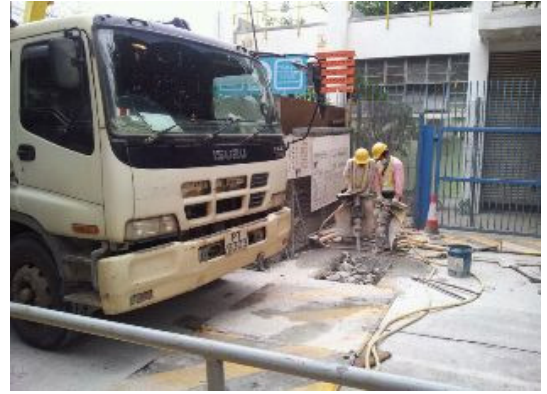
Photos 1 and 2 Rock breaking with using hand held breaker of other contractor

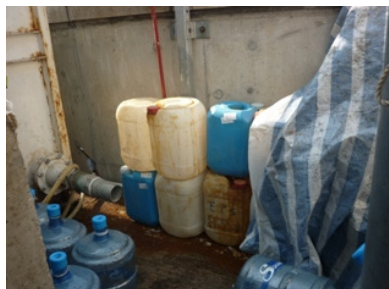
Photo 1 Some empty chemical drums were found near the sedimentation tank.

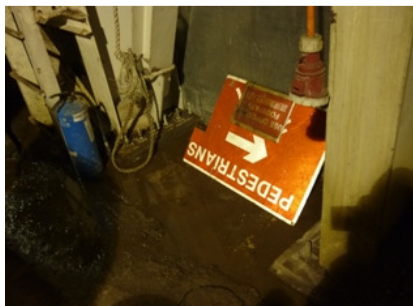
Photo 3 The accumulated water was found on the floor under the air compressor inside the noise enclosure.

1. The contractor was suggested to clear accumulated water.

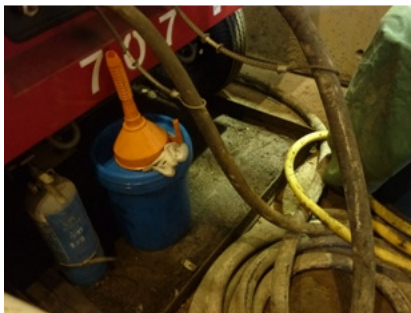
Photo 1 The unknown chemical was found near the air compressor in the noise enclosure

1. The contractor was reminded to provide properly label.
2. The contractor was reminded to place waste oil properly, such as waste chemical storage.

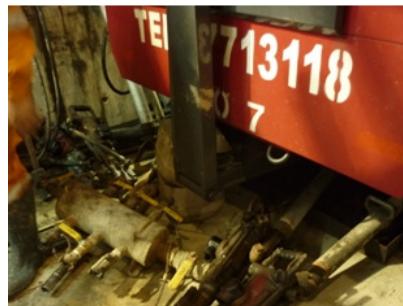
Photo 2 Two buckets of waste oil were found near the air compressor

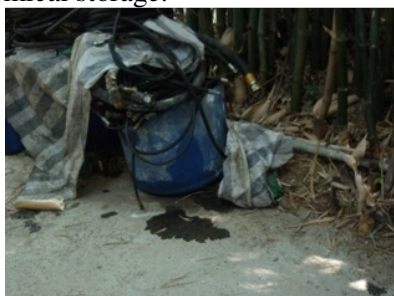
Photo 1 Oil stains were found on the floor near the chemical storage.

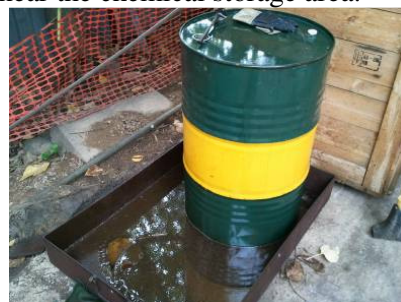
Photo 2 Accumulated water was found in the drip tray near the chemical storage area.

1. The contractor was reminded to clear the accumulated water regularly.

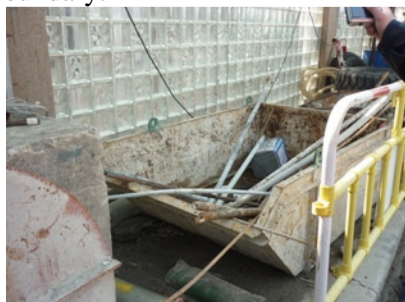
Photos 3 Accumulated water was found in skip near the boundary.

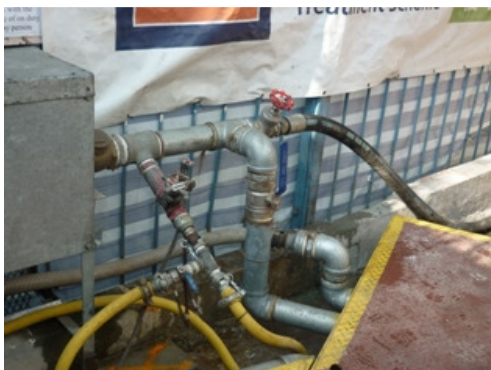
Photo 1

Water accumulation was found under the water tap near the boundary

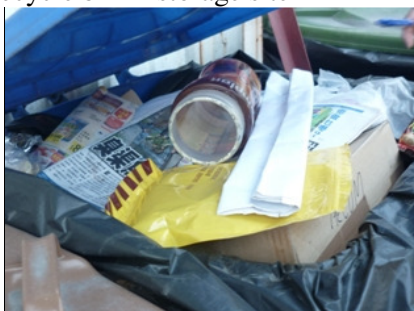
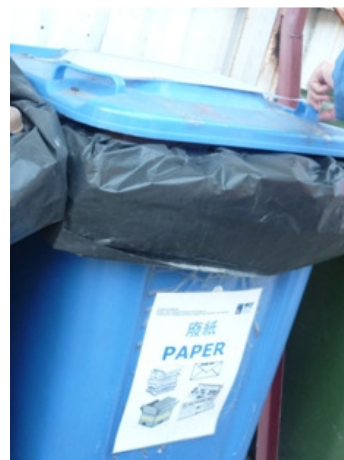
Photos 2 and 3 Some plastic matters were found in paper recycle bin in storage site

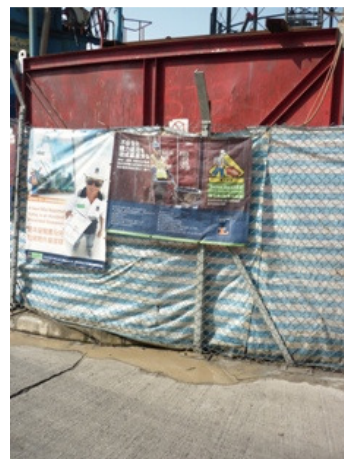
Photos 4 and 5 Some muddy water was found near the boundary behind the sedimentation tank

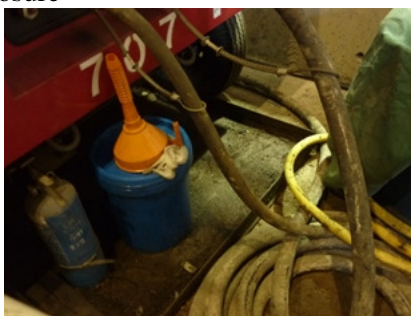
Photo 1 Unknown chemical was found near the air compressor in the noise enclosure

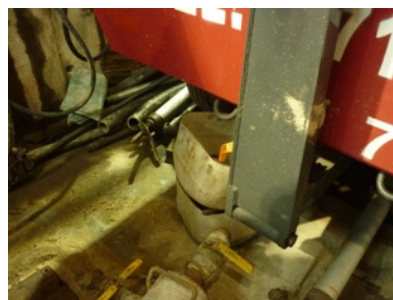
Photo 2 Two buckets of waste oil were found near the air compressor

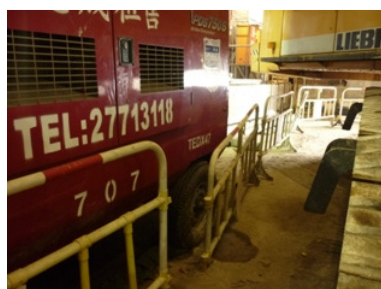
Photo 3 An oil stain was found near the air compressor

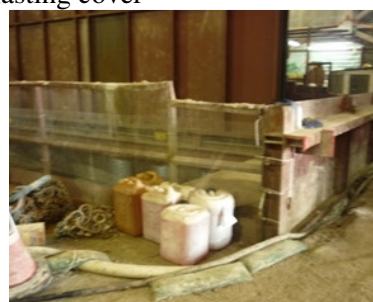
Photo 4 Some chemical drums without labels were found near the blasting cover

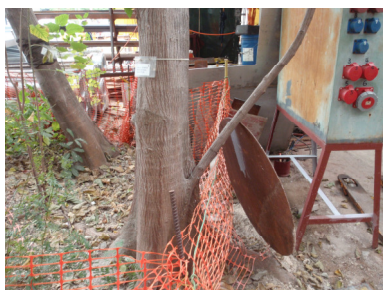
Photo 1 The metal material was found next to the tree

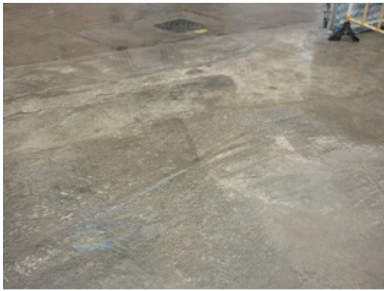
Photo 1 Oil stain was found on the floor at the entrance

1. The contractor is reminded to clear the oil stain at the entrance with oil dispenser.

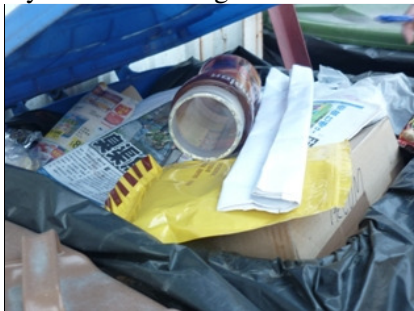
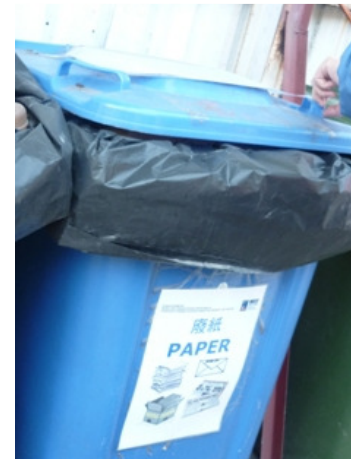
Photos 3 and 4 Some plastic matters were found in paper recycle bin in storage site

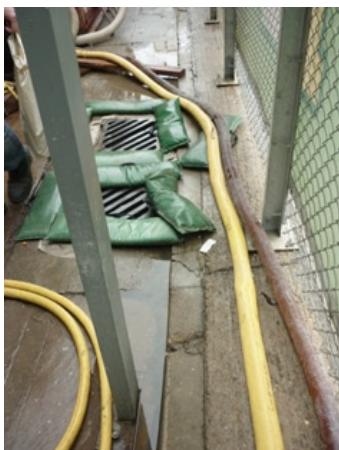
Photo 1 Oil water was found flowing into gully near Aqua. Sed tank

1. The contractor was reminded to ensure all contaminate water should be treated properly before discharge.

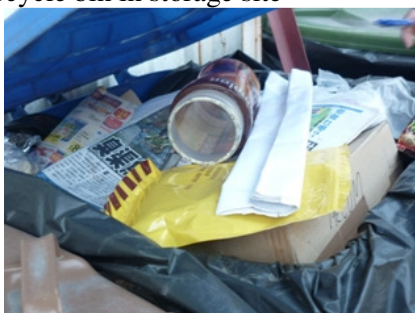
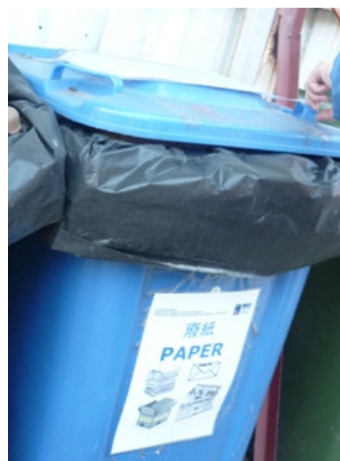
Photos 1 and 2 Some plastic matters were found in paper recycle bin in storage site

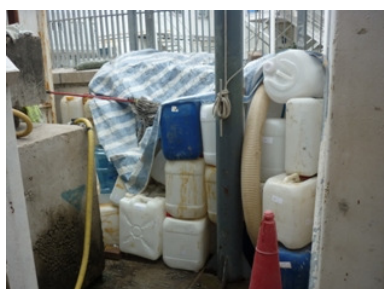
Photo 1 Empty drums were accumulated near the sedimentation tank.

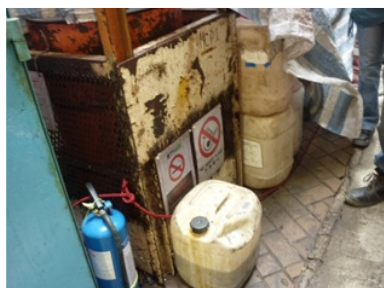
Photo 3 Oil drums were found without drip trays near noise enclosure.

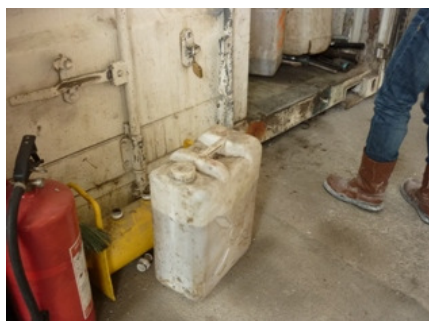
Photo 1 An unknown oil bucket was found near container

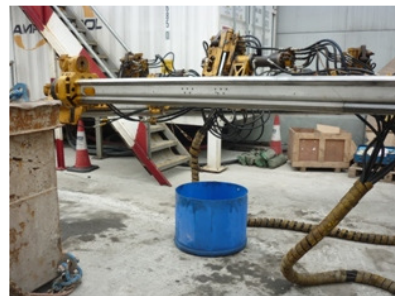
Photo 2 Oil stain was found on the floor in front of site office.

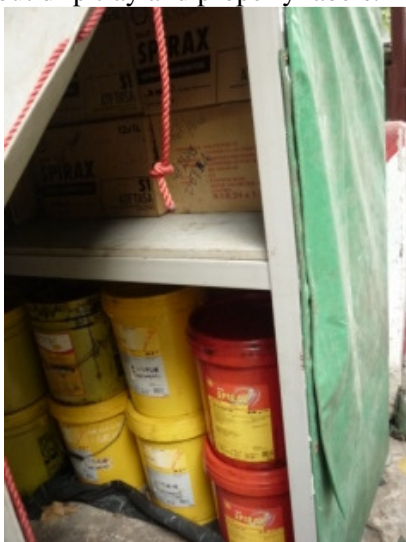
Photos 3 A chemical storage container was found without drip tray and properly labels.

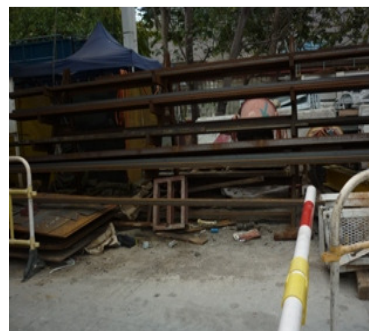
Photo 4 Trashes were found near the stockpiles.

1. The contractor was reminded to keep the site tidiness.

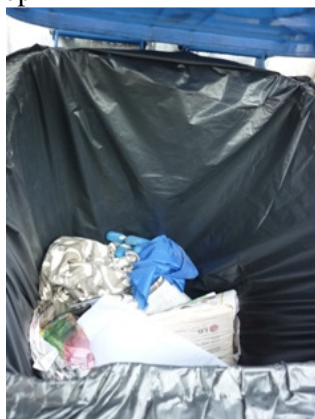
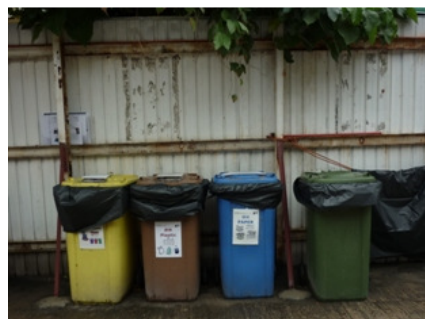
Photos 1 and 2 Non-recycle material were found in paper recycle bin in work shop

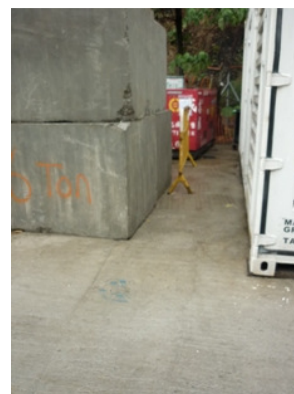
Photos 3 and 4 Oil stain was found near concert boxes in work shop

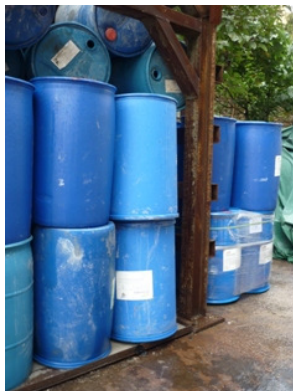
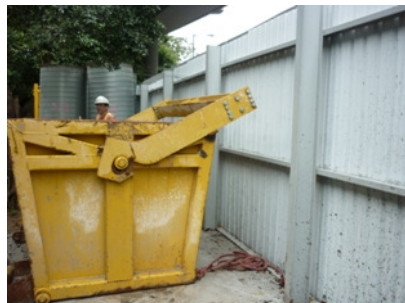
Photos 5 and 6 Water accumulation was found in skip near retained tree(T003) and drip tray in work shop

1. The contractor is reminded to avoid water accumulation and keep the site tidiness

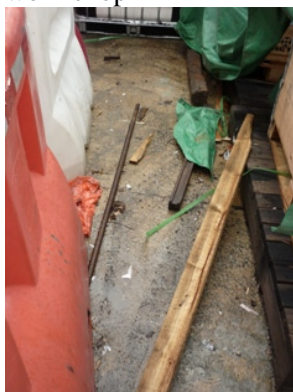
Photo 7 Trashes were found near the entrance of work shop

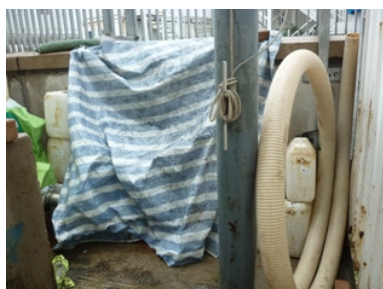
Photo 1 Empty drums were accumulated near the sedimentation tank.

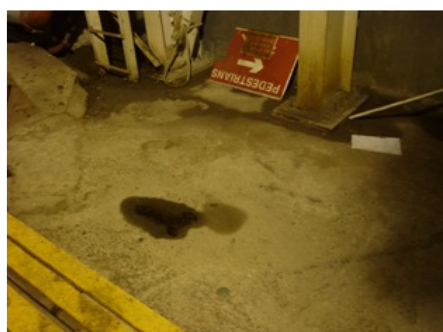
Photo 3 Oil stain was found in the noise enclosure under the air compressor.

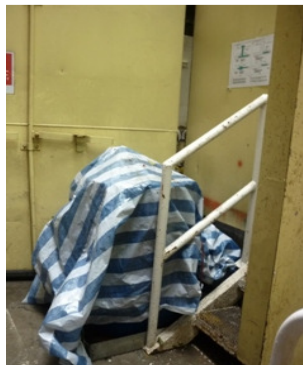
Photo 5 Water accumulation was found in drip tray near the entrance of noise enclosure

- 1. The contractor is reminded to avoid water accumulation and investigate the reason of dripping.

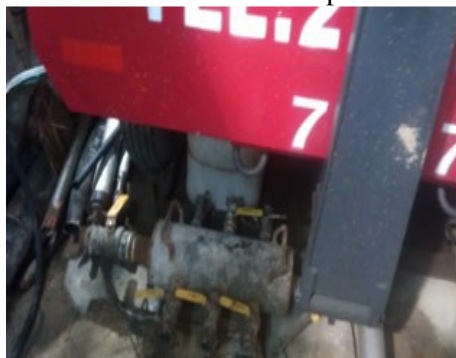
Photo 1 Two buckets of oil were found without suitable labels near the air compressor

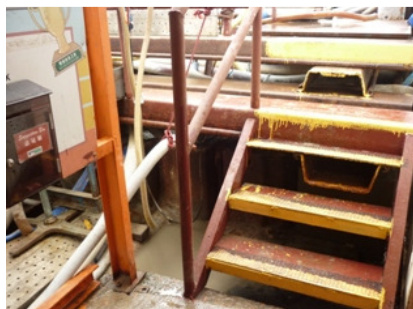
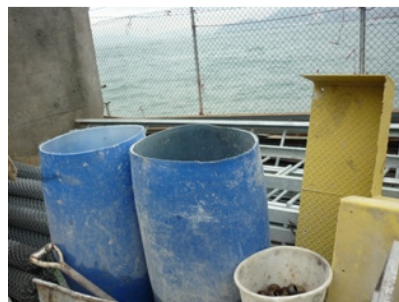
Photos 3 and 4 Water accumulation was found in drum and a pit near Environmental notice board

3. The contractor is recommended avoid water accumulation.

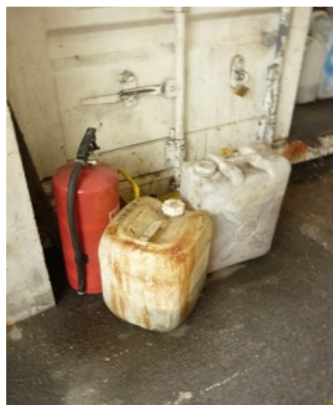
Photo 1 An unknown oil bucket was found near container since last inspection

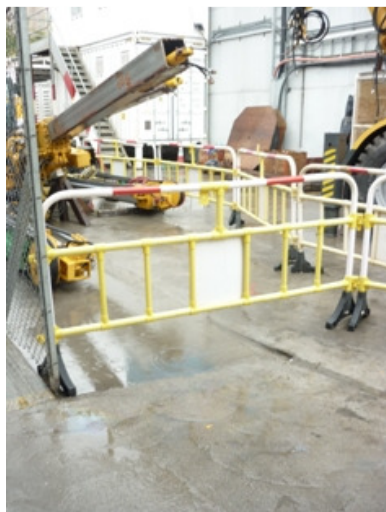
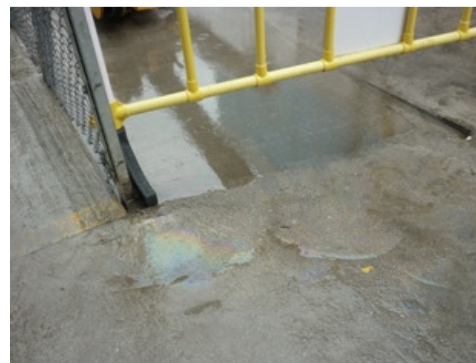
Photos 3 and 4 Oil stain was found near the plant

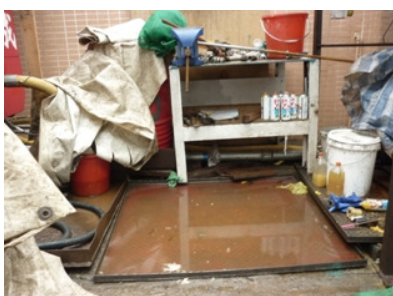
Photo 1 Water accumulation was found in drip tray near air compressor

1. To clear accumulated water in drip tray near air compressor.
