Contract No. DC/2007/24
Harbour Area Treatment Scheme Stage 2A
Construction of Sewage Conveyance System from Aberdeen to Sai Ying Pun

Environmental Certification Sheet – 42

Document/ Plan/Changes/Information to be Certified/ Verified:	Quarterly Environmental Monitoring and Audit Report No.10 (EMA/038, Rev B)
Date of Report:	24 July 2012
Date of correspondence to IEC:	25 July 2012
Date received:	25 July 2012

**Contract no. DC/2007/24
Construction of Sewage Conveyance System from Aberdeen to Sai Ying Pun
Submission of 10th Quarterly EM&A Report for April to June 2012 (Rev. B)**

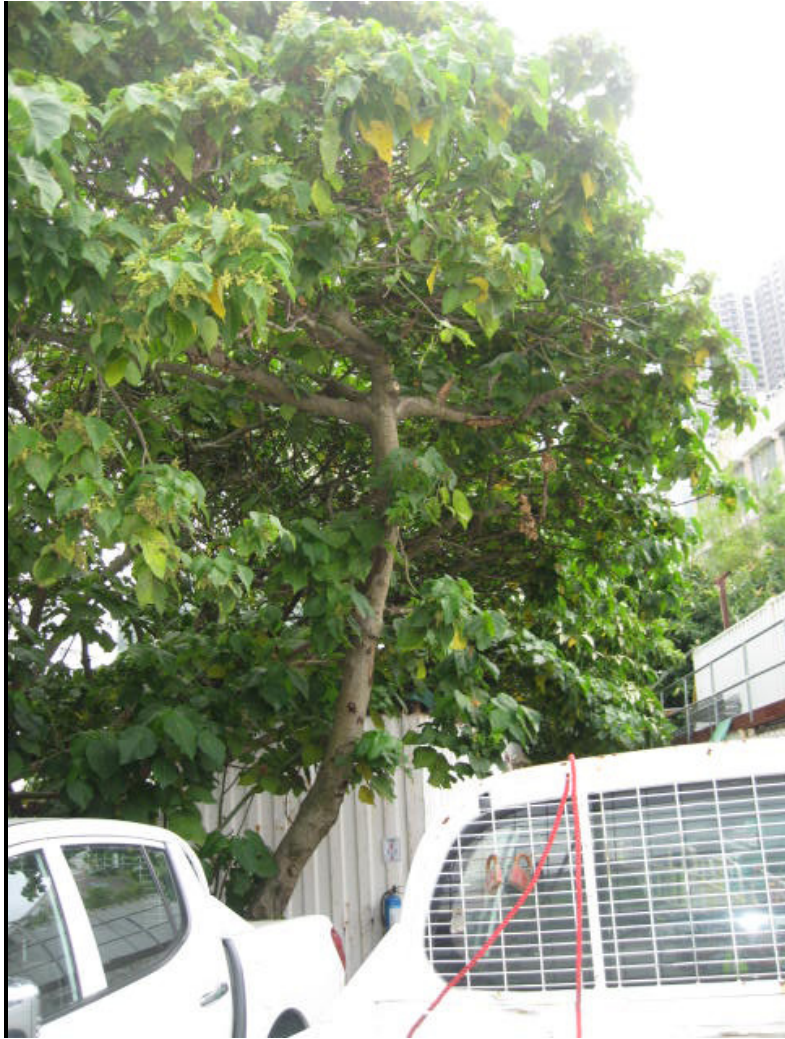
Sandy Bay site --- Photo 1

The retained Tree T038 (R) was still observed deteriorating in health.

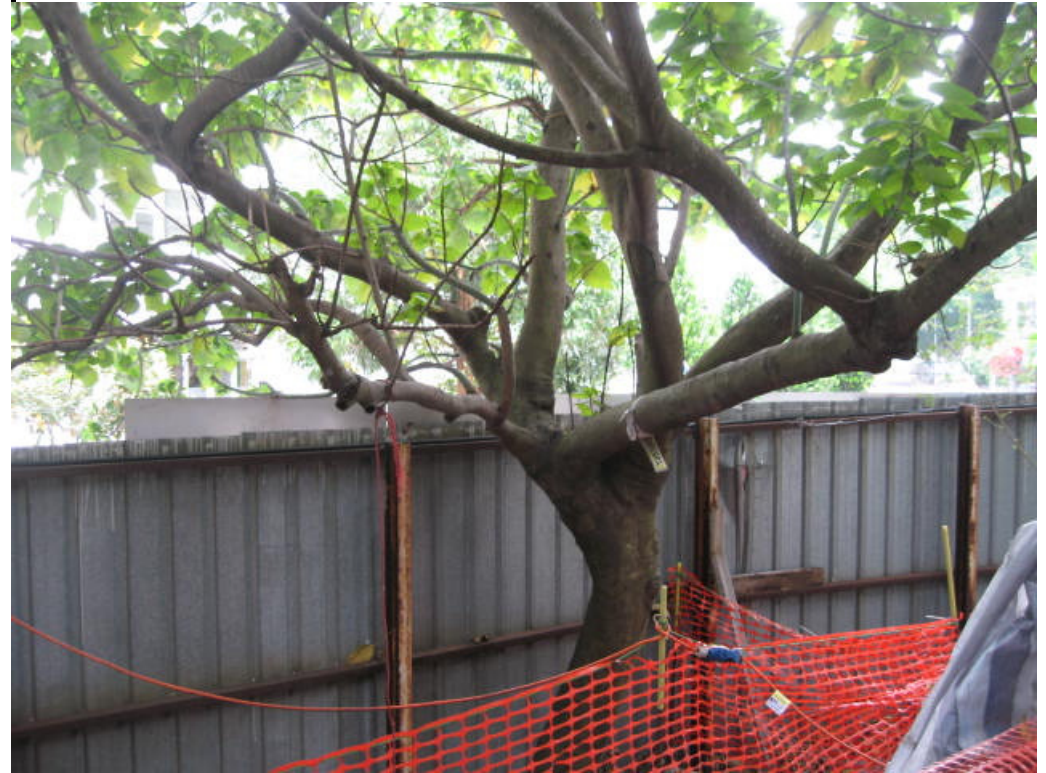
Sandy Bay site --- Photo 2

The retained Tree T053 (R) was still observed deteriorating in health.

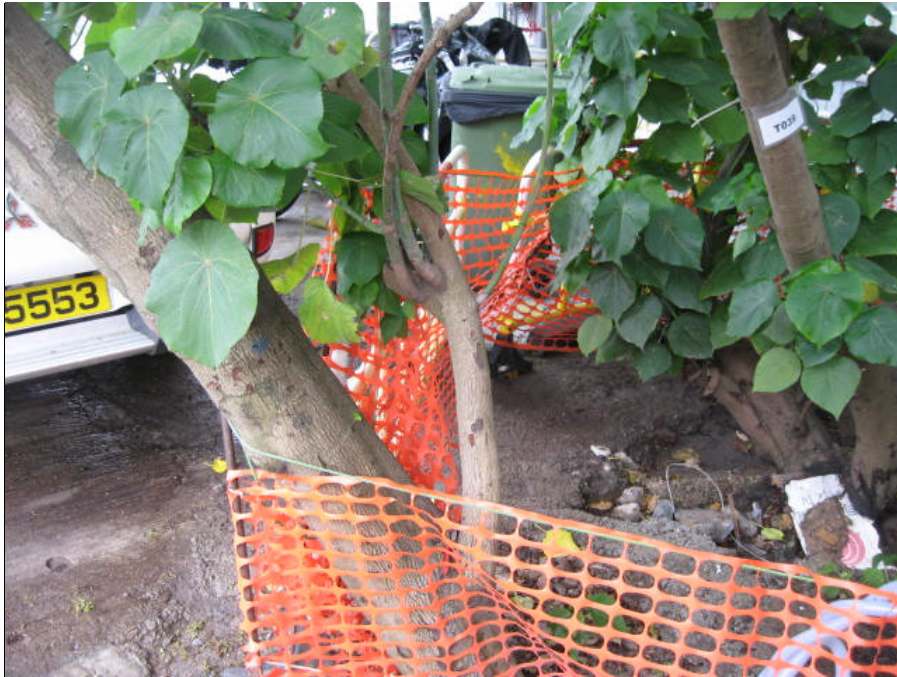
Sandy Bay site --- Photo 3
Tree identification tag was still found missing for the retained tree T038 (R).

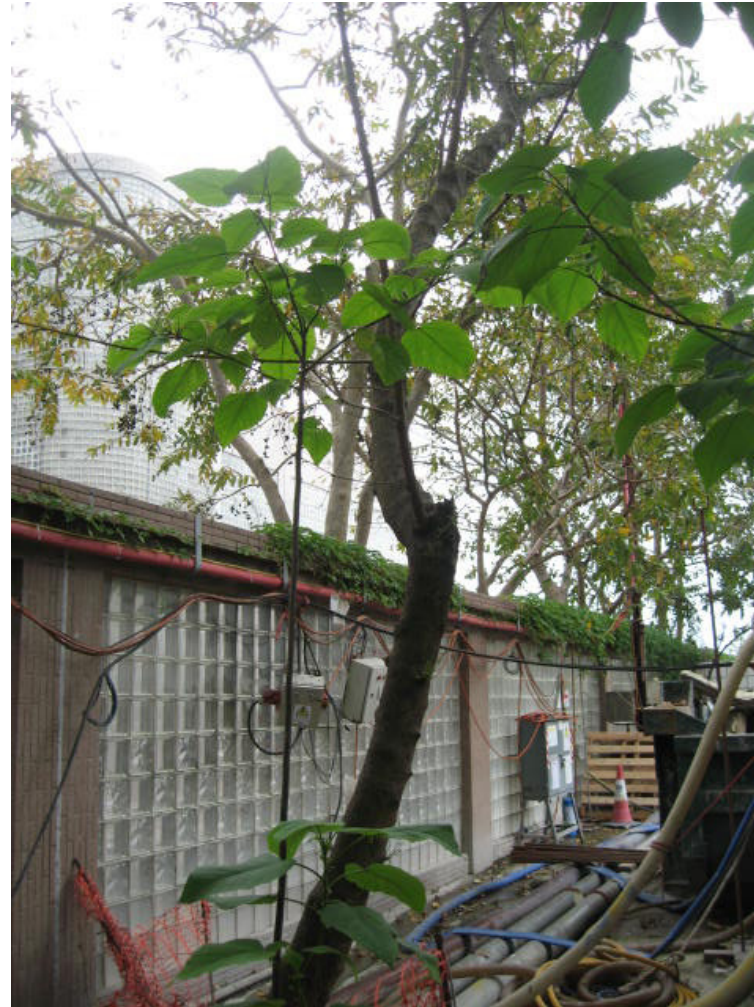
Sandy Bay site --- Photo 4
The retained Tree T214 (R) was observed to be in a very poor health condition.

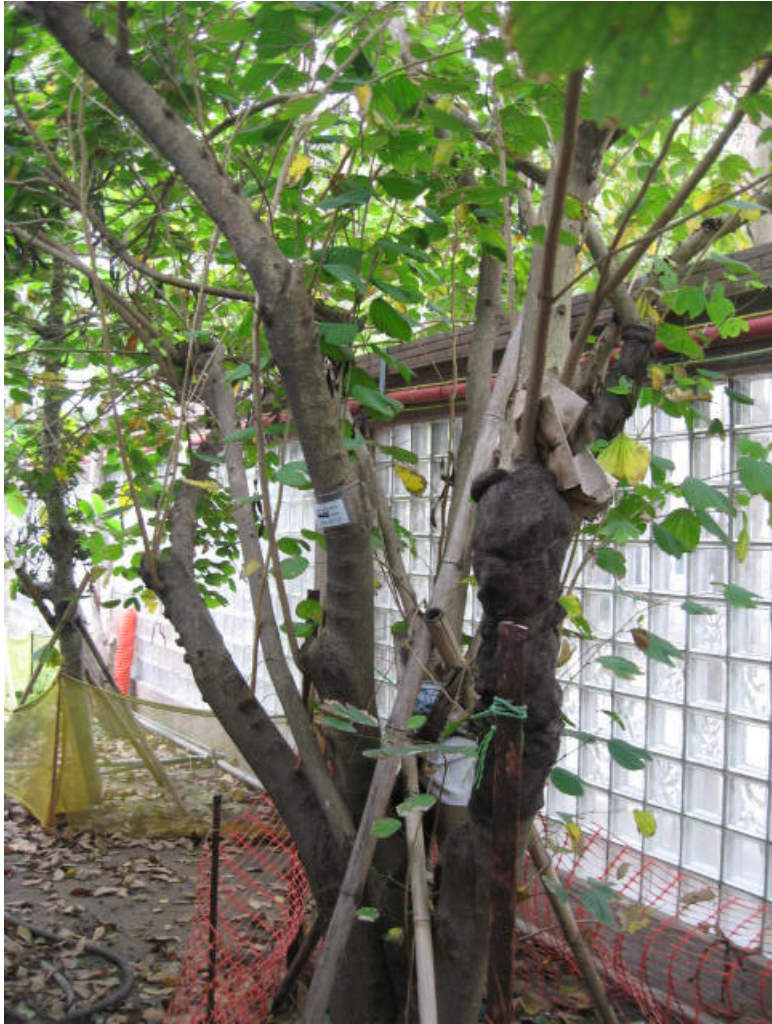
Sandy Bay site --- Photo 5
The transplanted tree T017 (T) was observed deteriorating in health.

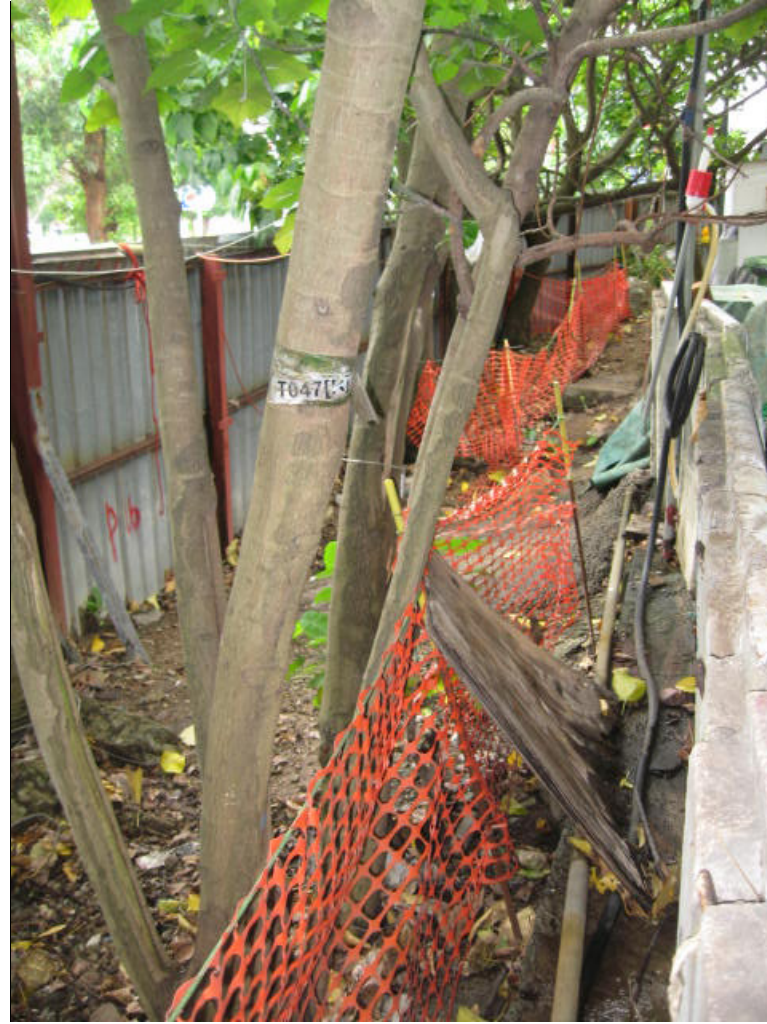
Sandy Bay site --- Photo 6
Construction materials were found stored close to the roots of retained Tree T047 (R).

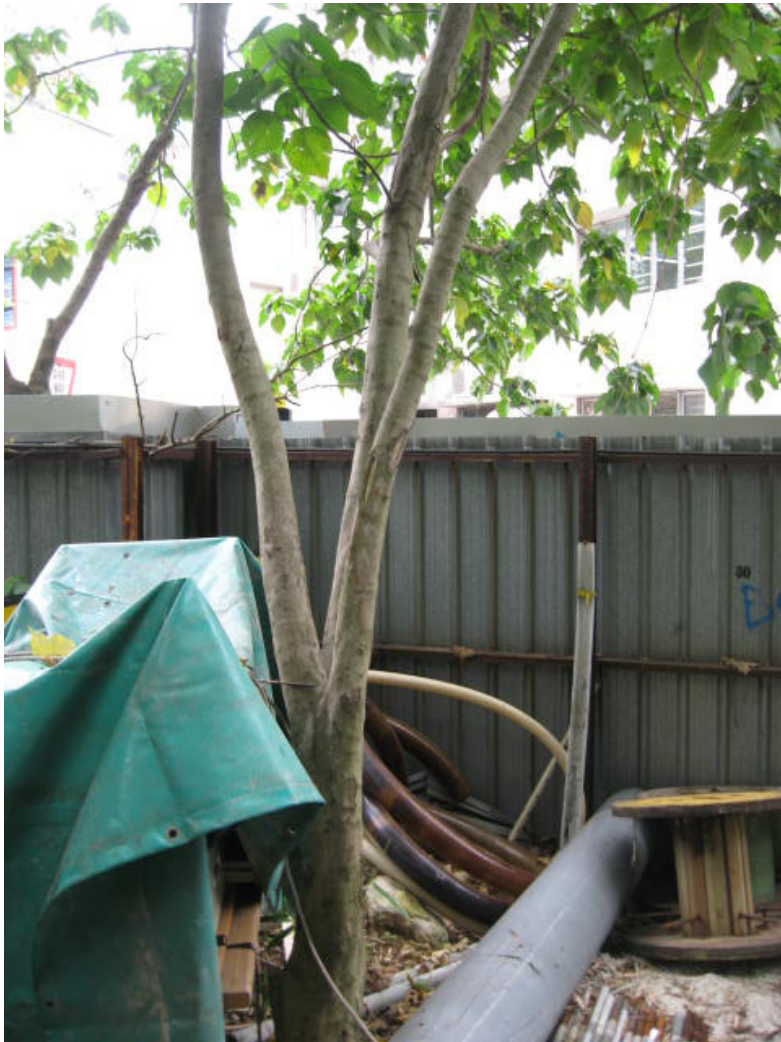
Sandy Bay site --- Photo 7
Untagged trees spotted by ERM during this month site audit.

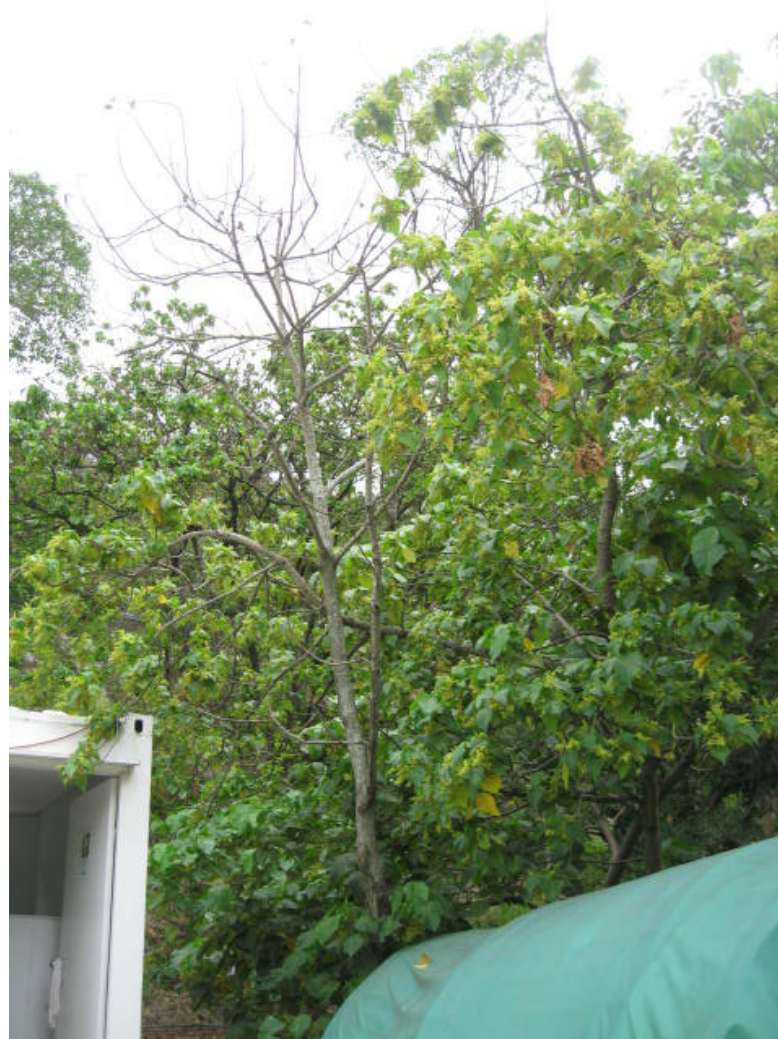
Aberdeen site --- Photo 10

The retained tree T076 (R) was still showing poor health condition.

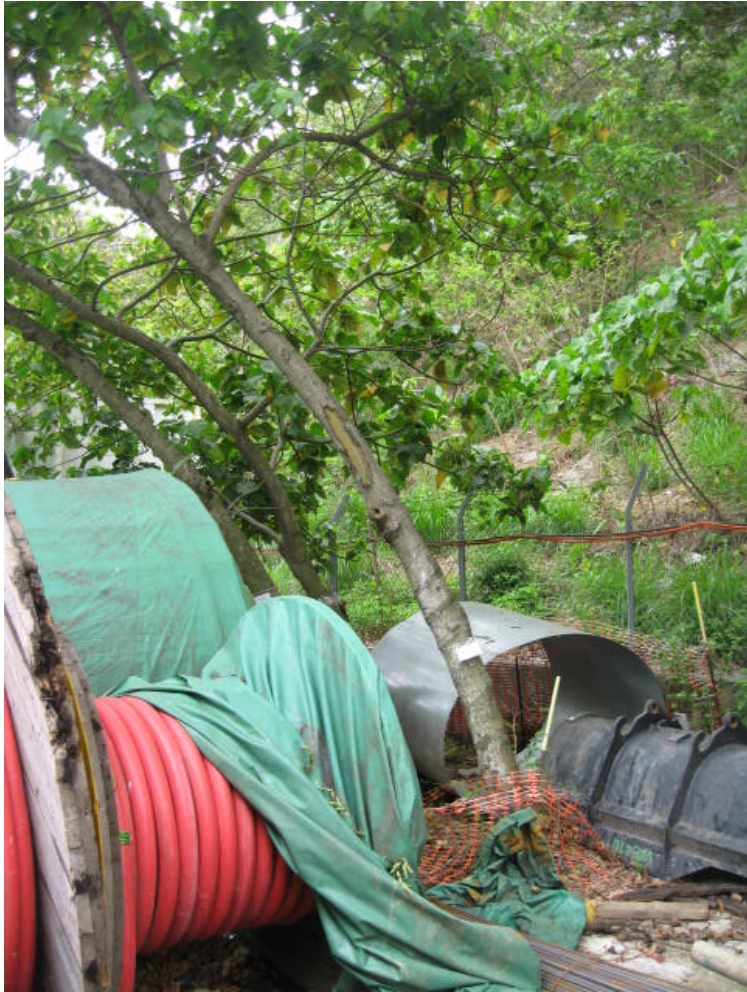
Aberdeen site --- Photo 11

The retained tree T078(R), T079 (R) and T080(R) were showing deterioration.

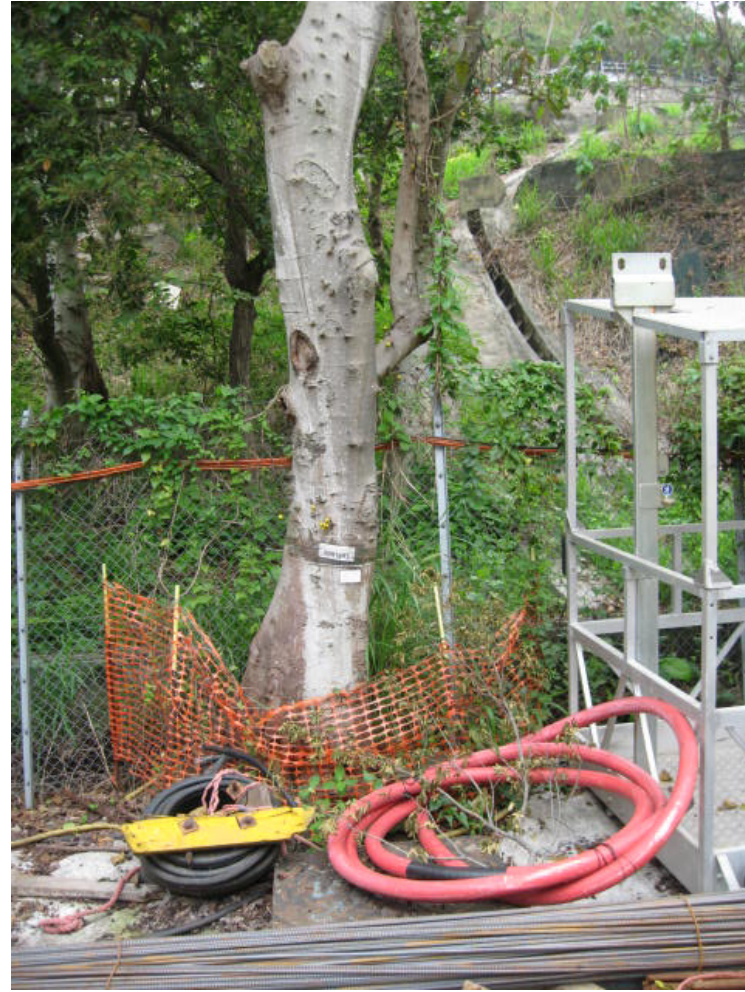
Aberdeen site --- Photo 12

Construction materials were still observed stored close to the roots of the retained tree T081 (R).

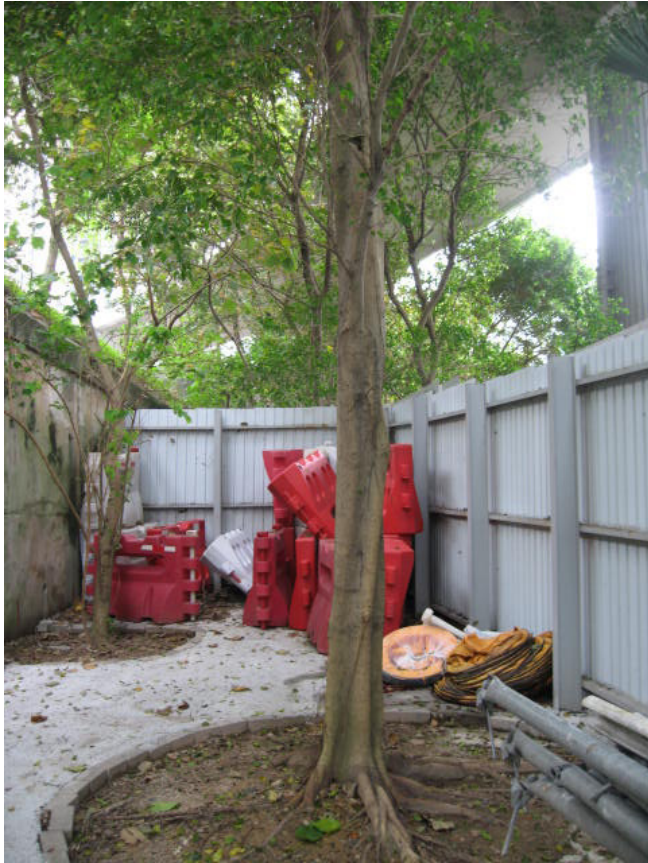
Aberdeen site --- Photo 13
Two trees found without proper identification tags.

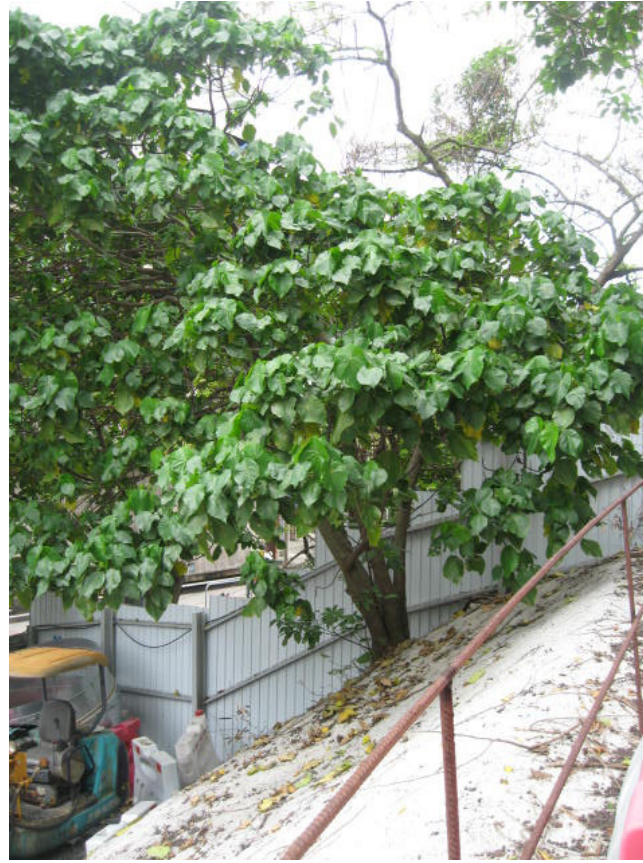
Aberdeen site --- Photo 14
Tree found without proper identification tag.

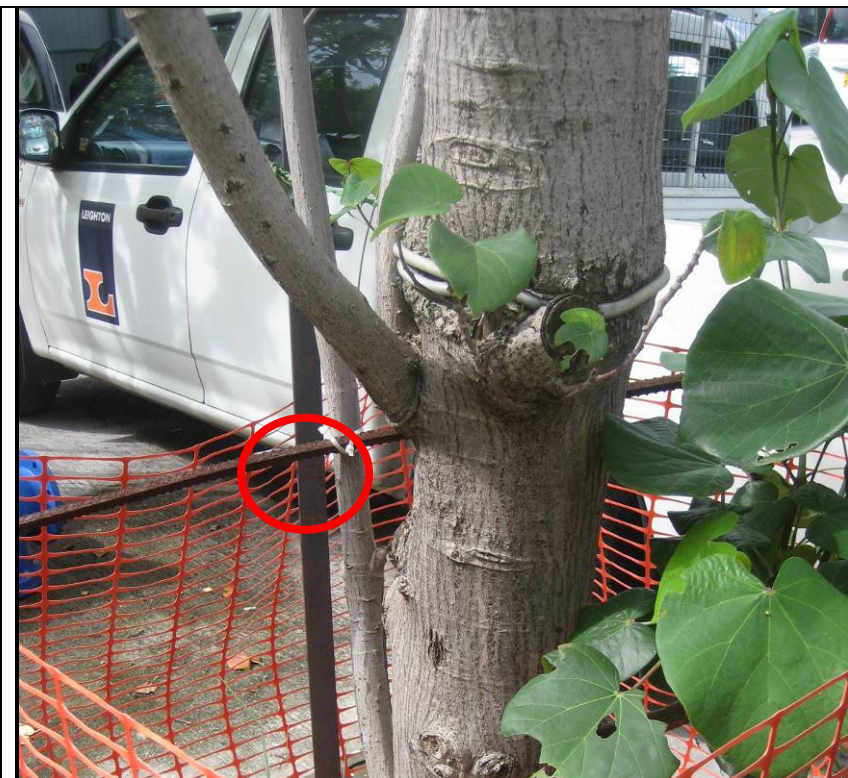
Cyberport site --- Photo 1

The retained tree T065(R) was observed being untagged. Also a metal bar was observed tied on the tree branch

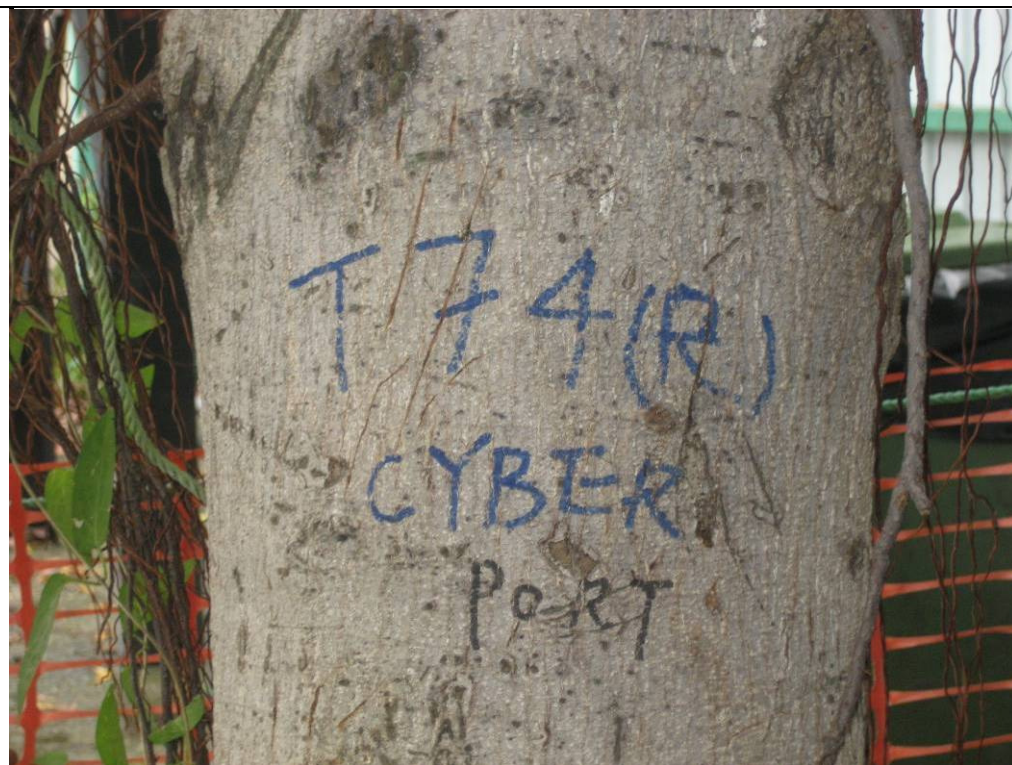
Cyberport site --- Photo 2

The retained tree T074(R) was observed not being properly tagged. Marking was also observed on the tree trunk.

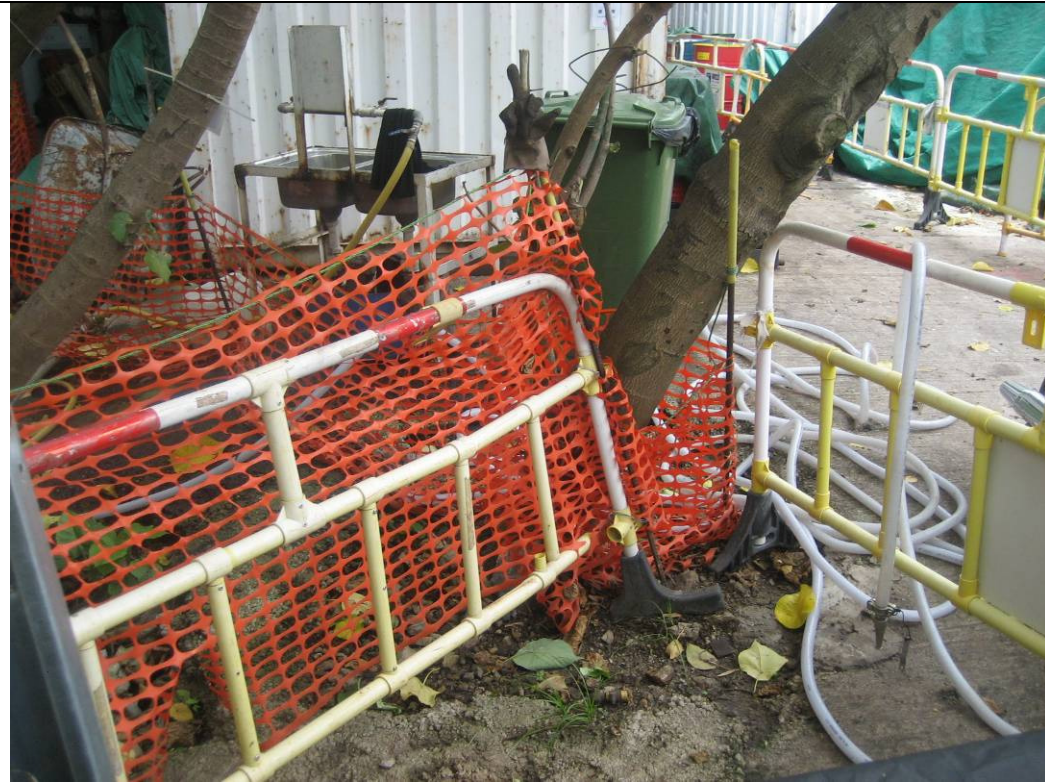
Sandy Bay site --- Photo 3

The tree protection zone for retained tree T038(R) was observed insufficient. Also the tree identification tag was still observed missing for the retained tree T038(R).

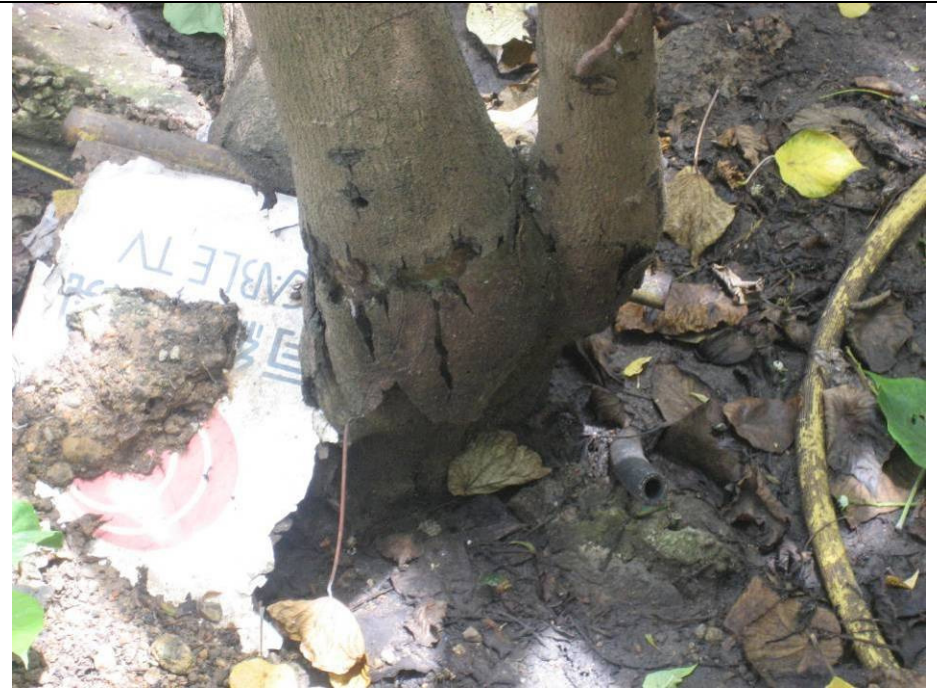
Sandy Bay site --- Photo 4

Root flare of retained tree T039(R) was observed in very poor condition.

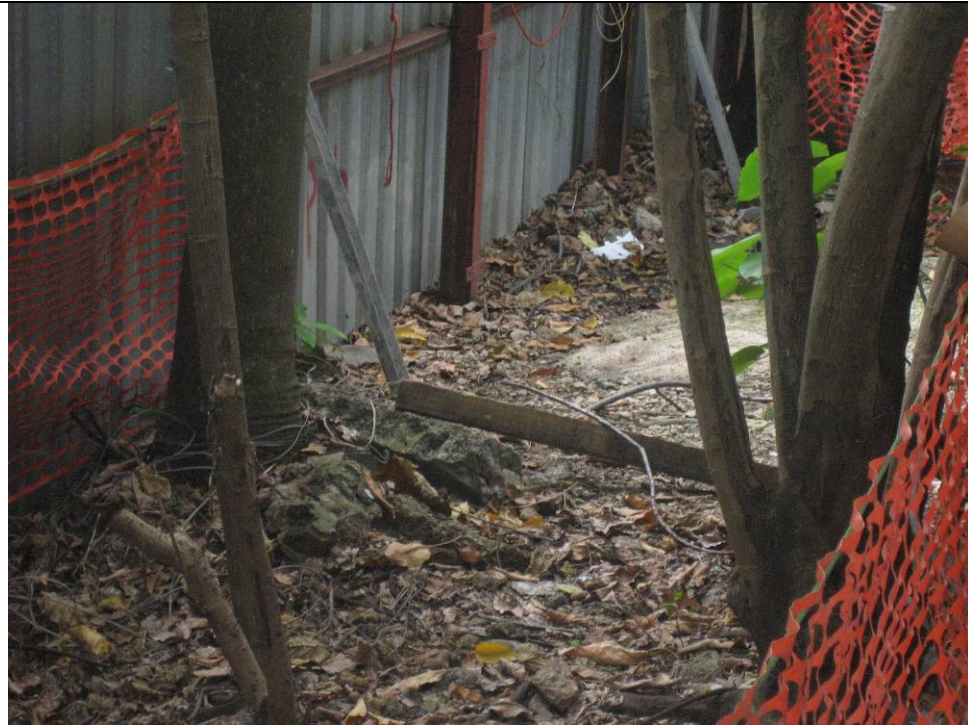
Sandy Bay site --- Photo 5

Construction materials were found stored close to the roots of the retained tree T047(R).

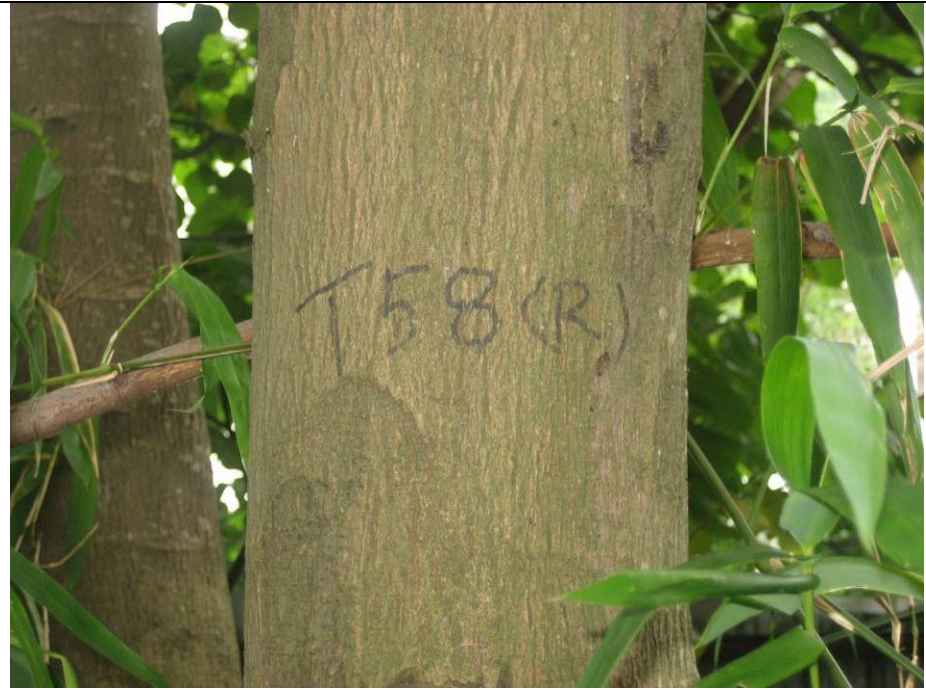
Sandy Bay site --- Photo 6

The retained tree T058(R) was observed not being properly tagged. Marking was also observed on the tree trunk.

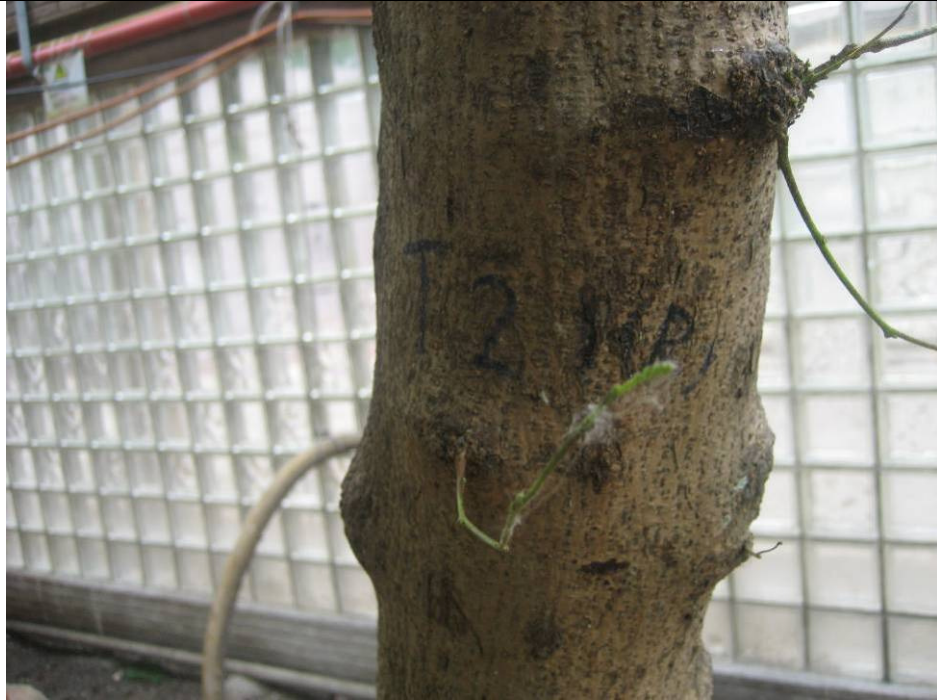
Sandy Bay site --- Photo 7

The retained tree T21(R) was observed not being properly tagged. Marking was also observed on the tree trunk.

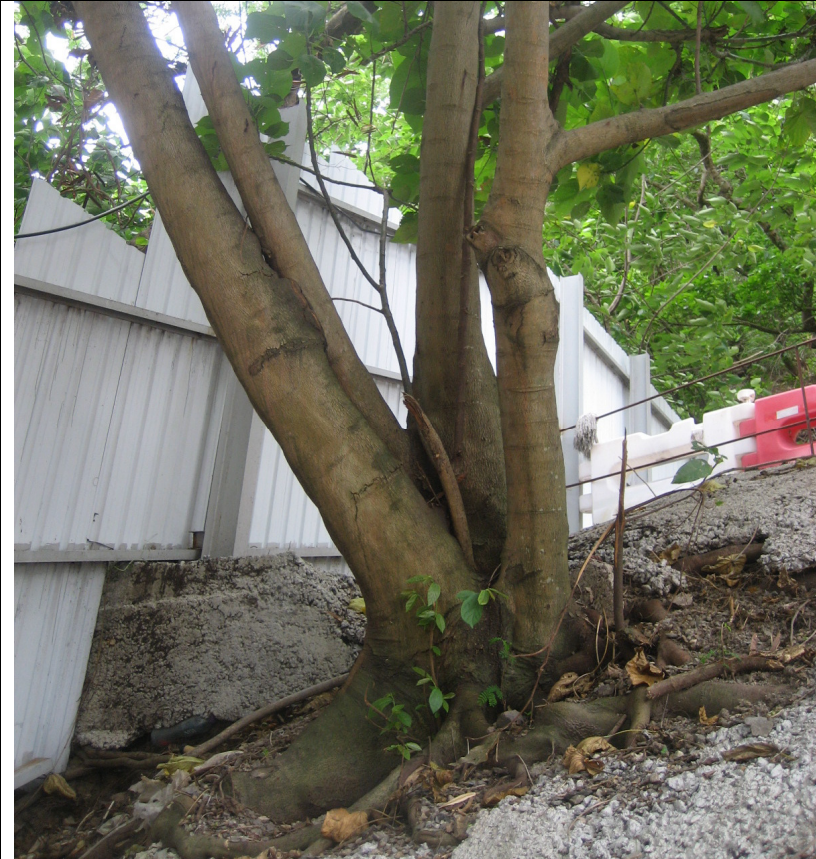
Aberdeen site --- Photo 8

A tree near the entrance was observed without proper identification tag.

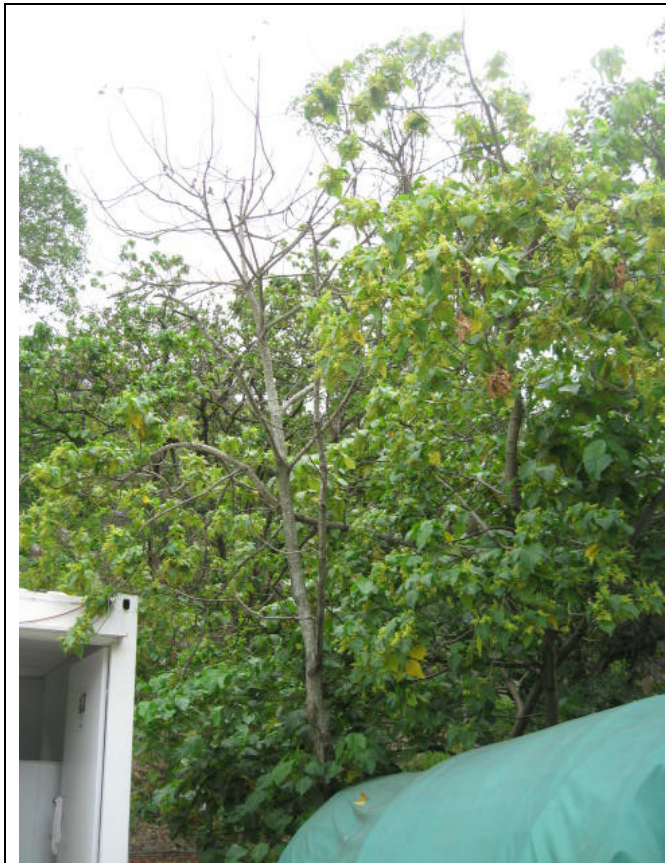
Aberdeen site --- Photo 9

The retained Tree T080(R) was observed to be in a very poor health condition.

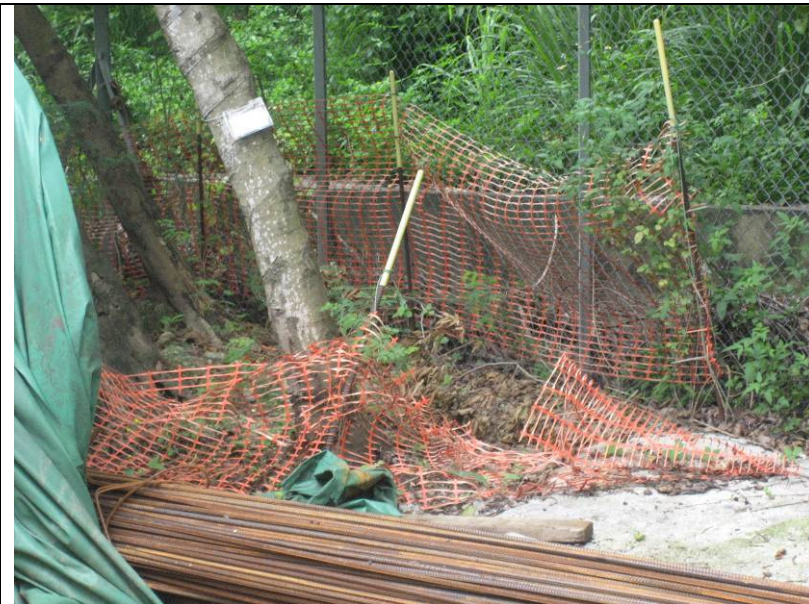
Aberdeen site --- Photo 10

Tree protect zone for the retained tree T078(R), T079(R) and T080(R) was damaged.

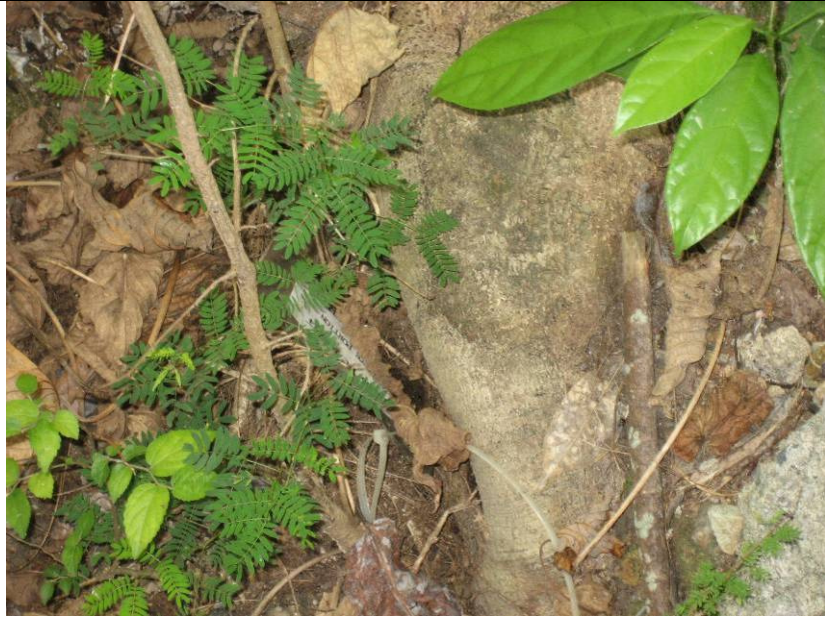
Aberdeen site --- Photo 11

The retained tree T078(R) was observed being untagged.

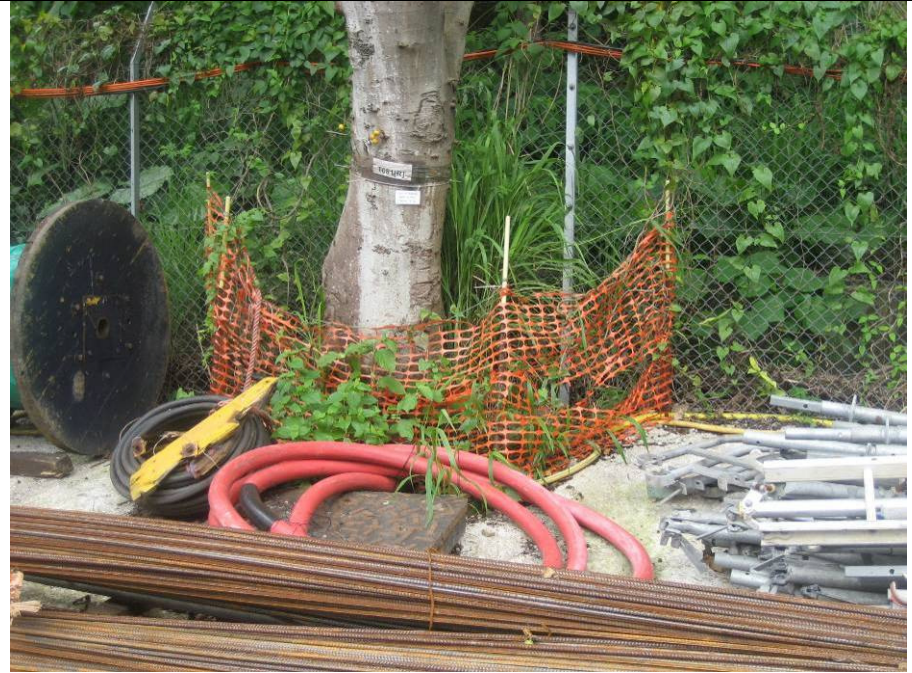
Aberdeen site --- Photo 12

Construction materials were still observed stored close to the roots of the retained tree T081(R).

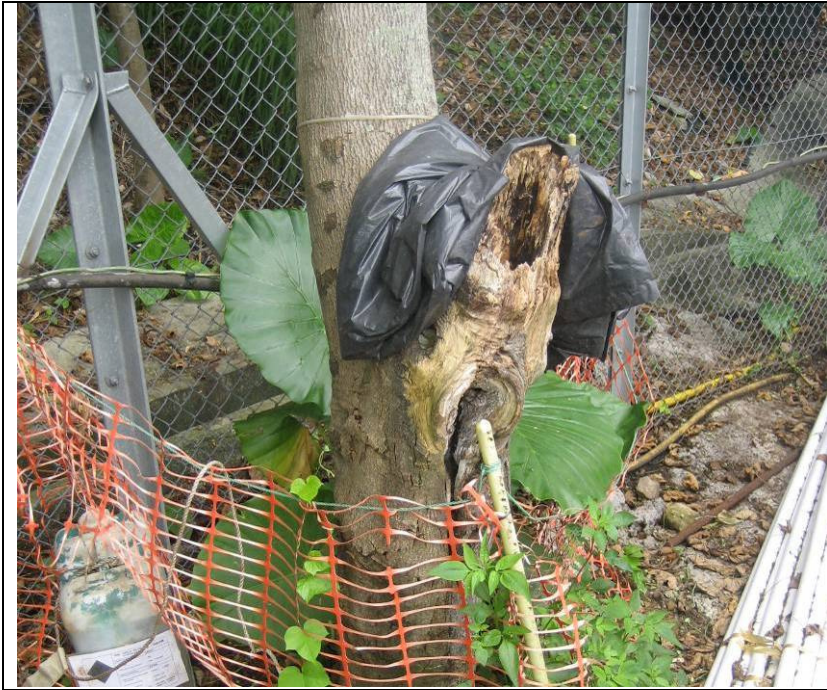
Aberdeen site --- Photo 13
Retained tree T083(R) was observed to be in a very poor health condition.

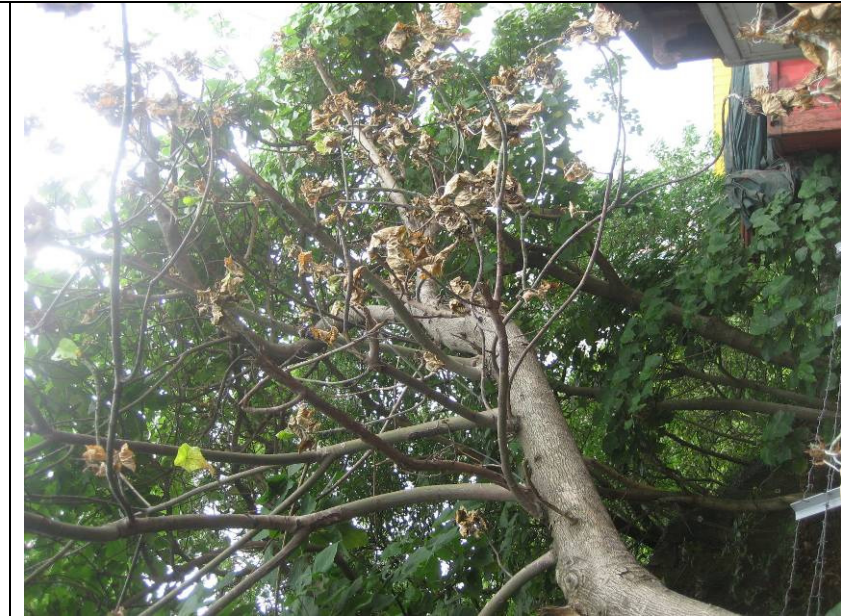
Aberdeen site --- Photo 14
Retained tree T083(R) was observed to be in a very poor health condition.

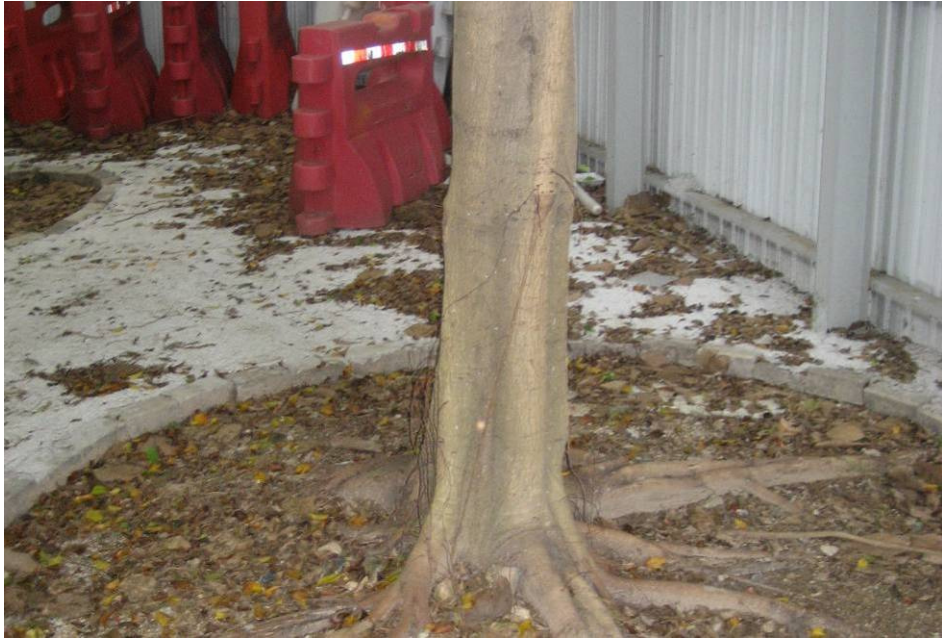
Aberdeen site --- Photo 15

A tree at the end of the storage area was observed without proper identification tag.

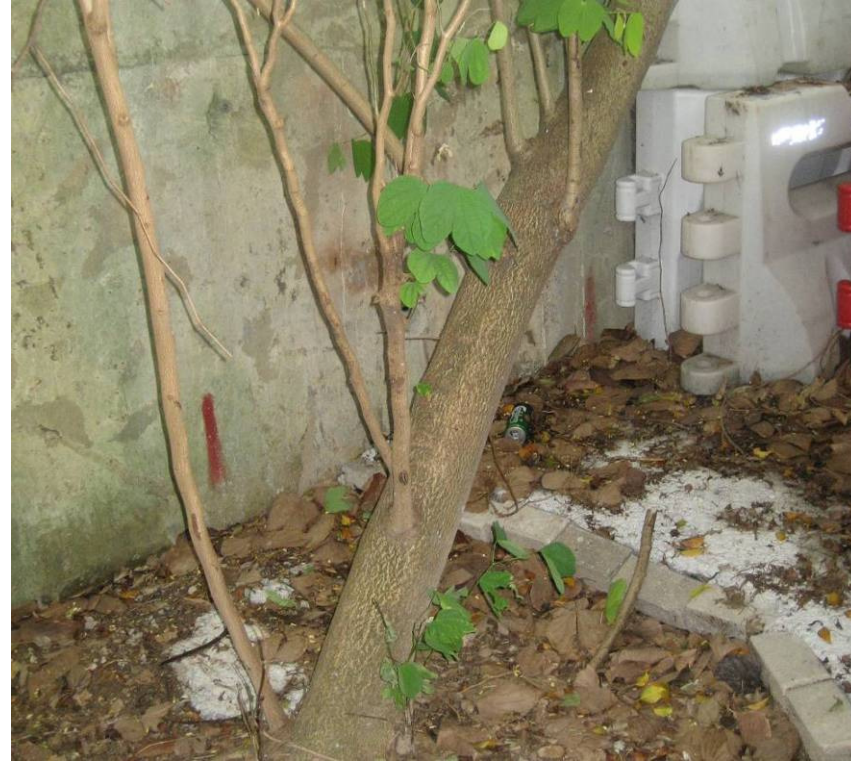
Aberdeen site --- Photo 16

A tree at the end of the storage area was observed without proper identification tag.

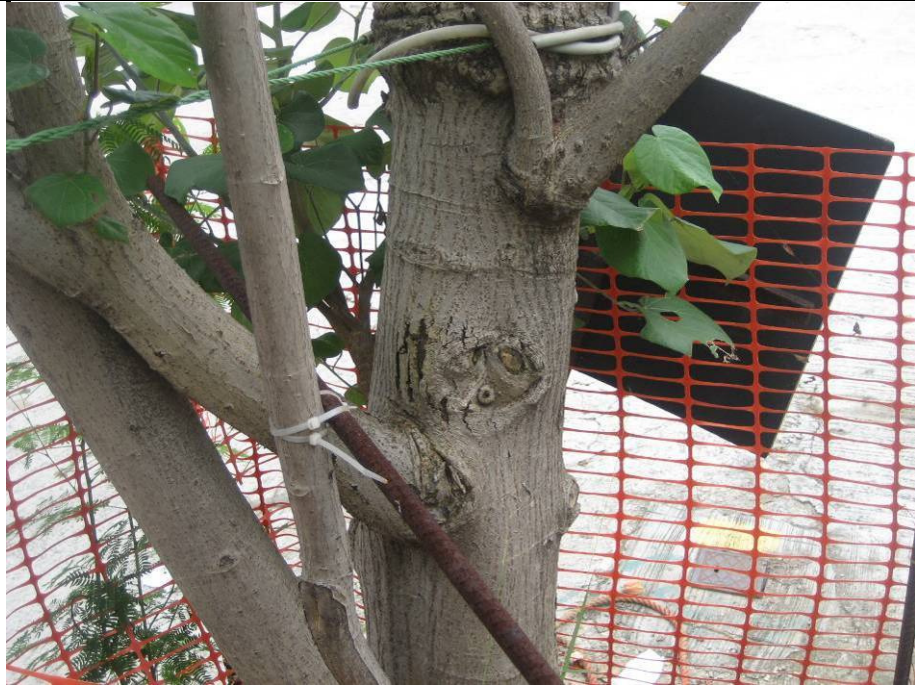
Cyberport site --- Photo 1

The retained tree T065(R) was still observed being untagged. Also a metal bar was still observed tied on the tree branch

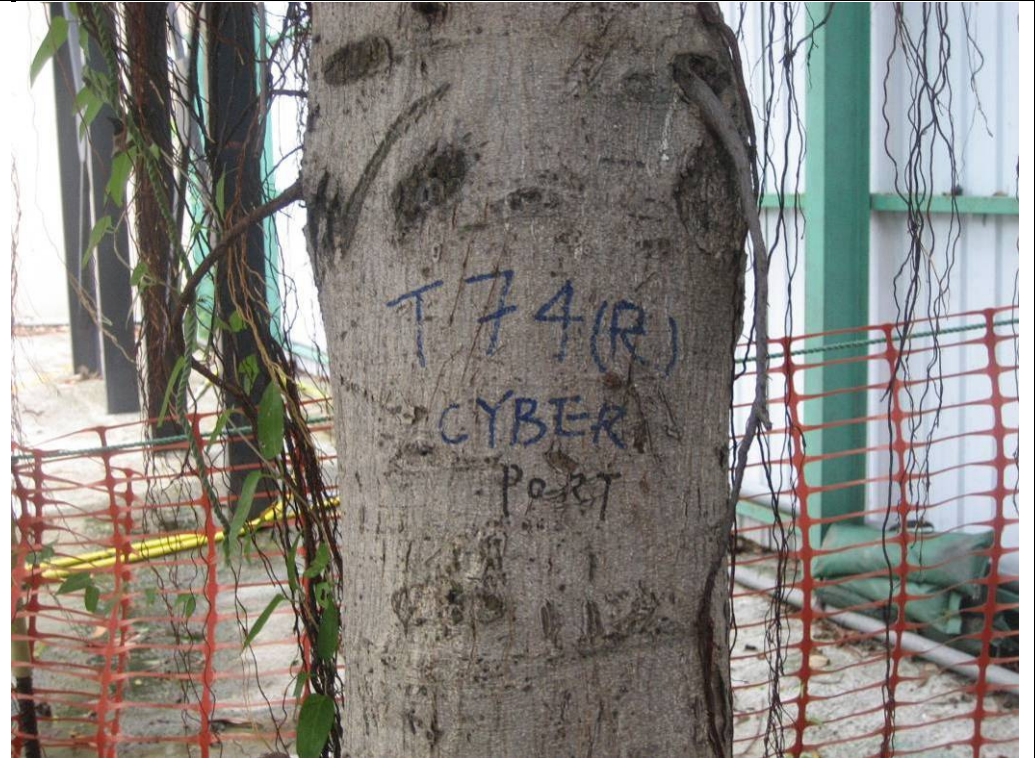
Cyberport site --- Photo 2

The retained tree T074(R) was still observed not being properly tagged. Marking was also observed on the tree trunk.

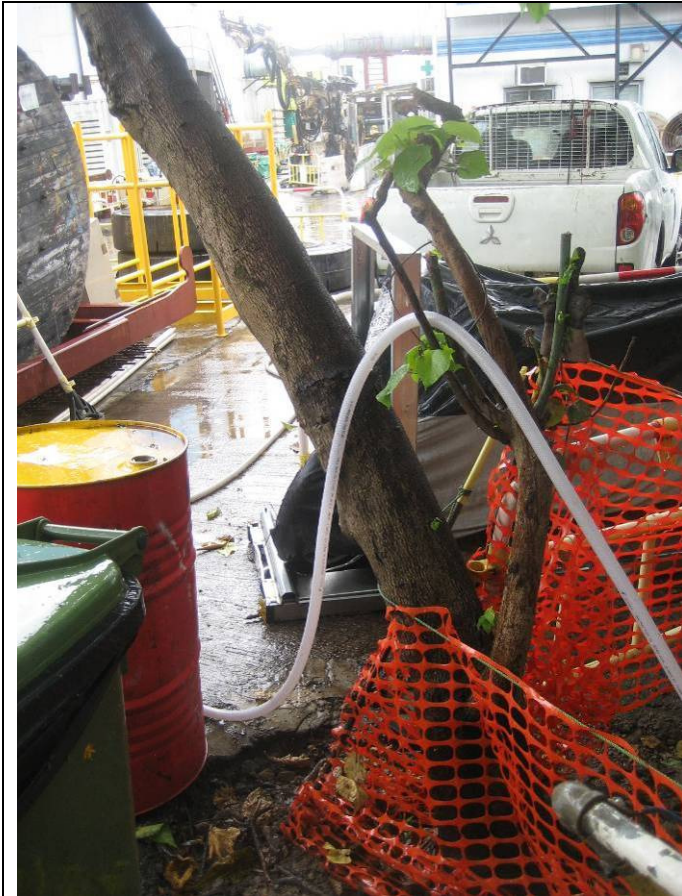
Sandy Bay site --- Photo 3

The tree protection zone for retained tree T038(R) was observed insufficient. The fencing was in contact with the tree trunk and part of the root was observed outside the tree protection zone. Also the tree identification tag was still observed missing for the retained tree T038(R).

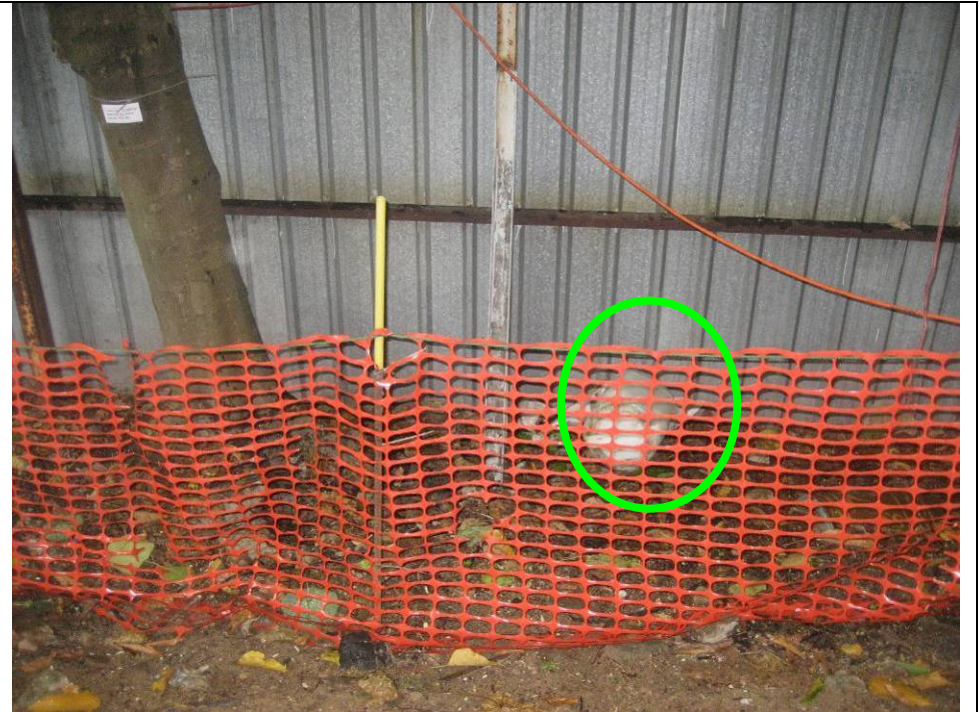
Sandy Bay site --- Photo 4

Construction waste was observed inside the tree protection zone of T052(R).
