Contract No. DC/2007/24
Harbour Area Treatment Scheme Stage 2A
Construction of Sewage Conveyance System from Aberdeen to Sai Ying Pun

Environmental Certification Sheet – 42

Document/ Plan/Changes/Information to be Certified/ Verified:	Quarterly Environmental Monitoring and Audit Report No.10 (EMA/038, Rev B)
Date of Report:	24 July 2012
Date of correspondence to IEC:	25 July 2012
Date received:	25 July 2012

**Contract no. DC/2007/24
Construction of Sewage Conveyance System from Aberdeen to Sai Ying Pun
Submission of 10th Quarterly EM&A Report for April to June 2012 (Rev. B)**

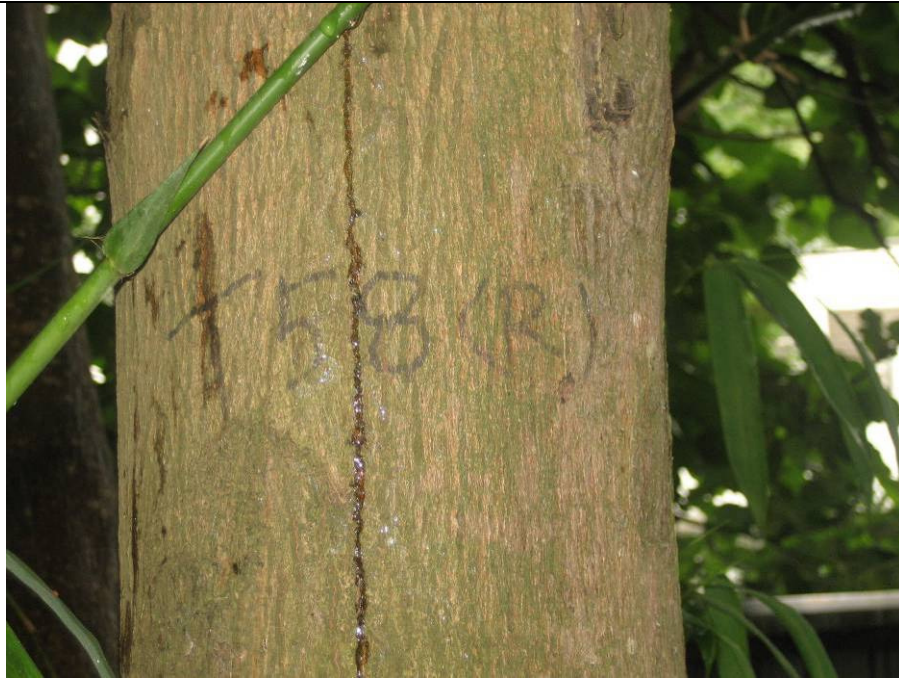
Sandy Bay site --- Photo 5

The retained tree T058(R) was observed not being properly tagged. Marking was also observed on the tree trunk.

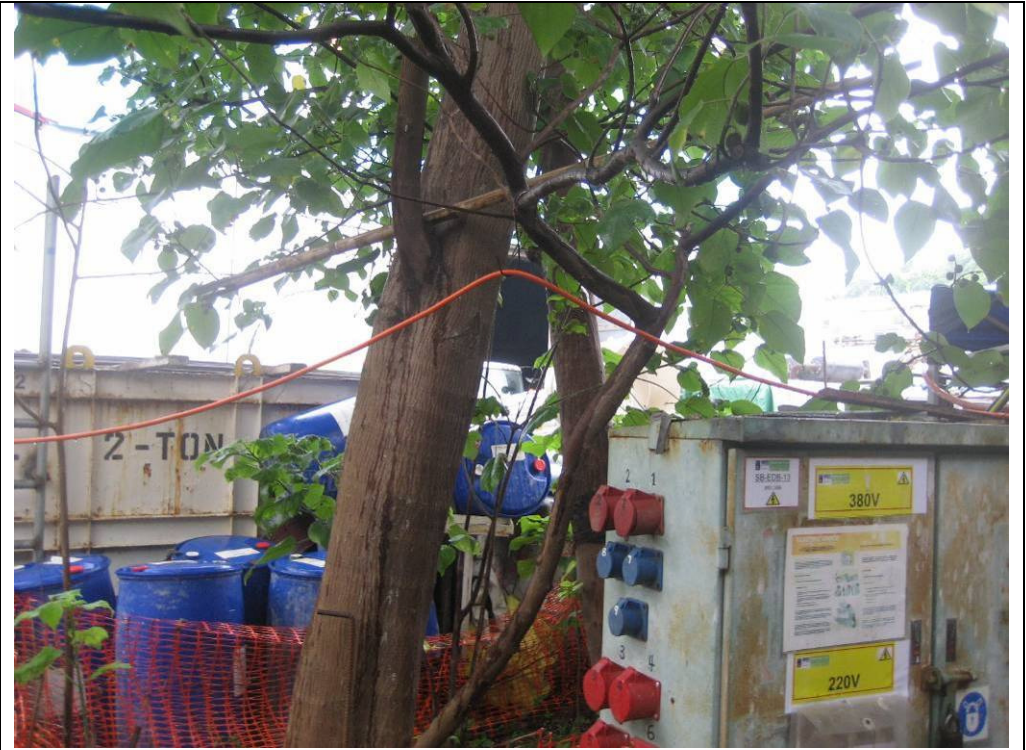
Sandy Bay site --- Photo 6

The retained tree T021(R) was observed not being properly tagged. Construction material and cable was observed hanging on the tree branches.

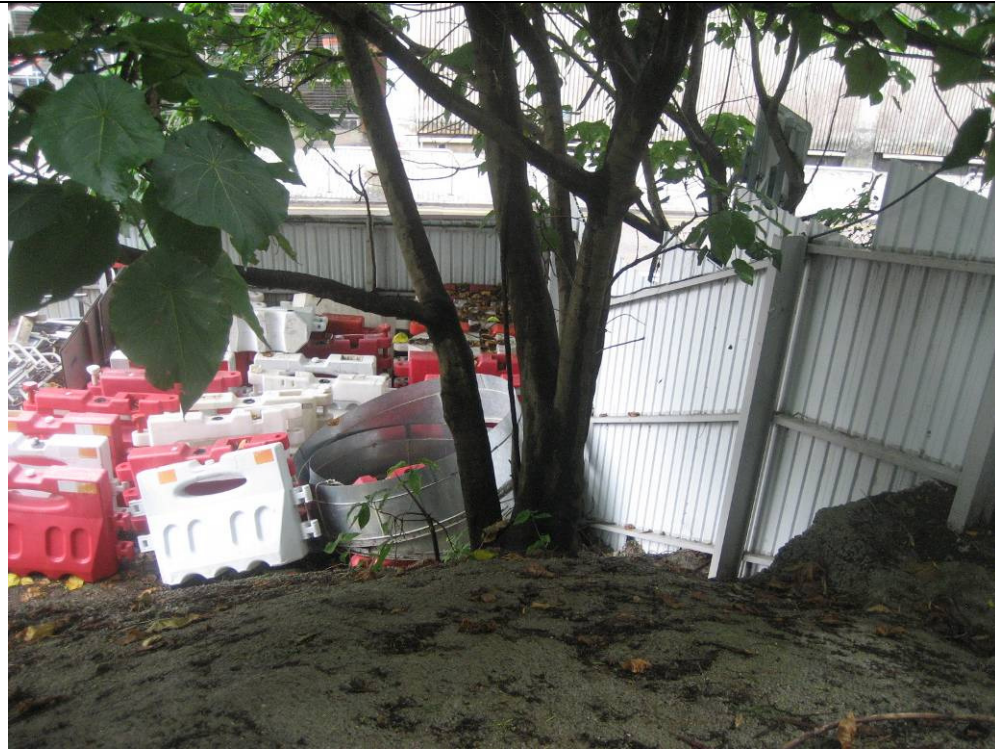
Sandy Bay site --- Photo 7

A tree near the entrance was observed without proper identification tag.

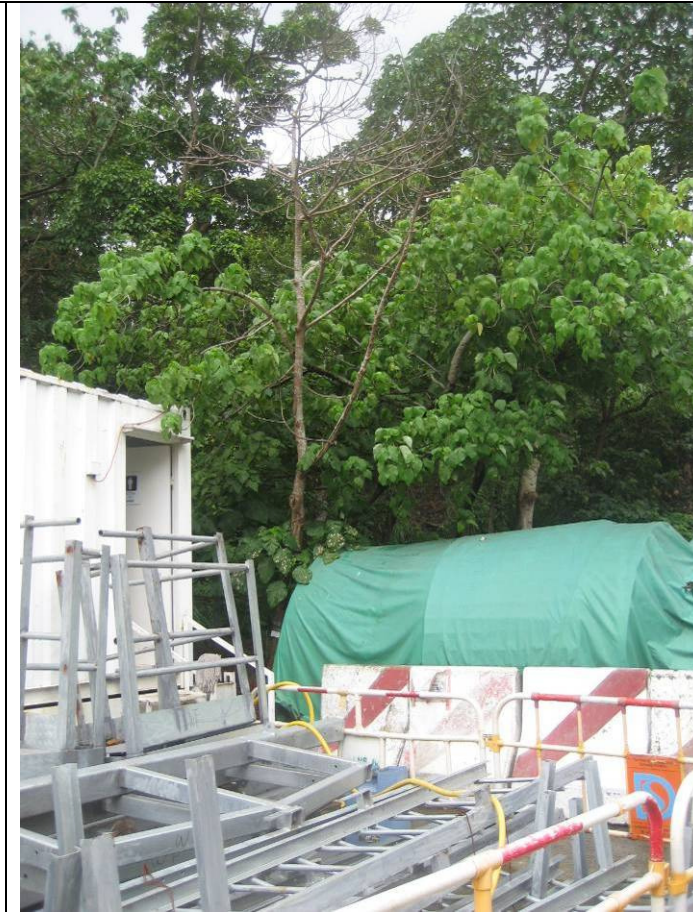
Aberdeen site --- Photo 8

The retained Tree T076(R) was observed to be in a very poor health condition.

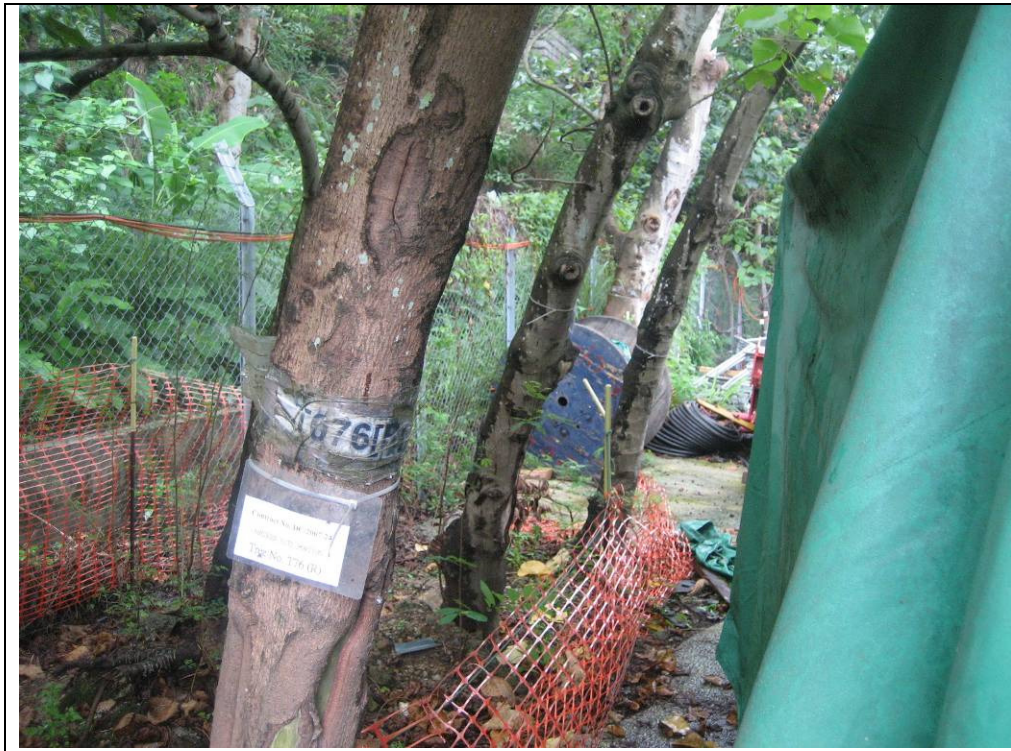
Aberdeen site --- Photo 9
Tree protect zone for the retained tree T076(R) and T077(R) was damaged.

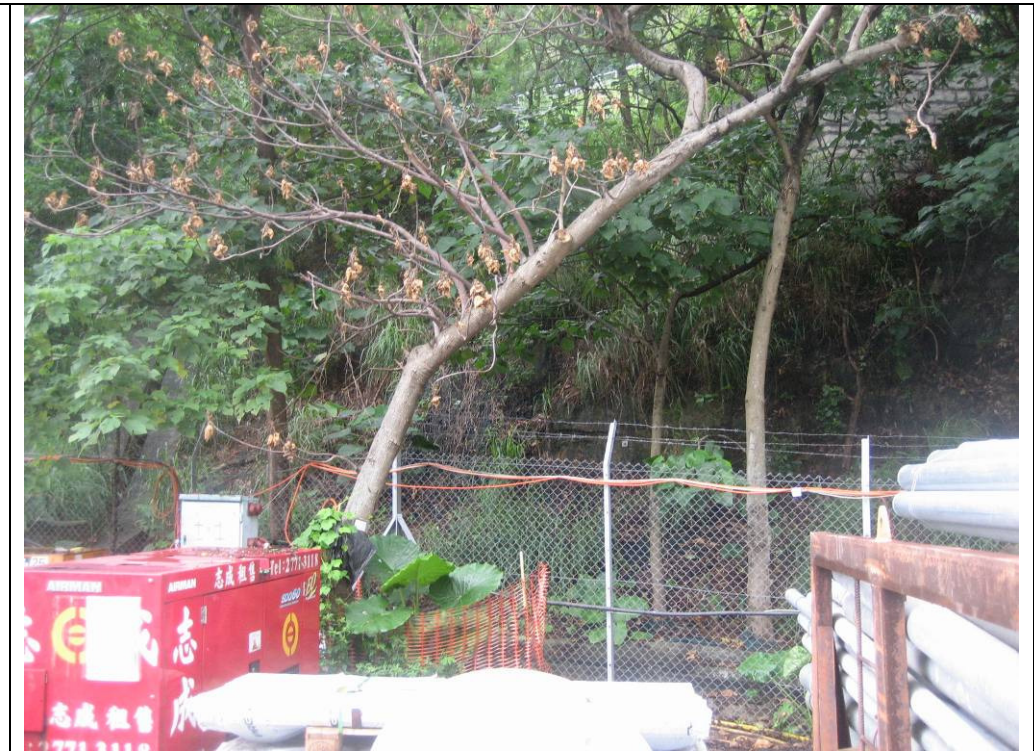
Aberdeen site --- Photo 10
The retained tress T083 was observed in very poor health.

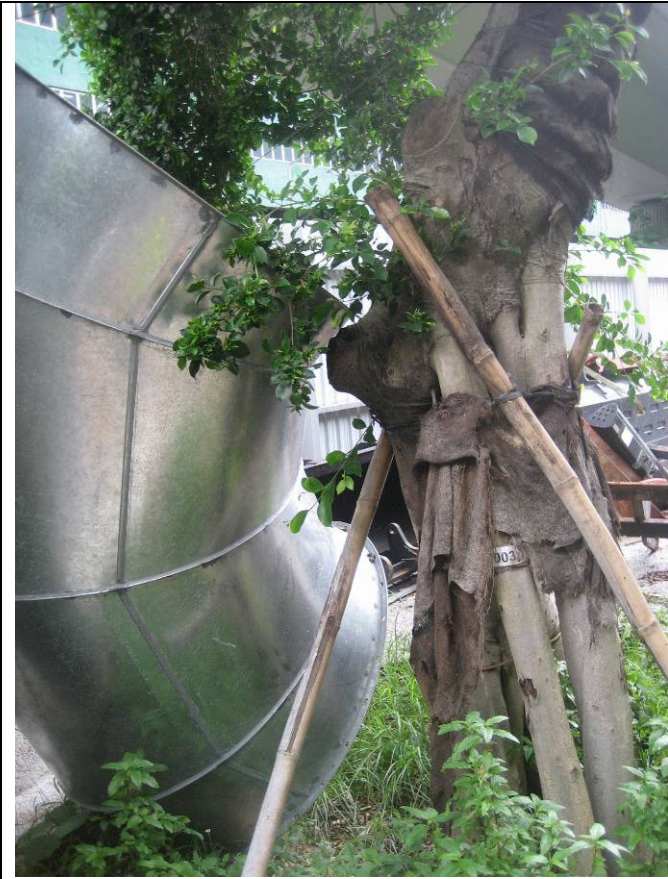
Aberdeen site --- Photo 11
 Construction material was observed stored very close to the retained tree T003(T).

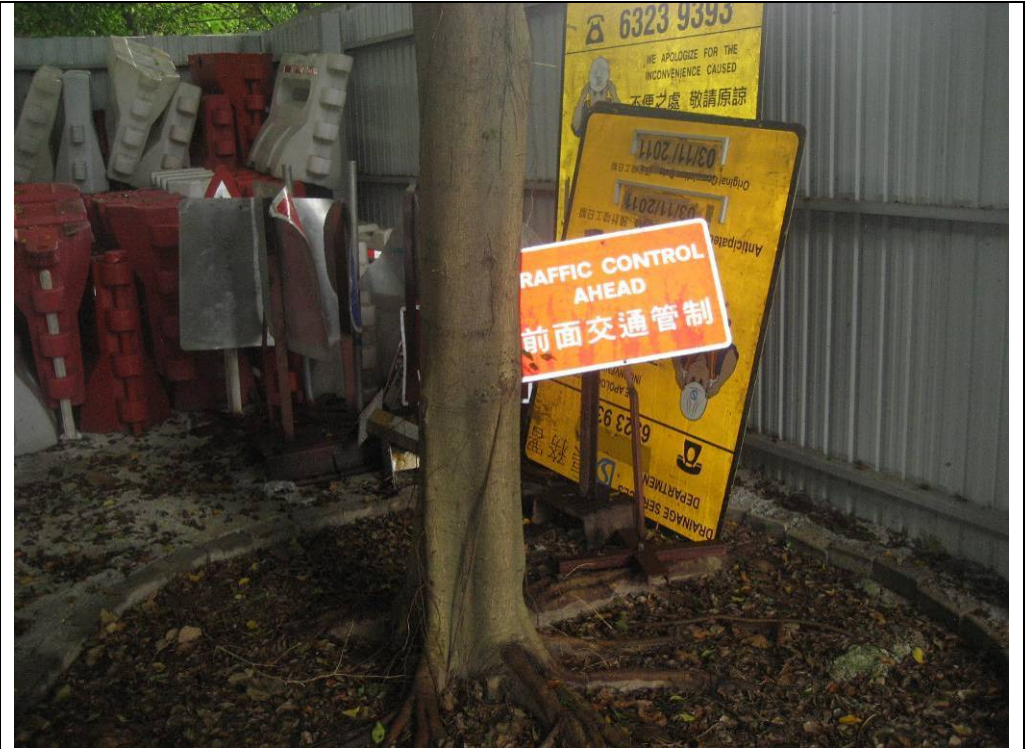
Aberdeen site --- Photo 12
 A tree at the end of the workshop area was still observed without proper identification tag

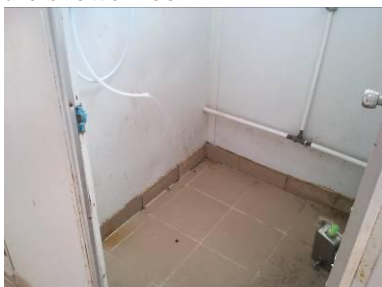
Photo 1 The water leakage was found from the water tap in the shower room

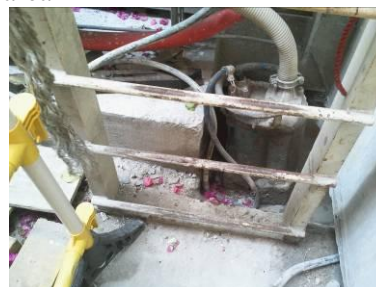
Photo 2 The trashes and leaves were found in the site area

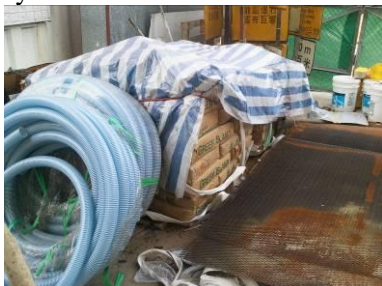
Photo 3 The cement bags were found without properly cover near the site entrance

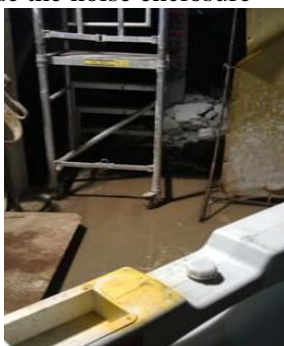
Photo 1 Water accumulation was found near access inside the noise enclosure

1. The contractor was reminded to clean the accumulated water to prevent mosquito breeding.
2. The contractor was reminded to clean the accumulated leaves in the pit behind the container.

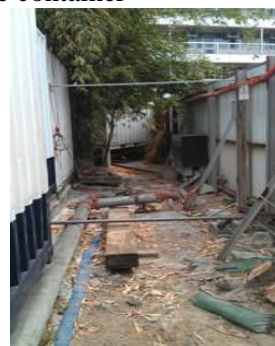
Photo 2 Leaves accumulation was found in the pit behind the container

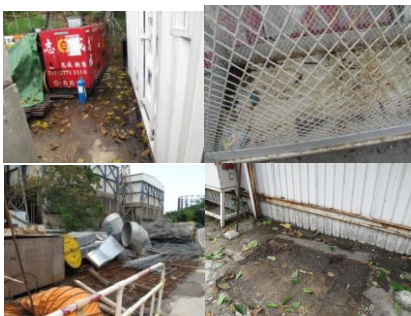
Photo 5 Trash accumulated in the workshop site area

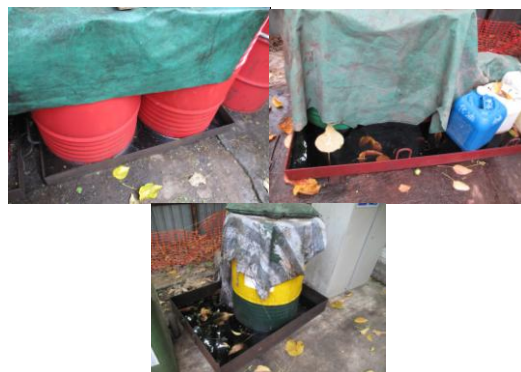
Photo 5 Stagnant water found on tarpaulin near chemical storage area

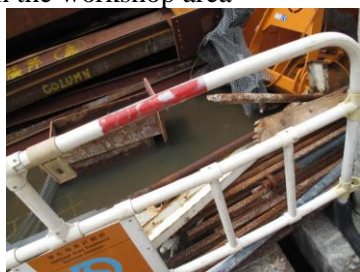
Photo 5 Stagnant water was found in the washing basin in the workshop area

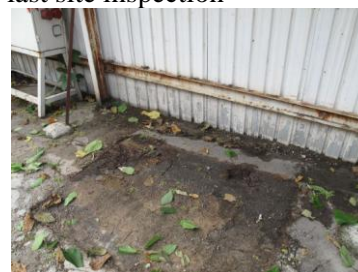
Photo 6 Trash was found in the workshop site area since last site inspection

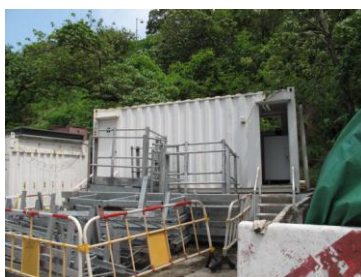
Photo 9 The sanitation level of the toilet was found poor

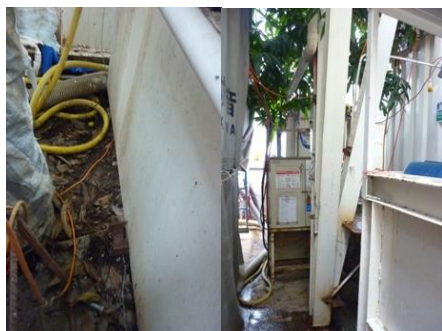
Photo 1 Leaves were found in the site near the electric box

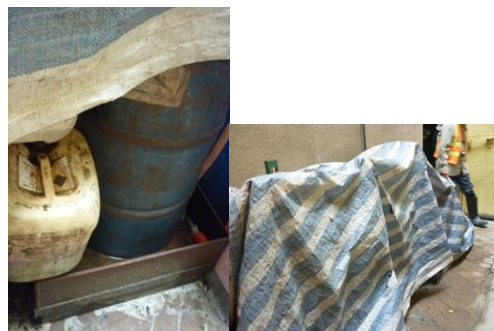
Photo 2 Stagnant water was found in the trip tray near the noise enclosure

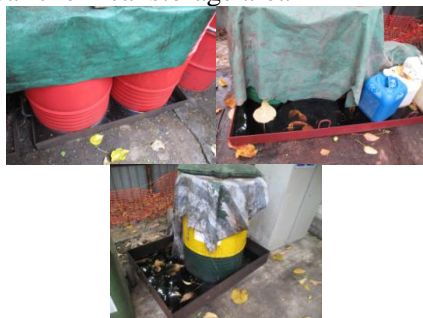
Photo 5 Stagnant water was found in drip trays near chemical storage area

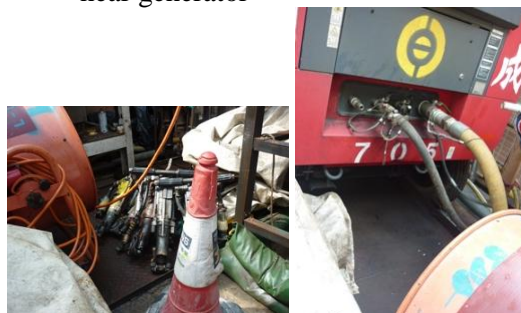
Photo 2 Stagnant water was found in drip tray near generator

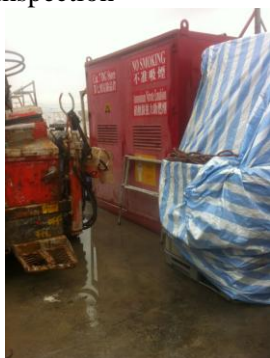
Photo 1 Accumulated water was found at the corner near the danger goods storage since last inspection

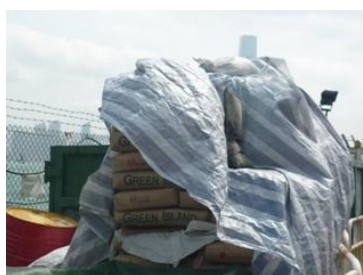
Photo 1 Some cement bags were found without proper cover

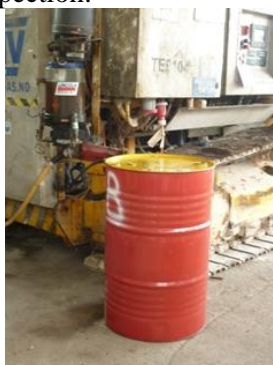
Photo 1 Fuel container near the AMV plant was found without drip tray since last inspection.

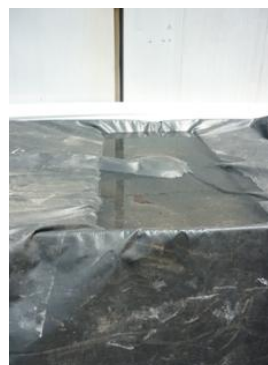
Photo 2 Water accumulation was found on the cover near the noise enclosure.

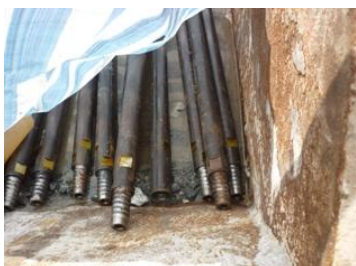
Photo 1 Water accumulation was found in skip on the noise platform

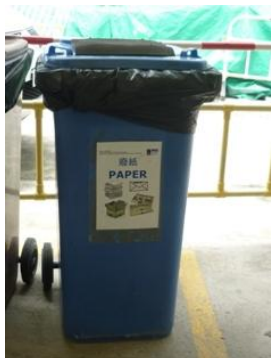
Photo 5 Non paper material was found in paper recycle bin since last inspection

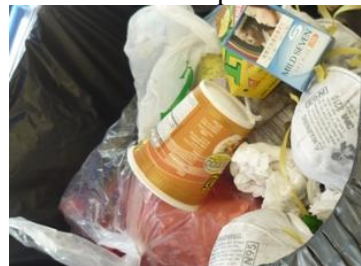
Photo 4 Non paper material was found in paper recycle bin since last inspection

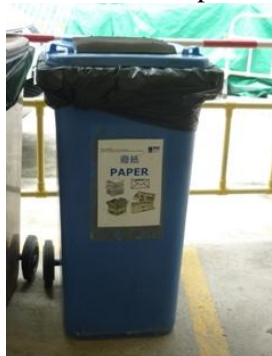
Photo 5 Non paper material was found in paper

recycle bin since last inspection

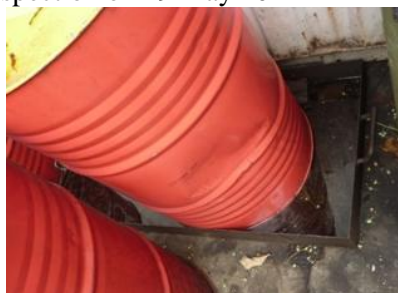
Photo 3 Water accumulation was found in drip tray near the Plant Department container since inspection on 29 May 2012

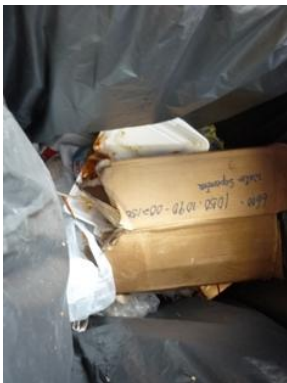
Photo 5 Non paper material was found in paper recycle bin since inspection on 29 May 2012

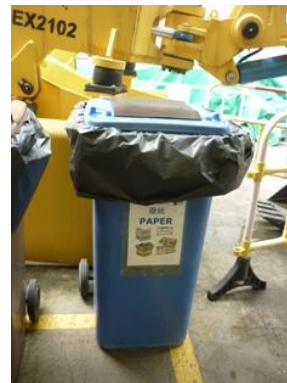
Photo 6 Non paper material was found in paper recycle bin since inspection on 29 May 2012

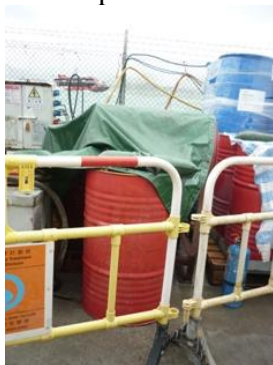
Photo 3 Chemical barrels without drip tray were found near stockpiles
