Central Police Station Conservation
and Revitalisation Project:
Thirty-third Monthly EM&A Report
(1 July to 31 July 2014)

Issue Date: August 2014

Environmental Resources Management

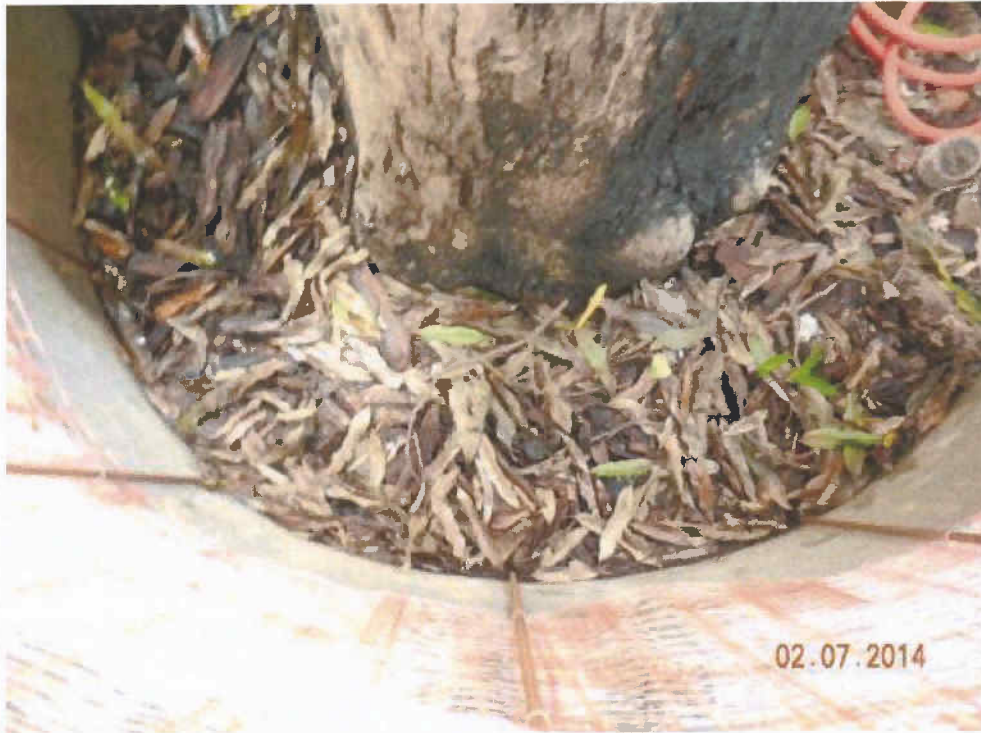
Fig 2. The root collar of Tree-5 is good. The planter is full of mulch.

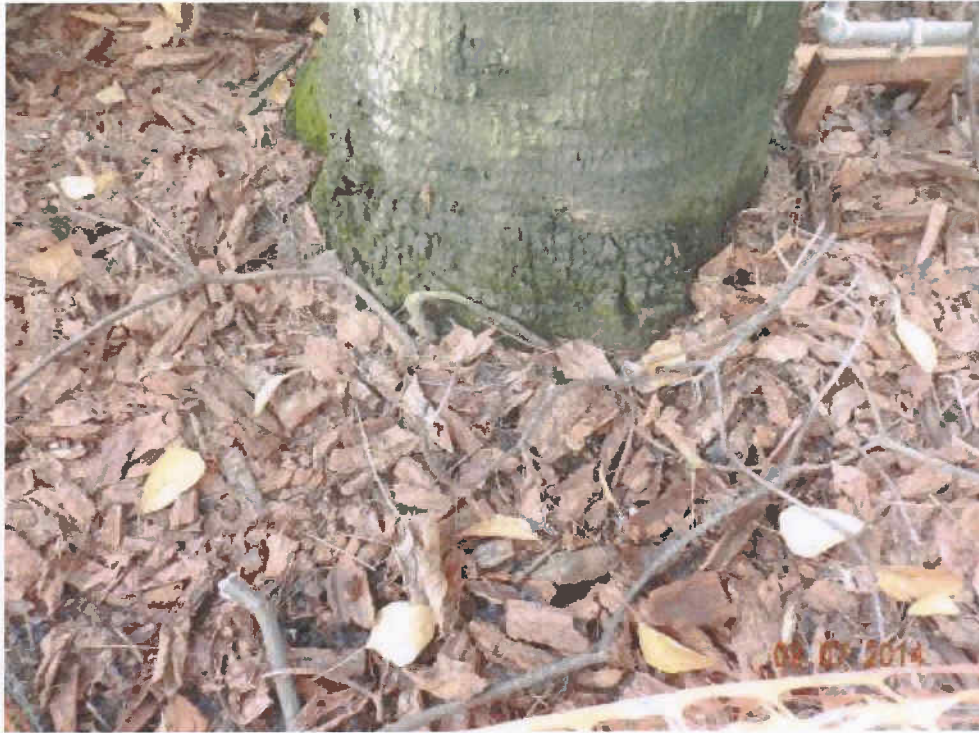
Fig 2. The root collar is normal. The planter is full of mulch.

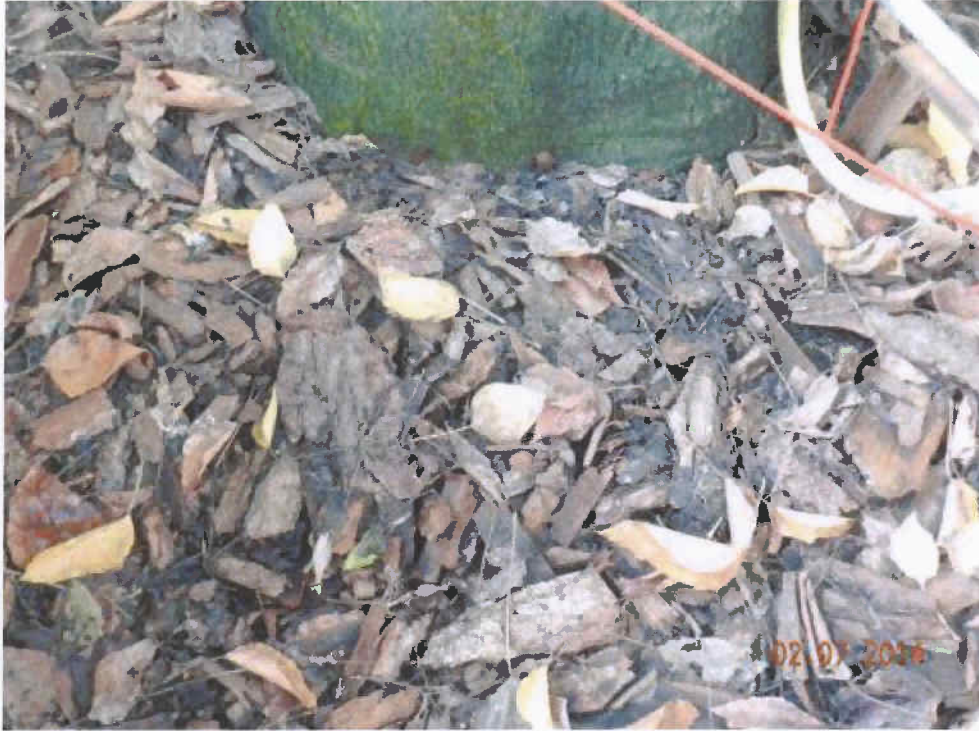
Fig 2. Root collar of Tree-7 is normal. The planter is full of mulch.

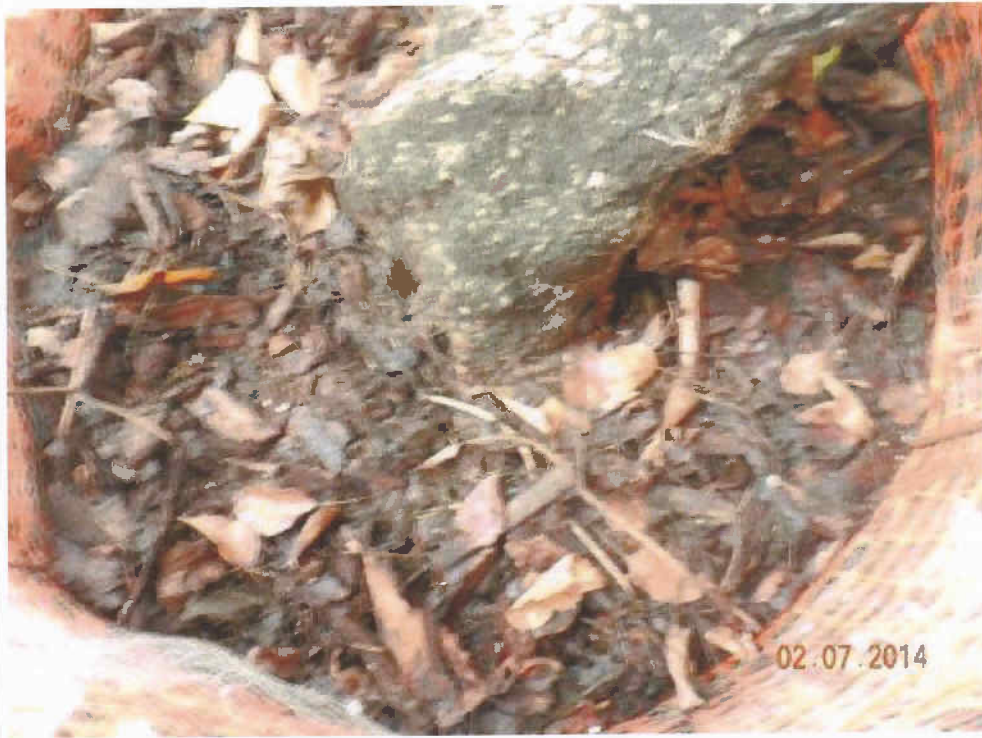
Fig 2. The root collar is normal. The planter is full of mulch.

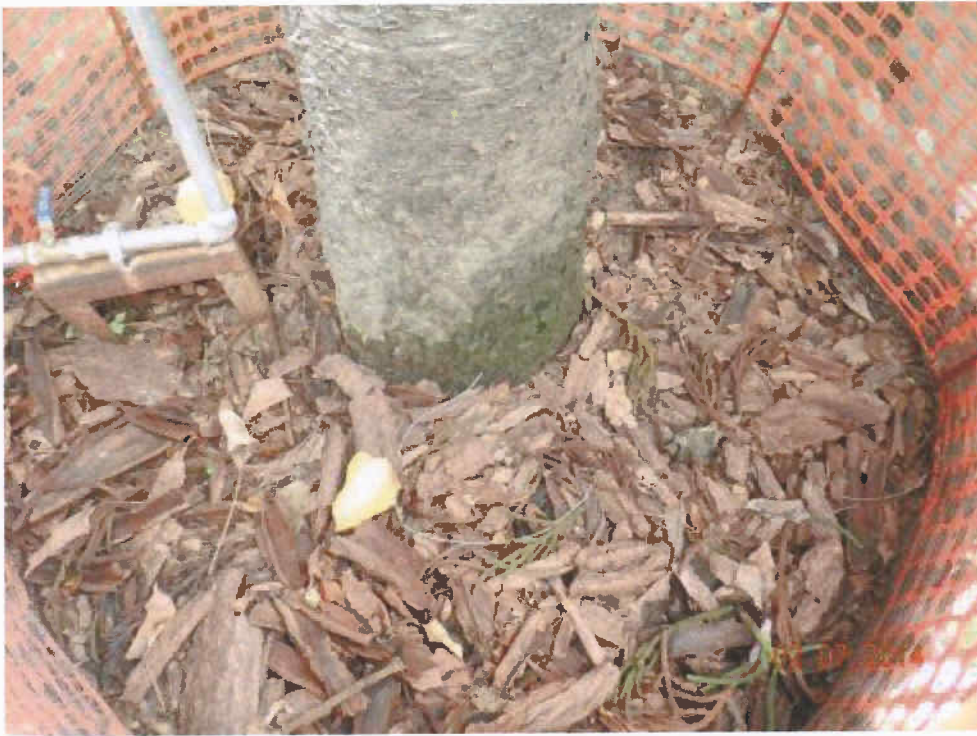
Fig 2. Root collar of Tree-9 is normal. The planter is full of mulch.

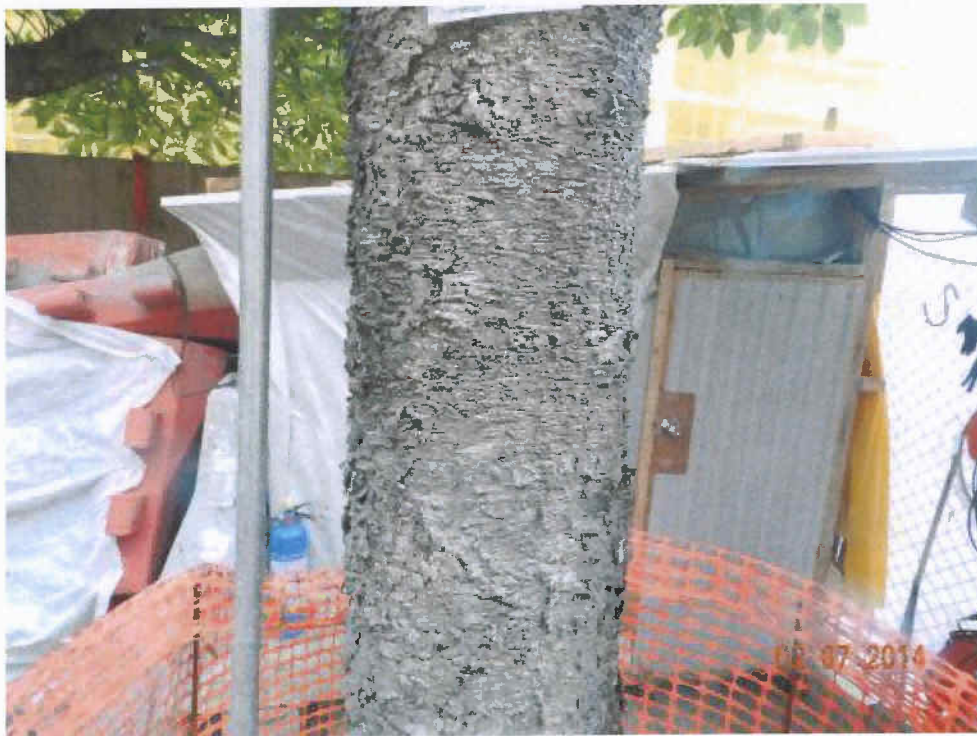
Fig. 4 No signs of sap flow have been detected again on the cavity.
