Central Police Station Conservation  
and Revitalisation Project:  
*Thirty-sixth Monthly EM&A Report*  
*(1 October to 31 October 2014)*

Issue Date: November 2014

The Jockey Club CPS Limited

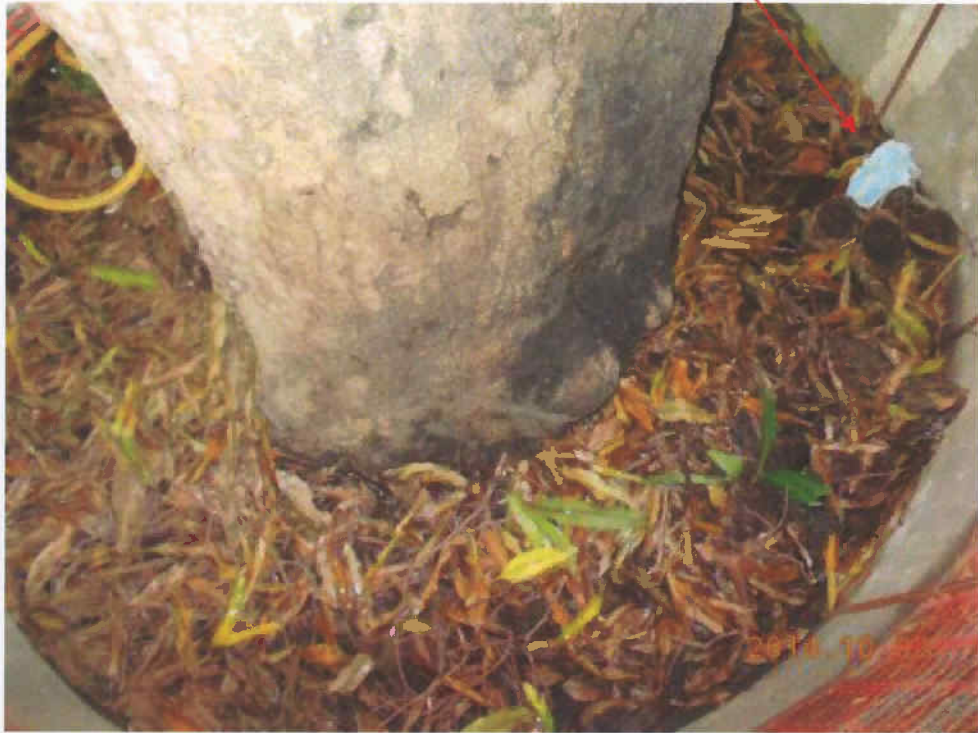
Fig 2. The root collar of Tree-5 is normal. A few litter has been found at the planter.

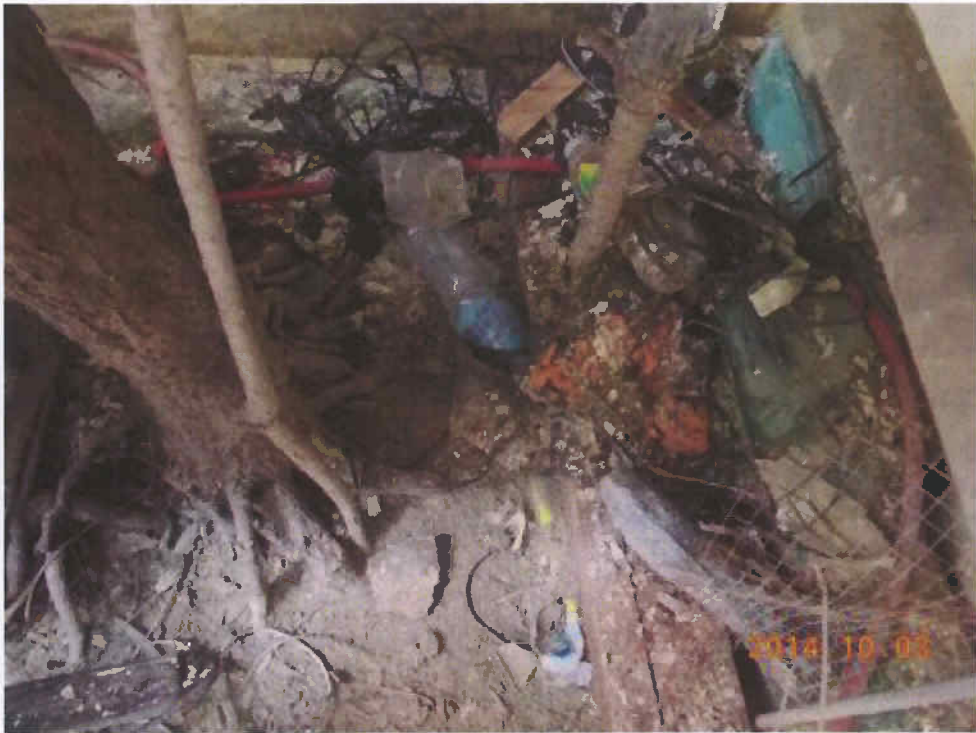
Fig. 2 Cleanliness of the planter is poor. The top-soil near Tree-11 has been seriously polluted by the construction debris and litter.

Fig. 3 Other side view of the planter. The top-soil near Tree-11 has been seriously polluted by the construction debris and litter.

1. To take immediate mitigation measures against the land pollution.

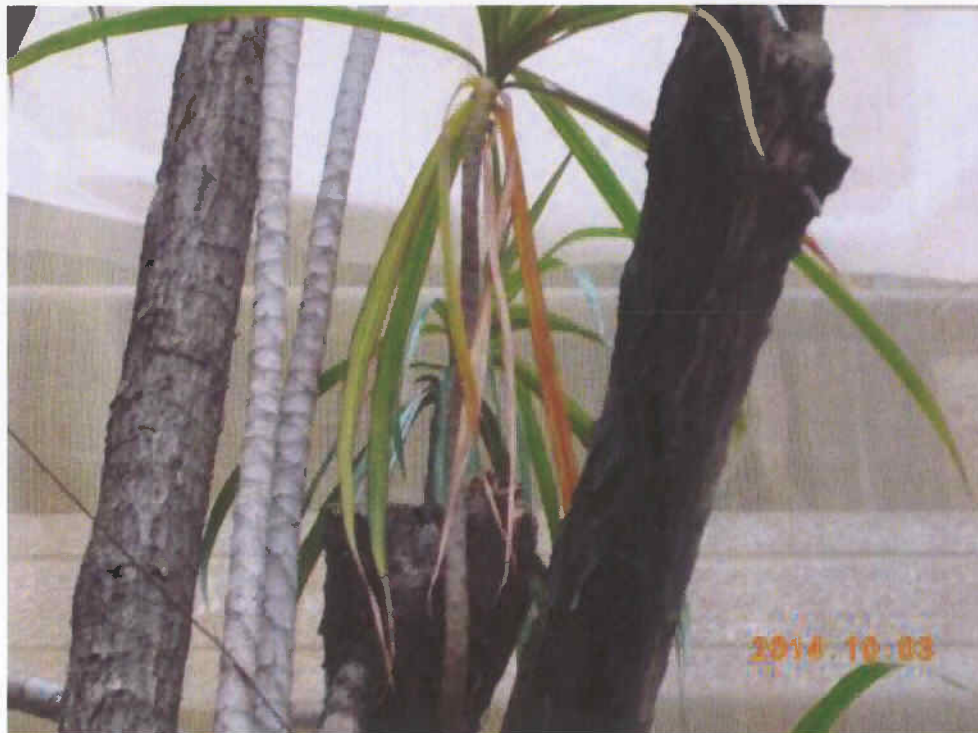
Fig. 6 Lots of withered leave appear on the upper branches.

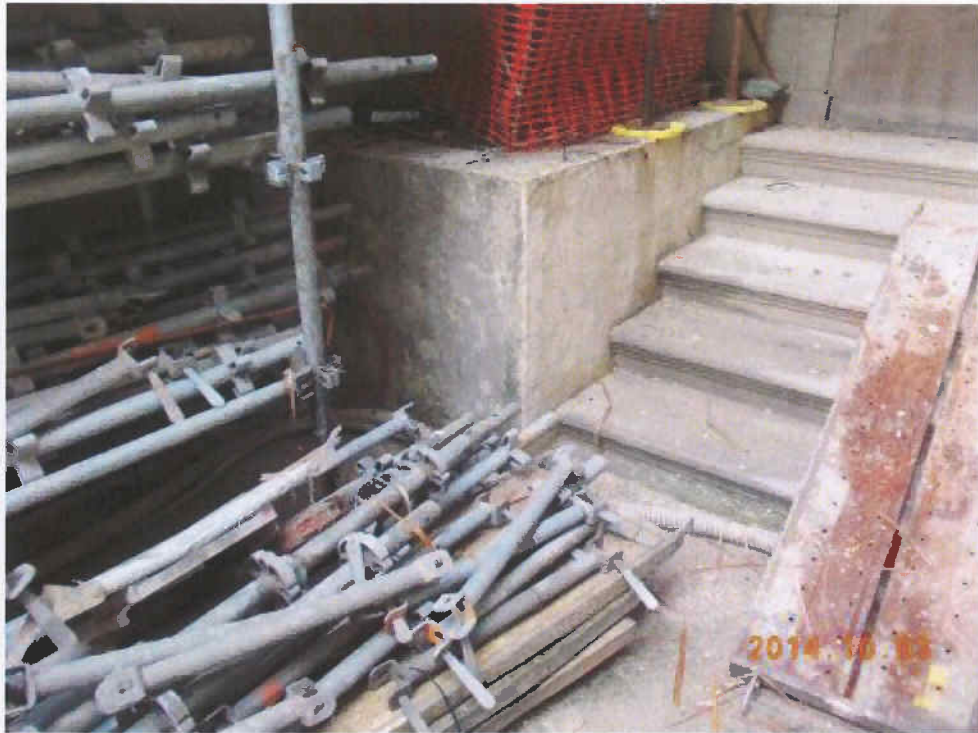
Fig. 9 The small cordon zone has been broken by the metal tubes.
