Central Police Station Conservation and Revitalisation Project: 23rd Quarterly EM&A Report (1 May 2017 to 31 July 2017)

Issue Date: October 2017

The Jockey Club CPS Limited

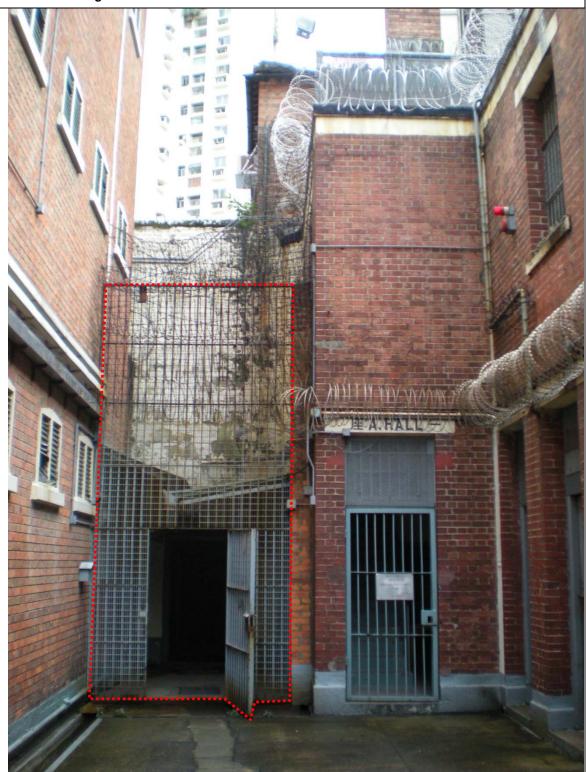
Above, photo taken on 30th July 2009, dotted line showing the Transfer Gate "A" within A Hall Yard.

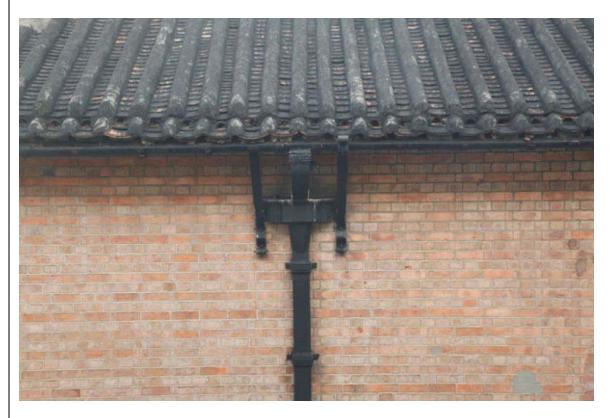
Above, photo taken on 17th August 2011, showing the historic hopper at its location.

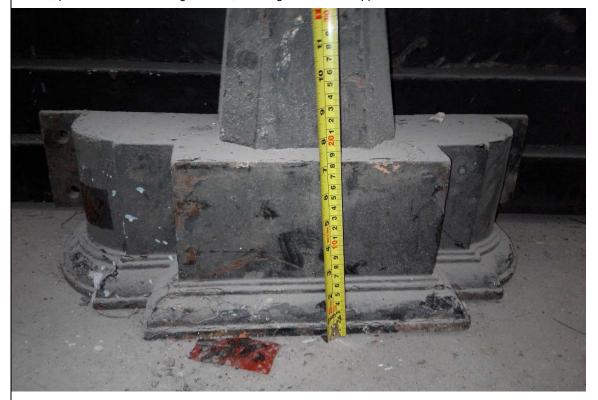
Above, photo taken on 22nd January 2015, showing the hopper being salaved from the building.

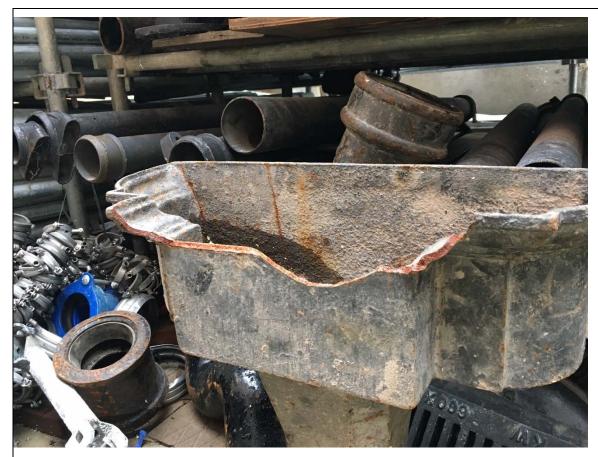
Above, photo taken on 27th April 2017, showing the hopper was damaged.
