# **Construction Waste Management Plan**

## **Central Police Station Conservation and Revitalisation Project (Rev.5)**

| | Central Police Station Conservation and<br>Revitalisation Project Management<br>Contract | Rev. No. : 5 |

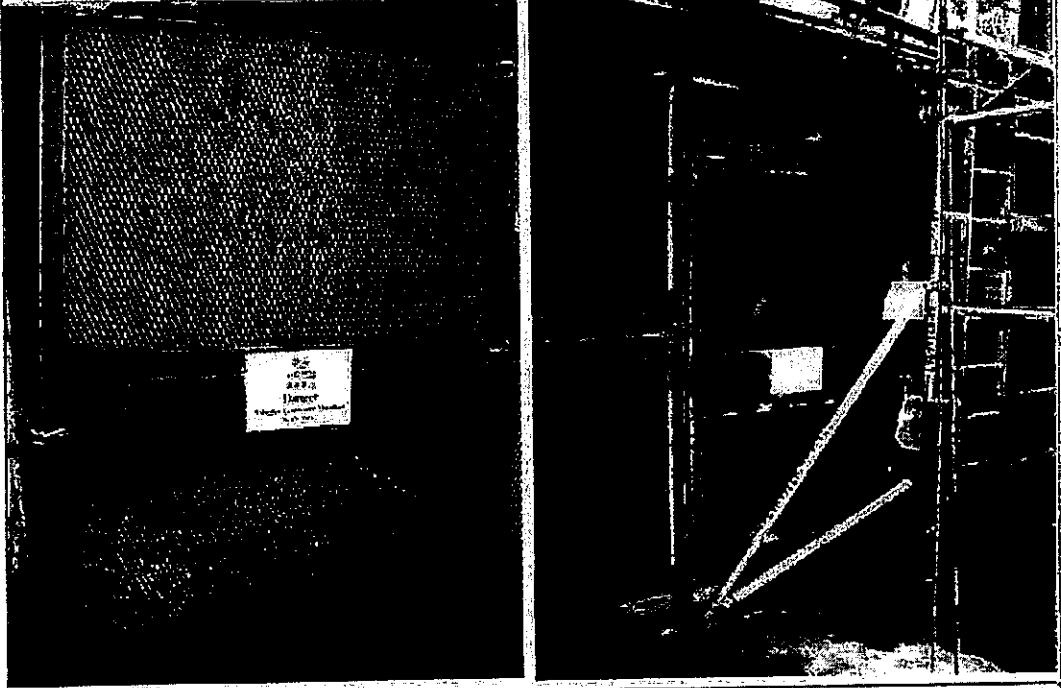
**Photo 3 & 4**  
The metal door is locked with warning notice

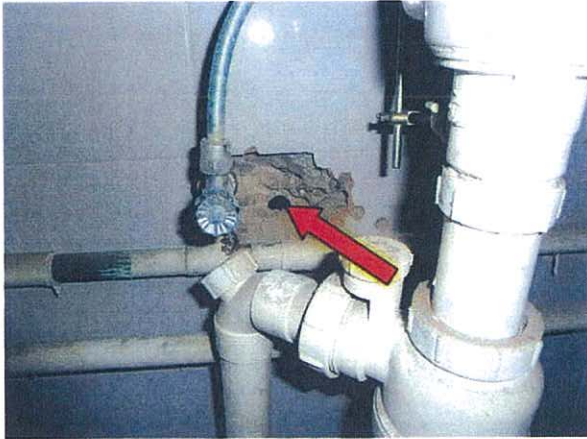
Photo 2. Embedded hot water pipe was insulated with uPVC material

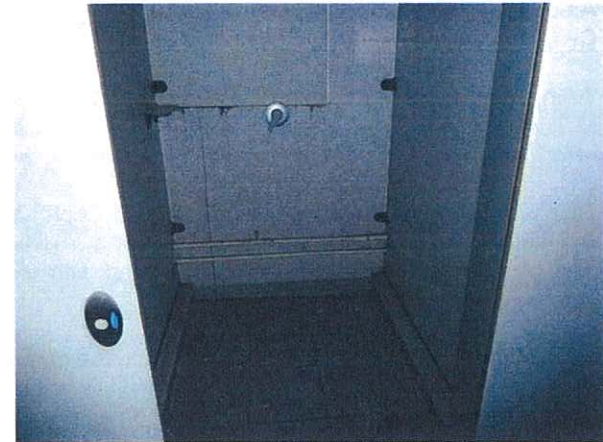
Photo 3. No insulation was found in pipe opening
